Contract No. HY/2011/09
Hong Kong-Zhuhai-Macao Bridge
Hong Kong Link Road – Section between HKSAR Boundary and Scenic Hill

Submission under Environmental Permit (EP-352/2009/D – Condition 4.4)
Monthly EM&A Report – July 2016

**Contract No. HY/2011/09 HZMB Hong Kong Link Road –
Section between HKSAR Boundary and Scenic Hill
Revised Monthly EM&A Report for July 2016 (EP-352/2009/D)**

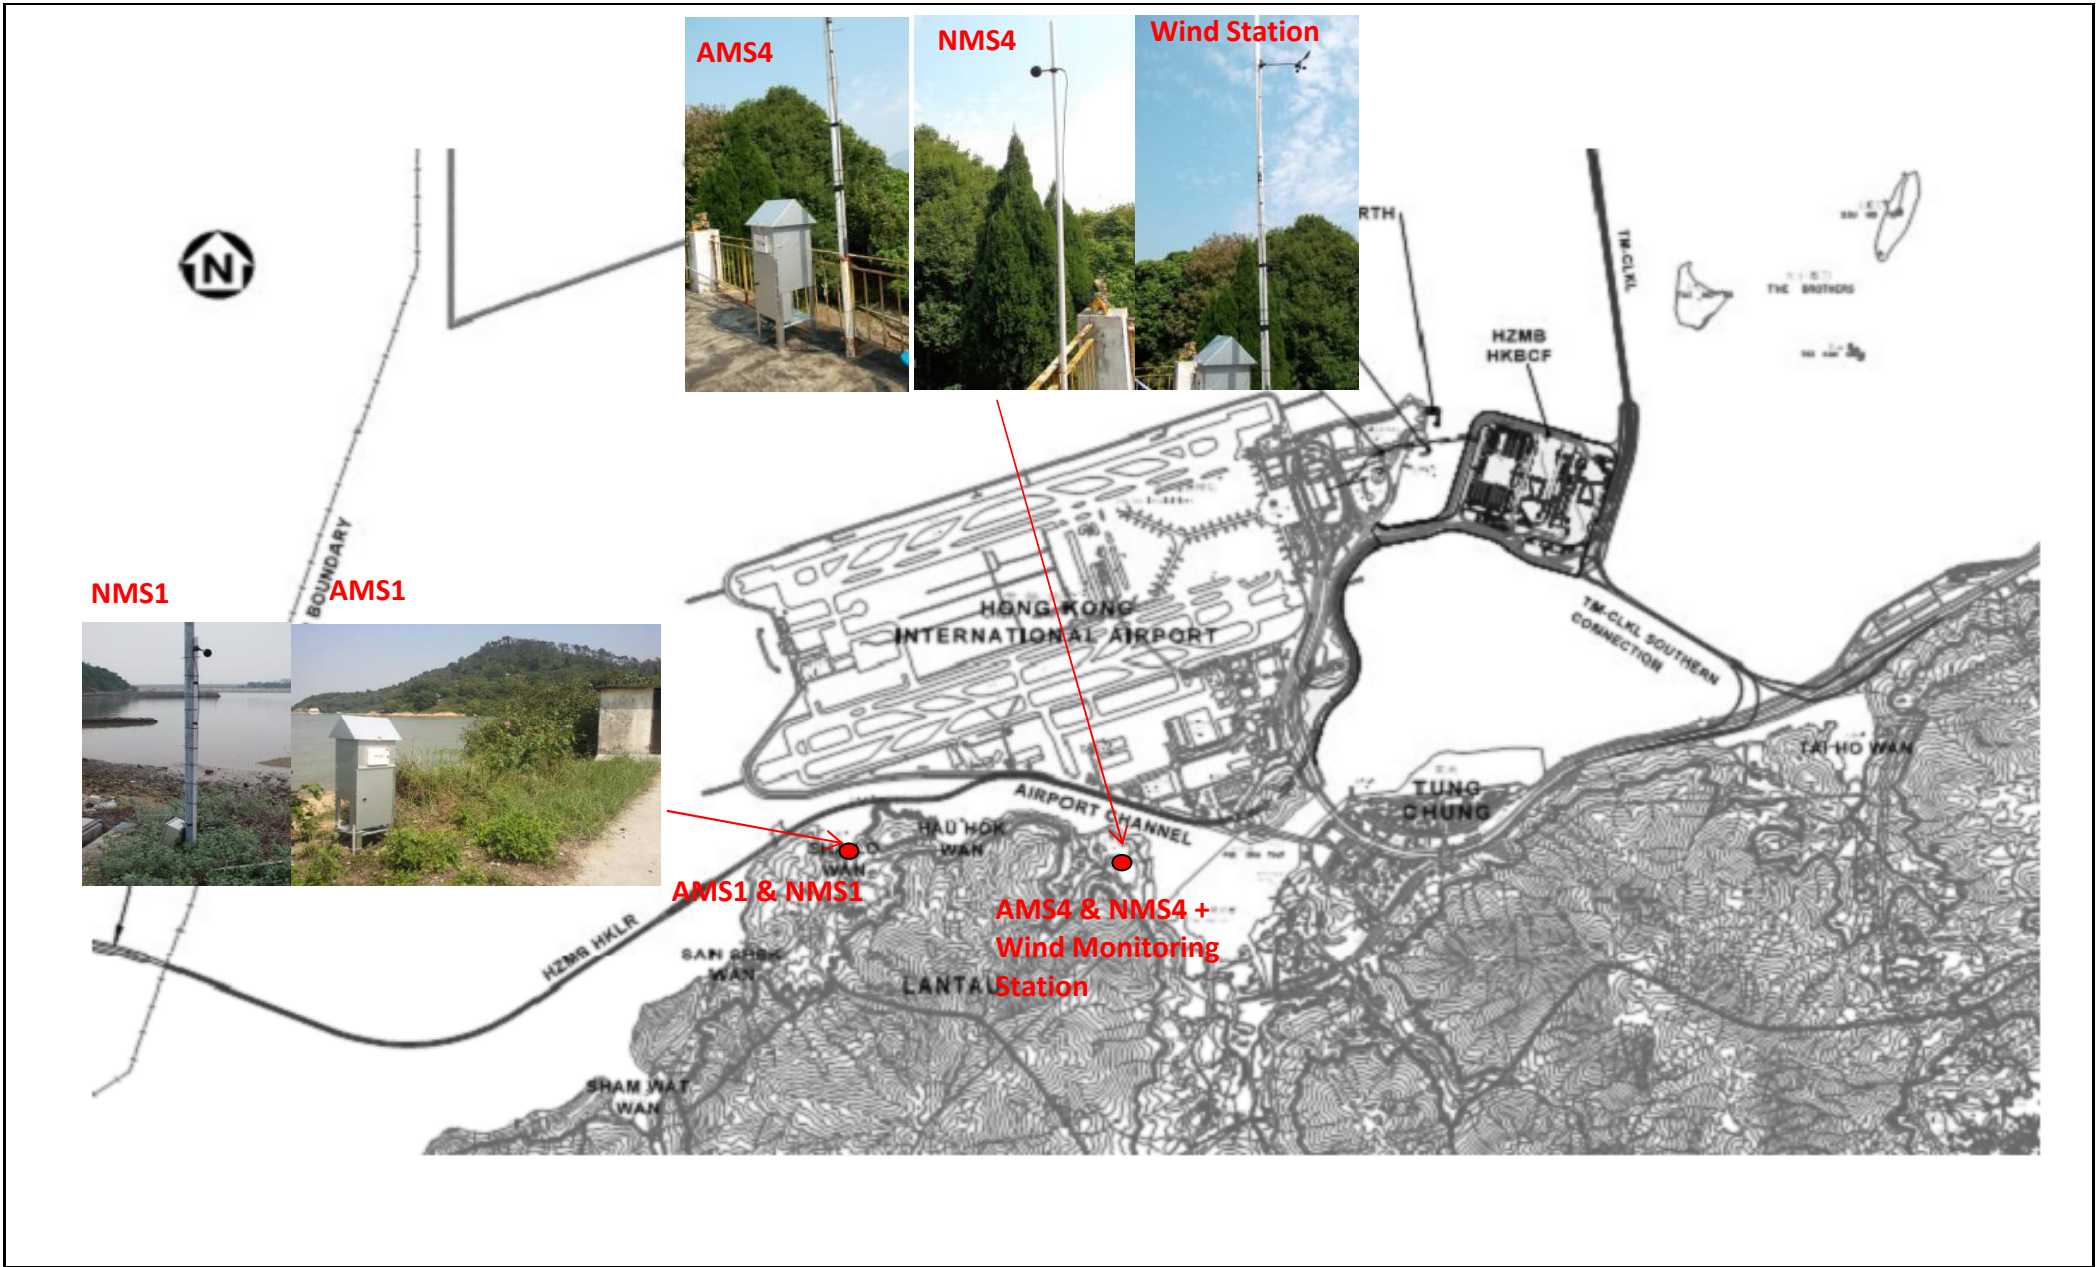
Title	Contract No. HY/2011/09 Hong Kong-Zhuhai-Macao Bridge Hong Kong Link Road – Section between HKSAR Boundary and Scenic Hill	Scale	N.T.S	Propose No.	MA12014	CINOTECH
		Date	Feb-13	Figure	3	
Locations of Air Quality and Noise Monitoring Stations

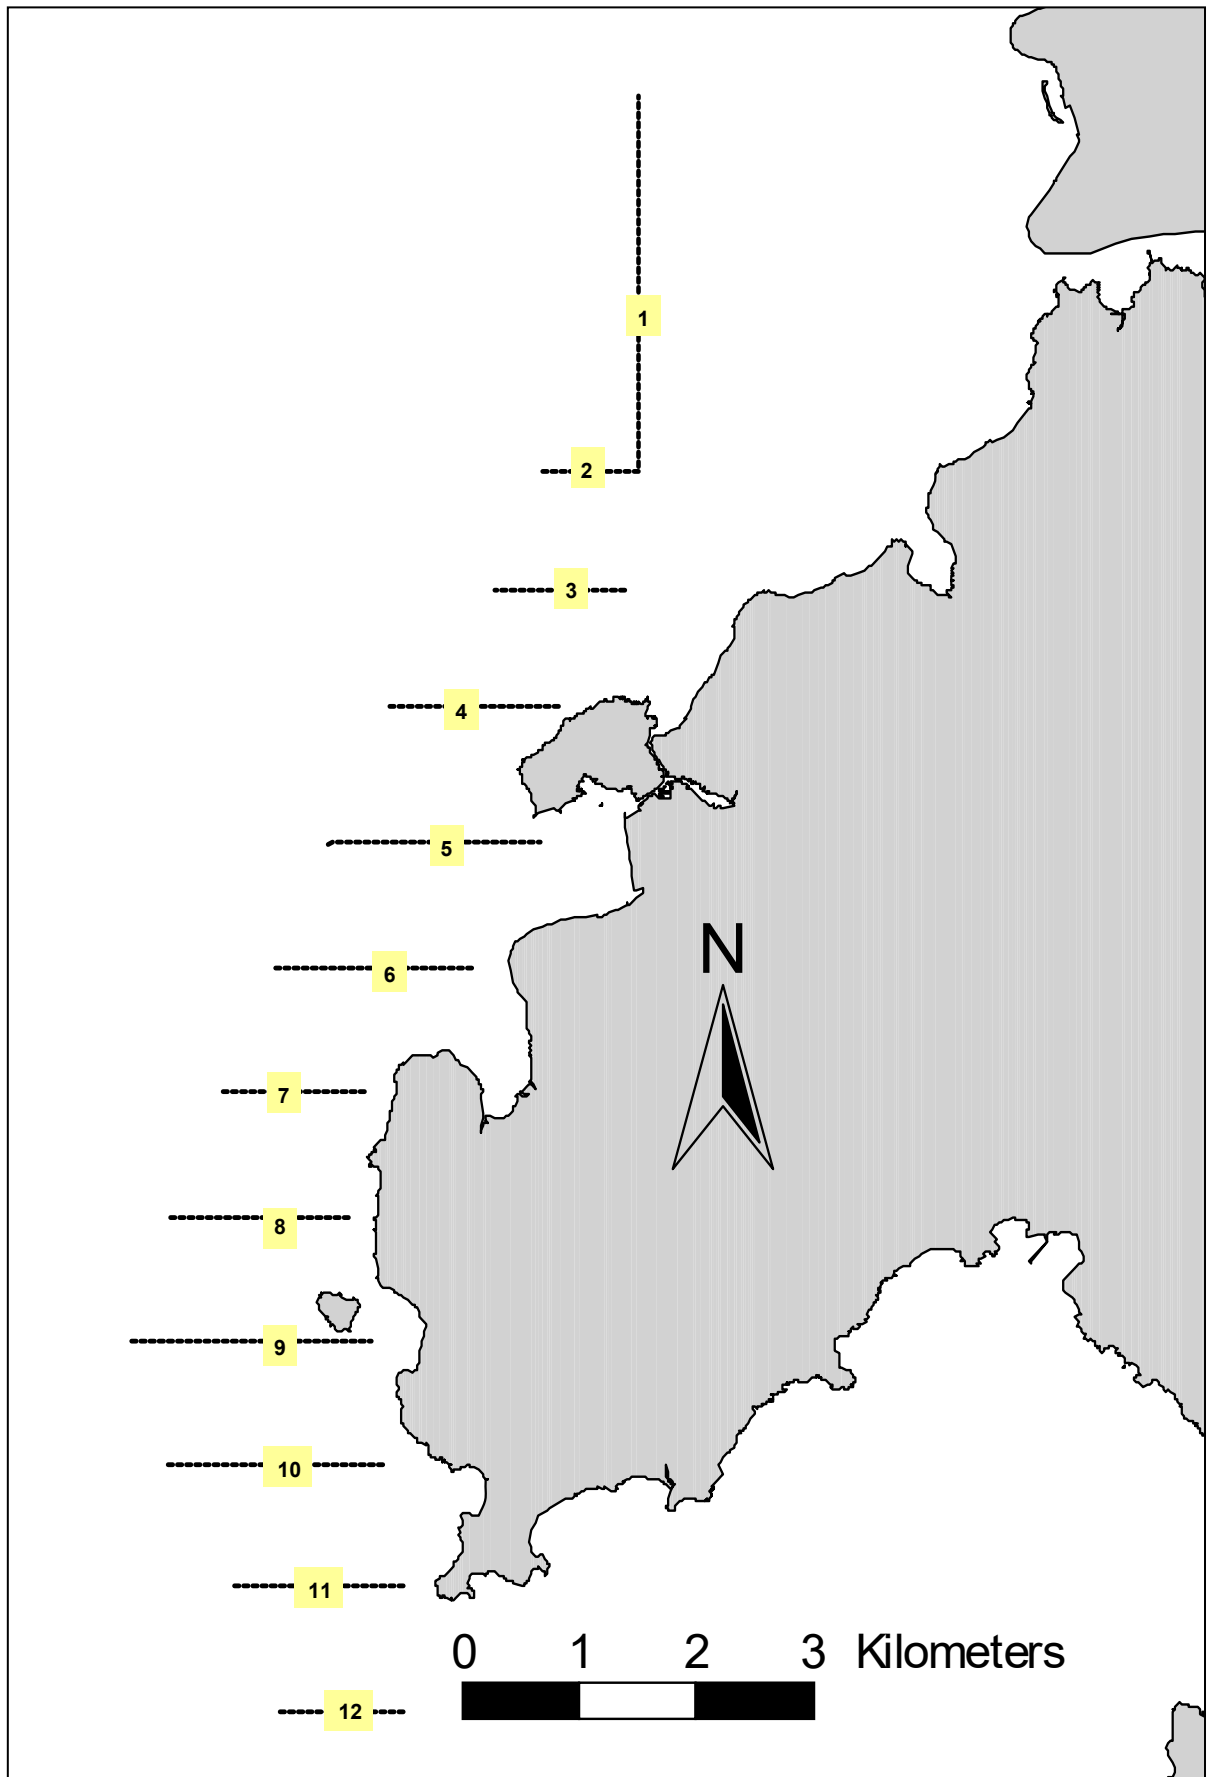
Figure 1. Transect Line Layout in West Lantau Survey Areas

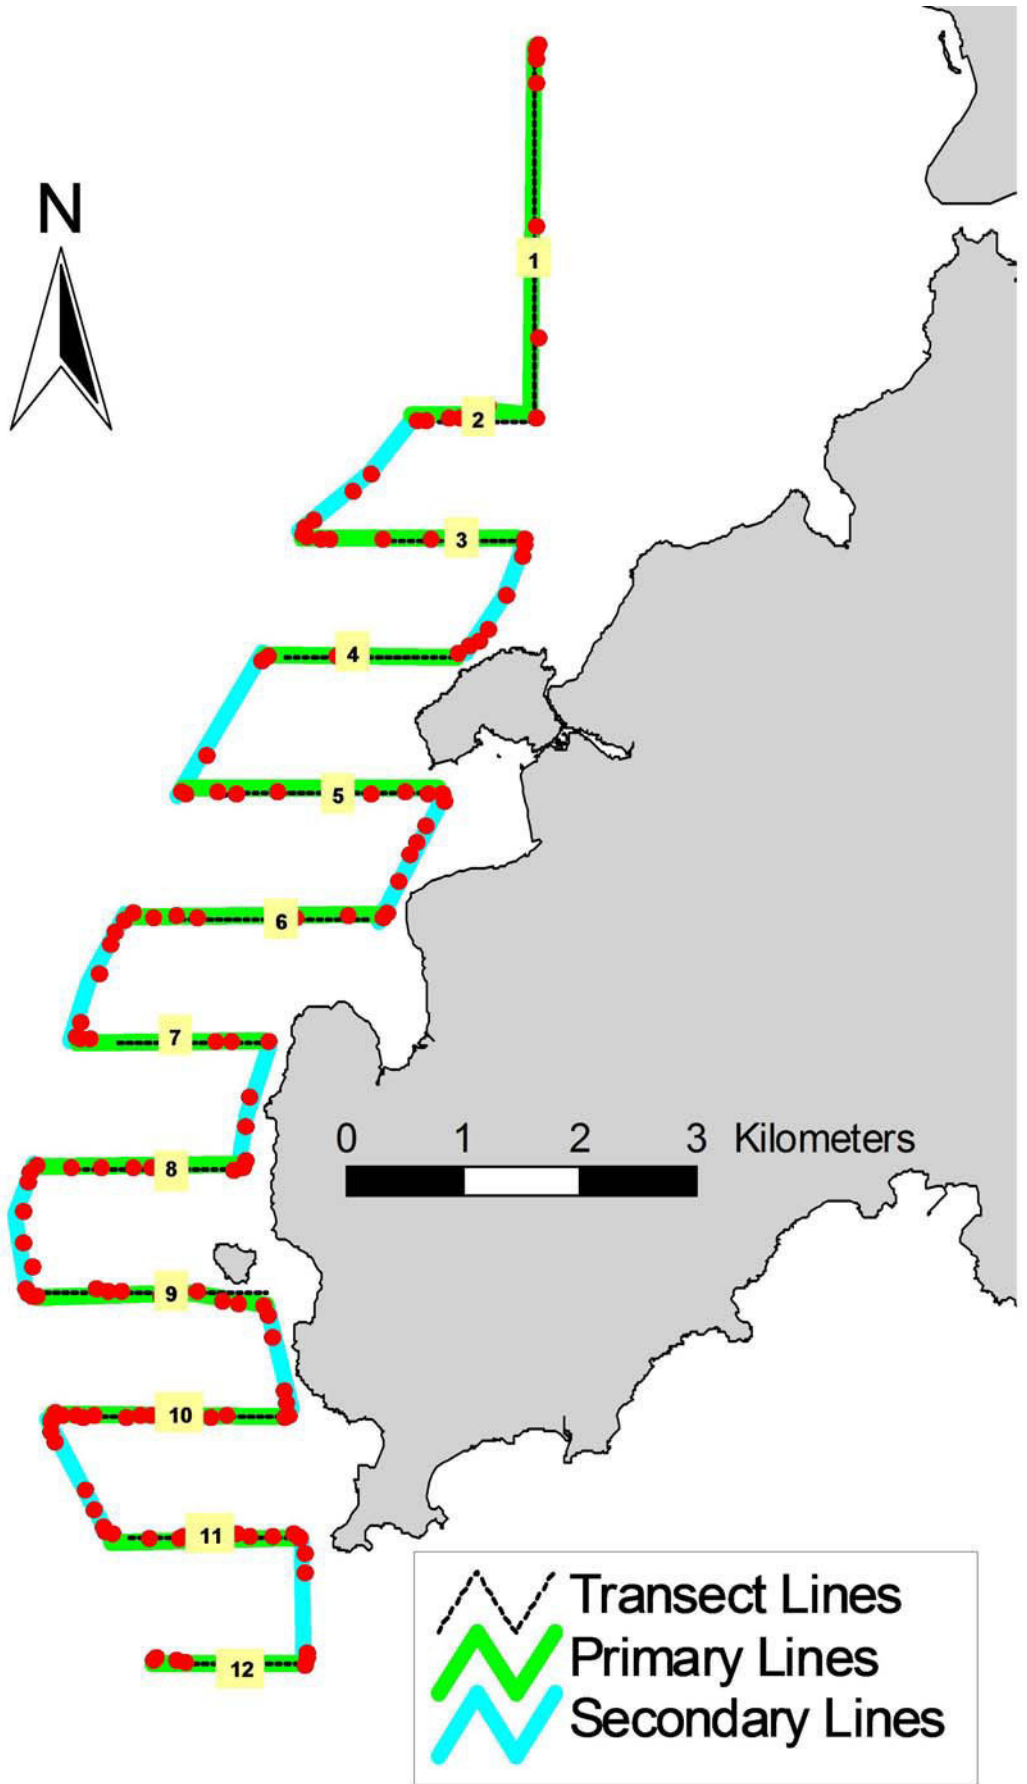
Figure 2. Survey Route on July 6th, 2016 (note: red dots represent the tracked positions of survey boat logged continuously by GPS throughout the course of the survey)

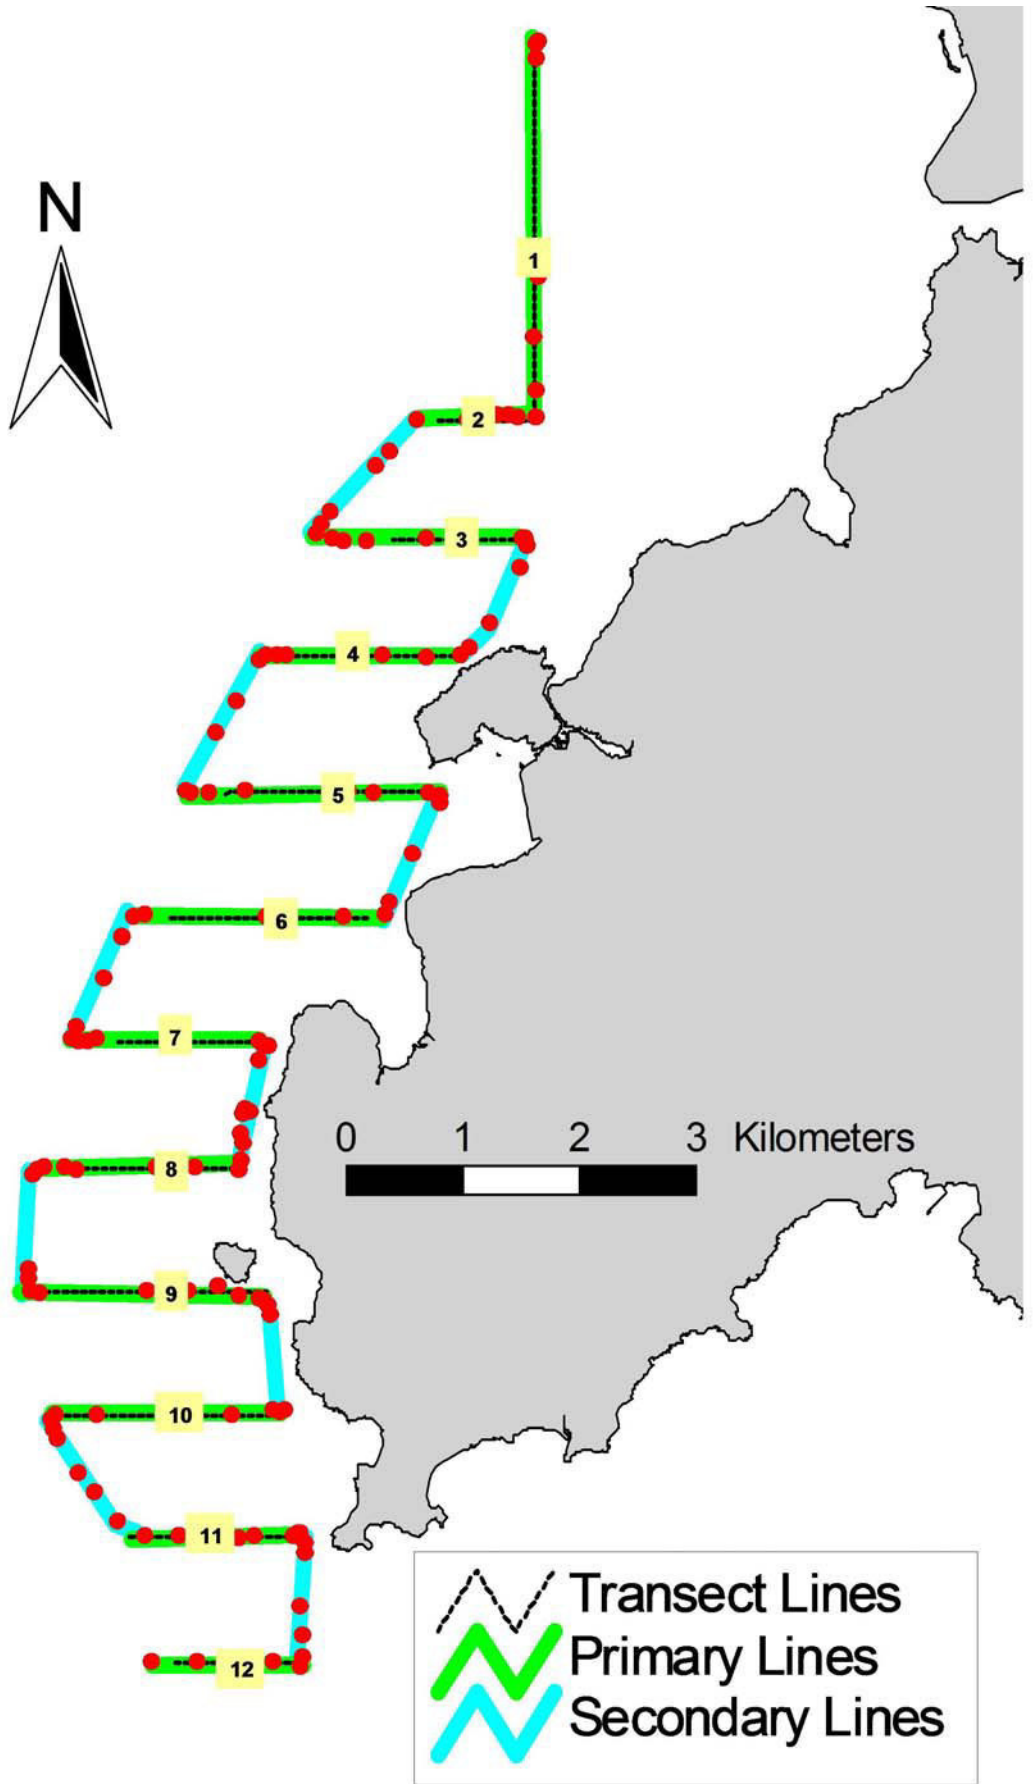
Figure 3. Survey Route on July 13th, 2016 (note: red dots represent the tracked positions of survey boat logged continuously by GPS throughout the course of the survey)

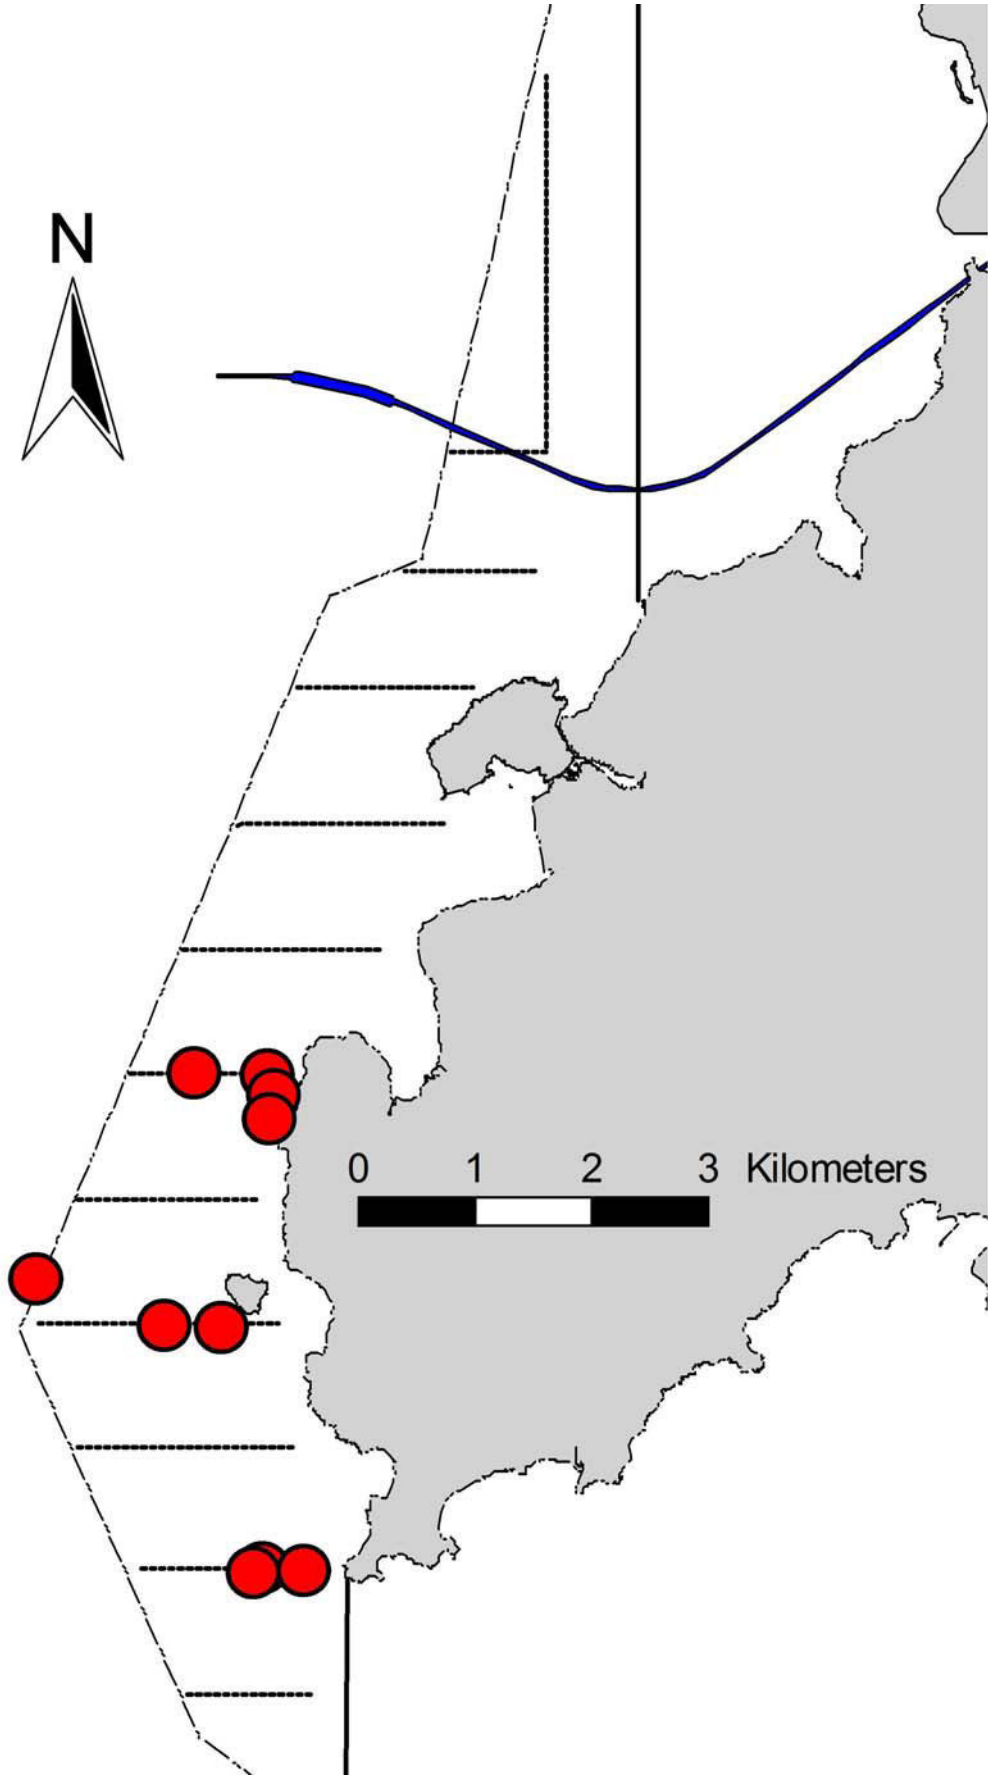
Figure 4. Distribution of Chinese White Dolphin Sighting during July 2016 HKLR09 Monitoring Surveys

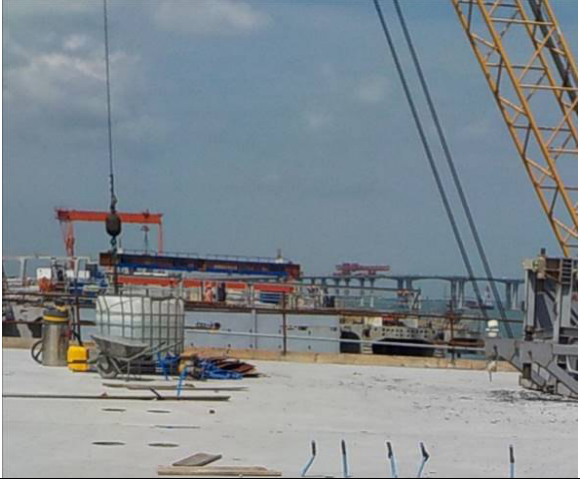
<p>Ref No: 160705-R01</p> <p>Impact: Waste / Chemical Management (F1iii.)</p> <p>Details: To clear the accumulated waste material at P57.</p> <p>Follow Up: The accumulated waste material was cleared.</p>

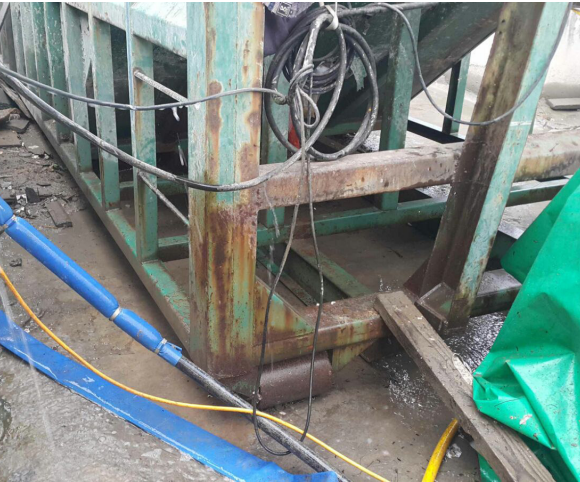
<p>Ref No: 160705-R02</p> <p>Impact: Waste / Chemical Management (F1iii.)</p> <p>Details: To properly repair the waste skip at entrance of Portion C.</p> <p>Follow Up: The waste skip was repaired and the surrounding rubbish was also cleared.</p>

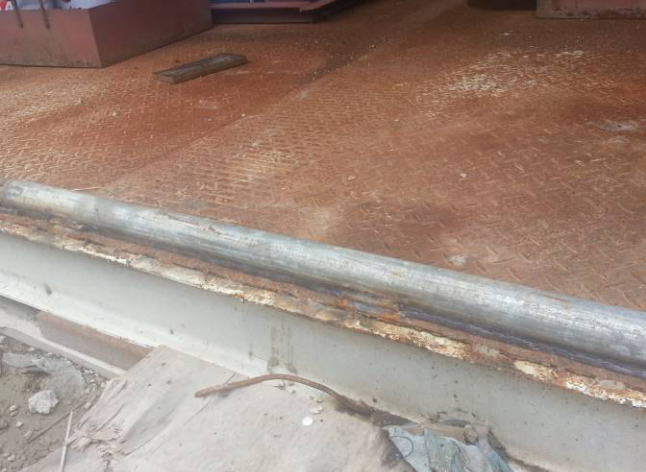
<p>Ref No: 160705-R03</p> <p>Impact: Waste / Chemical Management (F8)</p> <p>Details: To improve the bunding at the chemical storage area of Portion C.</p> <p>Follow Up: The bund area at the chemical waste storage area was improved to avoid the gap.</p>

05/07/2016	To improve the bunding at the chemical storage area of Portion C.	Rectification/improvement was observed during the follow-up audit session on 12 July 2016.
	12/07/2016	Clear the rubbish at the planter area at P107 (Portion A).	Rectification/improvement was observed during the follow-up audit session on 19 July 2016.
	19/07/2016	Clear the accumulated rubbish at near P108 (Portion C).	Rectification/improvement was observed during the follow-up audit session on 26 July 2016.
	26/07/2016	To seal the hole / close the valve of the drip tray at P72.	Rectification/improvement was observed during the
