Contract No. HY/2011/09
Hong Kong-Zhuhai-Macao Bridge
Hong Kong Link Road – Section between HKSAR Boundary and Scenic Hill

Submission under Environmental Permit (EP-352/2009/D – Condition 4.4)
Monthly EM&A Report – August 2016

**Contract No. HY/2011/09 HZMB Hong Kong Link Road –
Section between HKSAR Boundary and Scenic Hill
Revised Monthly EM&A Report for August 2016 (EP-352/2009/D)**

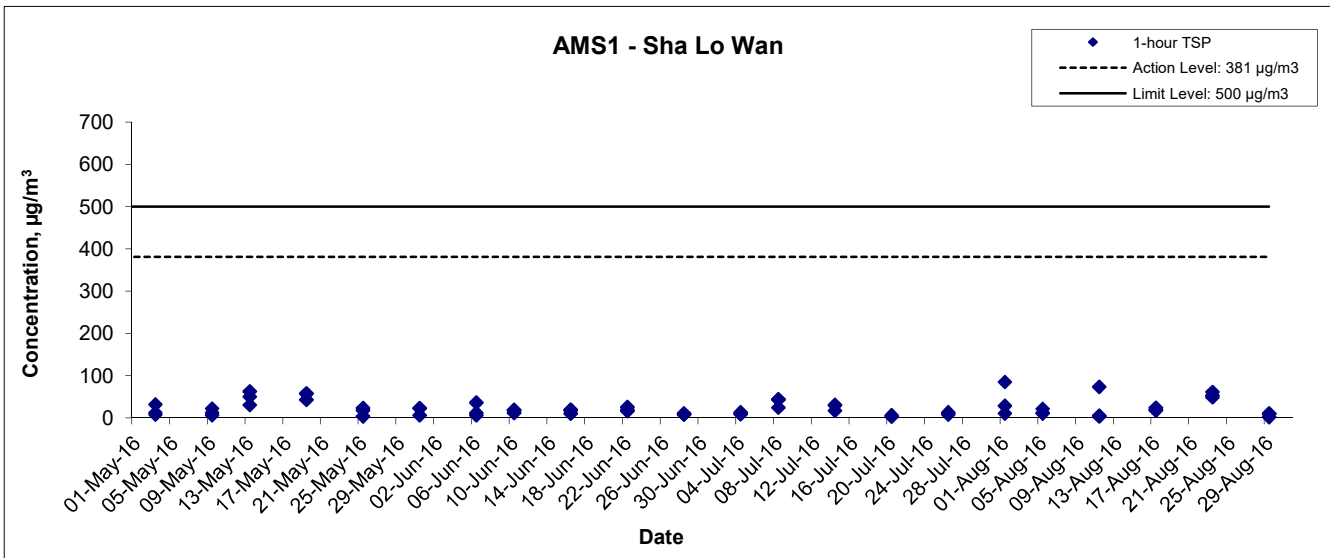
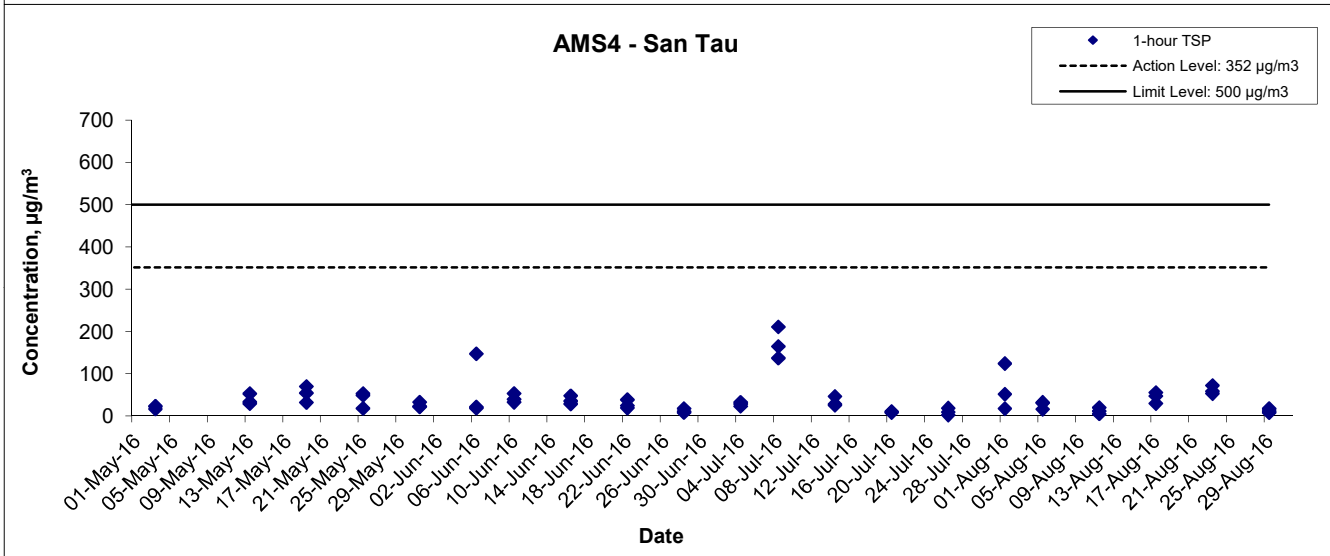
1-hour TSP Concentration Levels

Title Contract No. HY/2011/09 Hong Kong-Zhuhai-Macao Bridge Hong Kong Link Road – Section between HKSAR Boundary and Scenic Hill Graphical Presentation of 1-hour TSP Monitoring Results	Scale N.T.S	Project No. MA12014	
	Date Aug 16	Appendix E

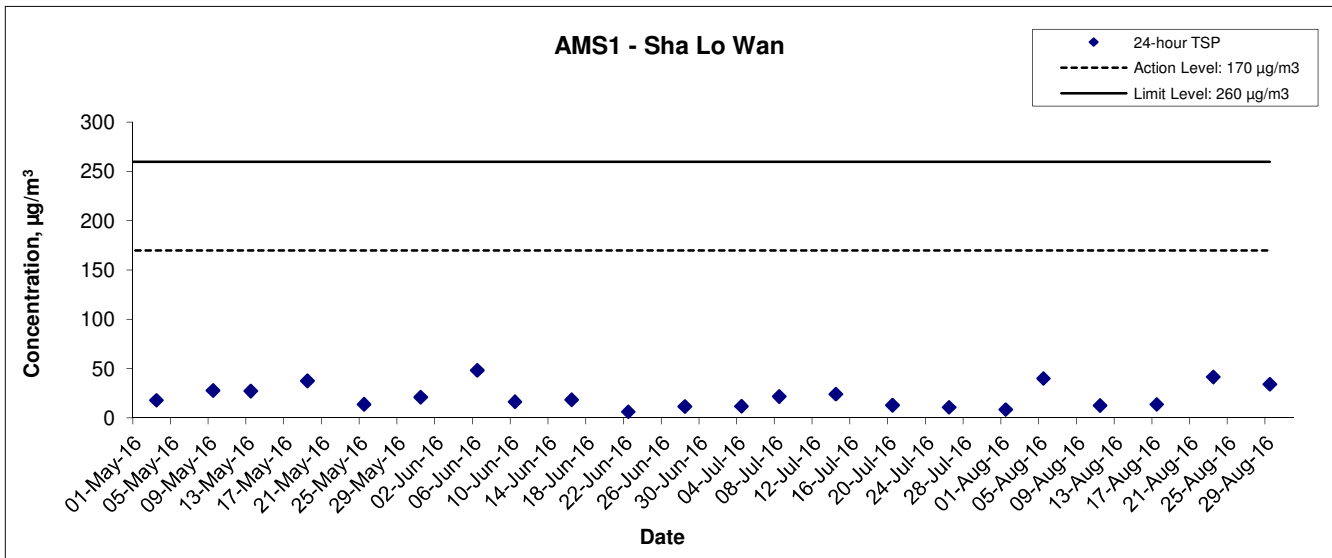
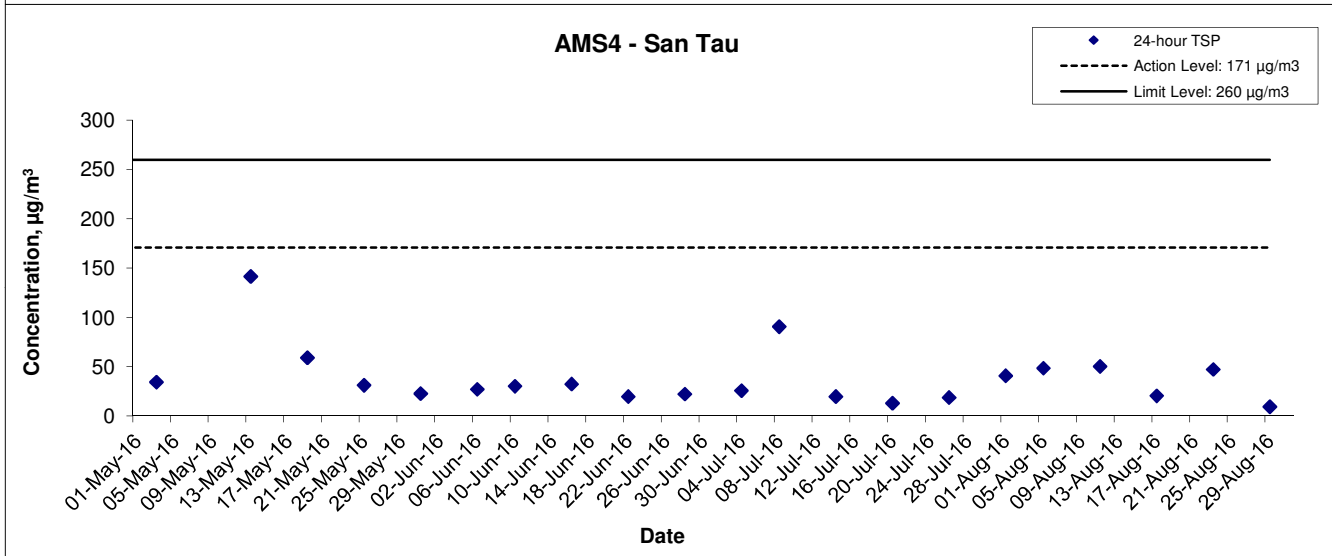
24-hour TSP Concentration Levels

Title Contract No. HY/2011/09 Hong Kong-Zhuhai-Macao Bridge Hong Kong Link Road – Section between HKSAR Boundary and Scenic Hill Graphical Presentation of 24-hour TSP Monitoring Results	Scale N.T.S	Project No. MA12014	CINOTECH
	Date Aug 16	Appendix F

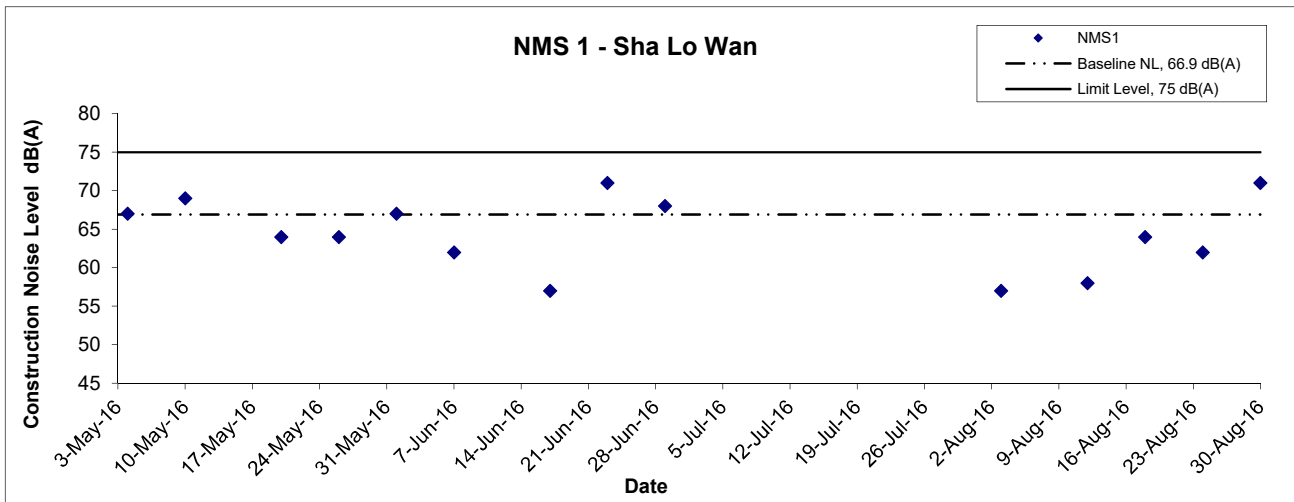
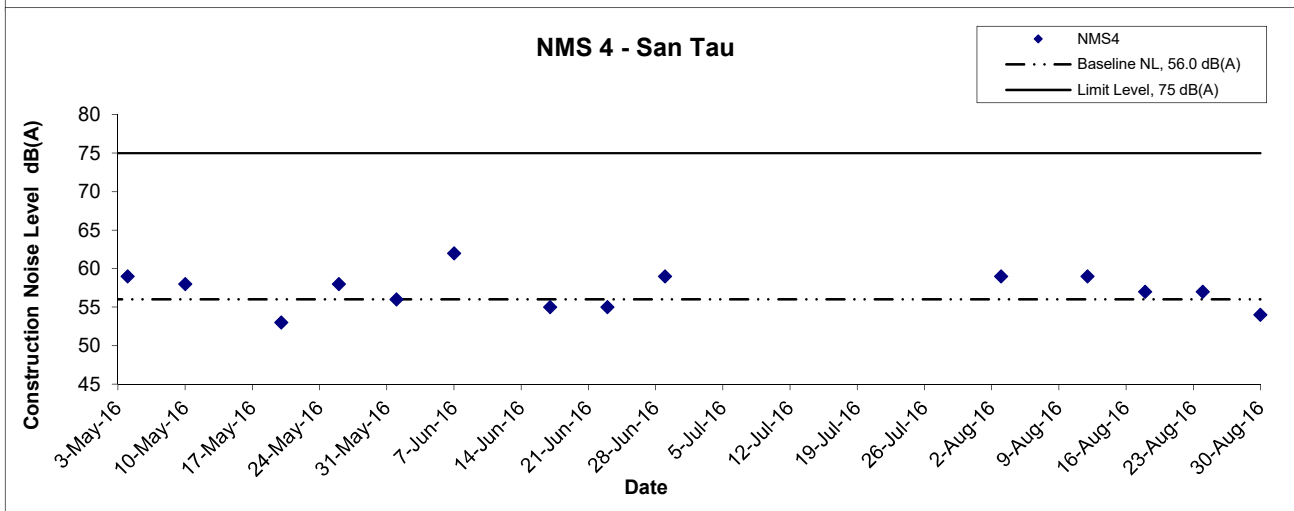
Noise Levels

Title Contract HY/2011/09 Hong Kong-Zhuhai-Macao Bridge Hong Kong Link Road-Section between HKSAR Boundary and Scenic Hill Graphical Presentation of Construction Noise Monitoring Results	Scale	N.T.S	Project No.	MA12014	
	Date	Aug 16	Appendix	G

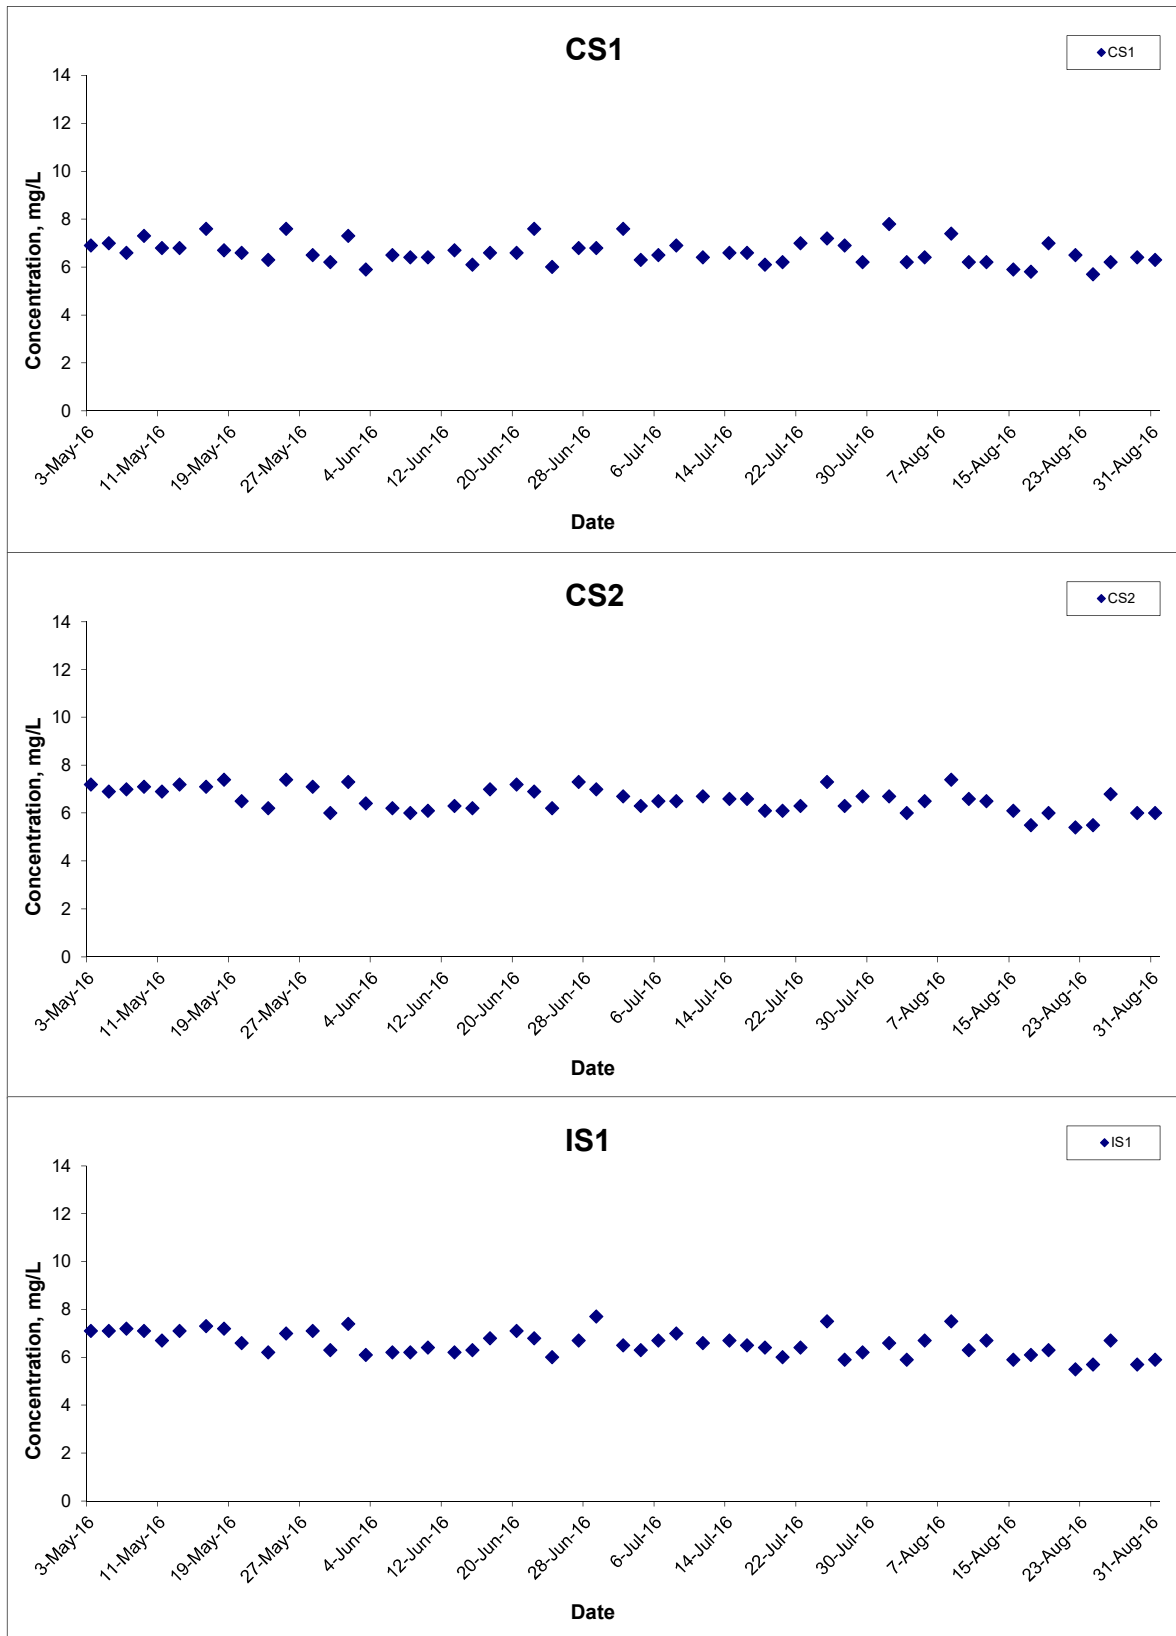
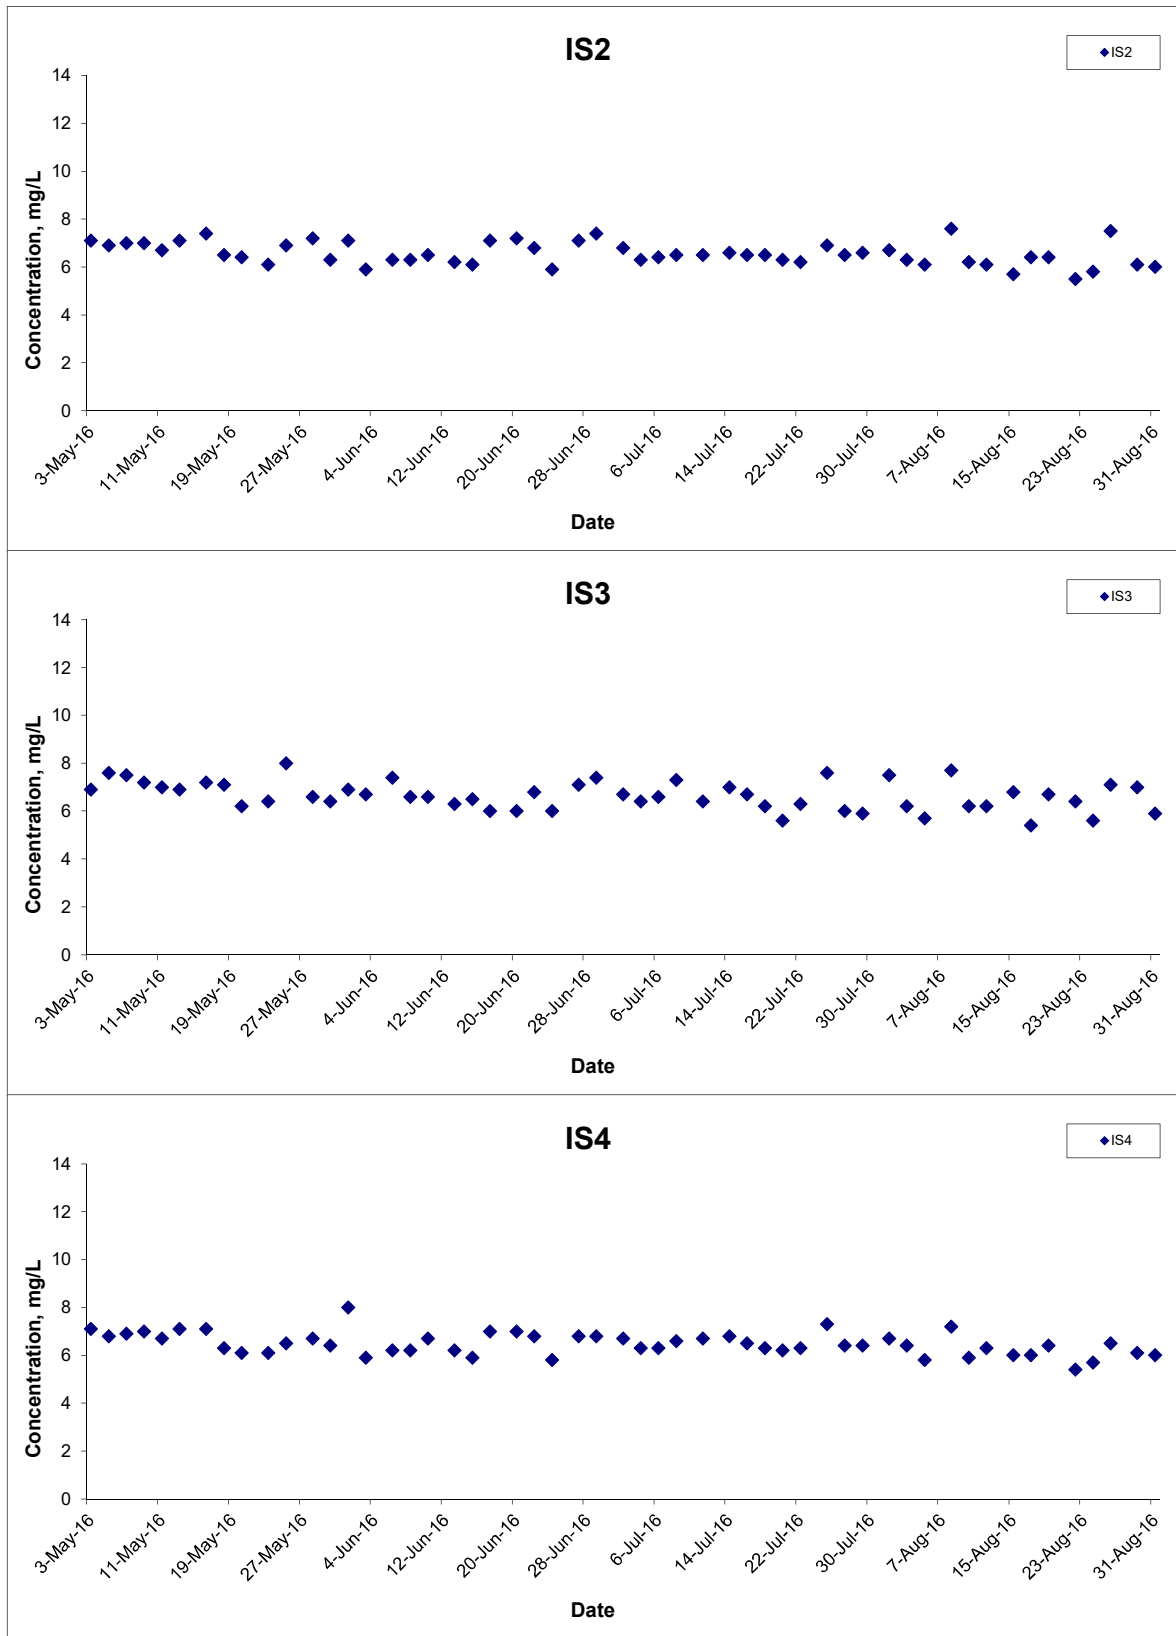
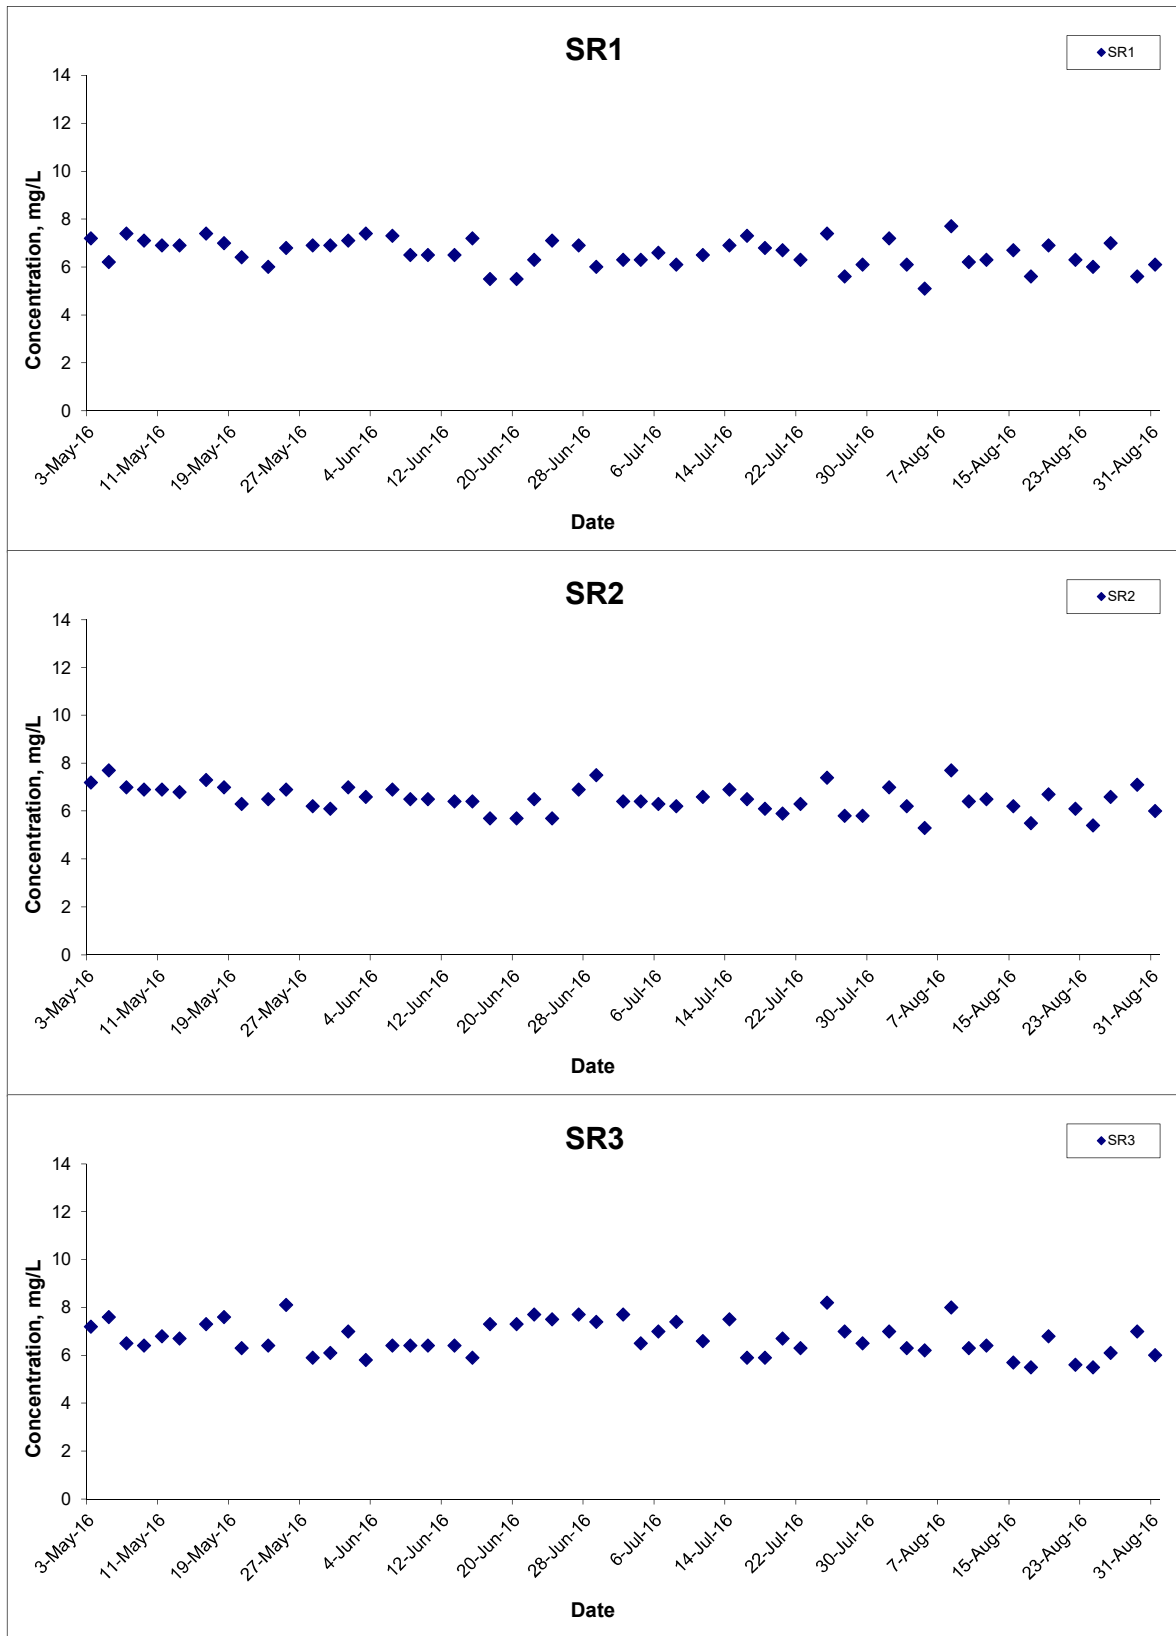
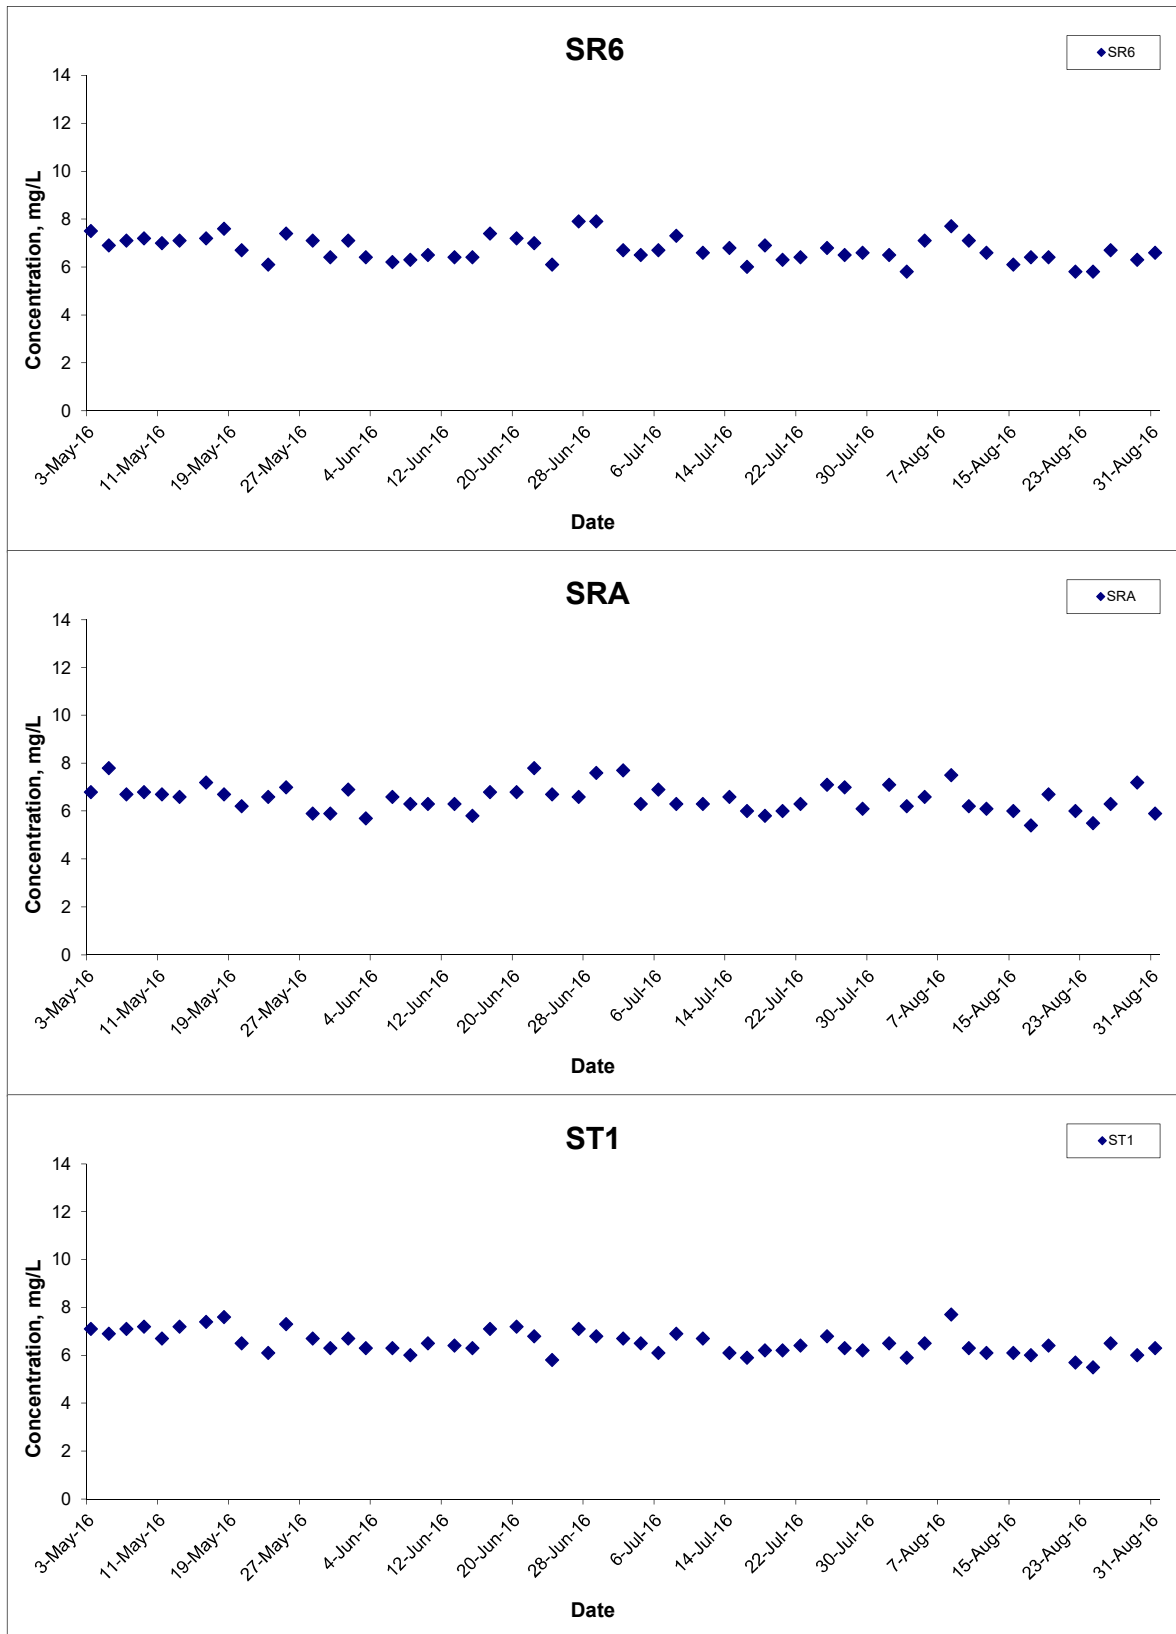
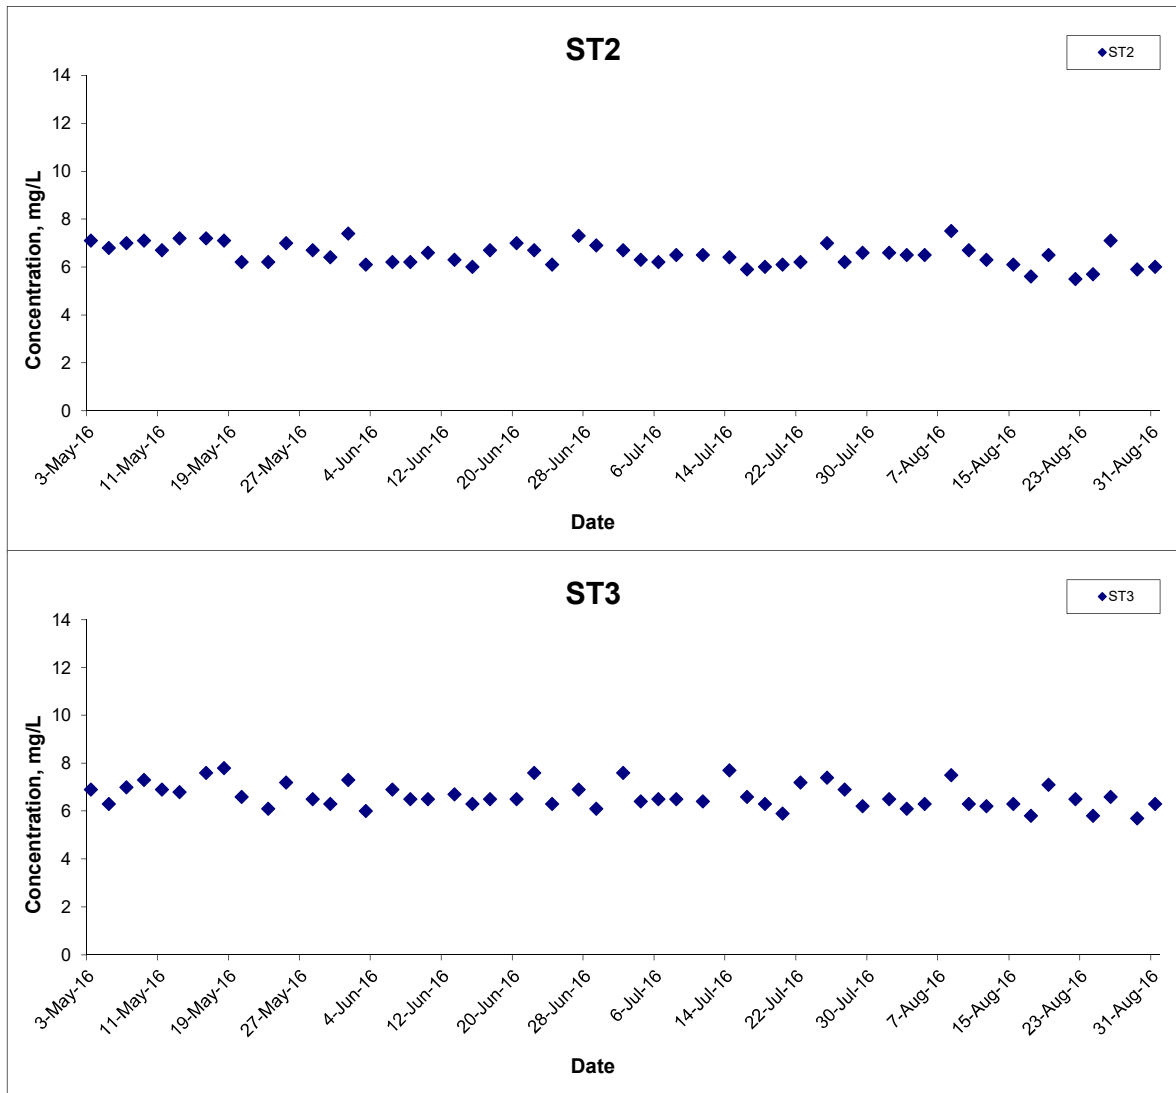
Dissolved Oxygen (Surface & Middle) at Mid-Ebb Tide

Title Contract HY/2011/09 Hong Kong-Zhuhai-Macao Bridge
 Hong Kong Link Road-Section between
 HKSAR Boundary and Scenic Hill
 Graphical Presentation of Water Quality Monitoring
 Results

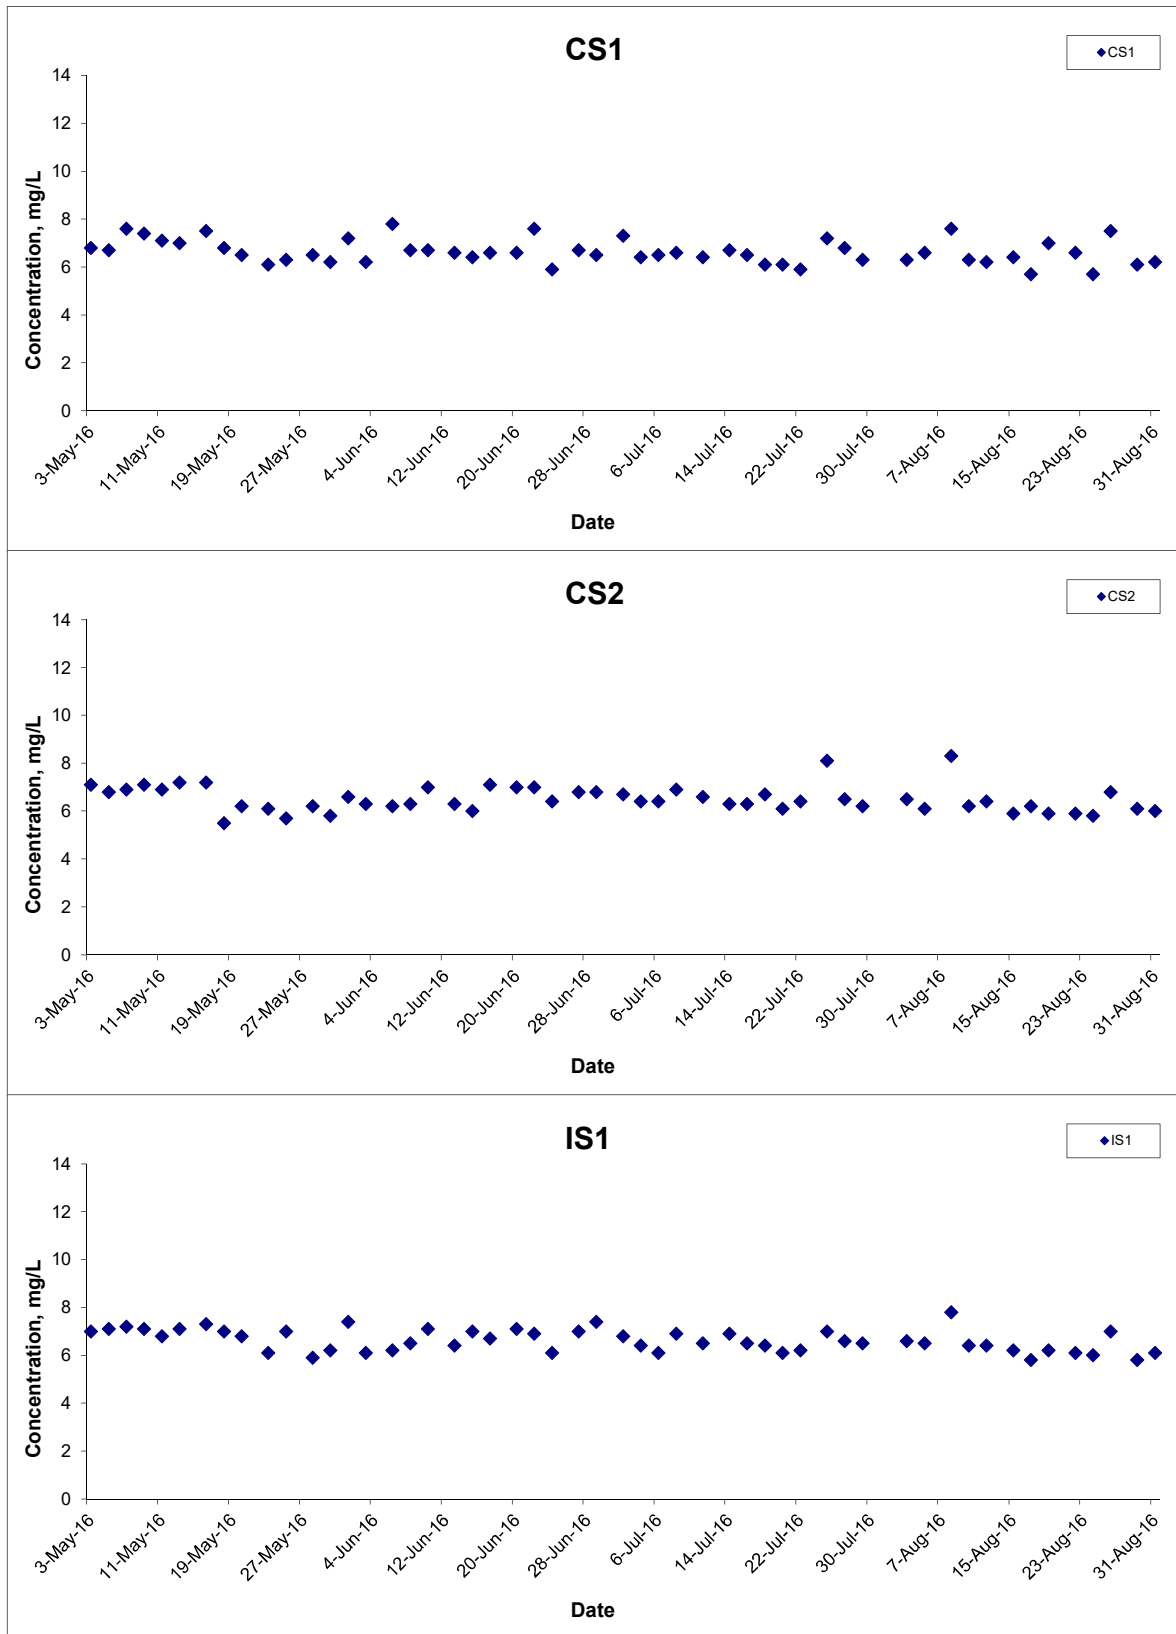
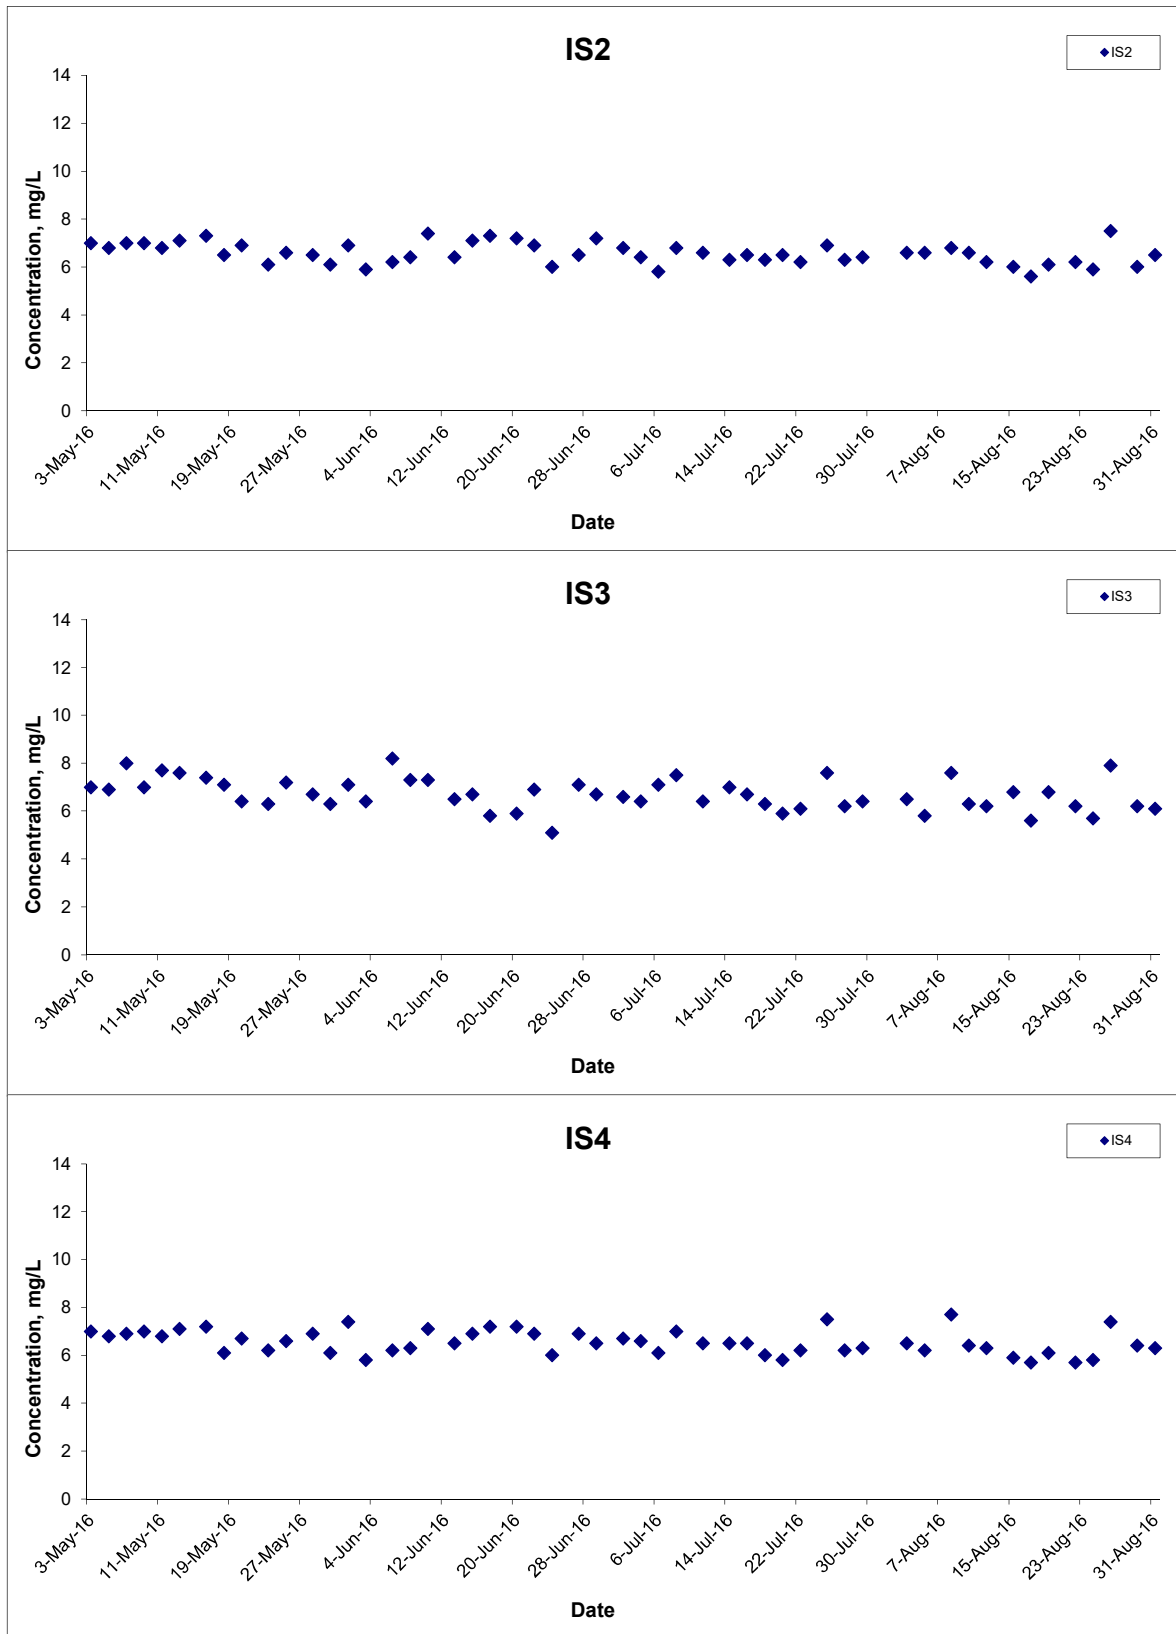
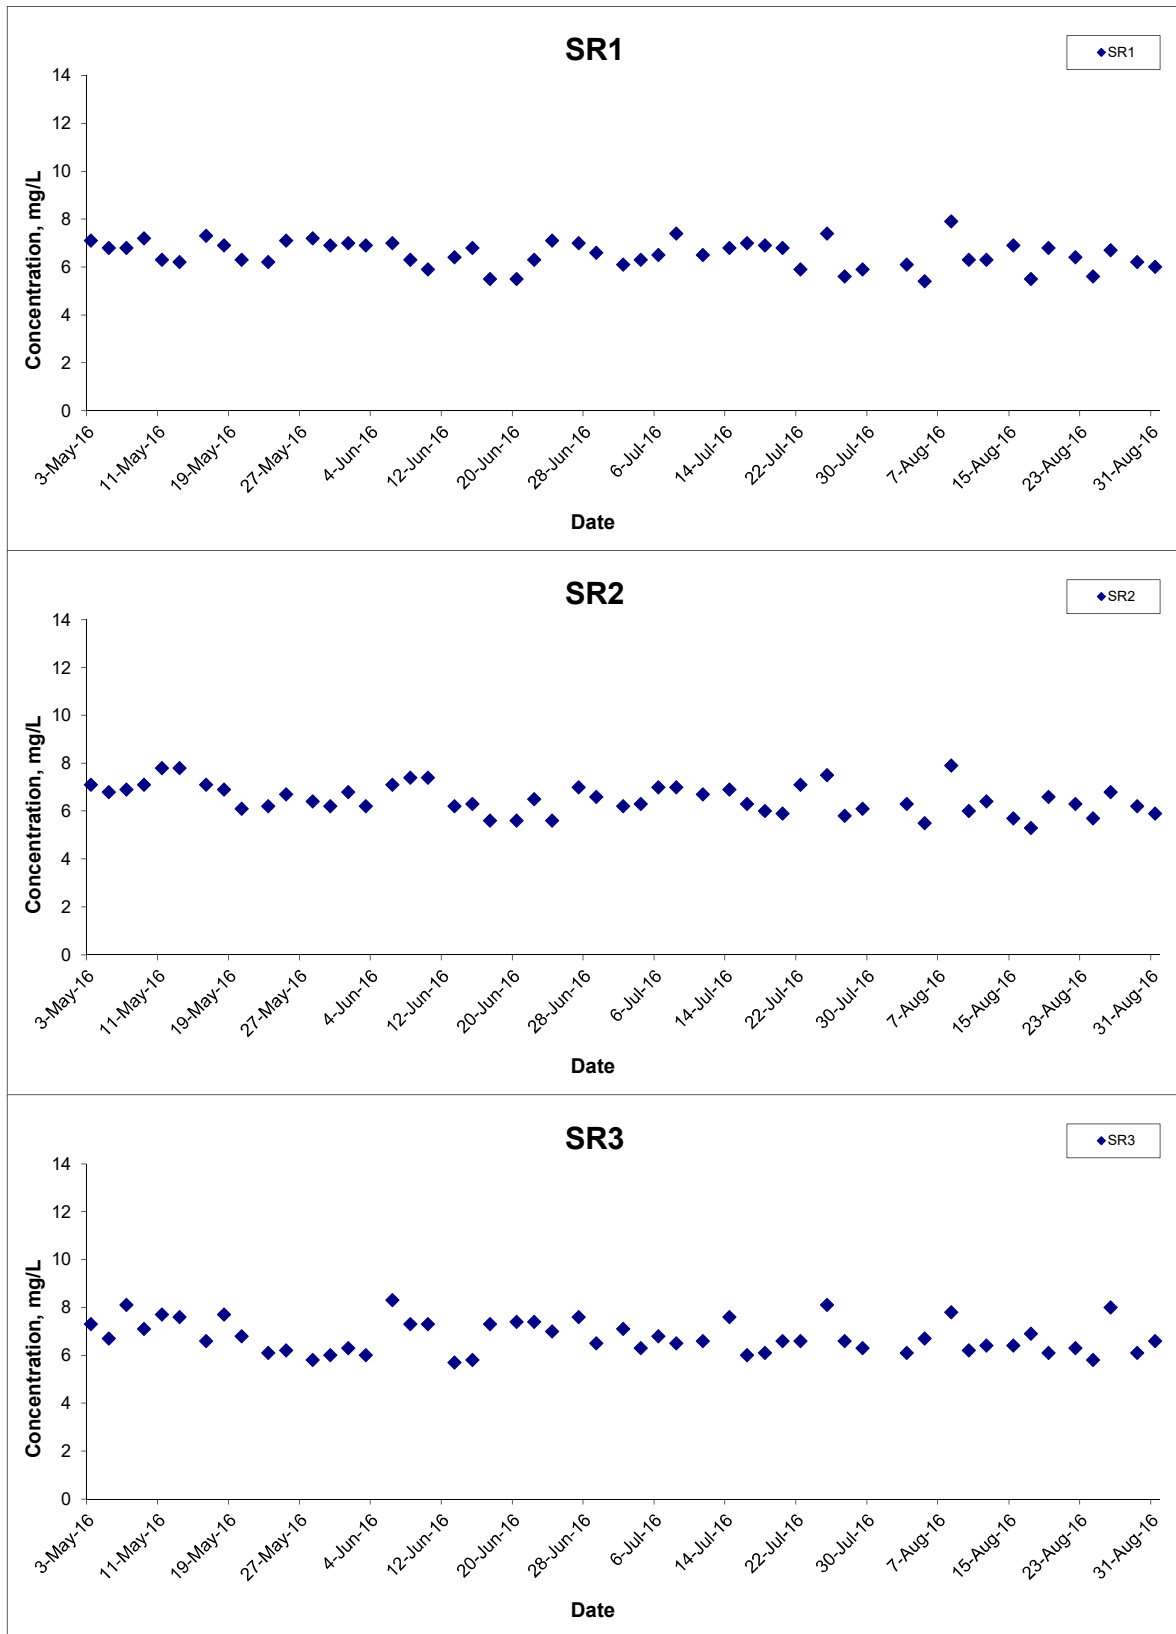
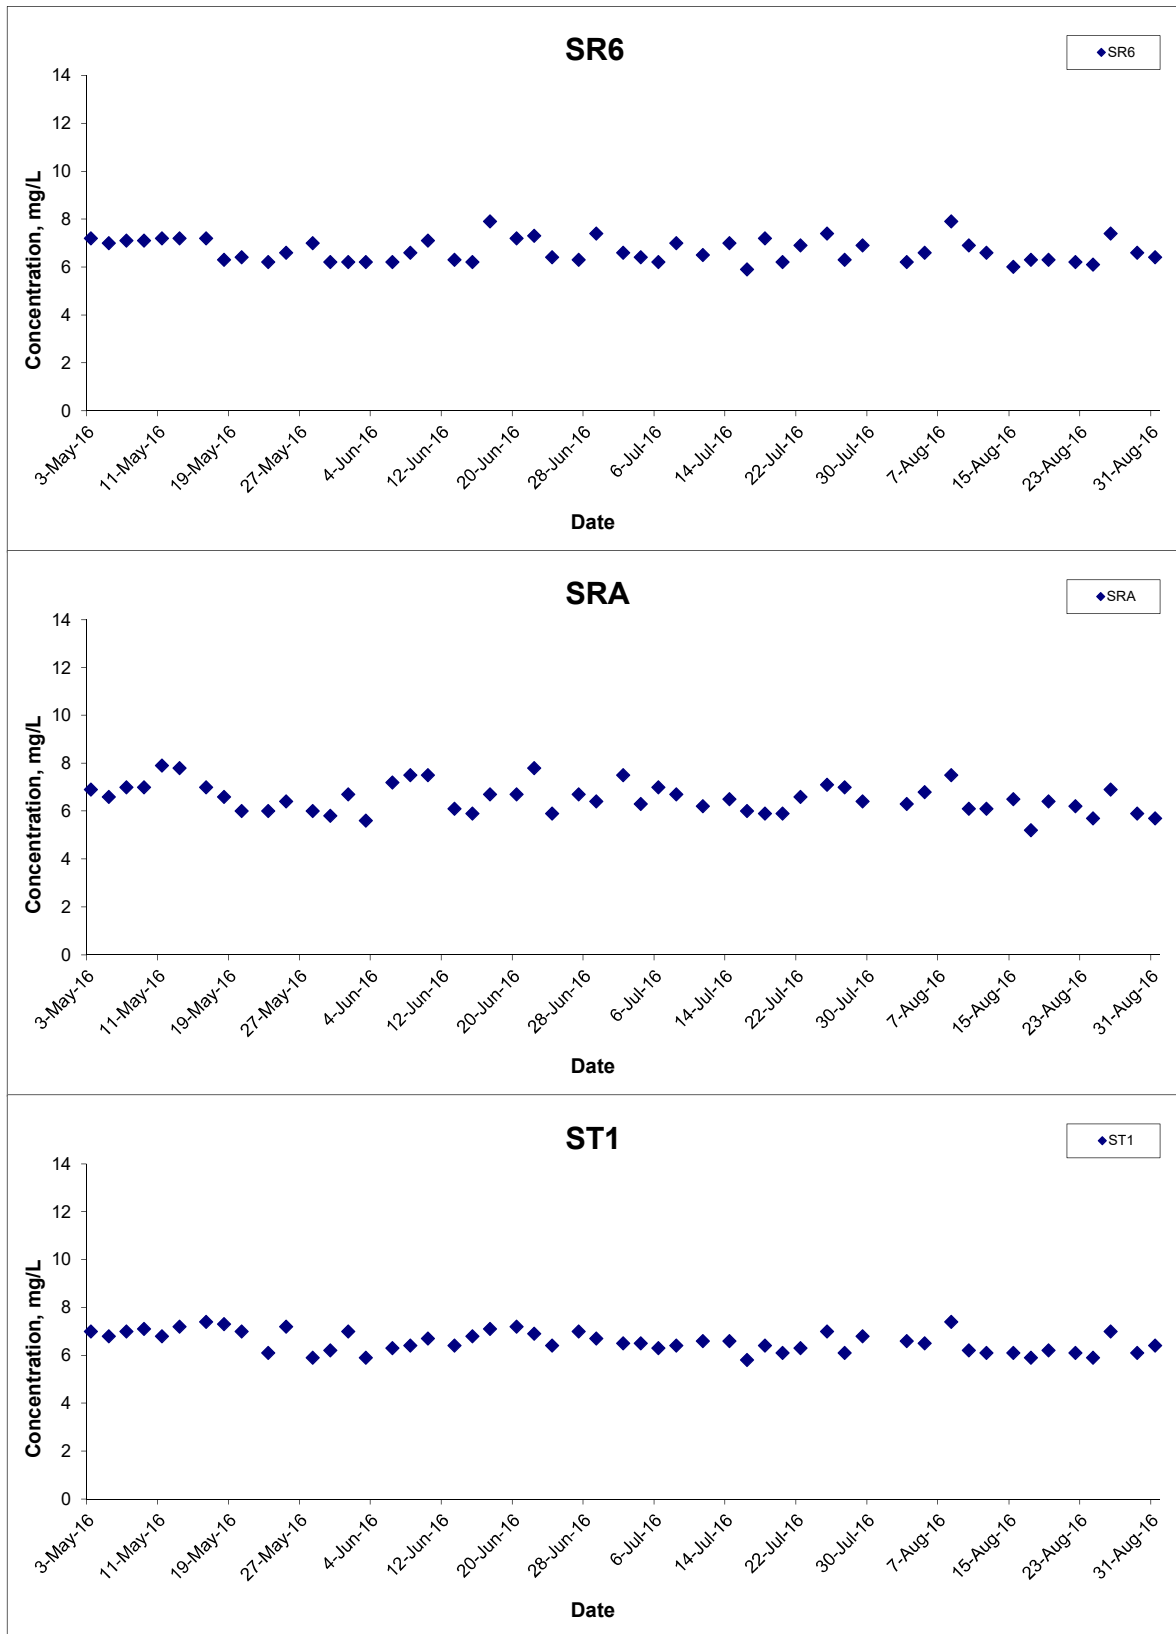
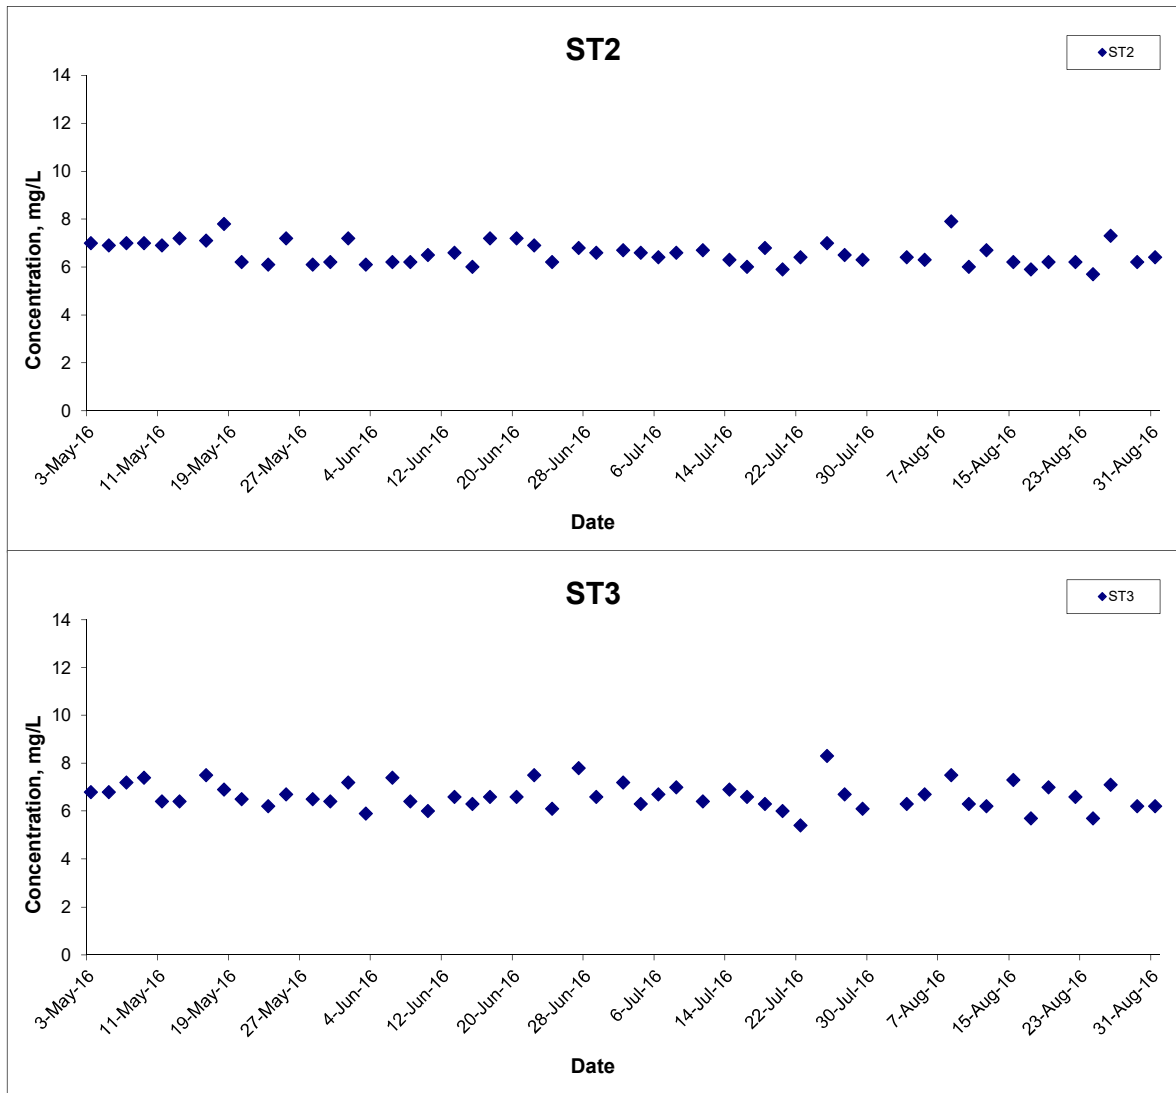
Dissolved Oxygen (Surface & Middle) at Mid-Flood Tide

Title Contract HY/2011/09 Hong Kong-Zhuhai-Macao Bridge
 Hong Kong Link Road-Section between
 HKSAR Boundary and Scenic Hill
 Graphical Presentation of Water Quality Monitoring
 Results
