Contract No. HY/2011/09
Hong Kong-Zhuhai-Macao Bridge
Hong Kong Link Road – Section between HKSAR Boundary and Scenic Hill

Submission under Environmental Permit (EP-352/2009/D – Condition 4.4)
Monthly EM&A Report – August 2016

**Contract No. HY/2011/09 HZMB Hong Kong Link Road –
Section between HKSAR Boundary and Scenic Hill
Revised Monthly EM&A Report for August 2016 (EP-352/2009/D)**

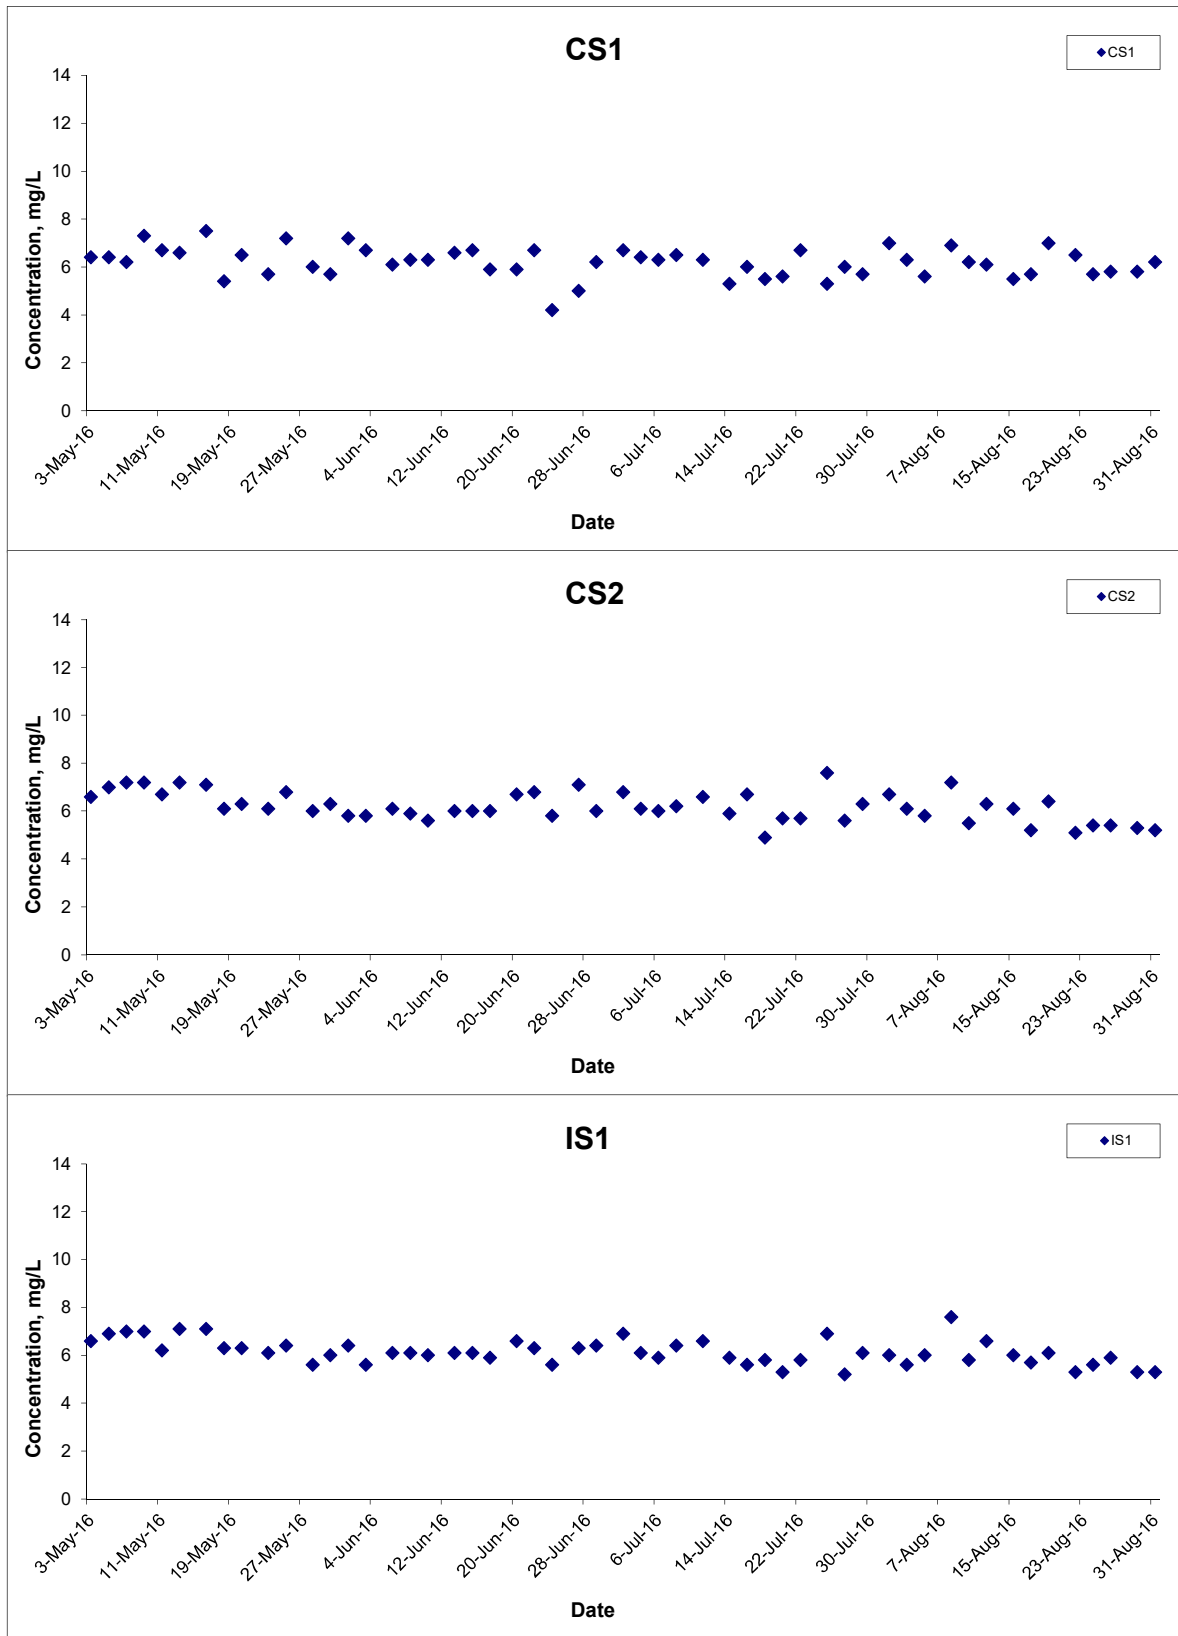
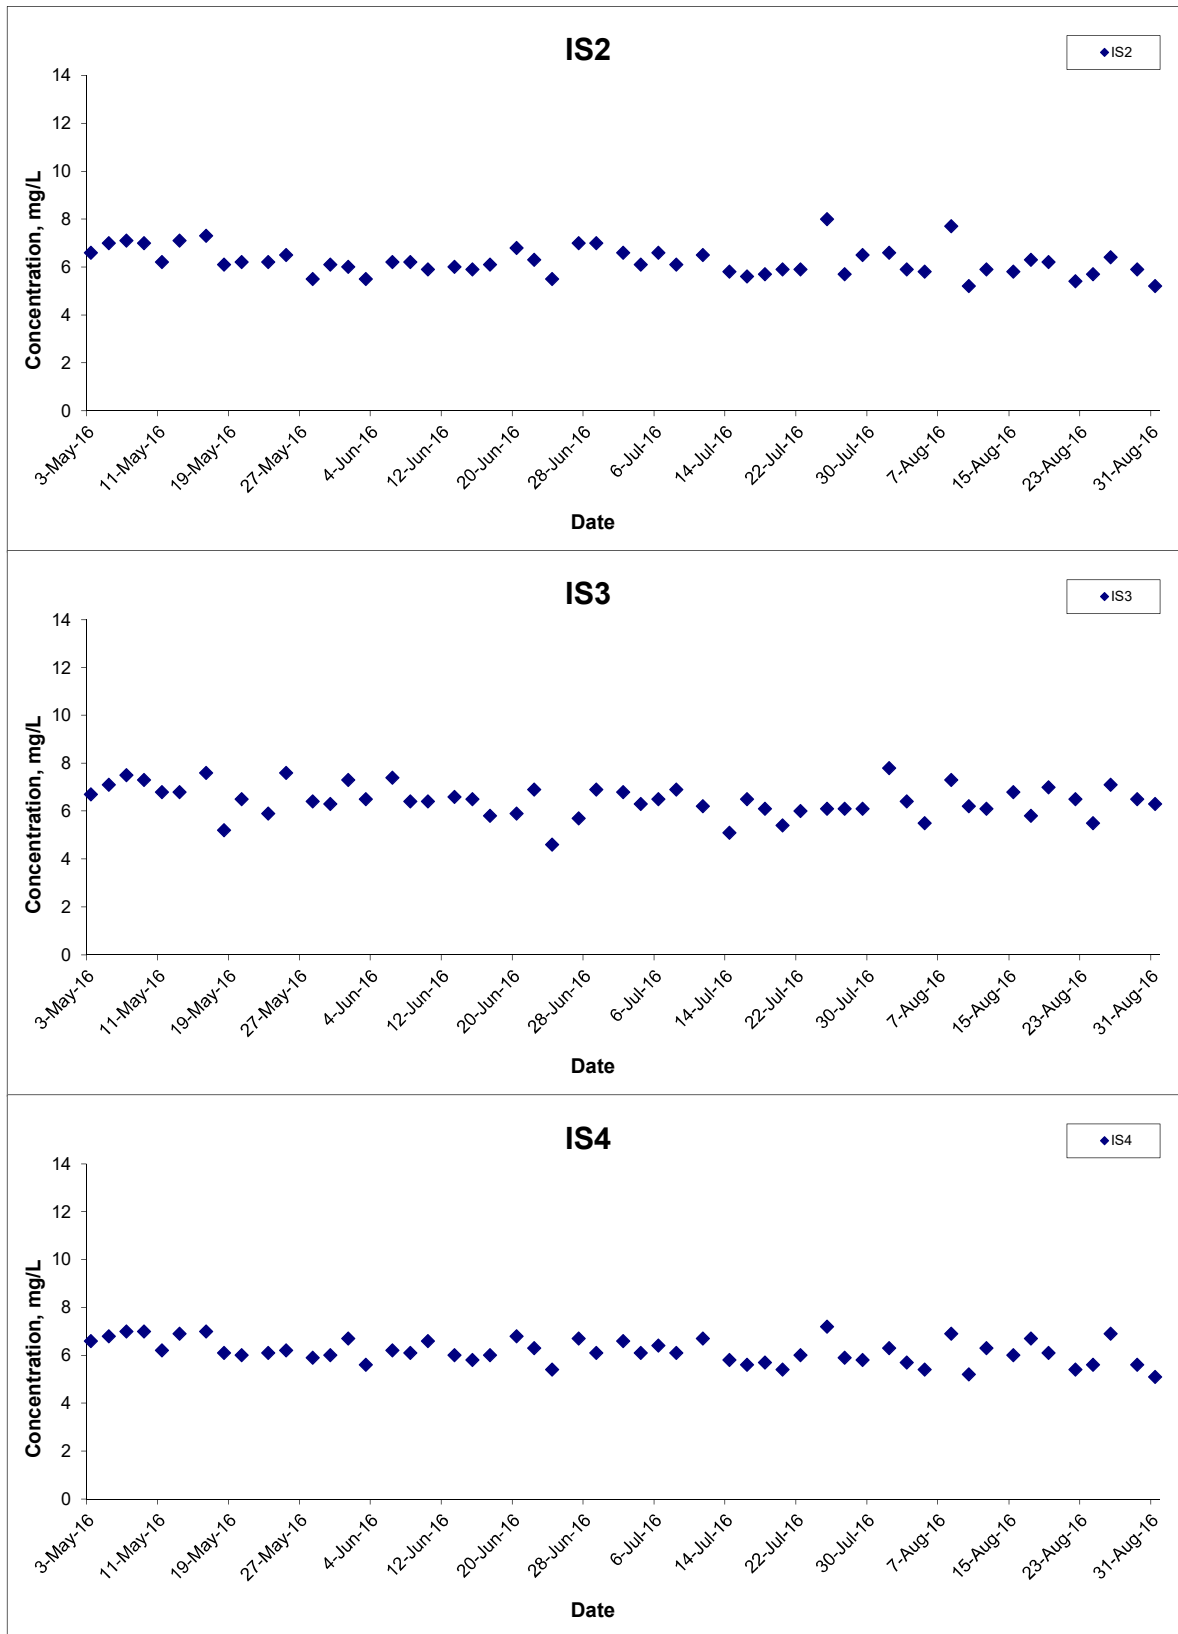
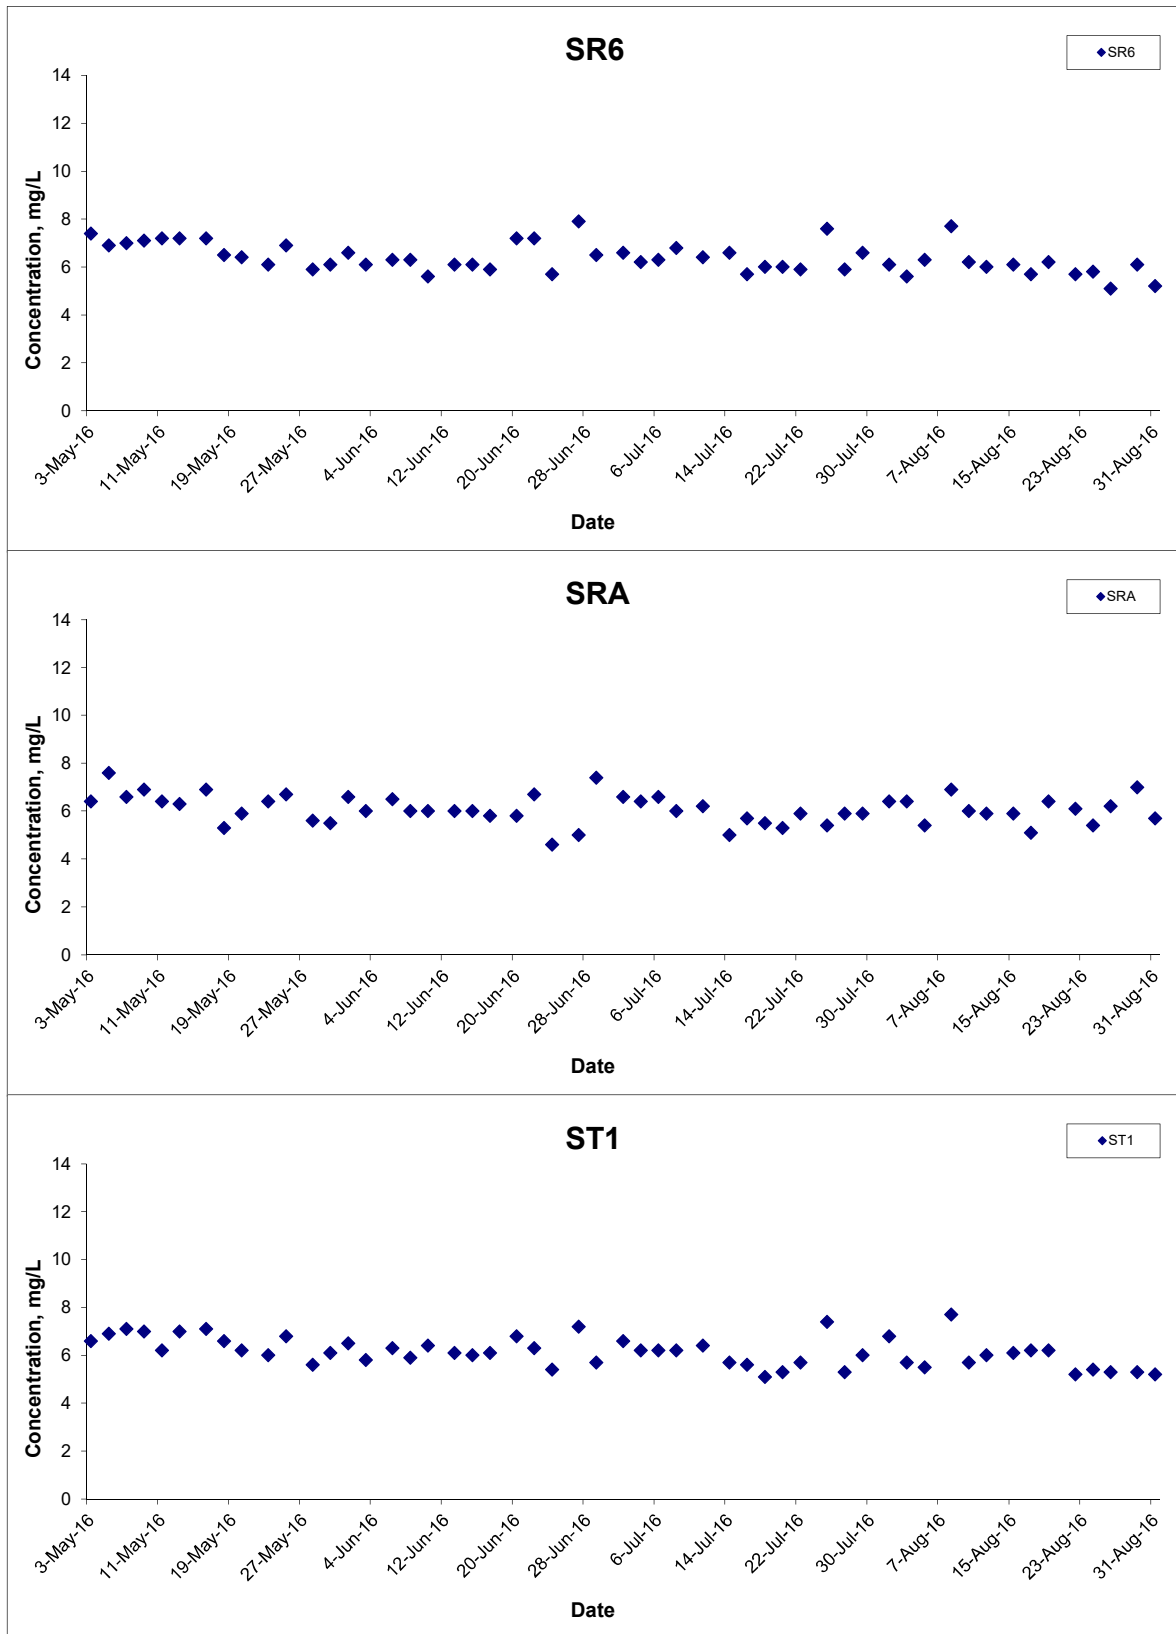
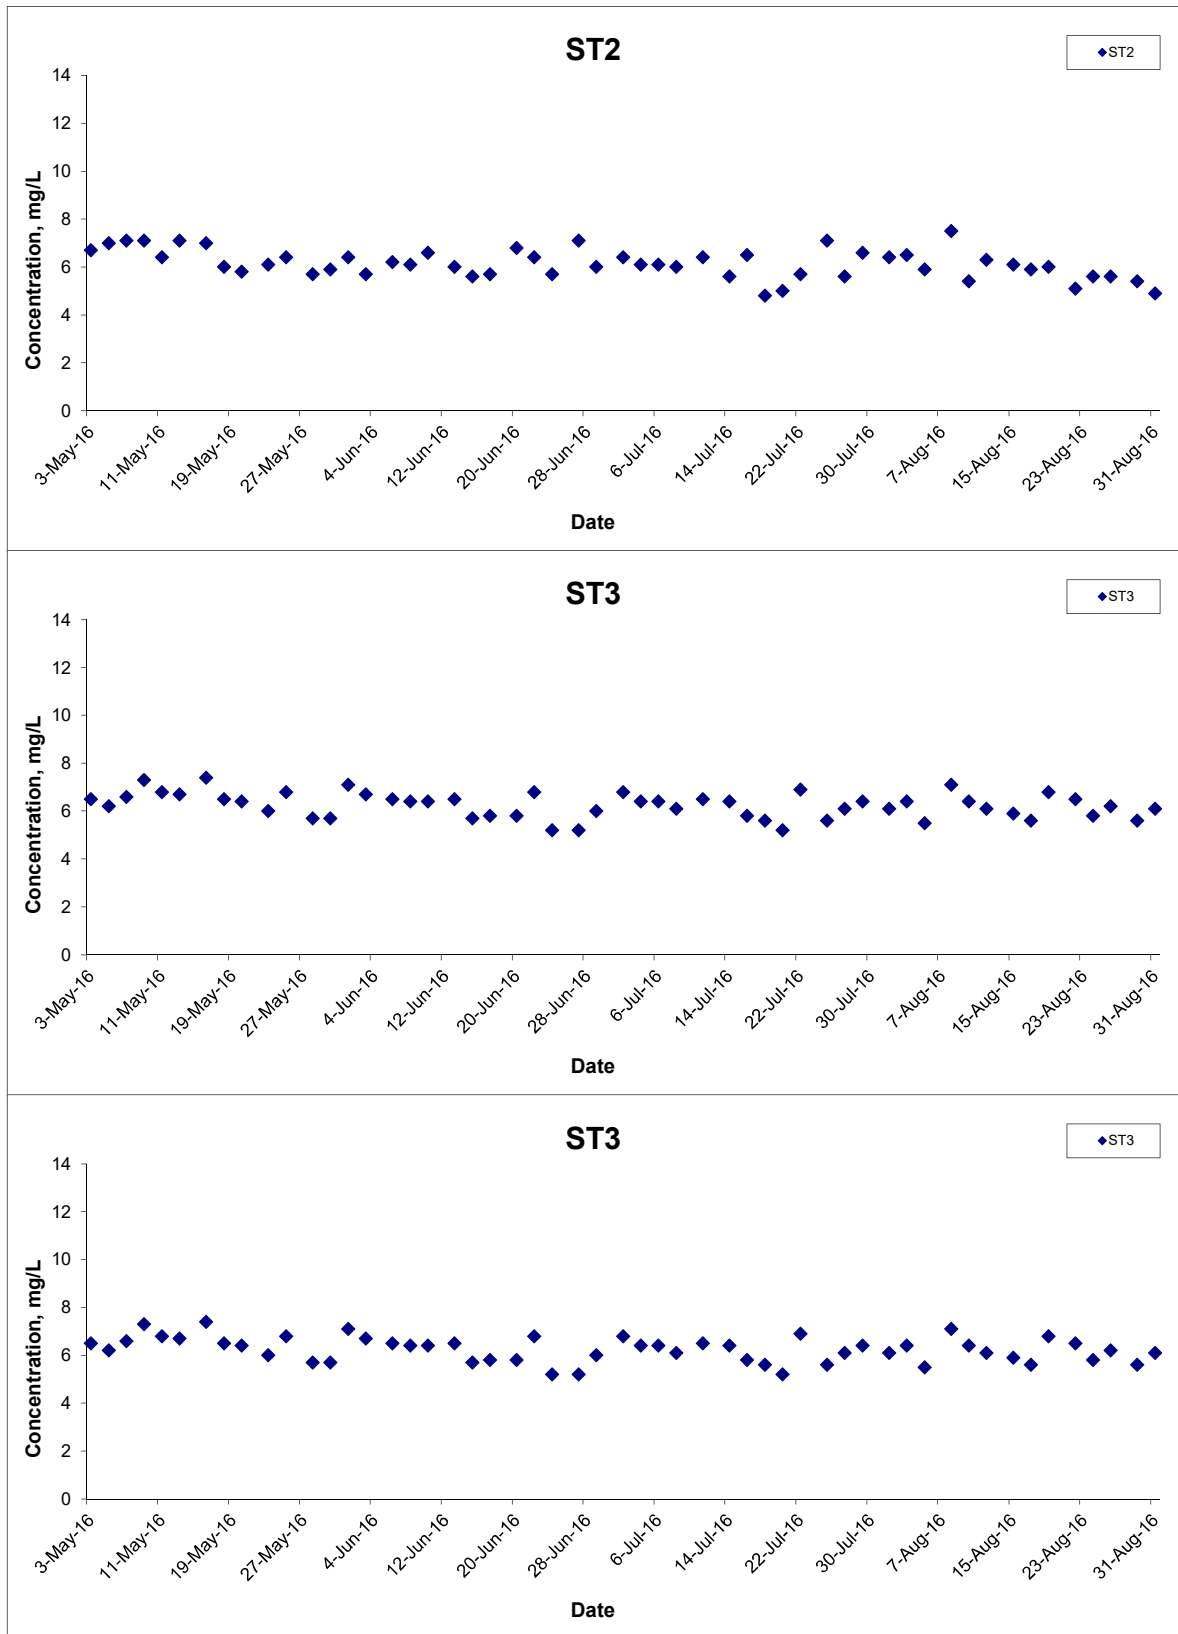
Dissolved Oxygen (Bottom) at Mid-Ebb Tide

Title Contract HY/2011/09 Hong Kong-Zhuhai-Macao Bridge
 Hong Kong Link Road-Section between
 HKSAR Boundary and Scenic Hill
 Graphical Presentation of Water Quality Monitoring
 Results

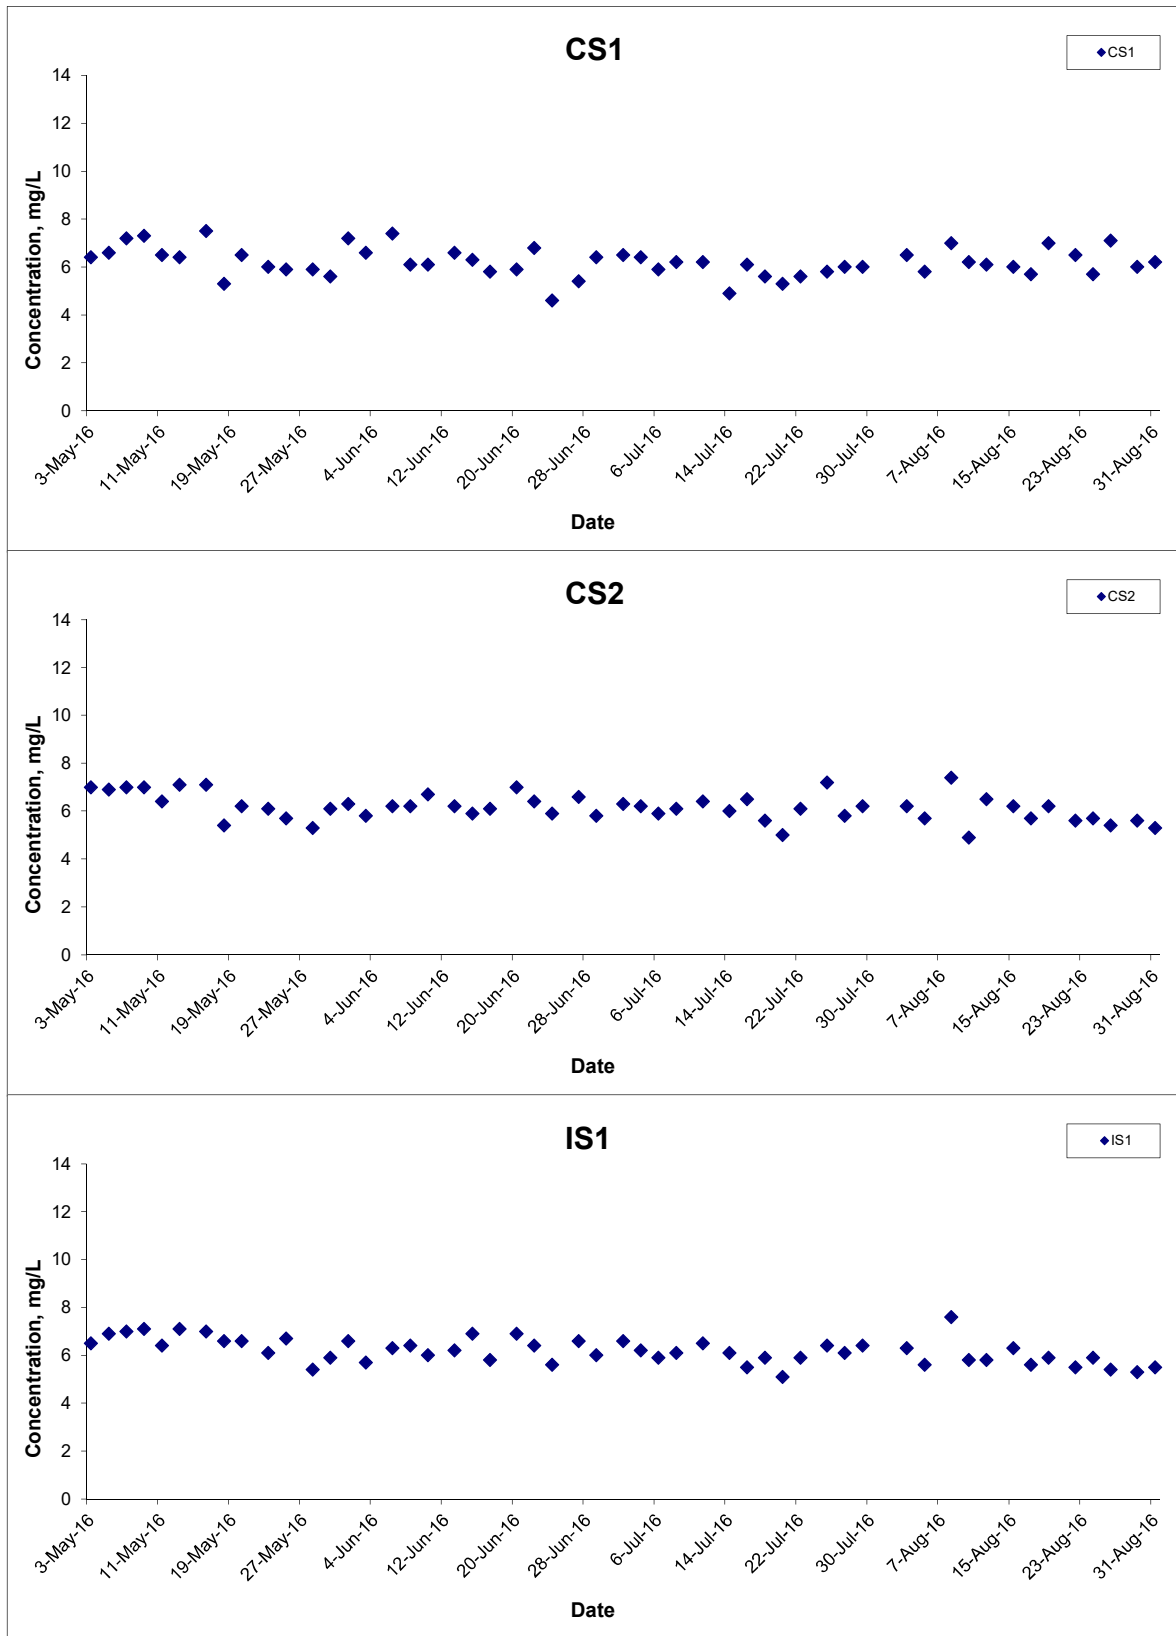
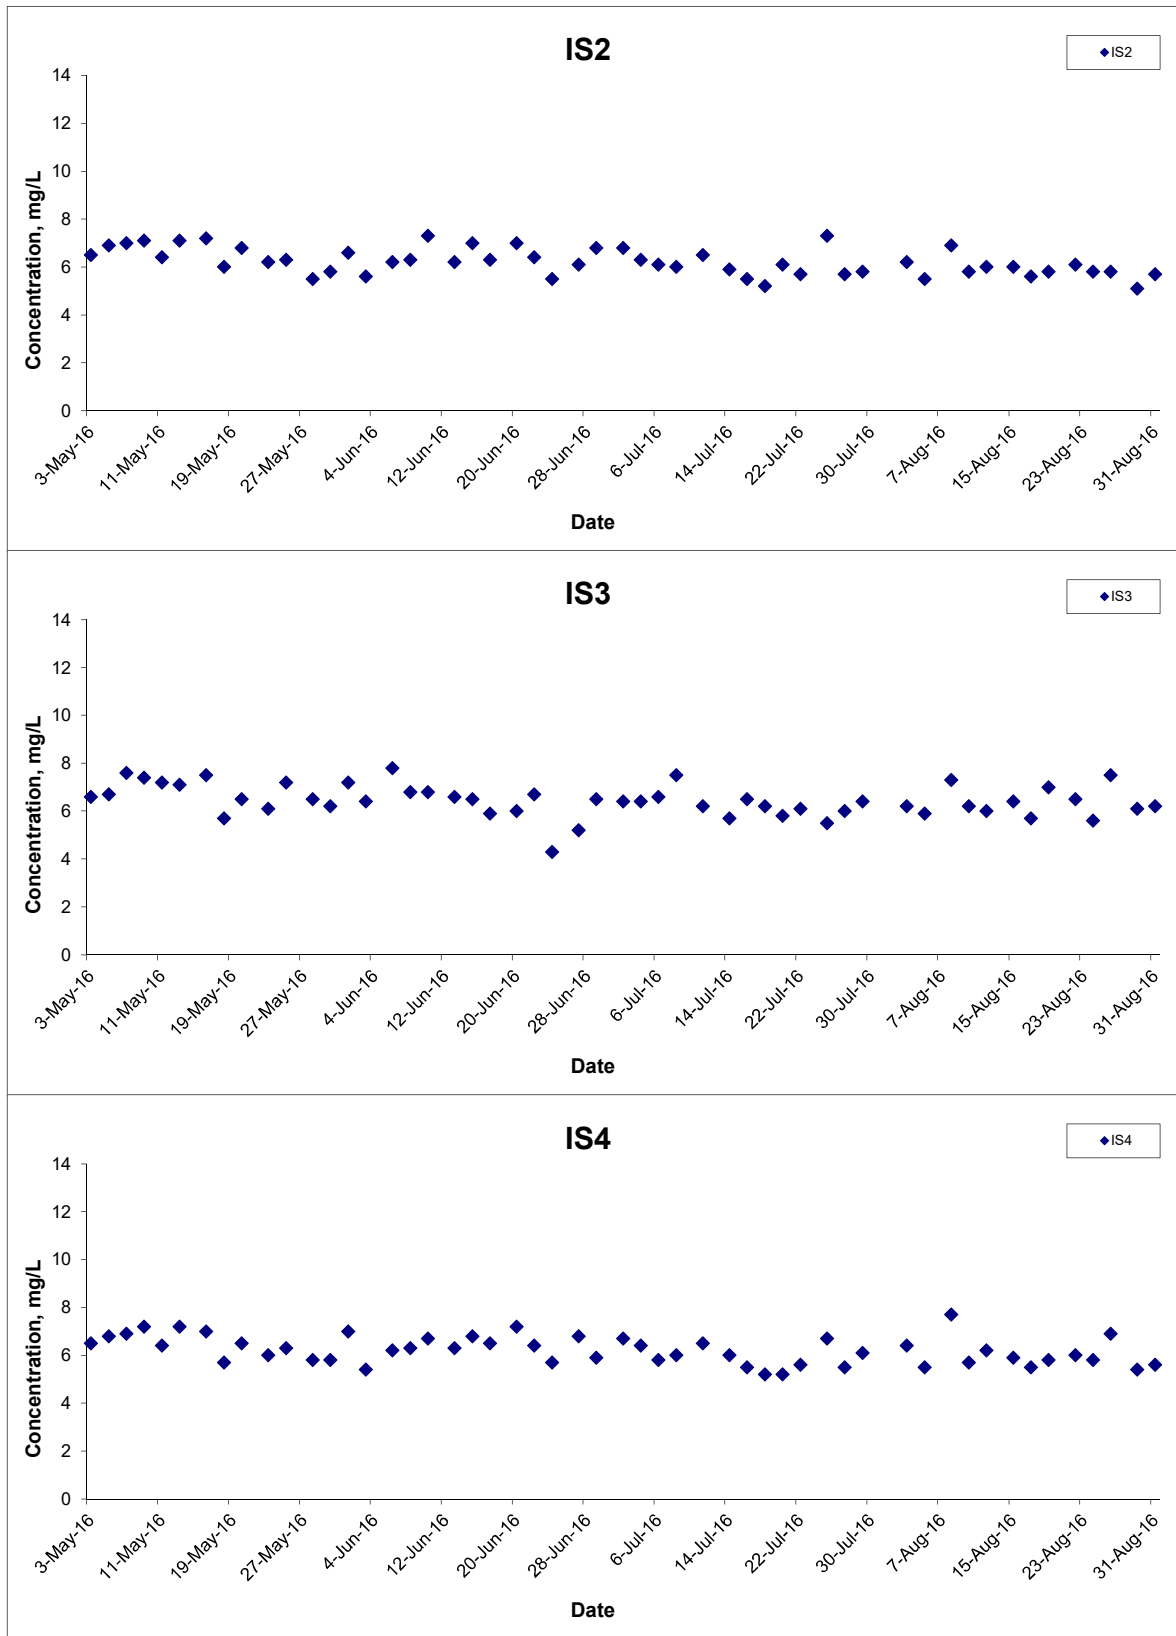
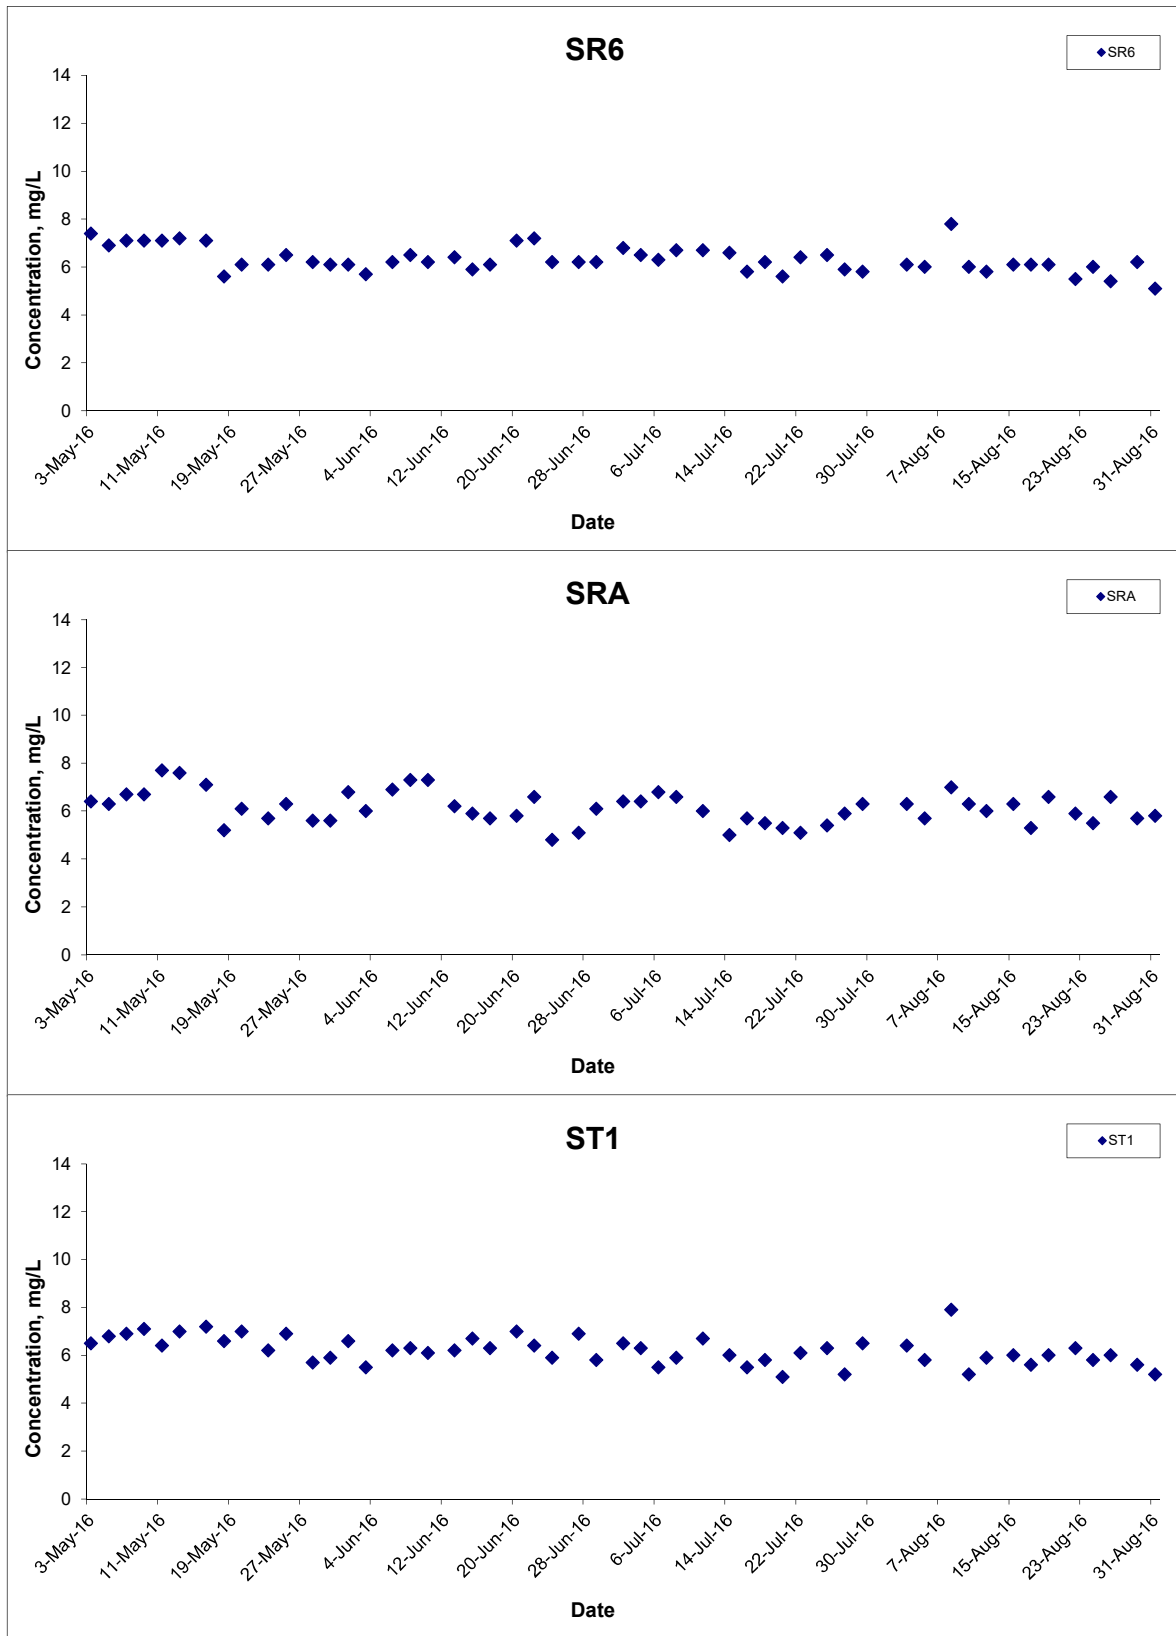
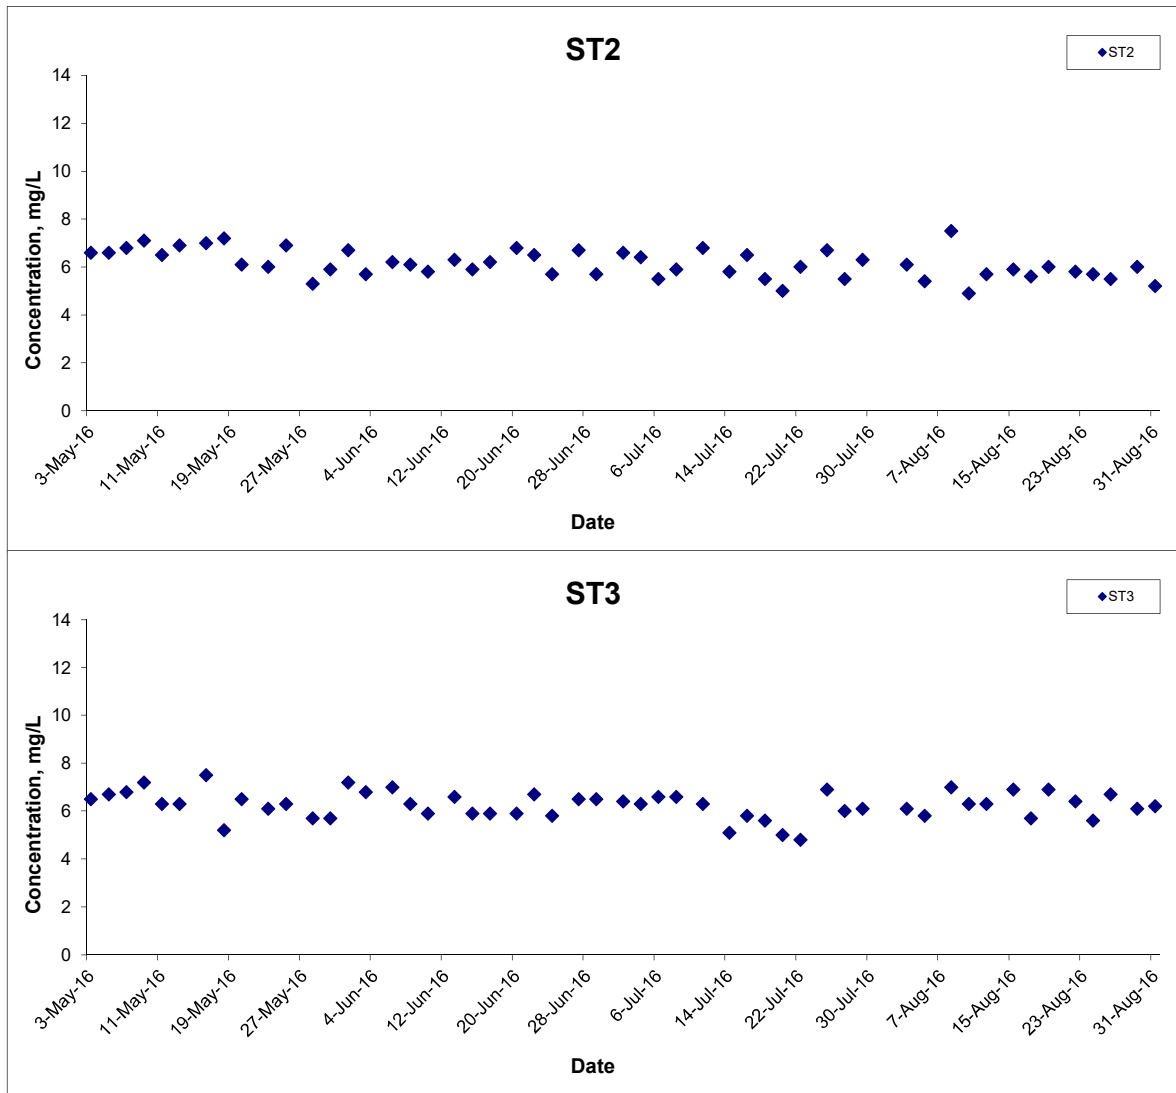
Dissolved Oxygen (Bottom) at Mid-Flood Tide

Title Contract HY/2011/09 Hong Kong-Zhuhai-Macao Bridge
 Hong Kong Link Road-Section between
 HKSAR Boundary and Scenic Hill
 Graphical Presentation of Water Quality Monitoring
 Results
