Contract No. HY/2011/09
Hong Kong-Zhuhai-Macao Bridge
Hong Kong Link Road – Section between HKSAR Boundary and Scenic Hill

Submission under Environmental Permit (EP-352/2009/D – Condition 4.4)
Monthly EM&A Report – August 2016

**Contract No. HY/2011/09 HZMB Hong Kong Link Road –
Section between HKSAR Boundary and Scenic Hill
Revised Monthly EM&A Report for August 2016 (EP-352/2009/D)**

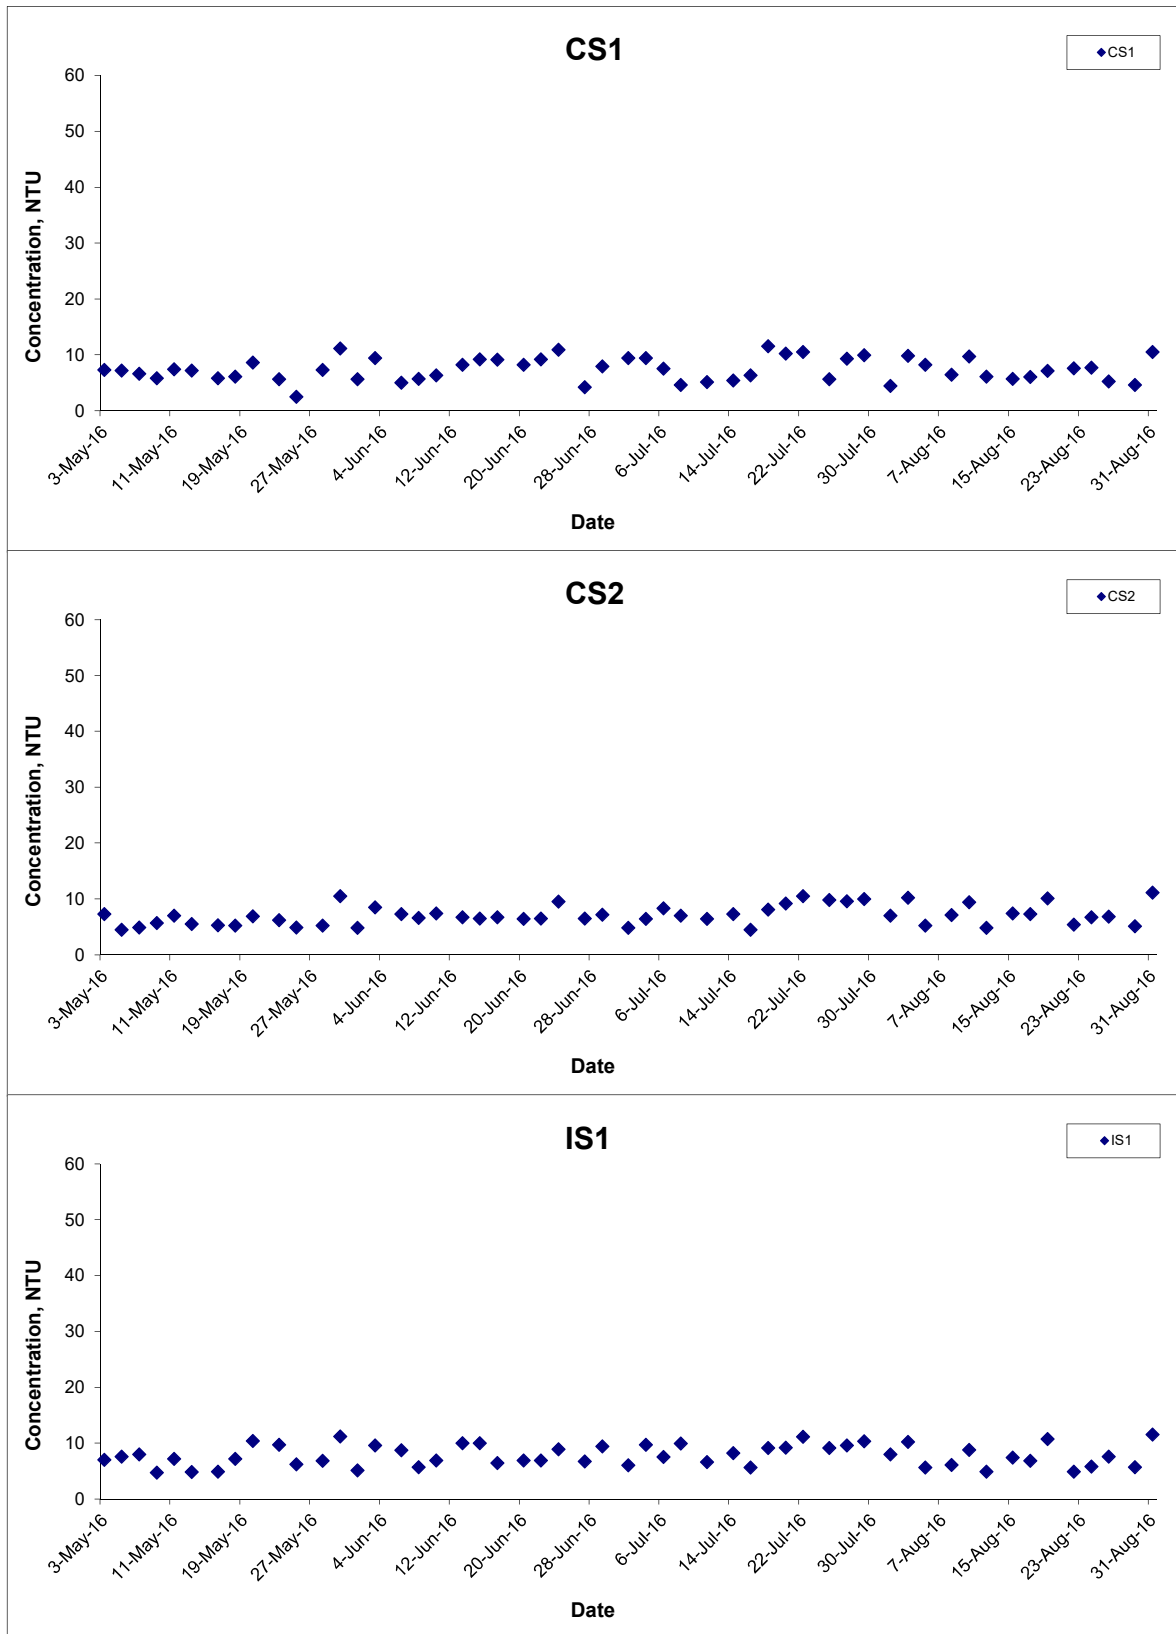
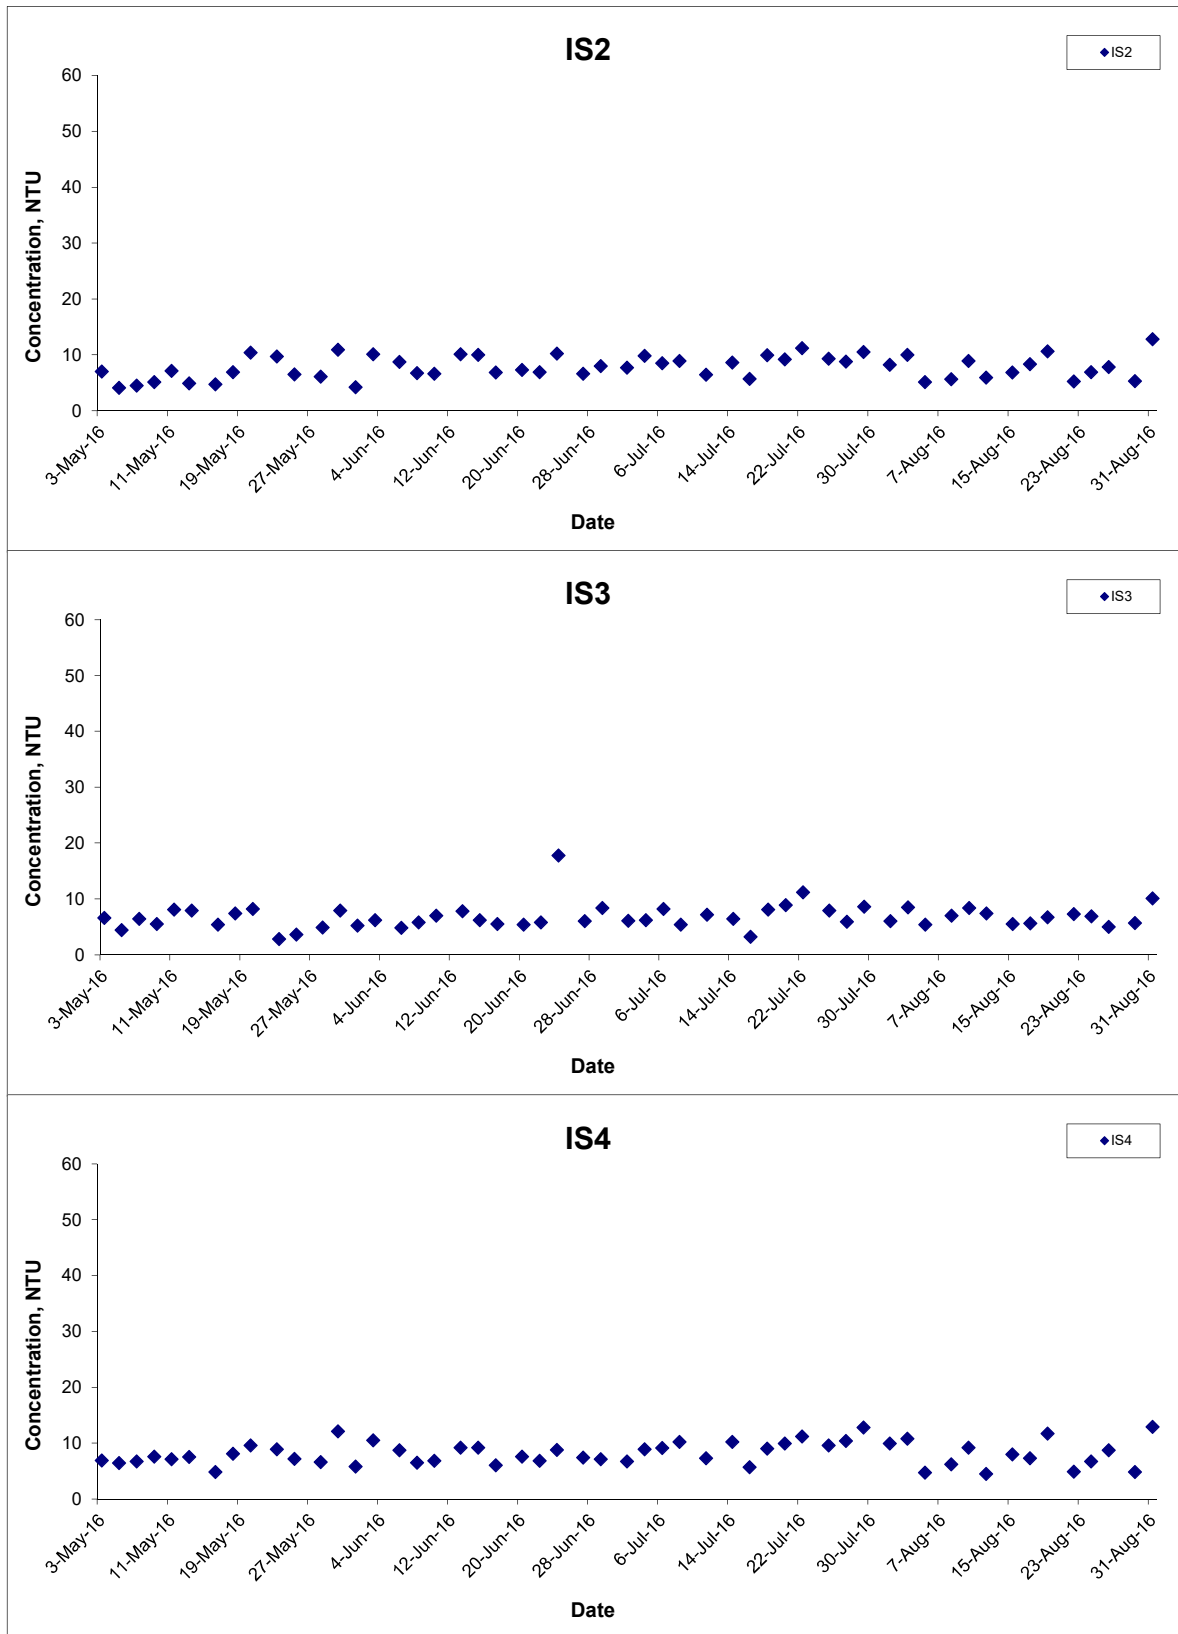
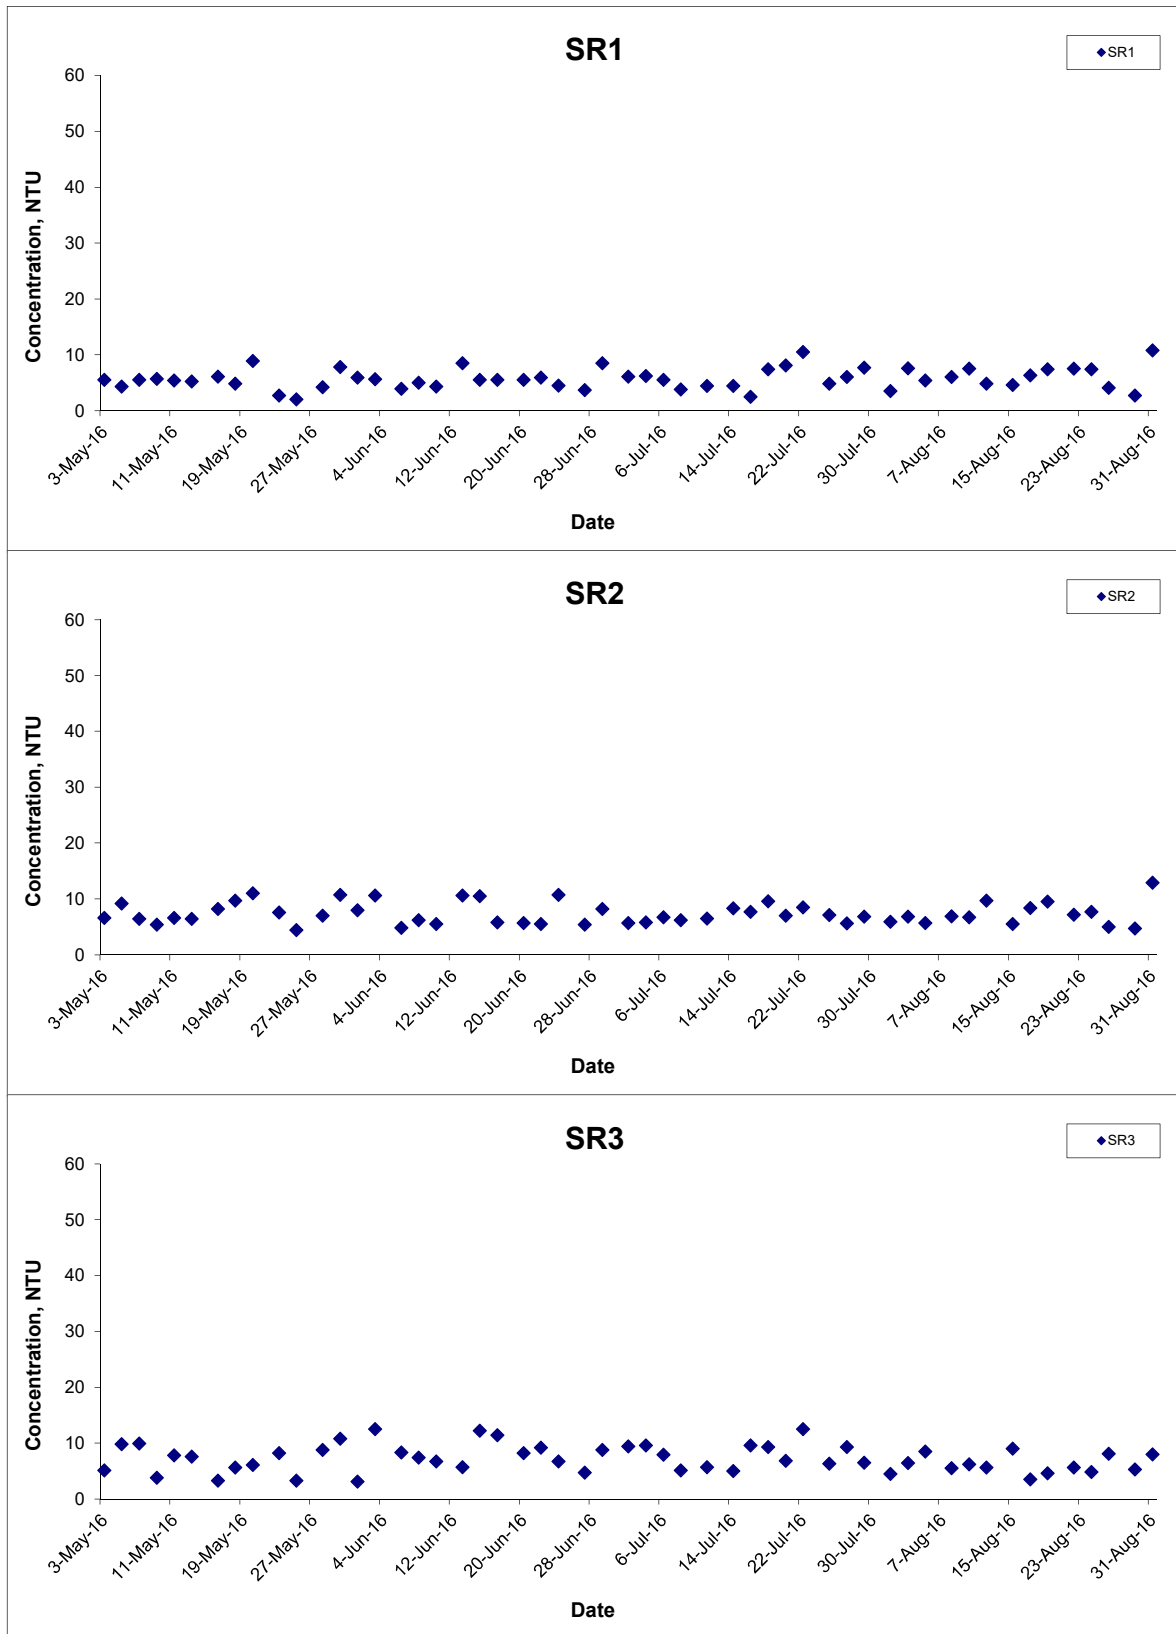
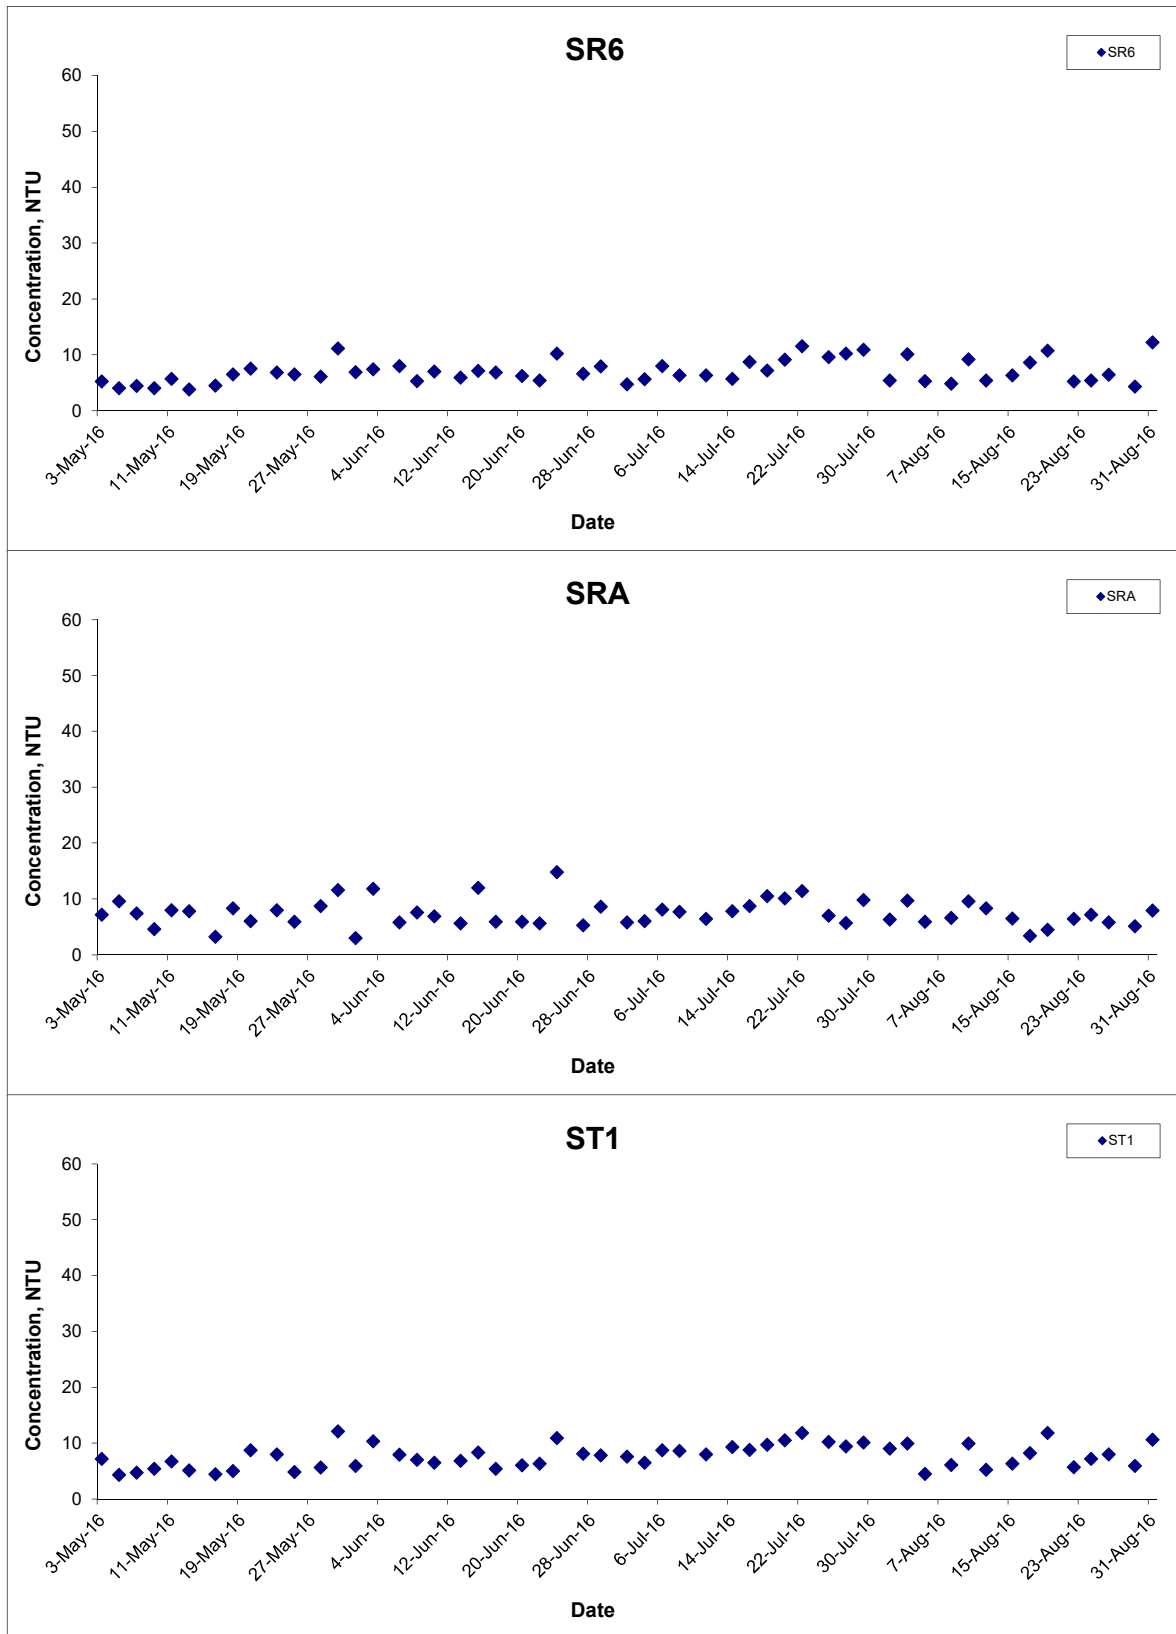
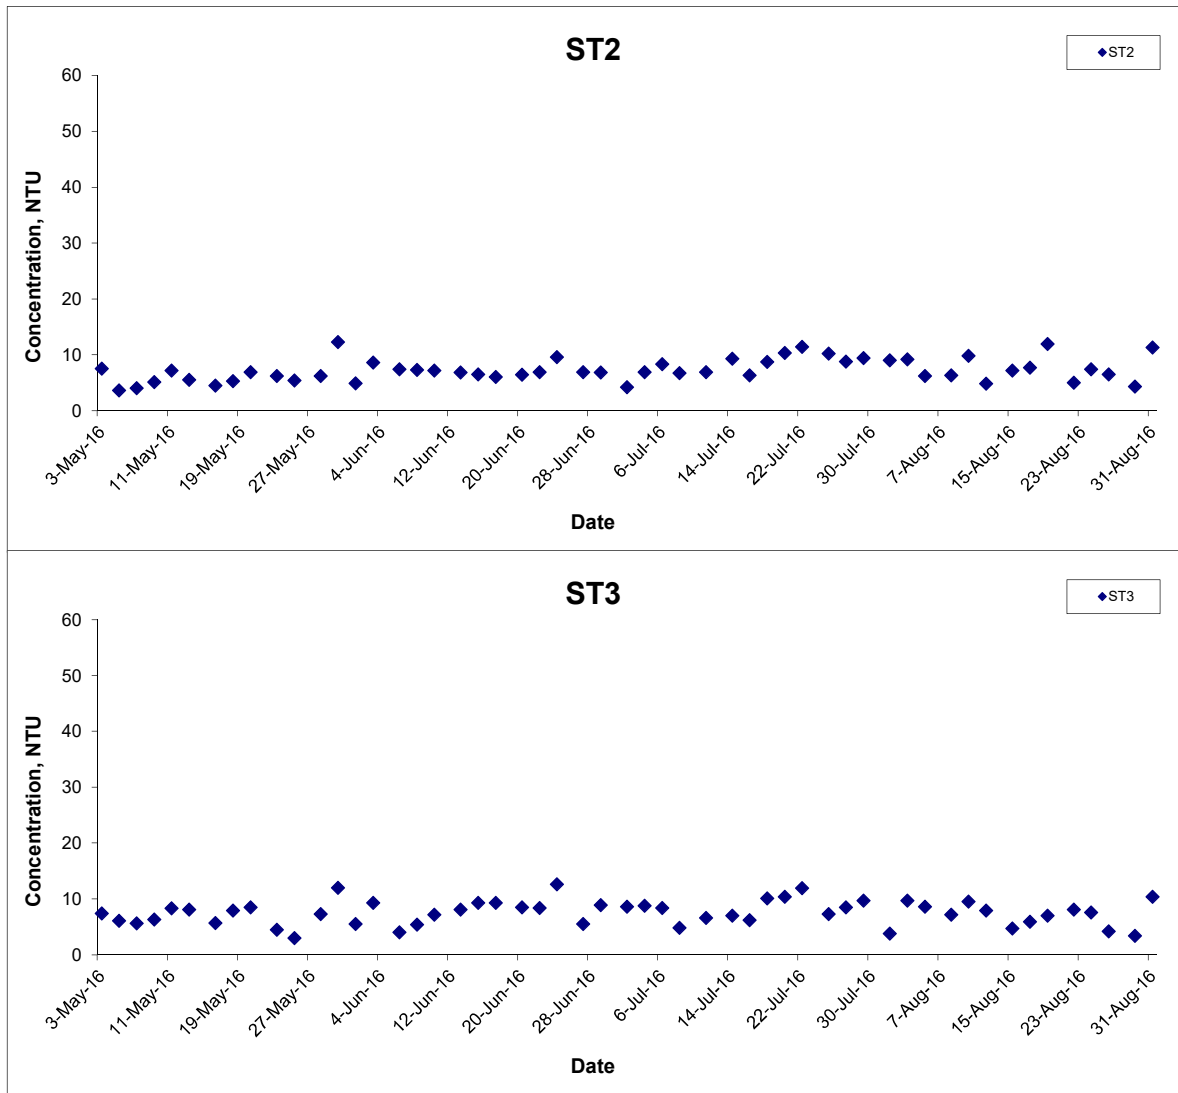
Turbidity (Depth-averaged) at Mid-Ebb Tide

Title Contract HY/2011/09 Hong Kong-Zhuhai-Macao Bridge
 Hong Kong Link Road-Section between
 HKSAR Boundary and Scenic Hill
 Graphical Presentation of Water Quality Monitoring
 Results

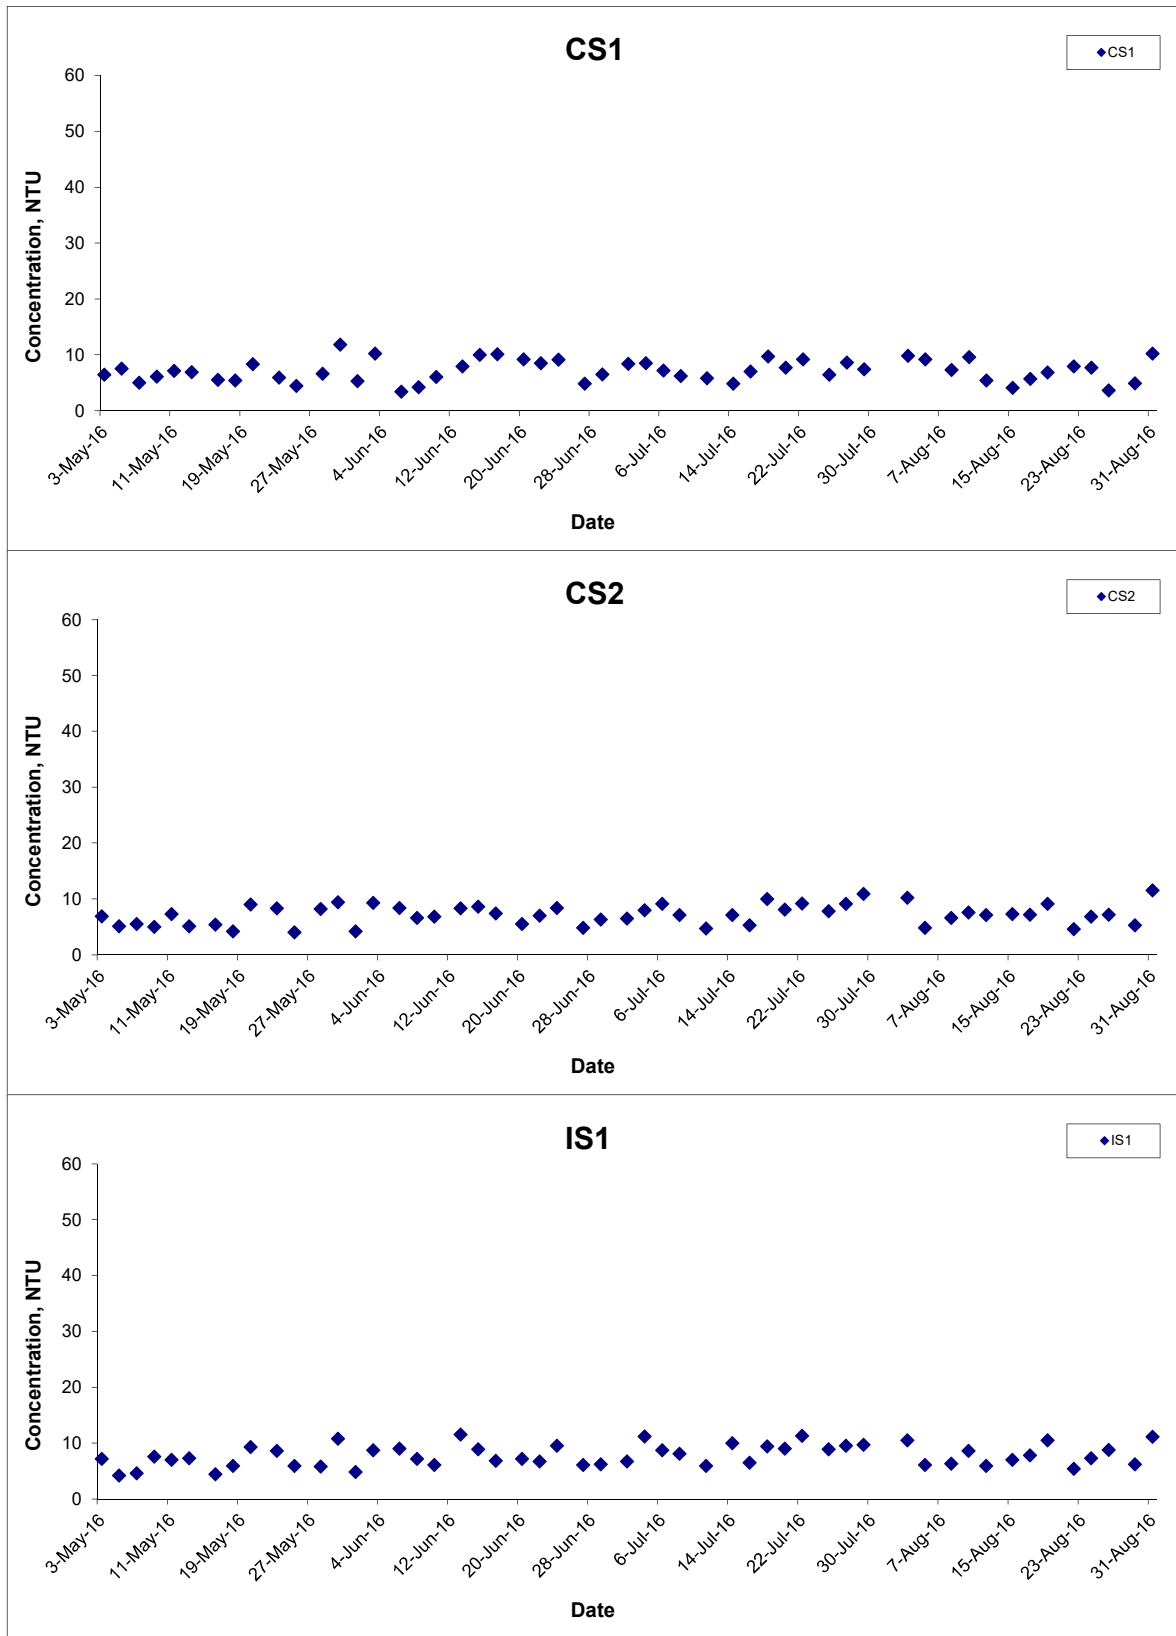
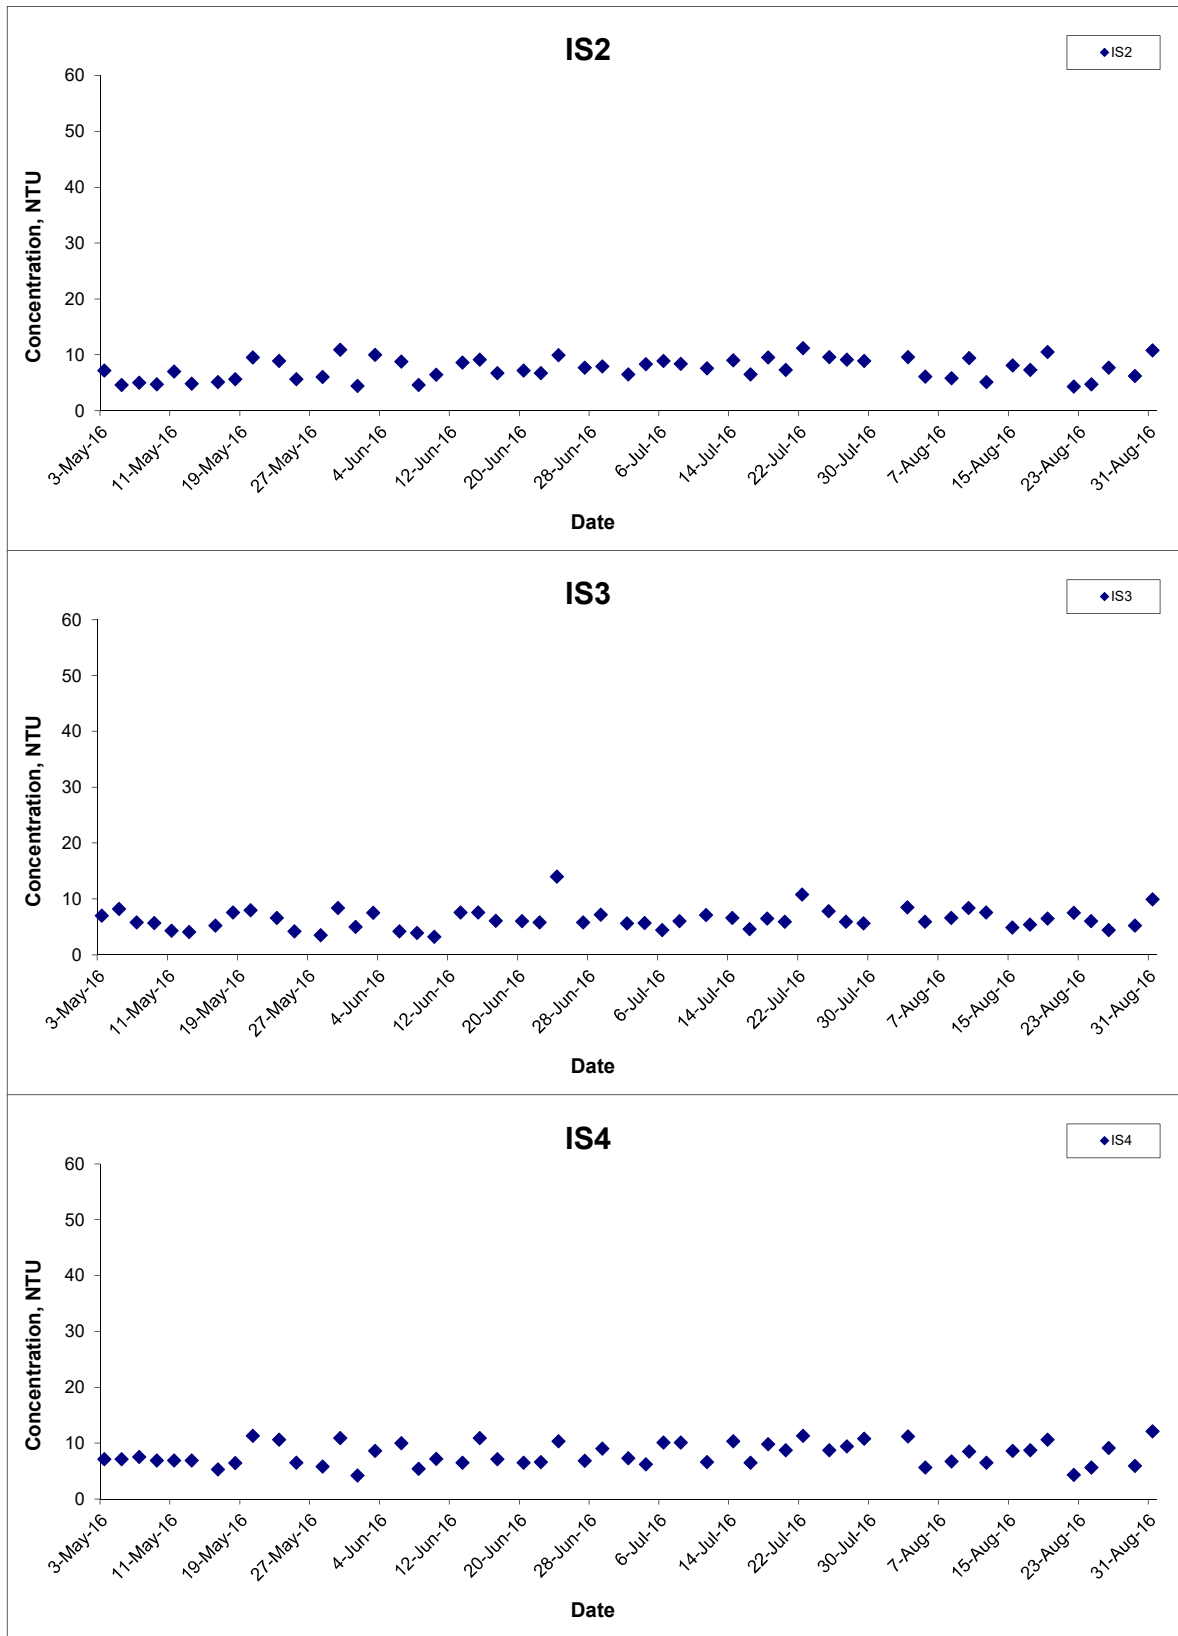
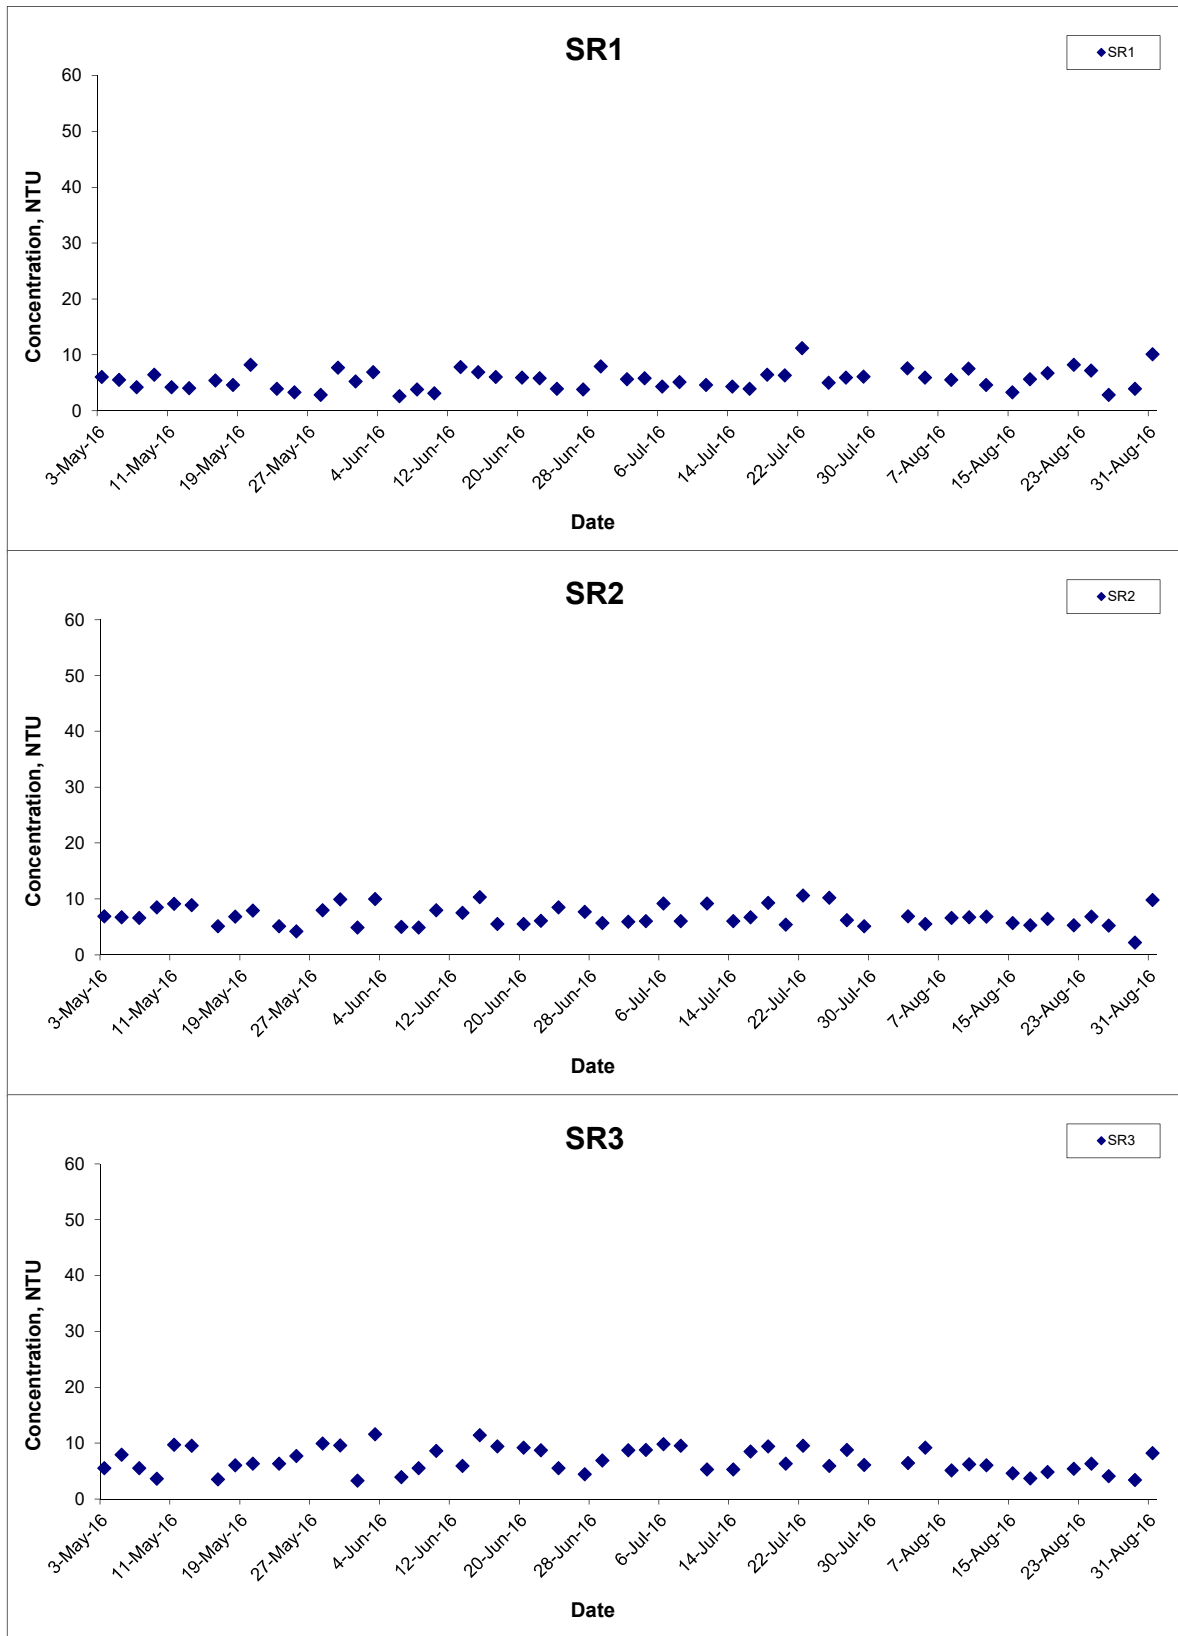
Turbidity (Depth-averaged) at Mid-Flood Tide

Title Contract HY/2011/09 Hong Kong-Zhuhai-Macao Bridge
 Hong Kong Link Road-Section between
 HKSAR Boundary and Scenic Hill
 Graphical Presentation of Water Quality Monitoring
 Results

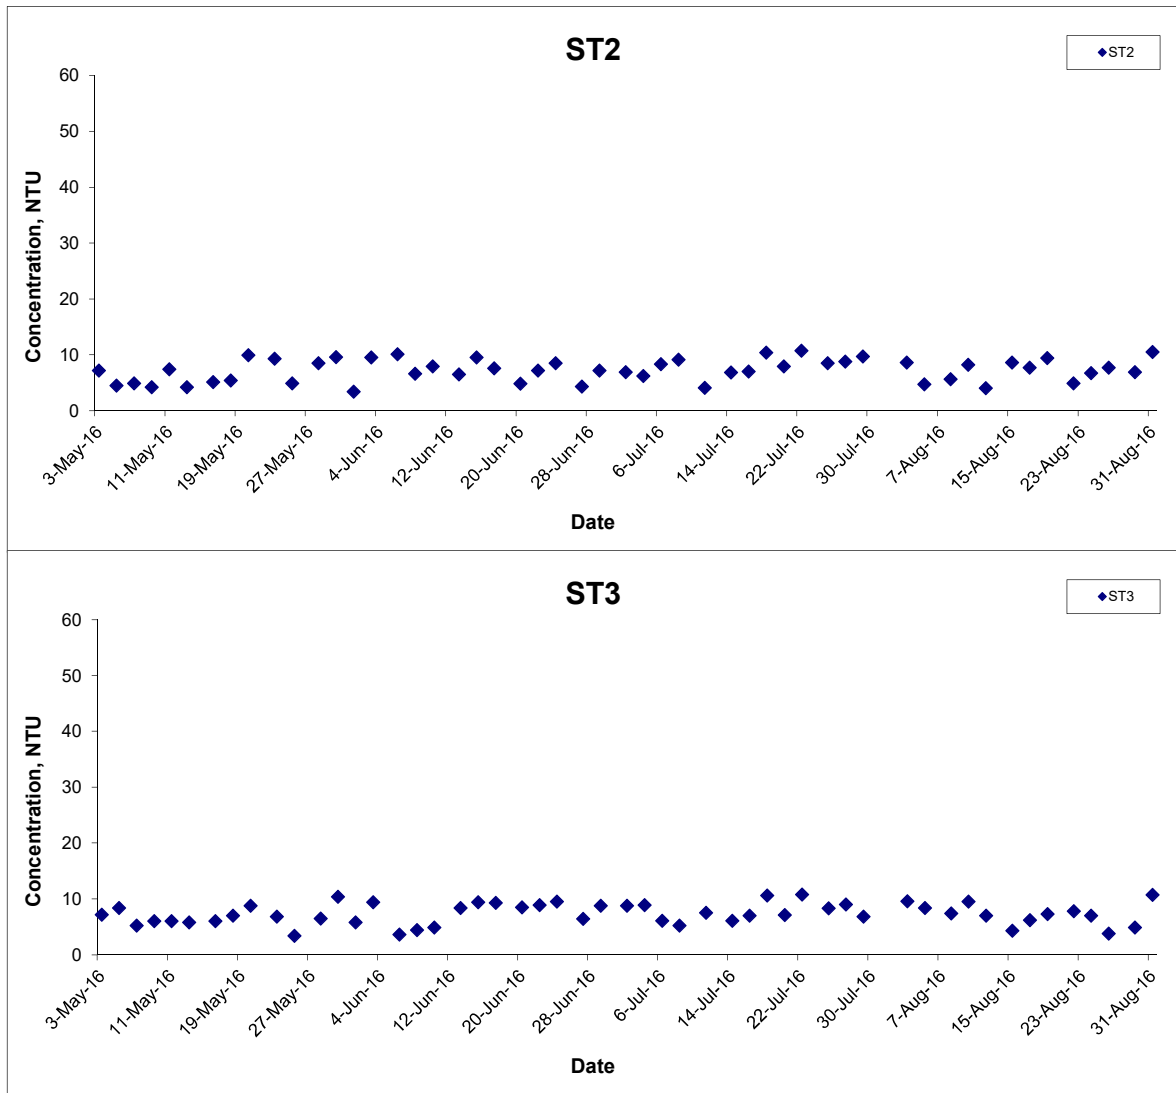
Turbidity (Depth-averaged) at Mid-Flood Tide

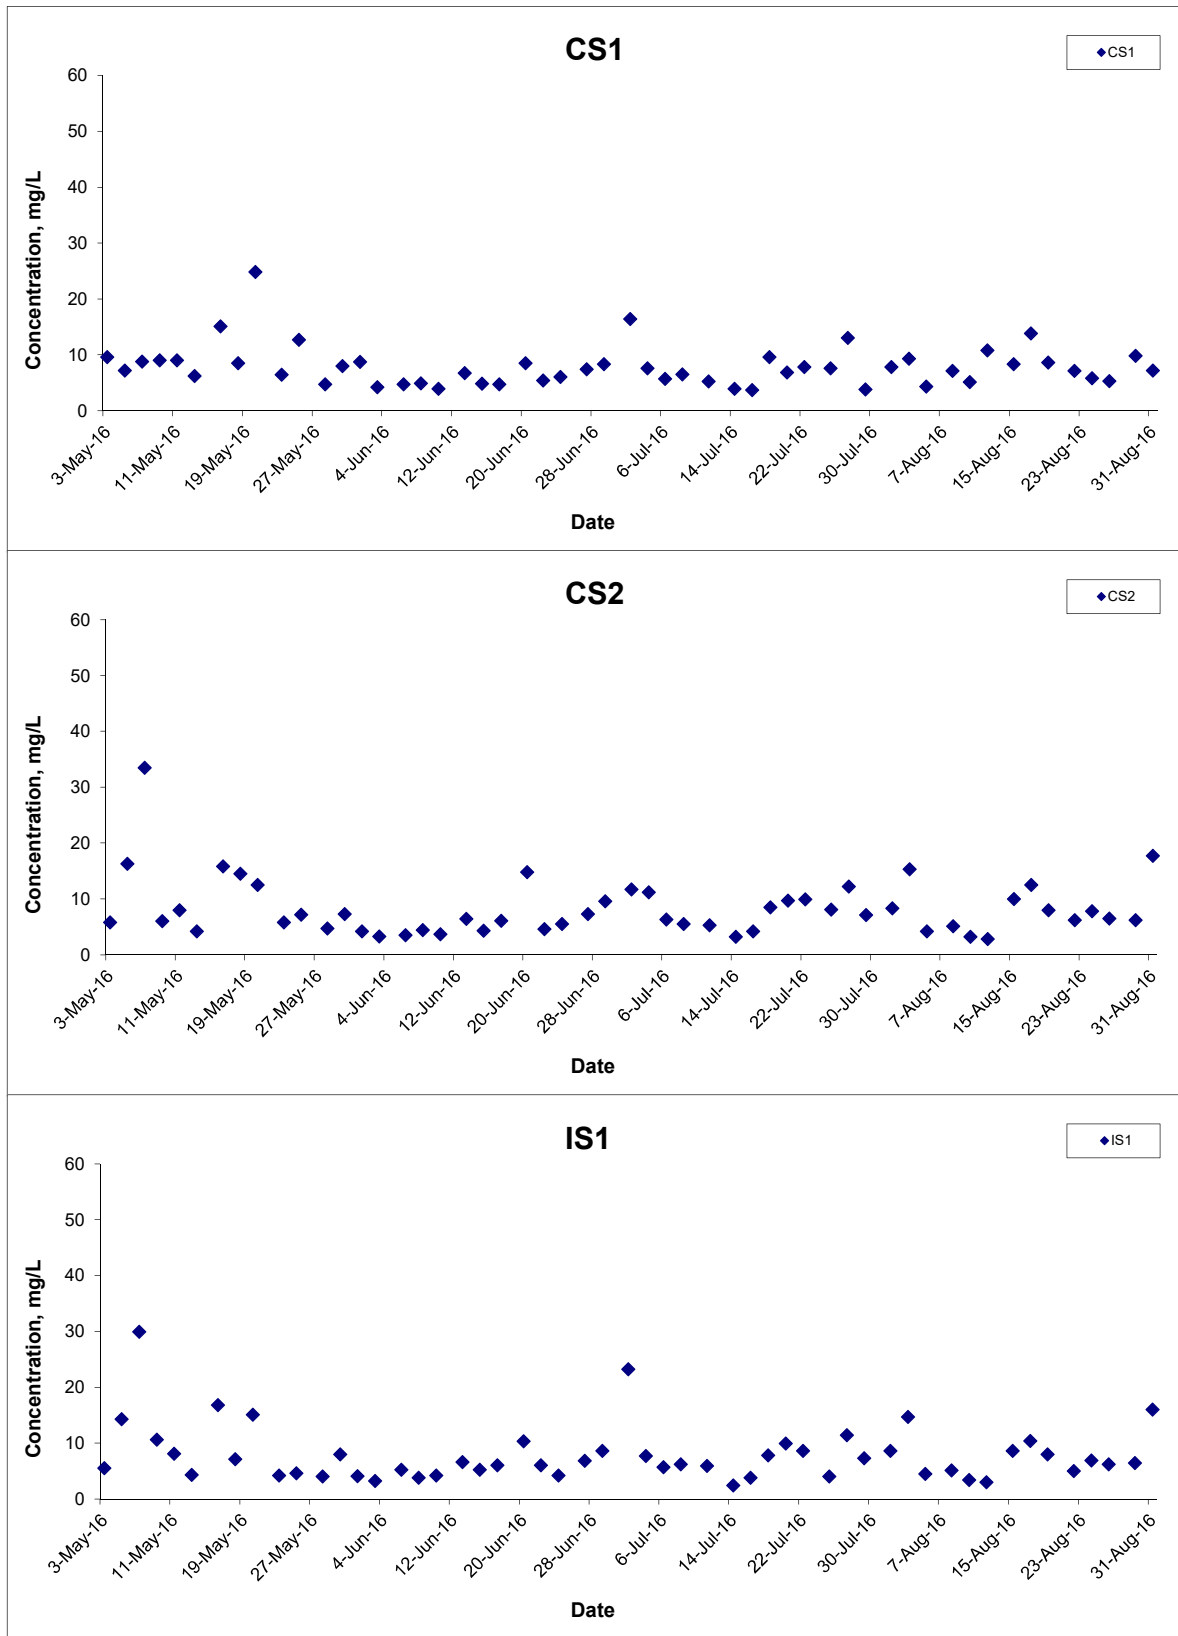
Suspended Solids (Depth-averaged) at Mid-Ebb Tide

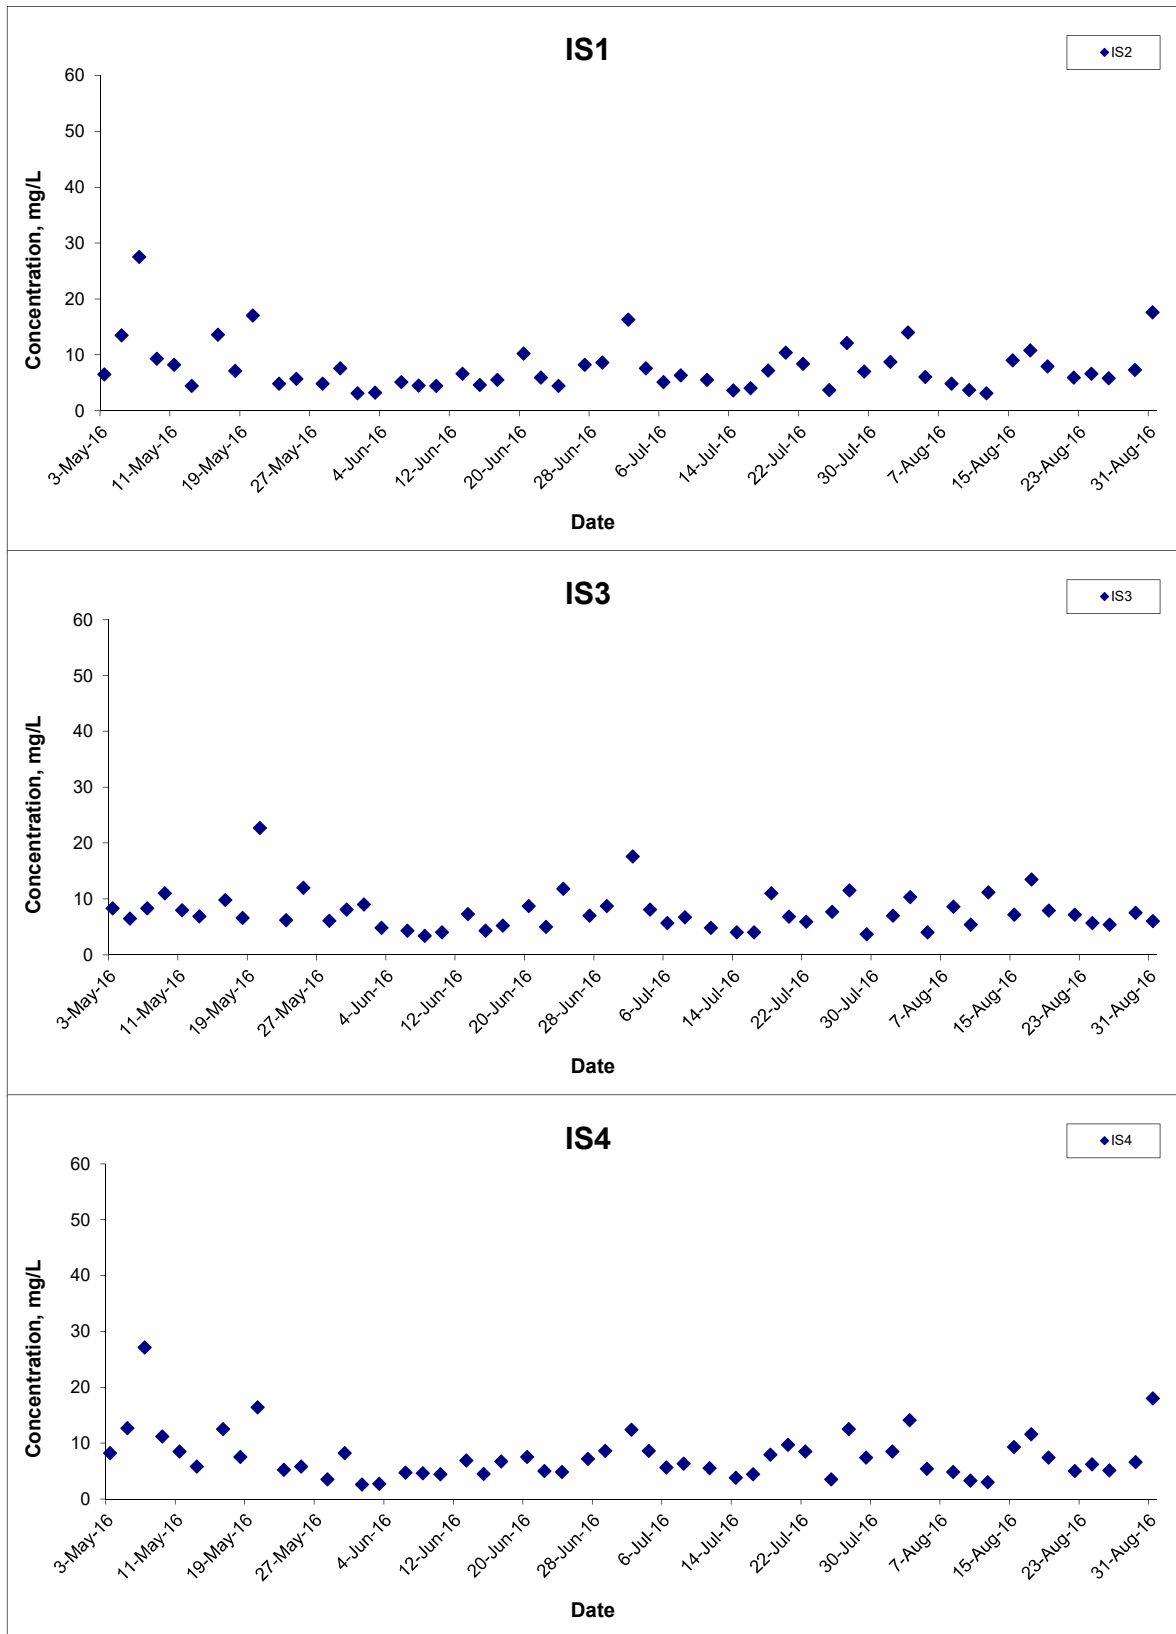
Suspended Solids (Depth-averaged) at Mid-Ebb Tide

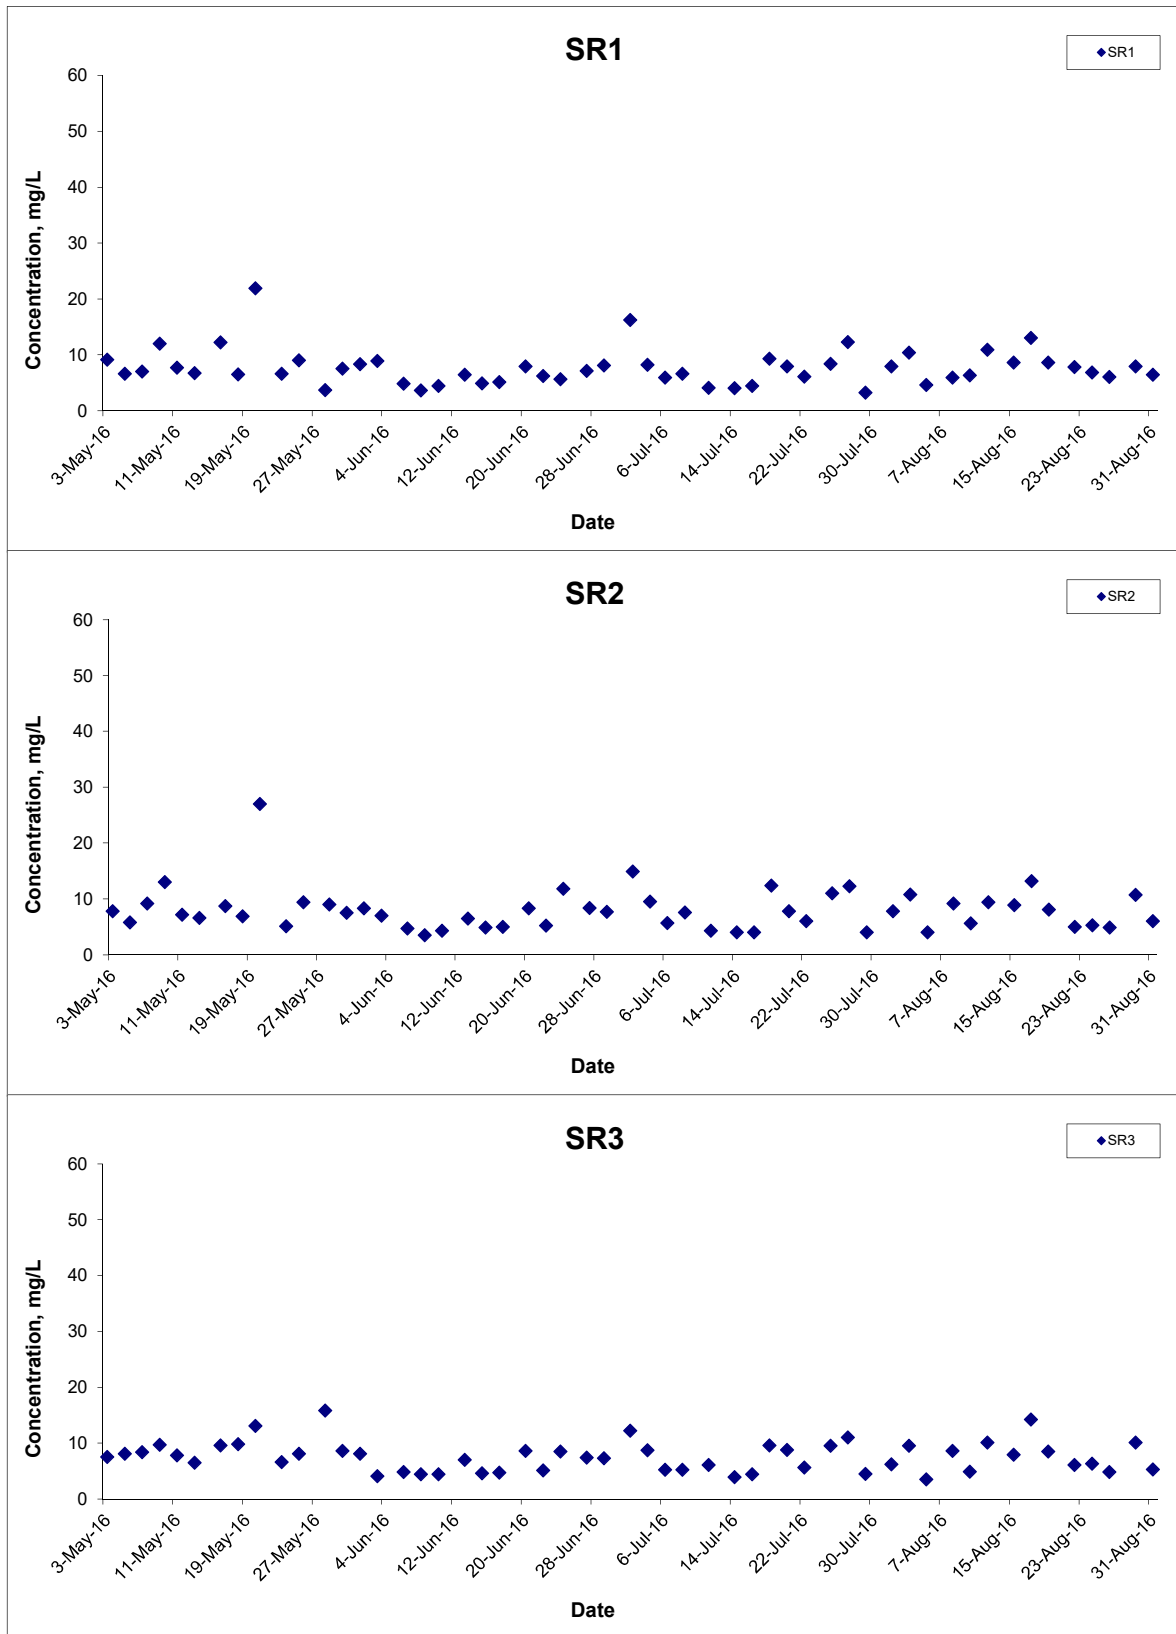
Suspended Solids (Depth-averaged) at Mid-Ebb Tide
