Contract No. HY/2011/09
Hong Kong-Zhuhai-Macao Bridge
Hong Kong Link Road – Section between HKSAR Boundary and Scenic Hill

Submission under Environmental Permit (EP-352/2009/D – Condition 4.4)
Monthly EM&A Report – August 2016

**Contract No. HY/2011/09 HZMB Hong Kong Link Road –
Section between HKSAR Boundary and Scenic Hill
Revised Monthly EM&A Report for August 2016 (EP-352/2009/D)**

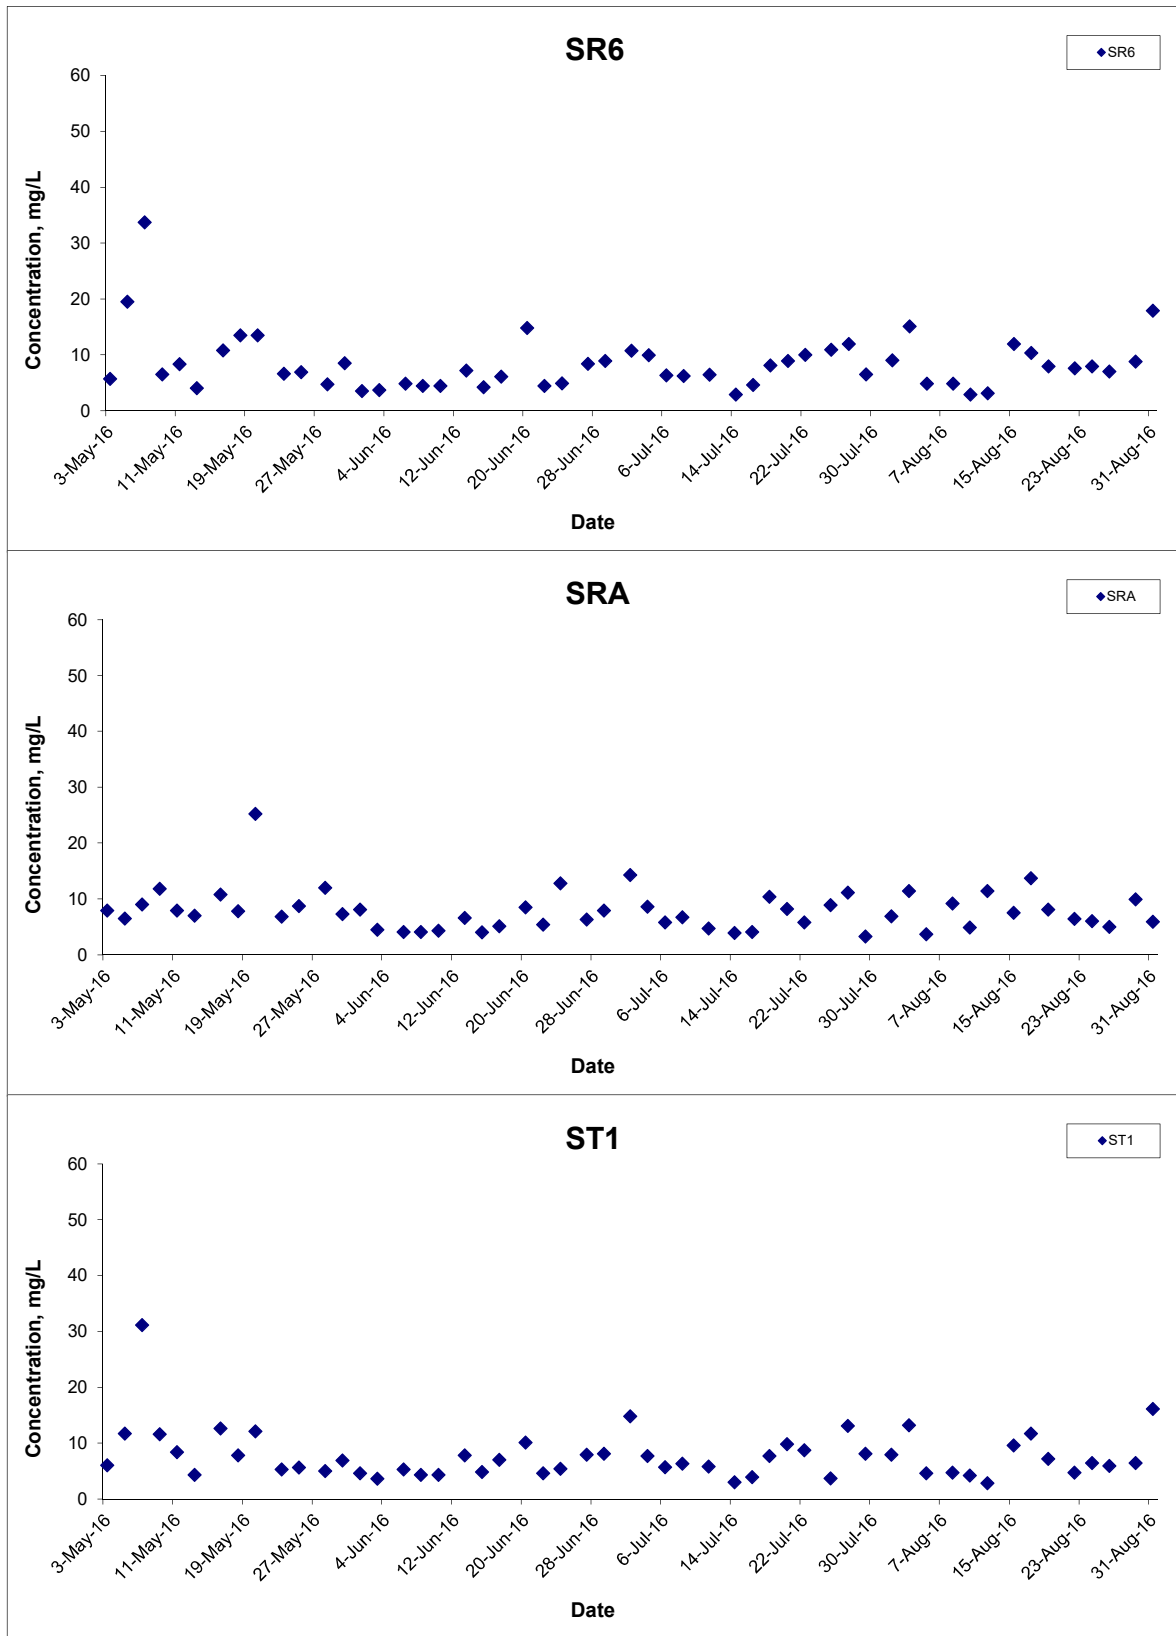
Suspended Solids (Depth-averaged) at Mid-Ebb Tide

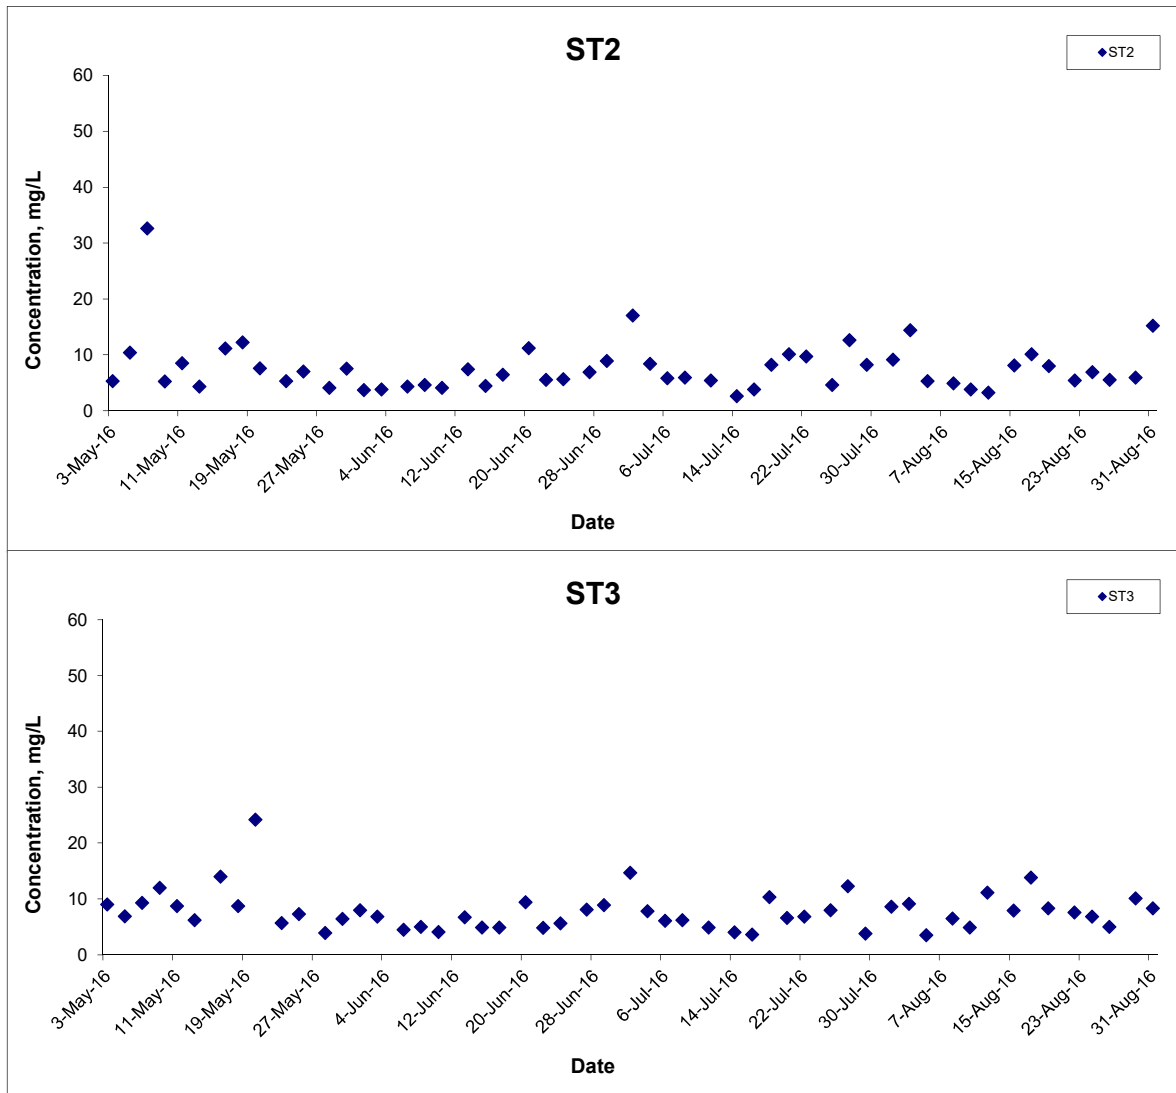
Suspended Solids (Depth-averaged) at Mid-Ebb Tide

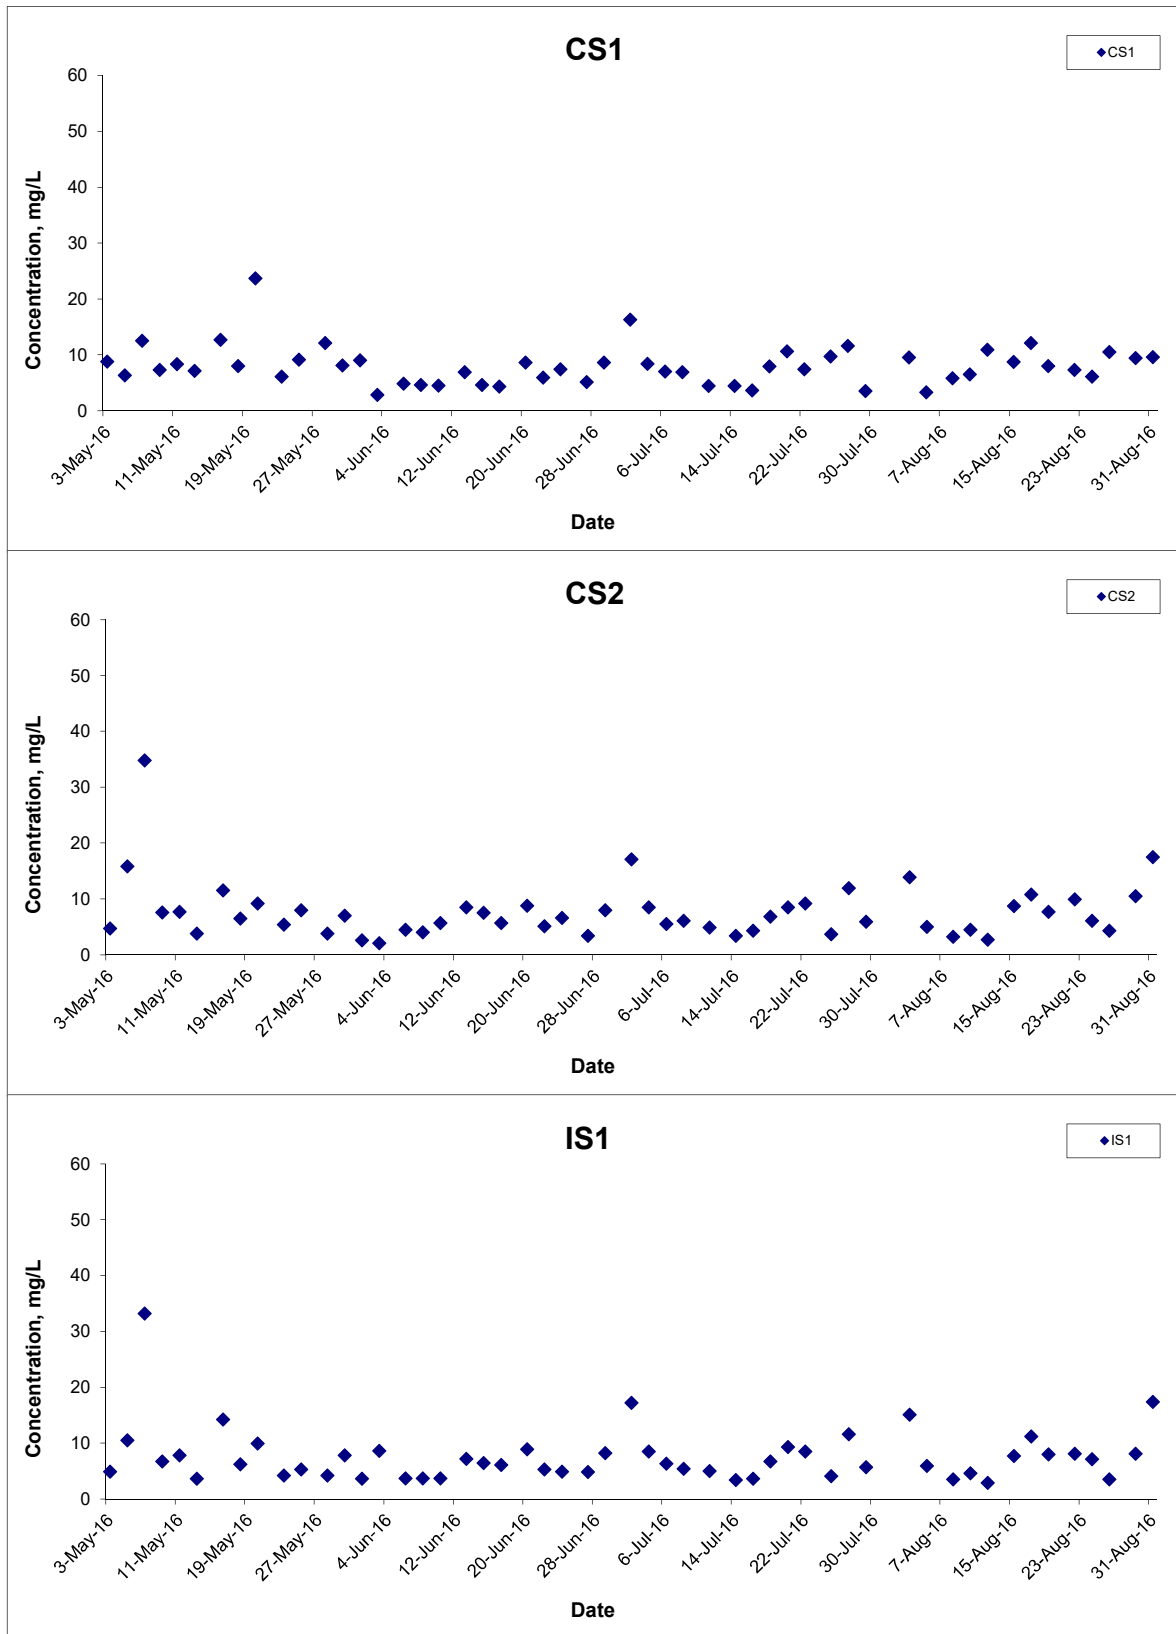
Suspended Solids (Depth-averaged) at Mid-Flood Tide

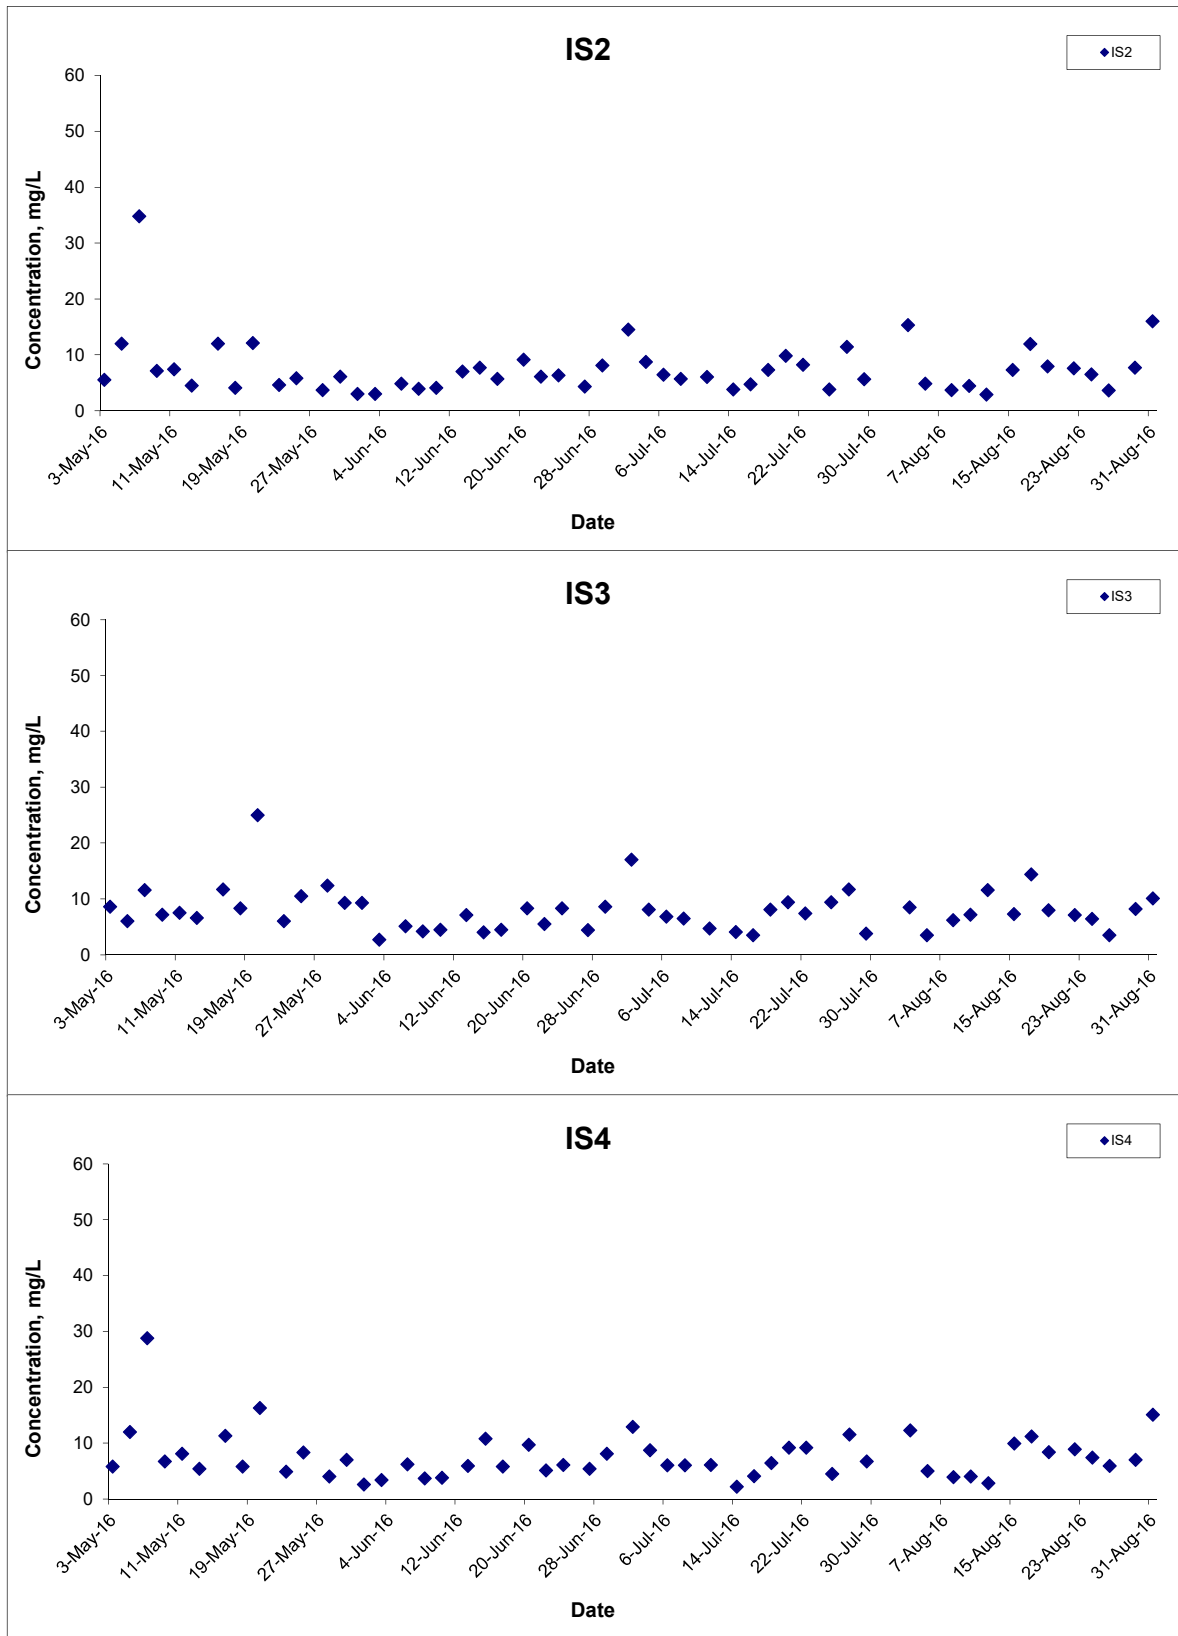
Suspended Solids (Depth-averaged) at Mid-Flood Tide

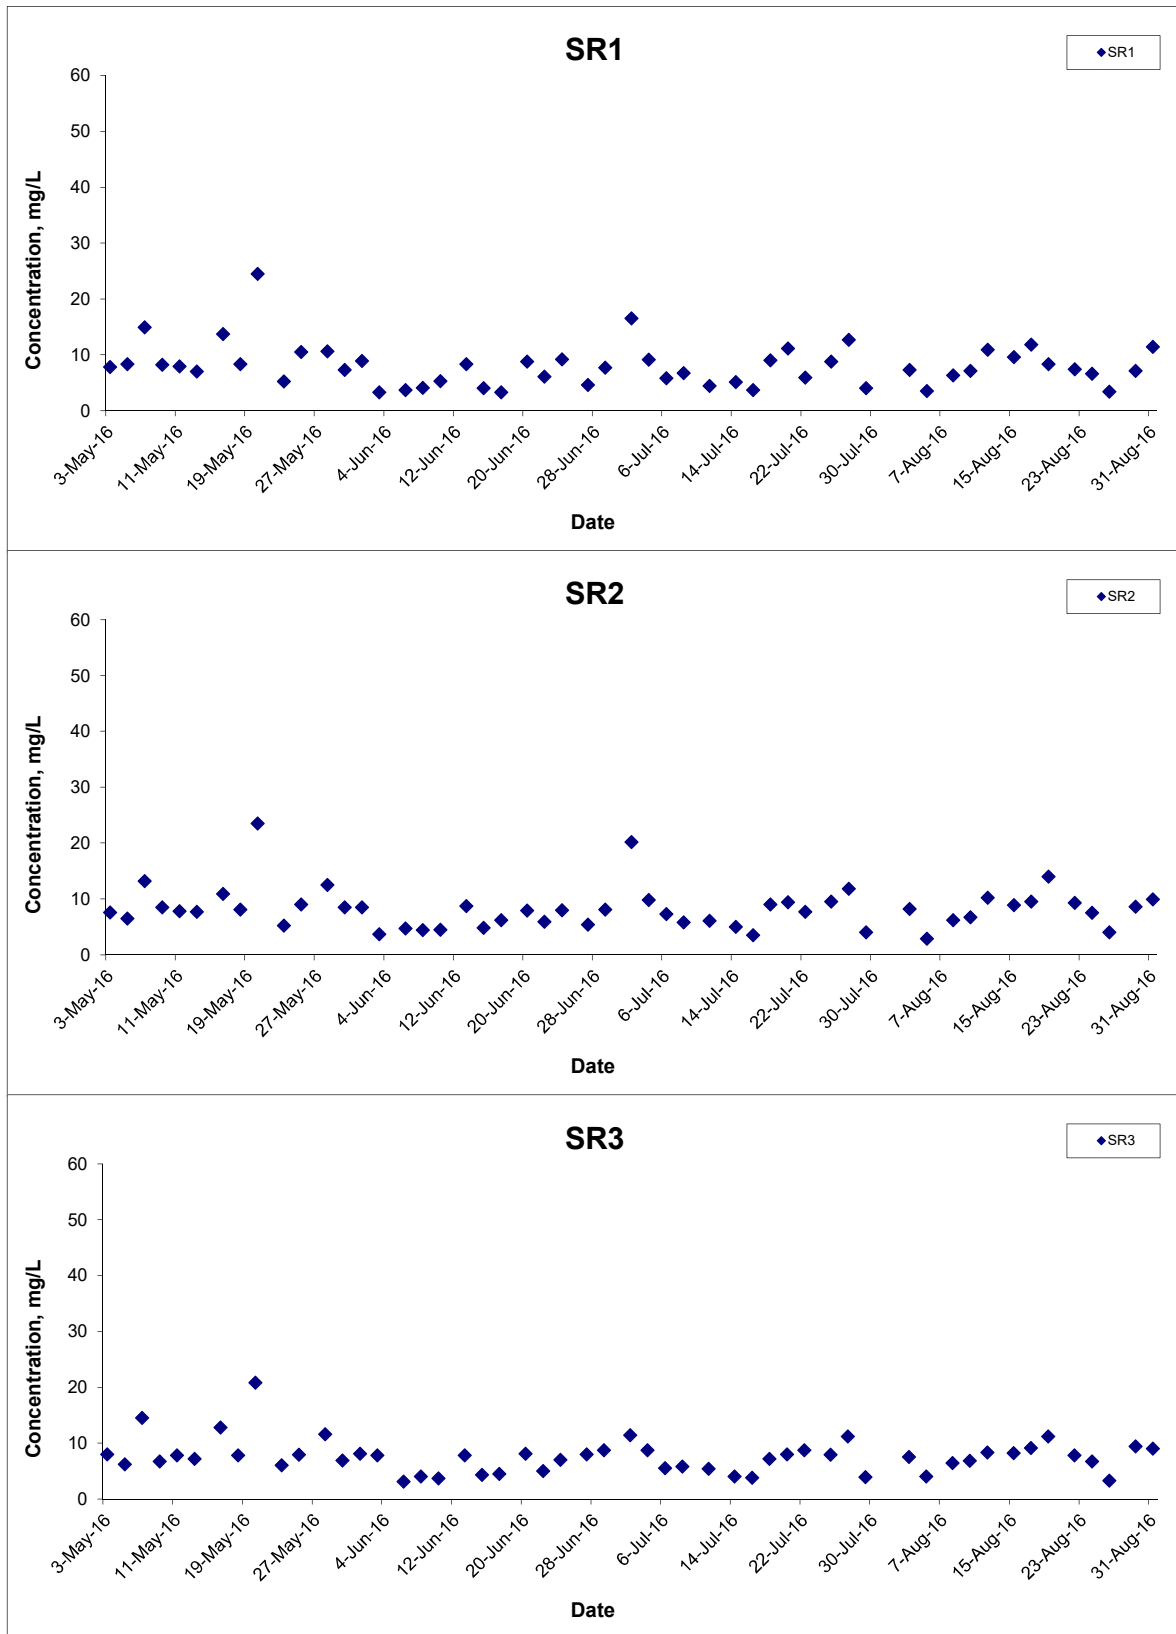
Suspended Solids (Depth-averaged) at Mid-Flood Tide

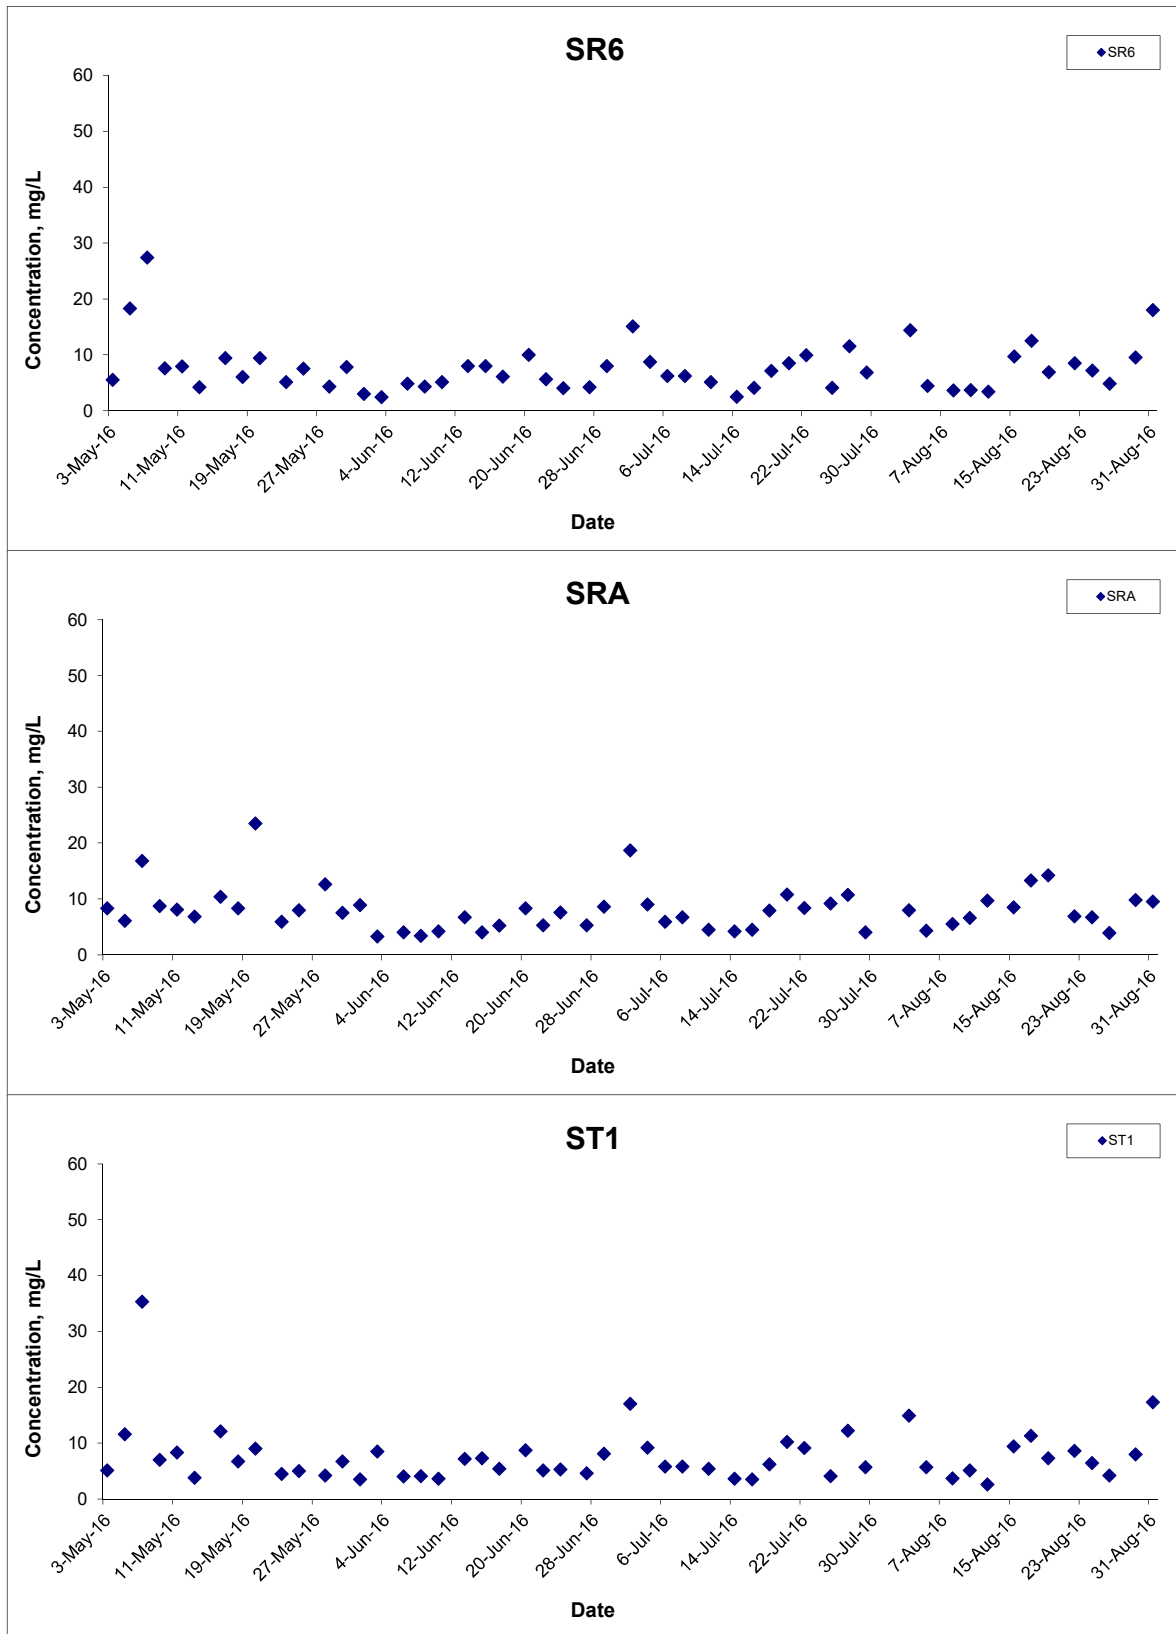
Suspended Solids (Depth-averaged) at Mid-Flood Tide

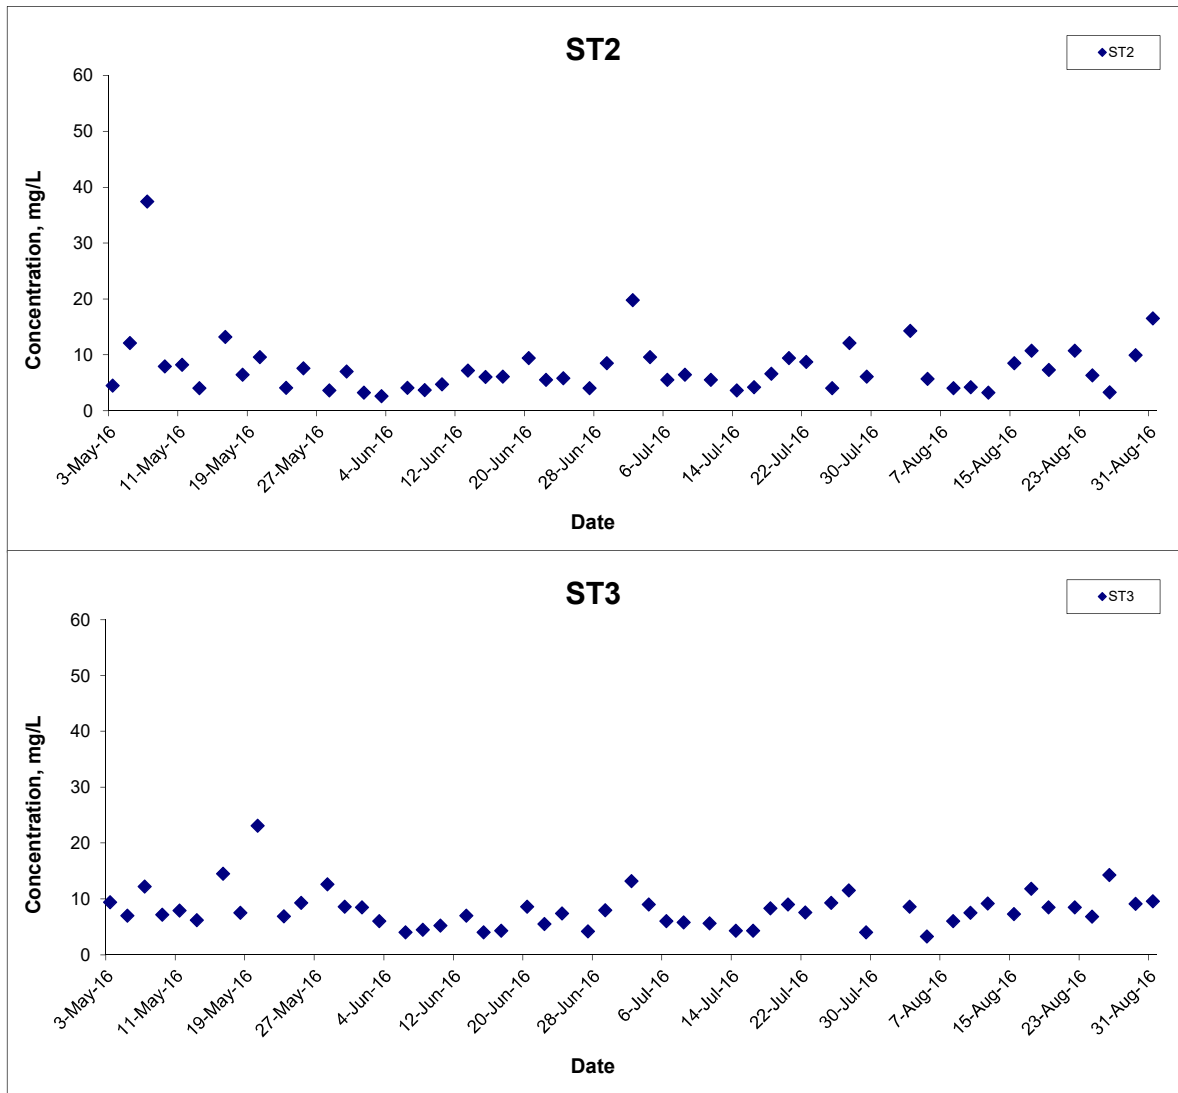
Suspended Solids (Depth-averaged) at Mid-Flood Tide

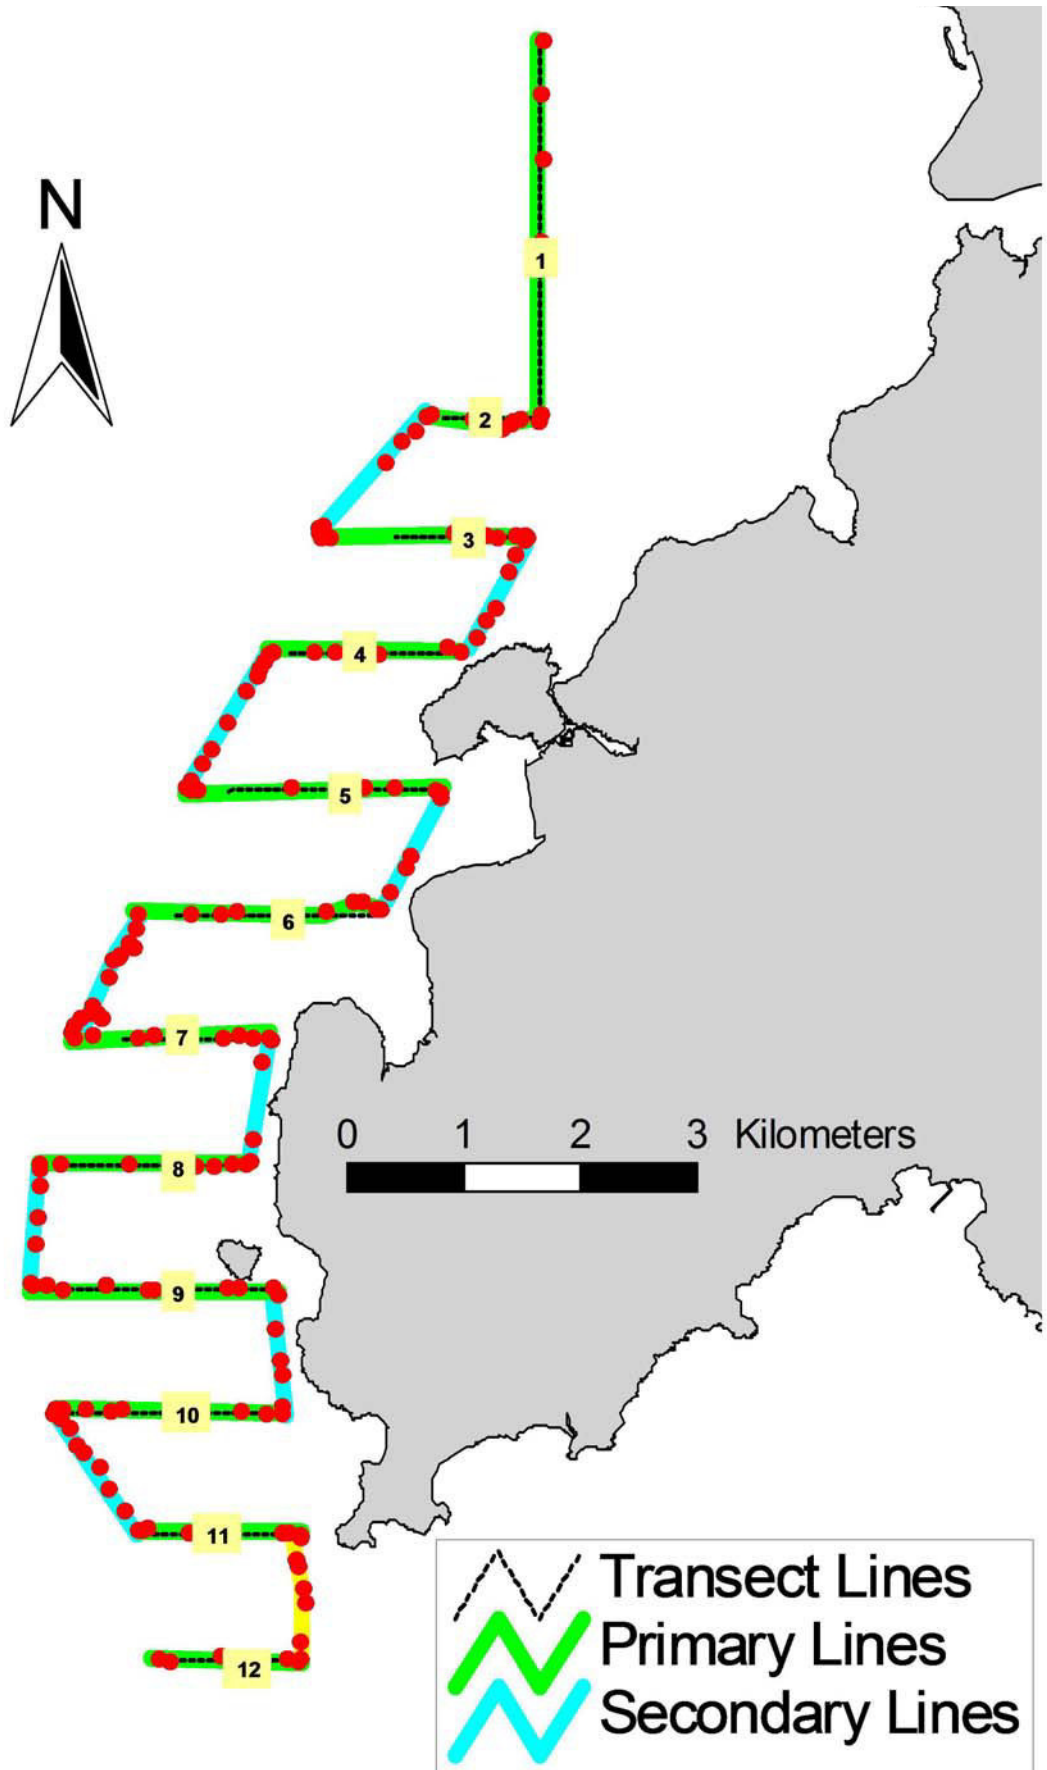
Figure 2. Survey Route on August 9th, 2016 (note: red dots represent the tracked positions of survey boat logged continuously by GPS throughout the course of the survey)

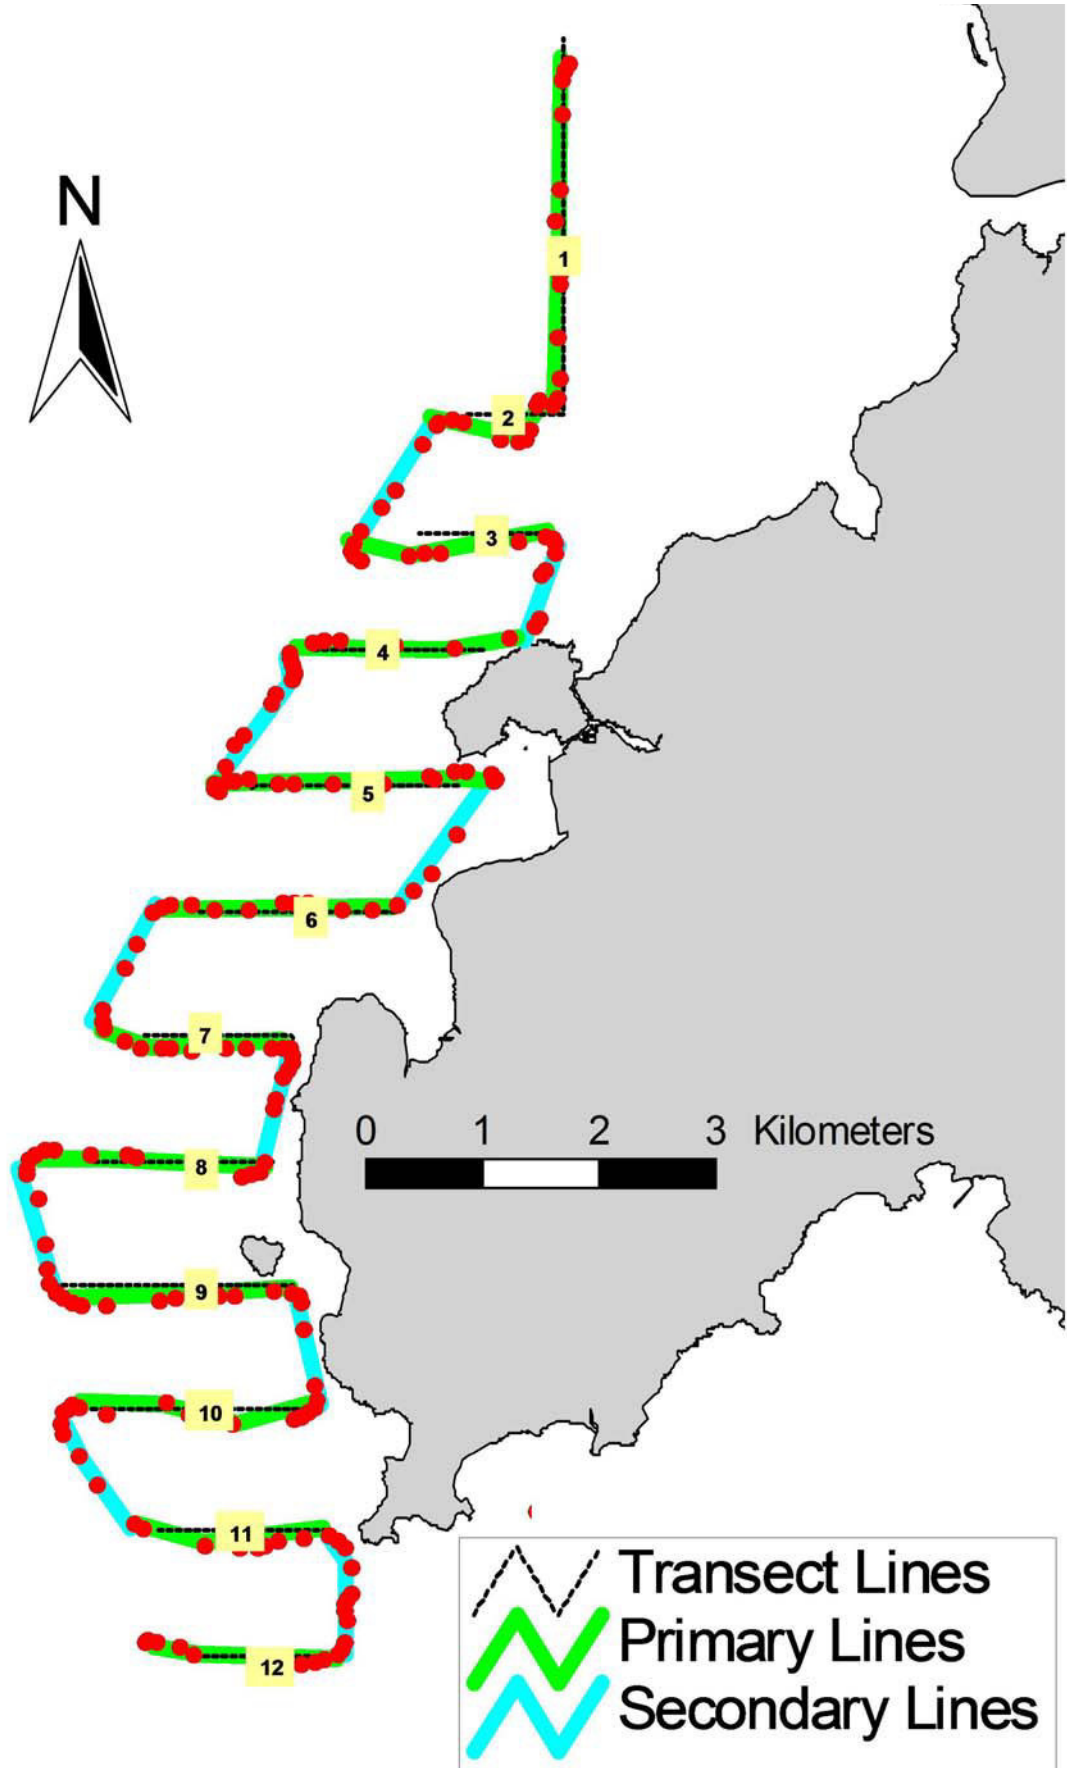
Figure 3. Survey Route on August 16th, 2016 (note: red dots represent the tracked positions of survey boat logged continuously by GPS throughout the course of the survey)

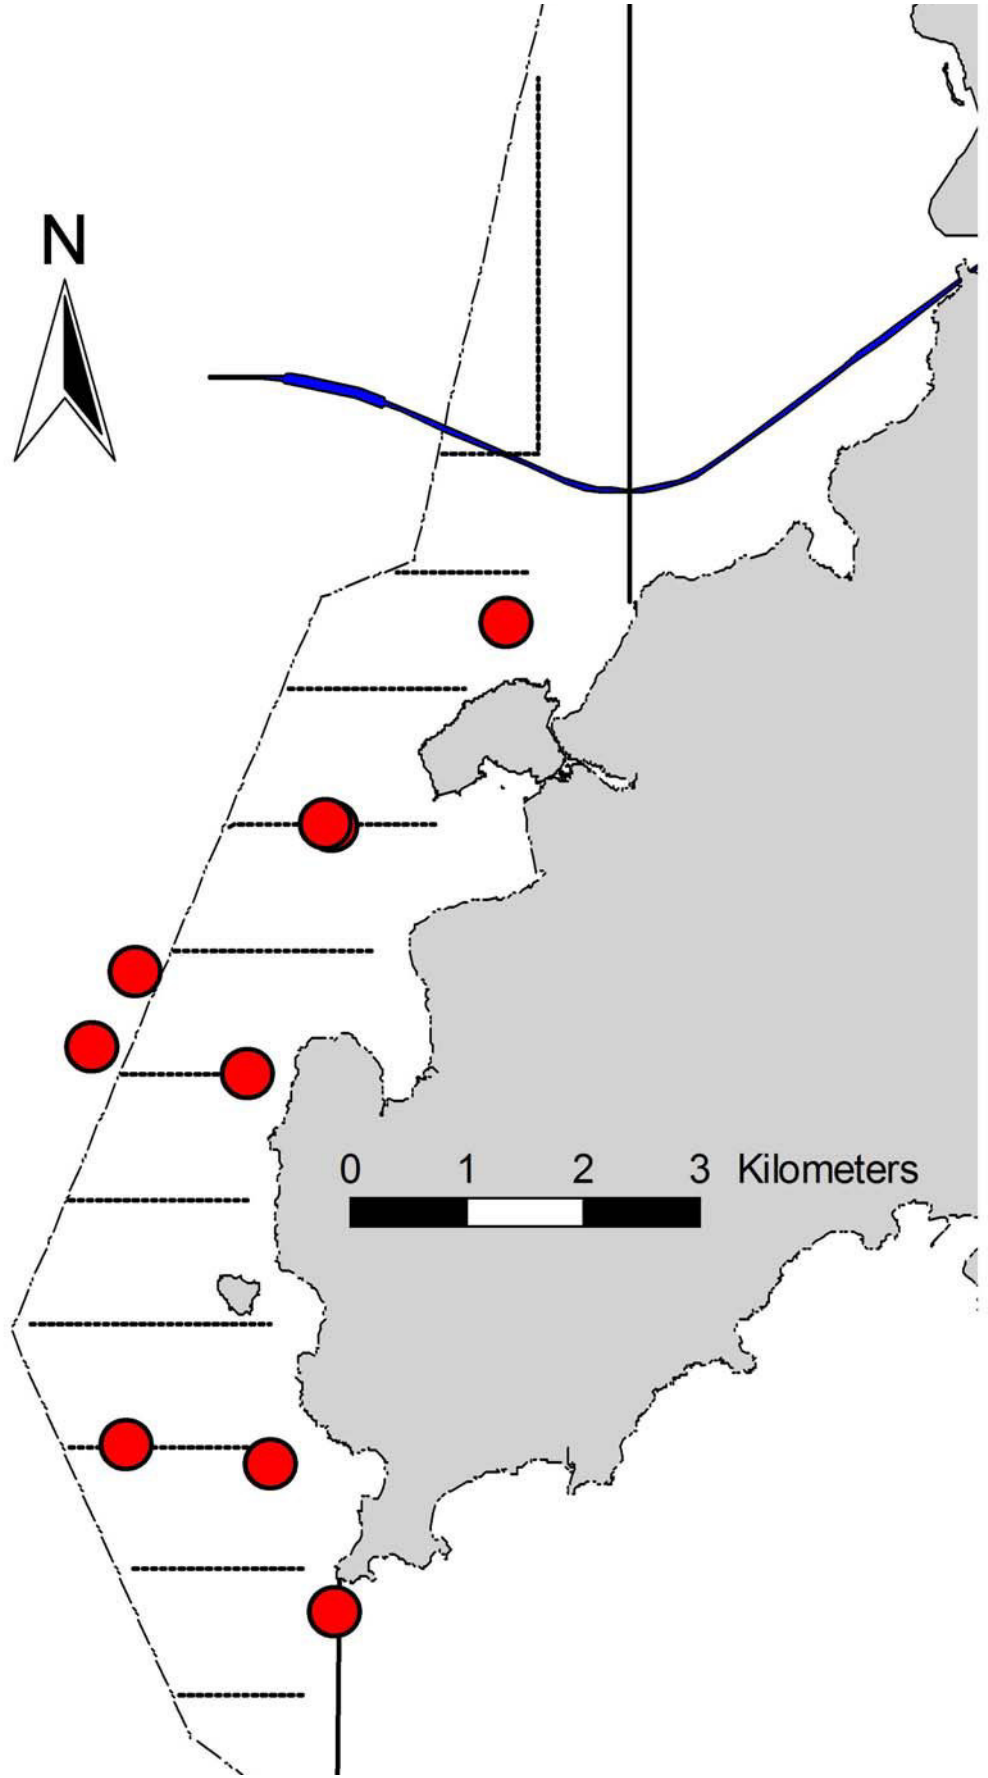
Figure 4. Distribution of Chinese White Dolphin Sighting during August 2016 HKLR09 Monitoring Surveys

- 6.12 Most dolphin groups were small in size with 1-3 animals, but there were also two medium-sized groups with 5 and 8 animals respectively.
- 6.13 During this month of dolphin monitoring, marine construction activities have continued under this contract. However, no adverse impact on Chinese white dolphins was noticeable from general observations.
- 6.14 Evaluation of impacts on dolphins due to construction work will be conducted in the quarterly EM&A report.
- 6.15 Detailed monitoring methodology and results can be found in **Appendix I**.

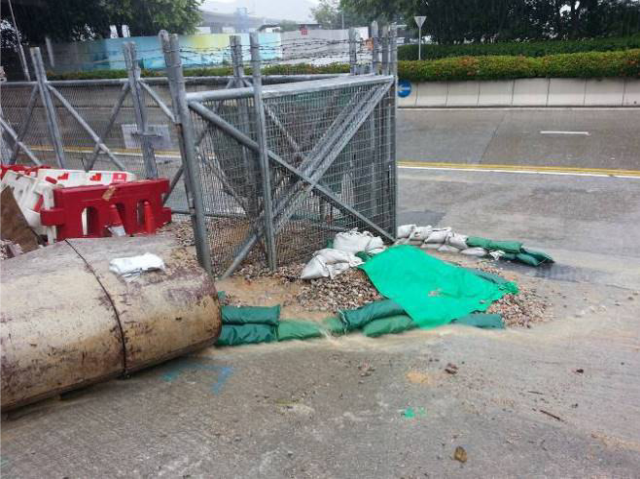
<p>Ref No: 160803-O01</p> <p>Impact: Water Quality (B1, B3i, B4, B6, B11i, B16)</p> <p>Details: Muddy water was observed discharge from site to the gullies during heavy rainstorm at P114. The Contractor was reminded to enhance the water quality mitigation measures (e.g. direct muddy water to appropriate sedimentation facilities, adequate maintenance of drainage, earth bunds or sand bag barriers to protect the gullies) to avoid flooding and untreated site runoff entering the public drainage directly.</p>

Parameters	Date	Observations and Recommendations	Follow-up
<i>Water Quality</i>	03/08/2016	Muddy water was observed discharge from site to the gullies during heavy rainstorm at P114. The Contractor was reminded to enhance the water quality mitigation measures (e.g. direct muddy water to appropriate sedimentation facilities, adequate maintenance of drainage, earth bunds or sand bag barriers to protect the gullies) to avoid flooding and untreated site runoff entering the public drainage directly.	Rectification/improvement was observed during the follow-up audit session on 9 August 2016.
	03/08/2016	Clear the floating rubbish within the site curtain after the typhoon at Portion A.	Rectification/improvement was observed during the follow-up audit session on 23 August 2016.
	03/08/2016	Provide earth bunds or sand bag barrier at the site boundary at P101 to prevent the site runoff discharging to the sea.	Rectification/improvement was observed during the follow-up audit session on 9 August 2016.

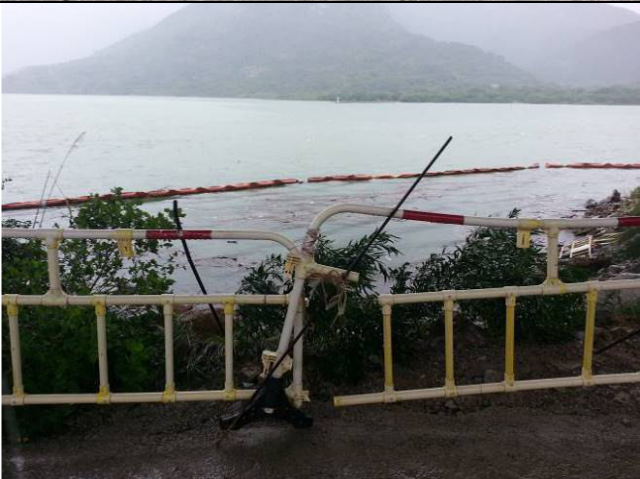
<p>Ref No: 160803-R02</p> <p>Impact: Water Quality (B21)</p> <p>Details: Clear the floating rubbish within the site curtain after the typhoon at Portion A.</p>

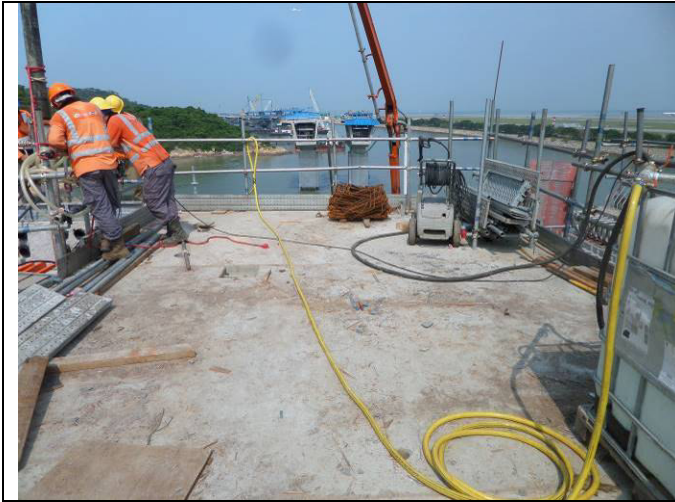
Ref No: 160809-R01

Impact:
Waste / Chemical Management (F7)

Details:
To maintain a good house-keeping at works area of P77.

<p>Ref No: 160809-R01</p> <p>Impact: Waste / Chemical Management (F7)</p> <p>Details: To maintain a good house-keeping at works area of P77.</p> <p>Follow Up: Good housekeeping was maintained at the works area of P77.</p>

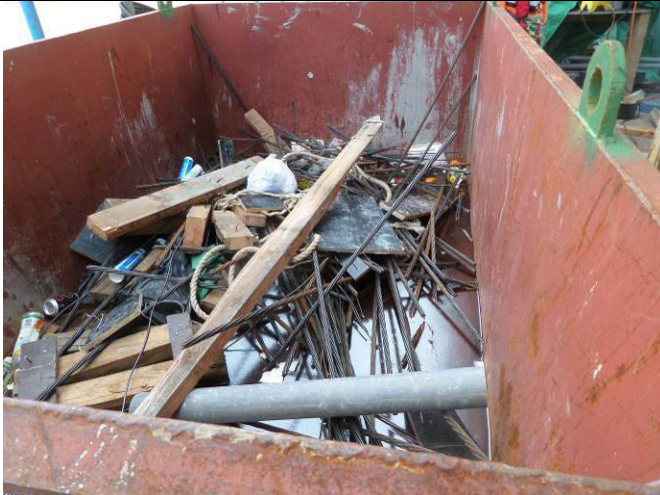
Ref No: 160809-R02

Impact:
Waste / Chemical Management (F2i, 2ii)

Details:
To clear the wastewater properly as chemical waste at the skip at P77.

<p>Ref No: 160809-R02</p> <p>Impact: Waste / Chemical Management (F2i, 2ii)</p> <p>Details: To clear the wastewater properly as chemical waste at the skip at P77.</p> <p>Follow Up: The wastewater at the skip was cleared properly.</p>

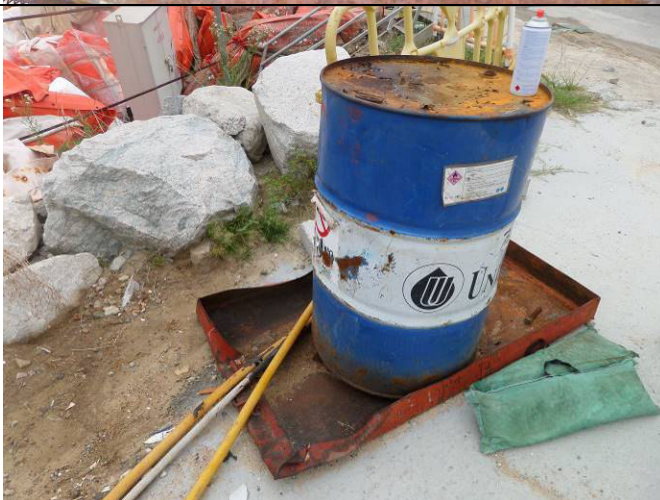
Ref No: 160809-R03

Impact:
Waste / Chemical Management (F9)

Details:
To properly repair the drip tray at Portion A.

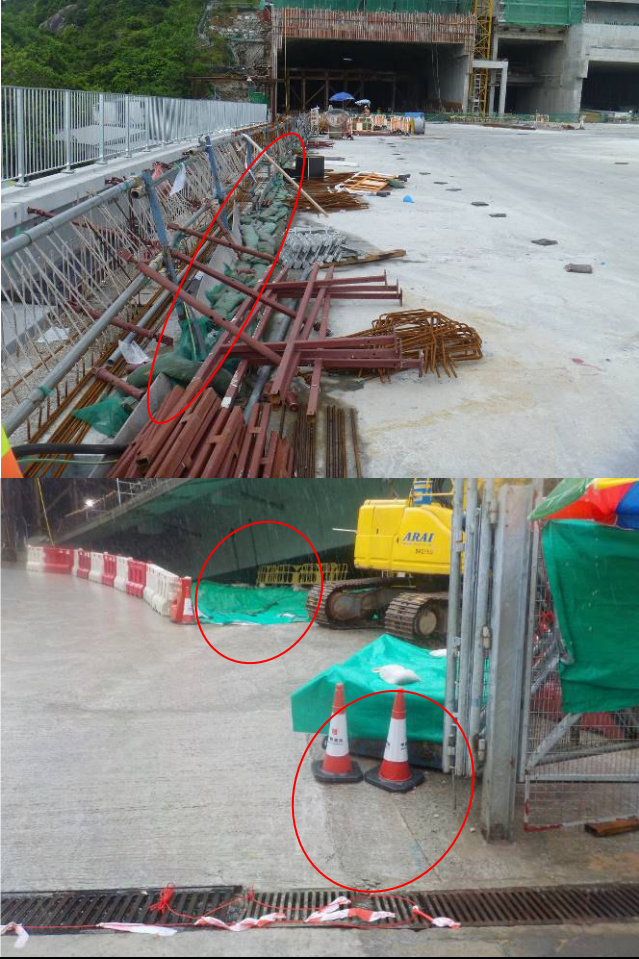
<p>Ref No: 160803-O01</p> <p>Impact: Water Quality (B1, B3i, B4, B6, B11i, B16)</p> <p>Details: Muddy water was observed discharge from site to the gullies during heavy rainstorm at P114. The Contractor was reminded to enhance the water quality mitigation measures (e.g. direct muddy water to appropriate sedimentation facilities, adequate maintenance of drainage, earth bunds or sand bag barriers to protect the gullies) to avoid flooding and untreated site runoff entering the public drainage directly.</p> <p>Follow Up: After investigation, the muddy water was generated due to the discharge of surface runoff from deck surface to the site area underneath of bridge deck at P114. Water quality mitigation measures (e.g. erect sand bag bund at the boundary of bridge deck to avoid the surface runoff from washing across the exposed soil surface, properly clear / cover the stockpile of soil etc.) were observed implemented by the Contractor. No further muddy water was observed discharge from site to the gullies and this site area has already handed over to the HKLR03.</p>

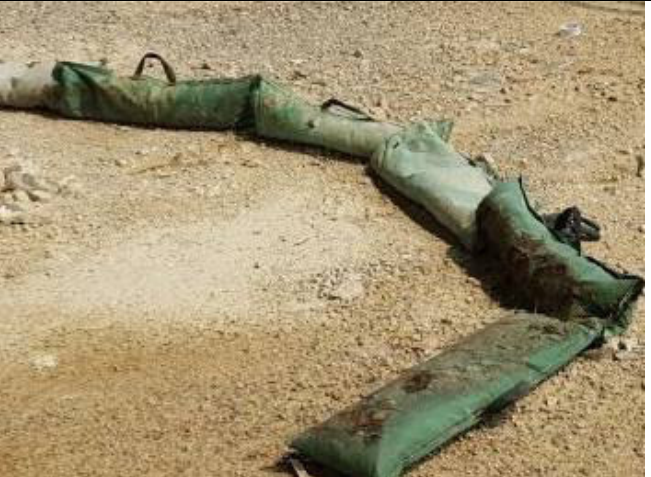
<p>Ref No: 160803-R03</p> <p>Impact: Water Quality (B16)</p> <p>Details: Provide earth bunds or sand bag barrier at the site boundary at P101 to prevent the site runoff discharging to the sea.</p> <p>Follow Up: Sand bag barrier was ready on site to prevent the site runoff discharging to the sea.</p>

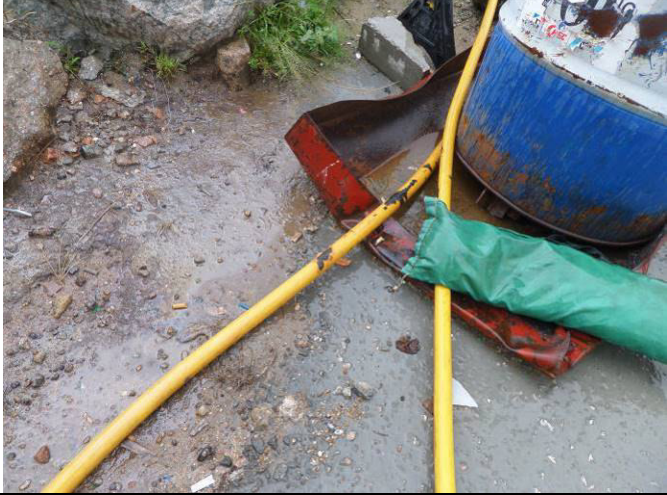
E. Noise	
	• No environmental deficiency was identified during site inspection.	
	F. Waste / Chemical Management	
160816-R01	• To properly repair the drip tray near P83 and clear the oil stain.	F8 & F9
160816-R02	• To clear the waste materials floating within the silt curtain near P91.	F4ii
160816-R04	• To clear the accumulated waste material near P68.	F1iii

<p>Ref No: 160816-R01</p> <p>Impact: Waste / Chemical Management (F8 & F9)</p> <p>Details: To properly repair the drip tray near P83 and clear the oil stain.</p>

<p>Ref No: 160816-R01</p> <p>Impact: Waste / Chemical Management (F8 & F9)</p> <p>Details: To properly repair the drip tray near P83 and clear the oil stain.</p> <p>Follow Up: The worn drip tray was repaired by the worker and the surrounding oil stain was also cleared.</p>

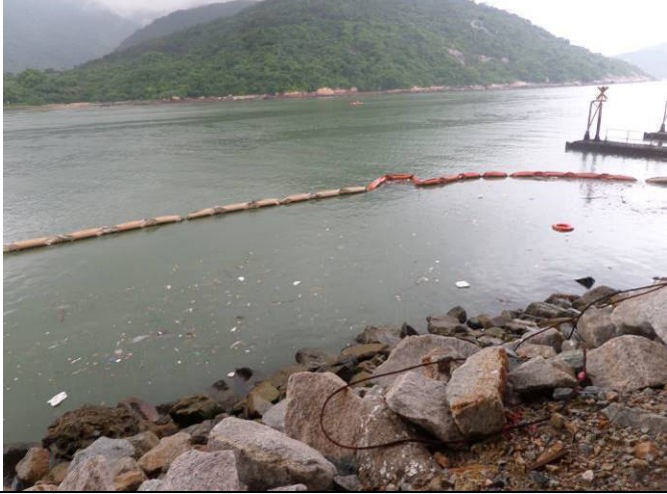
<p>Ref No: 160816-R02</p> <p>Impact: Waste / Chemical Management (F4ii)</p> <p>Details: To clear the waste materials floating within the silt curtain near P91.</p>

<p>Ref No: 160816-R02</p> <p>Impact: Waste / Chemical Management (F4ii)</p> <p>Details: To clear the waste materials floating within the silt curtain near P91.</p> <p>Follow Up: The floating waste materials within the silt curtains were cleared.</p>

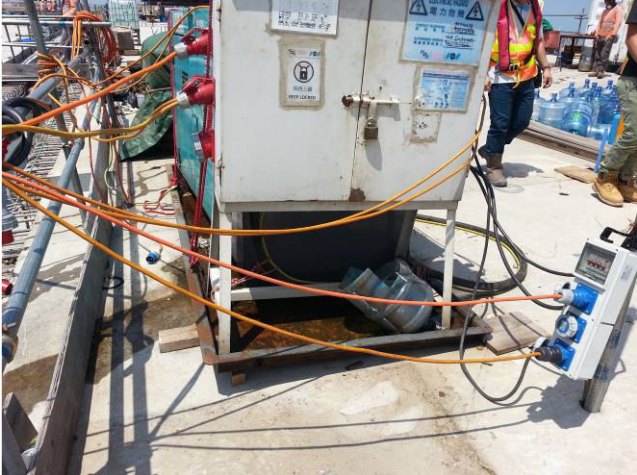
<p>Ref No: 160823-R02</p> <p>Impact: Waste / Chemical Management (F9)</p> <p>Details: To close the opening of drip tray for the generator at P71.</p>

<p>Ref No: 160823-R02</p> <p>Impact: Waste / Chemical Management (F9)</p> <p>Details: To close the opening of drip tray for the generator at P71.</p> <p>Follow Up: The opening of drip tray was closed by the worker.</p>
