Contract No. HY/2011/09
Hong Kong-Zhuhai-Macao Bridge
Hong Kong Link Road – Section between HKSAR Boundary and Scenic Hill

Submission under Environmental Permit (EP-352/2009/D – Condition 4.4)
Monthly EM&A Report – August 2016

**Contract No. HY/2011/09 HZMB Hong Kong Link Road –
Section between HKSAR Boundary and Scenic Hill
Revised Monthly EM&A Report for August 2016 (EP-352/2009/D)**

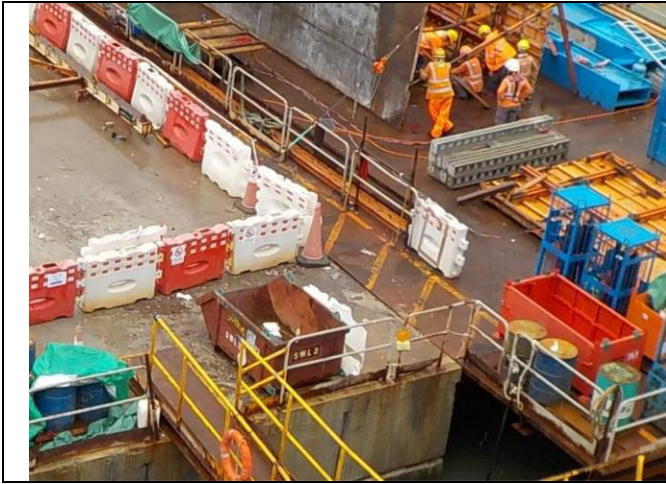
Ref No: 160816-R04

Impact:
Waste / Chemical Management (F1iii)

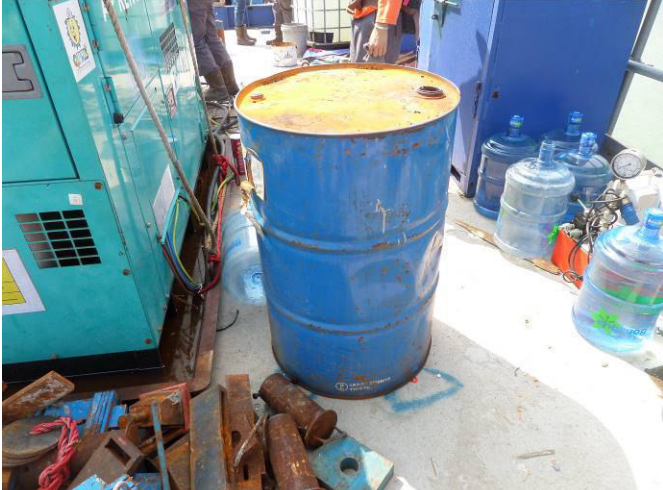
<p>Ref No: 160830-R01</p> <p>Impact: Waste / Chemical Management (F8 & F9)</p> <p>Details: To provide a drip tray for oil drums and label it properly at P60 and LF3.</p>

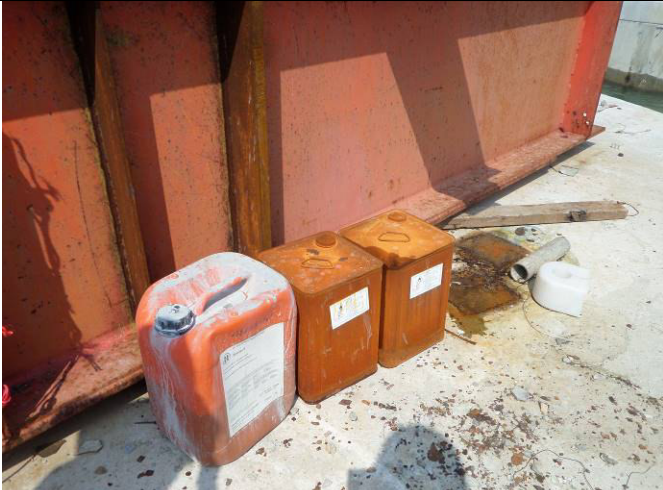
<p>Ref No: 160830-R02</p> <p>Impact: Waste / Chemical Management (F2i)</p> <p>Details: To properly store the chemical containers or remove it near P60.</p>

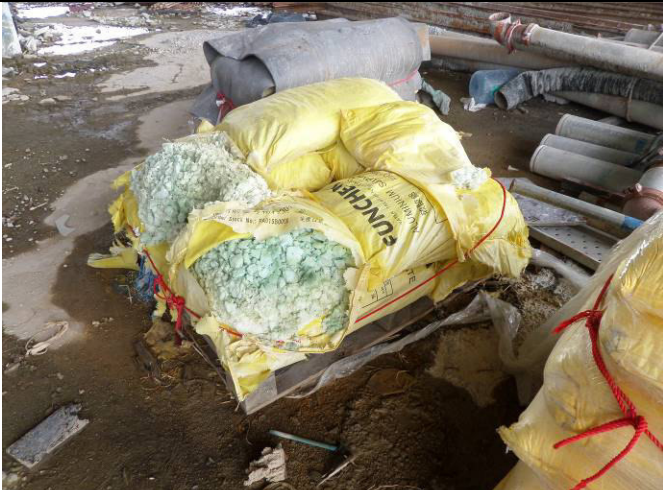
<p>Ref No: 160830-R03</p> <p>Impact: Waste / Chemical Management (F2i)</p> <p>Details: Chemical material should be properly stored in chemical storage area at Portion C.</p>
