Contract No. HY/2011/09
Hong Kong-Zhuhai-Macao Bridge
Hong Kong Link Road – Section between HKSAR Boundary and Scenic Hill

Submission under Environmental Permit (EP-352/2009/D – Condition 4.4)
Monthly EM&A Report – October 2016

**Contract No. HY/2011/09 HZMB Hong Kong Link Road –
Section between HKSAR Boundary and Scenic Hill
Revised Monthly EM&A Report for October 2016 (EP-352/2009/D)**

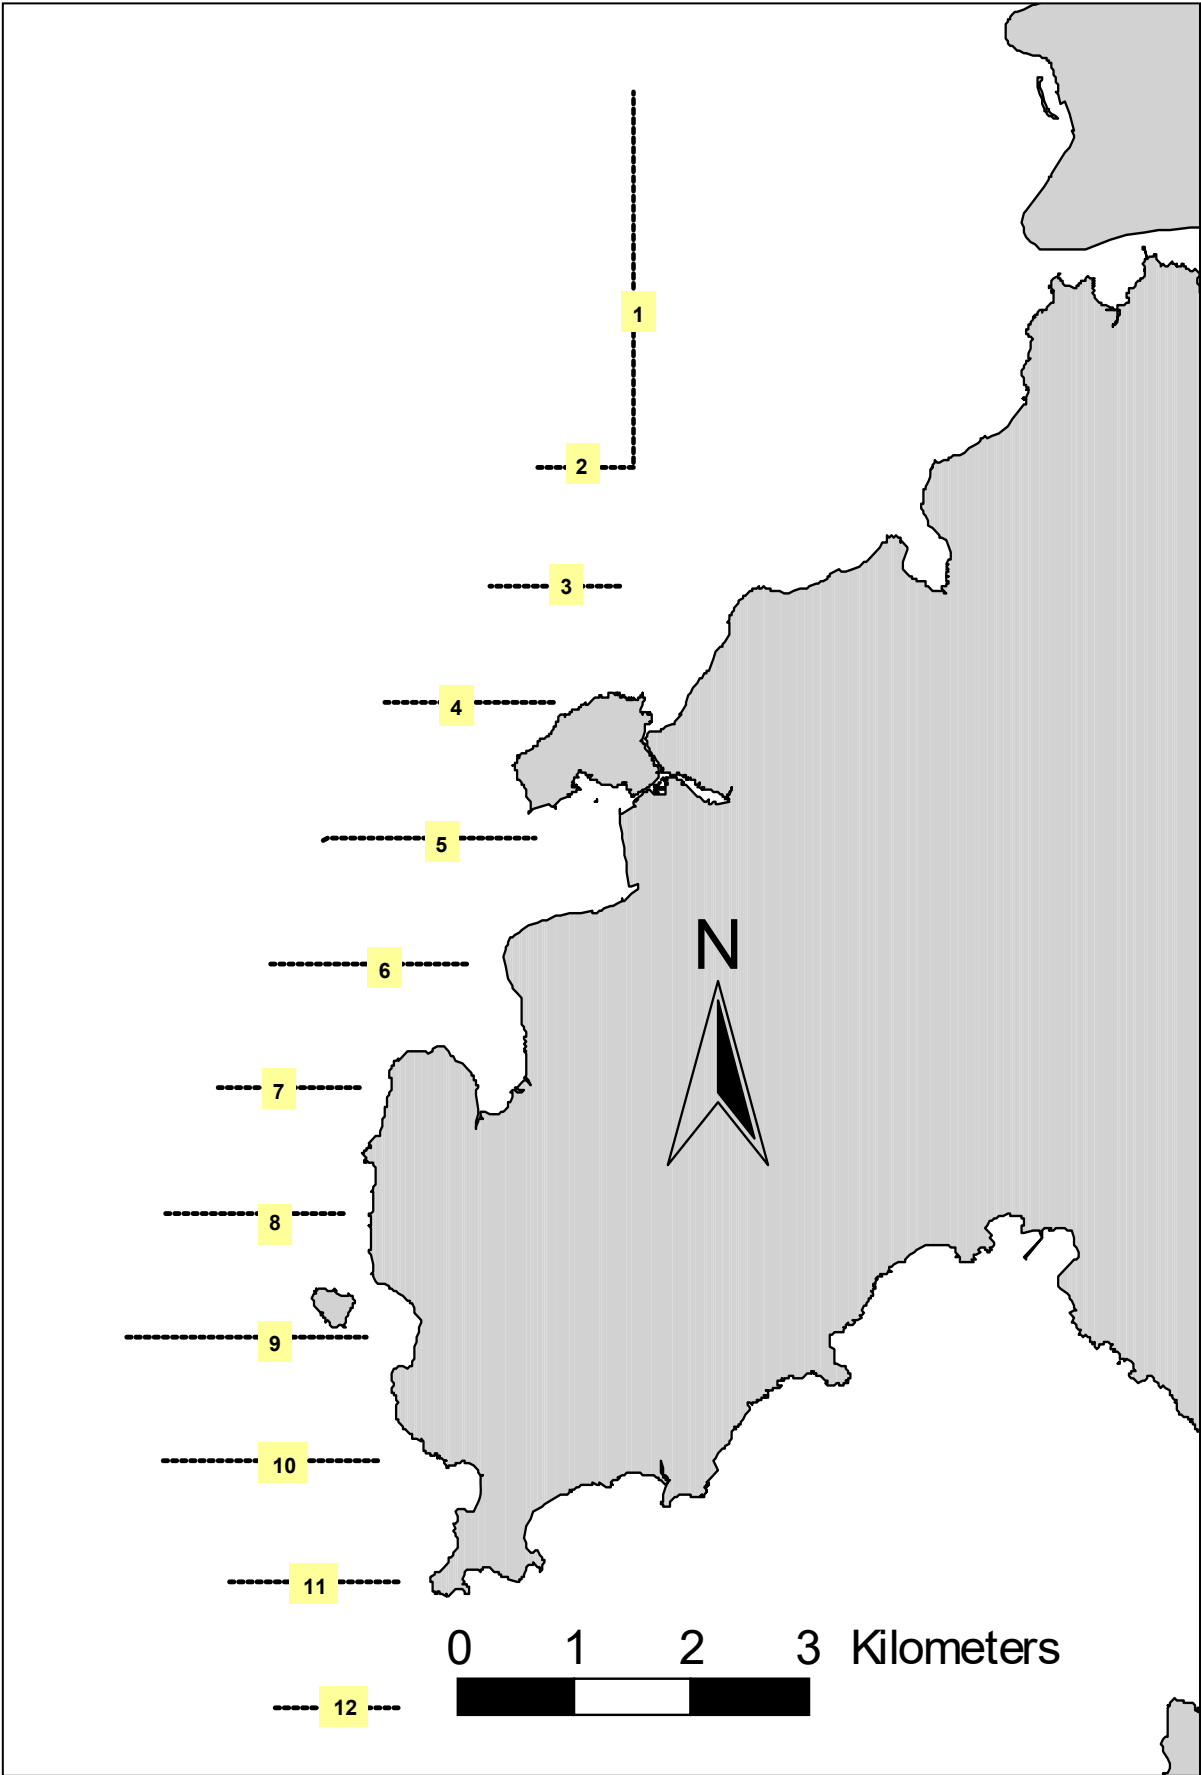
Figure 1. Transect Line Layout in West Lantau Survey Areas

6.8 From these surveys, a total of 66.09 km of survey effort was collected, with 92.0% of the total survey effort being conducted under favorable weather conditions (i.e. Beaufort Sea State 3 or below with good visibility) Out of the 66.09 km of survey effort, the total survey effort conducted on primary lines (the horizontal lines perpendicular to the coastlines) was 44.29 km.

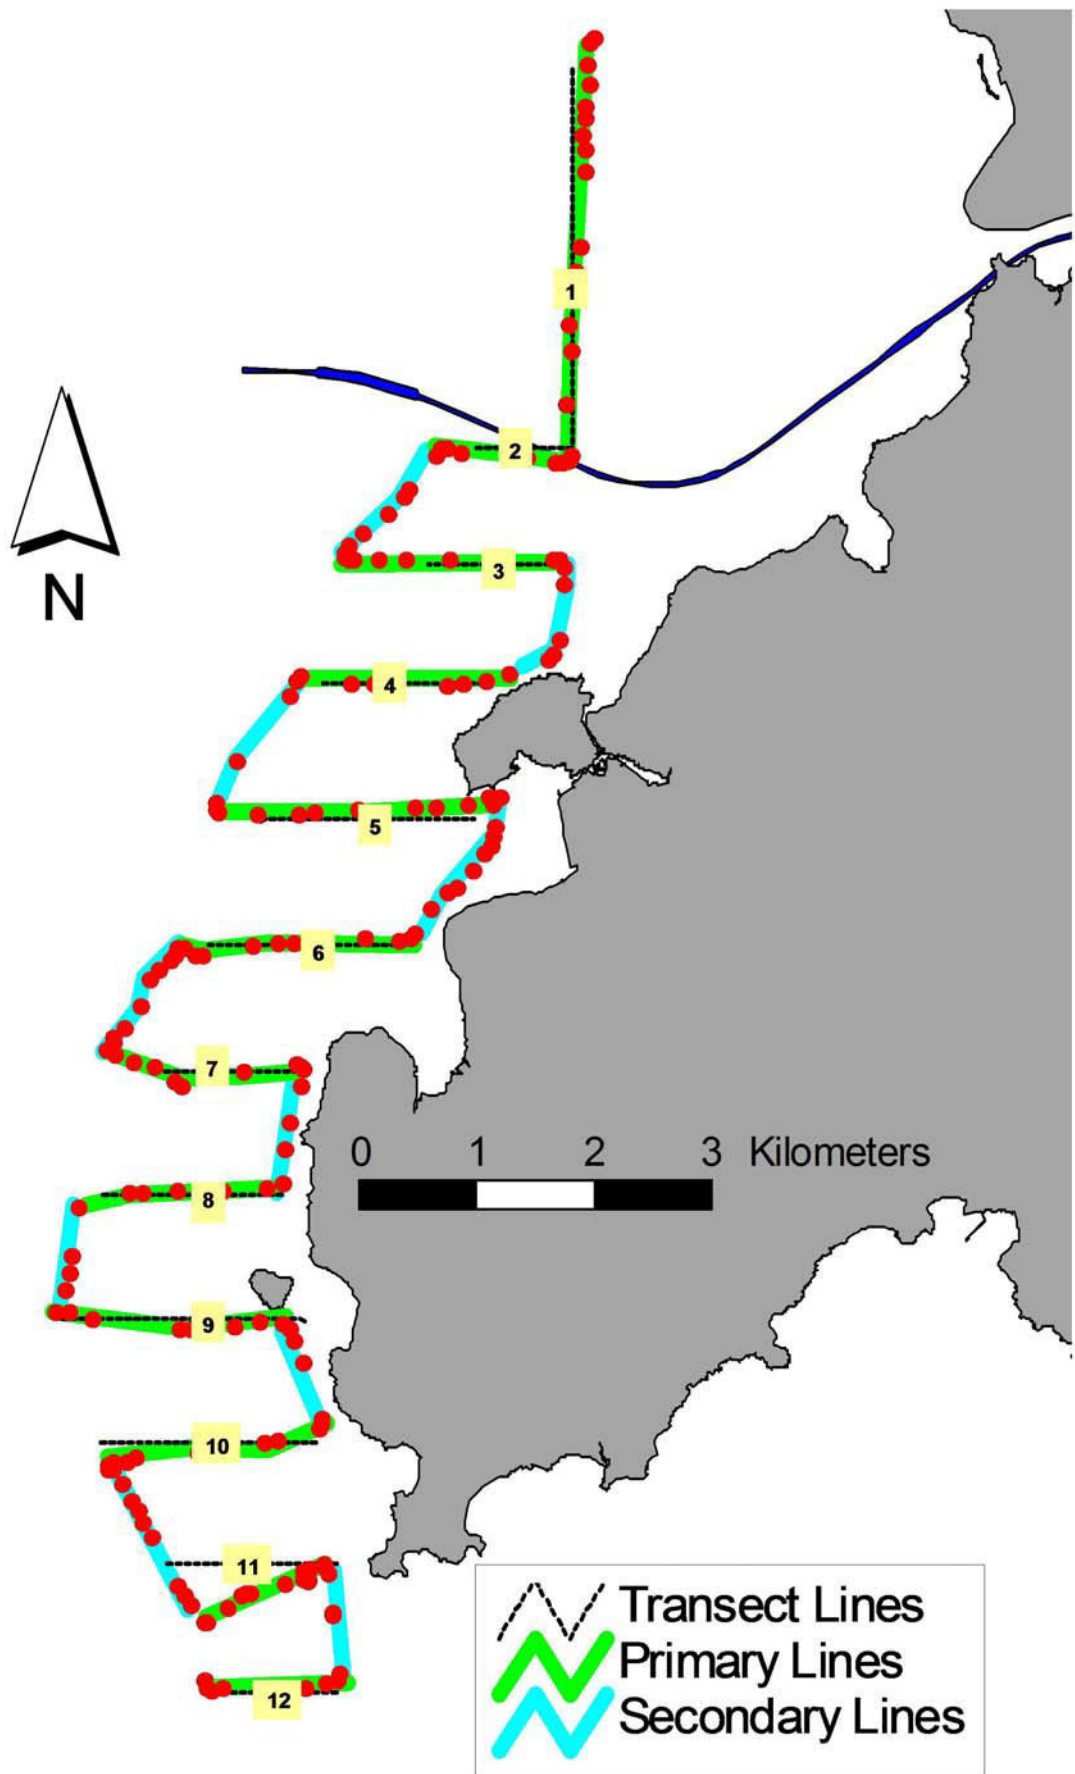
Figure 2. Survey Route on October 14th, 2016 (note: red dots represent the tracked positions of survey boat logged continuously by GPS throughout the course of the survey)

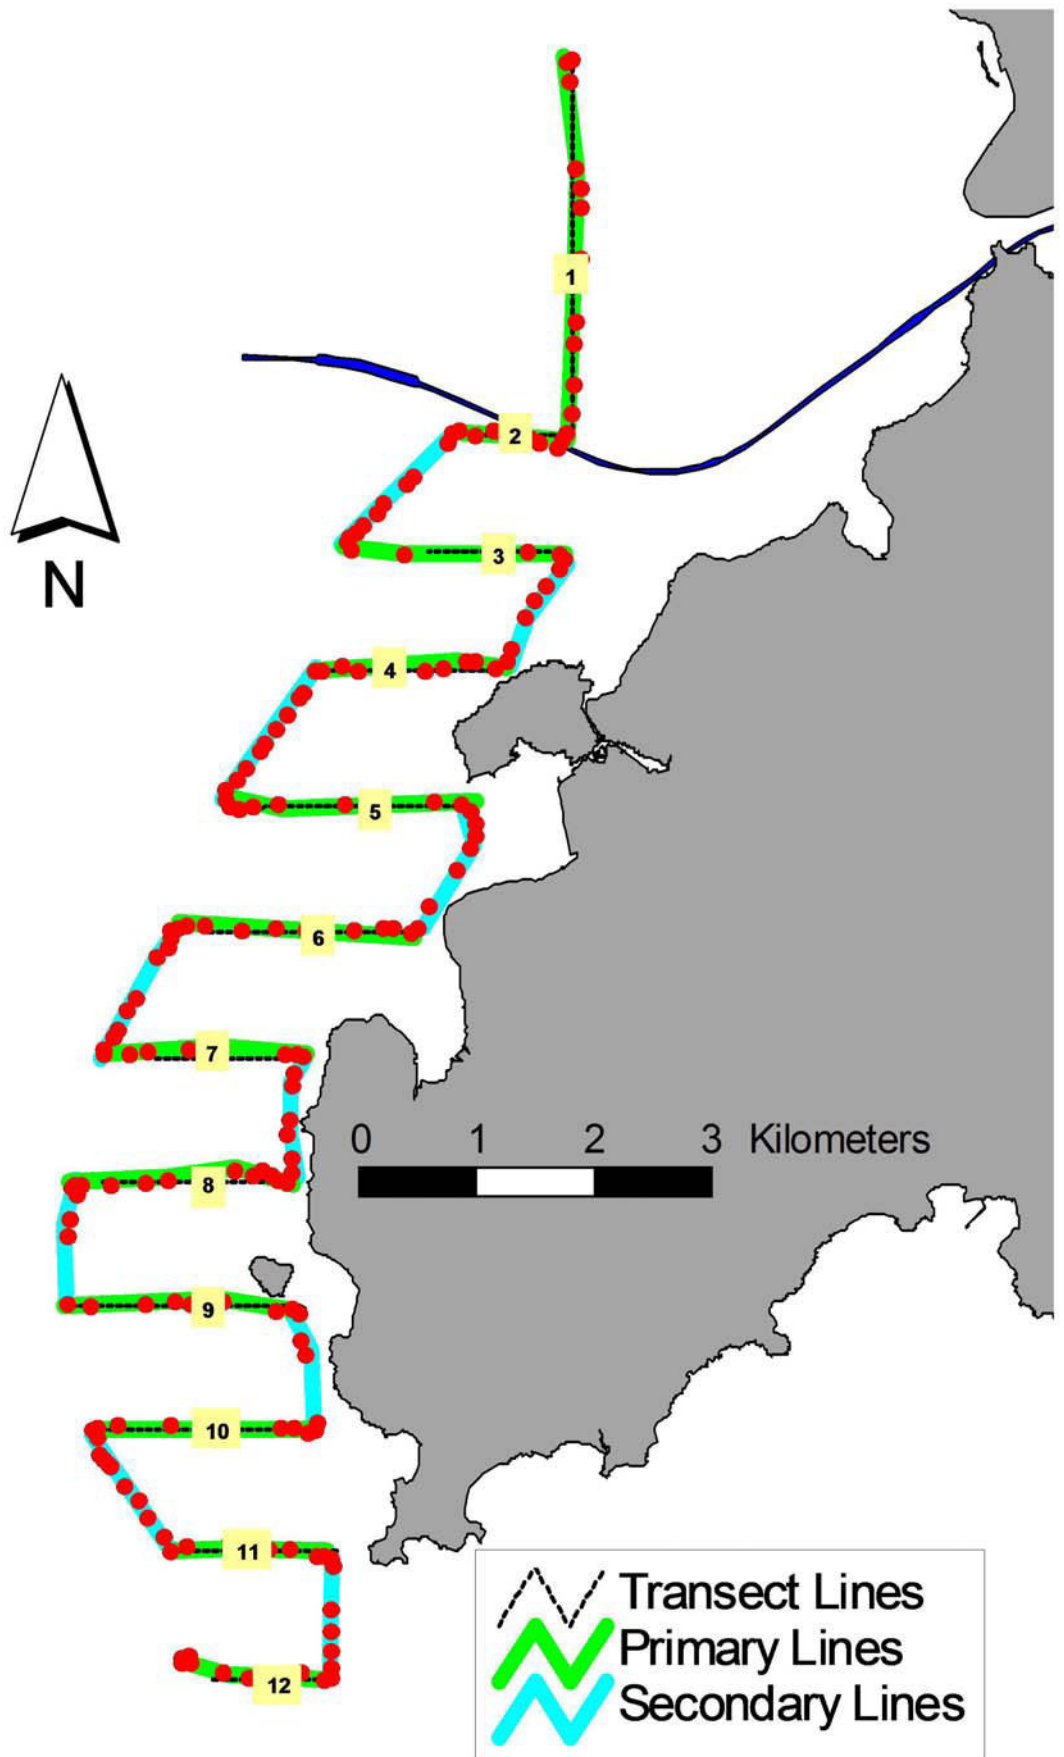
Figure 3. Survey Route on October 20th, 2016 (note: red dots represent the tracked positions of survey boat logged continuously by GPS throughout the course of the survey)

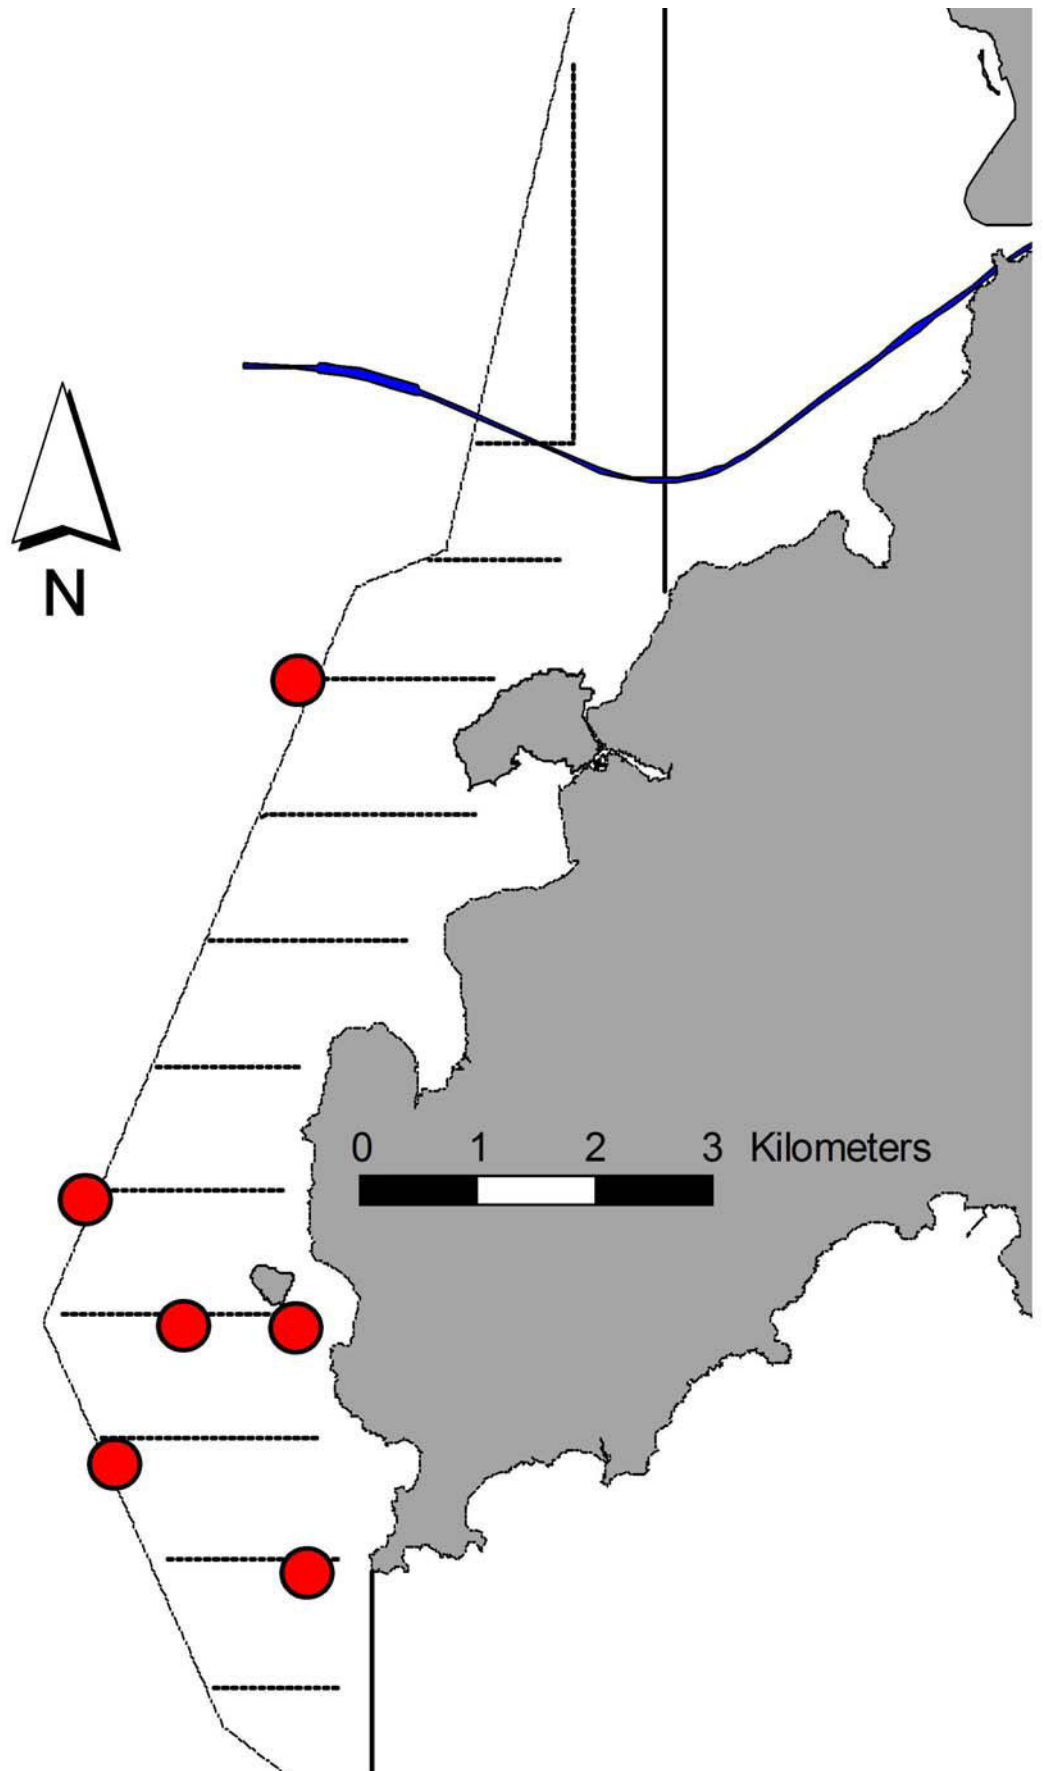
Figure 4. Distribution of Chinese White Dolphin Sighting during October 2016 HKLR09 Monitoring Surveys

- 6.12 Three of the six dolphin groups were small in size with 1-3 animals, while the other three were medium-sized groups with 4-7 animals per group.
- 6.13 During this month of dolphin monitoring, marine construction activities have continued under this contract. However, no adverse impact on Chinese white dolphins was noticeable from general observations.
- 6.14 Evaluation of impacts on dolphins due to construction work will be conducted in the quarterly EM&A report.
- 6.15 Detailed monitoring methodology and results can be found in **Appendix I**.

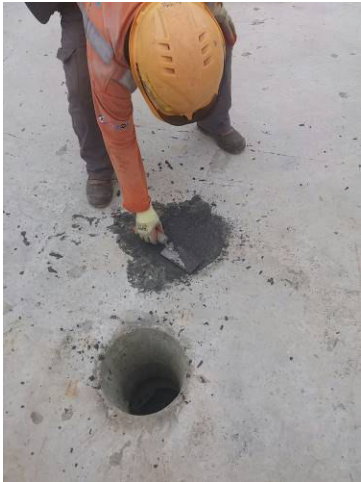
<p>Ref No: 160927-R01</p> <p>Impact: Water Quality (B22)</p> <p>Details: Sandbag bunds should be provided before kicking plates to prevent leakage from grouting works for P53 to P58.</p> <p>Follow up: Before starting the grouting works at the hole, the stagnant water inside was removed so that the leakage of concrete water due to the overflow at the hole can be avoided. No further leakage from the grouting works was observed.</p>

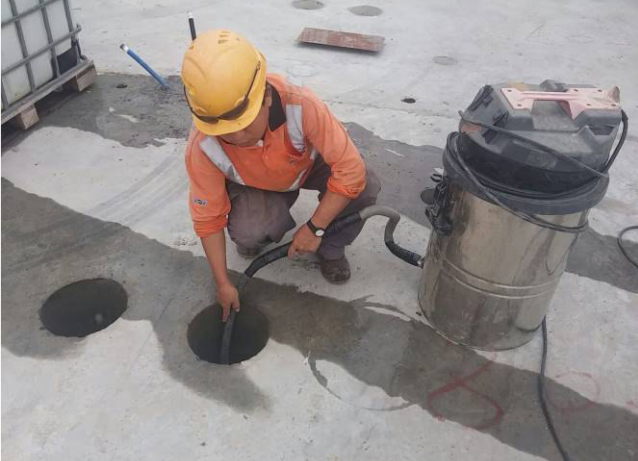
<p>Ref No: 160927-R02</p> <p>Impact: Water Quality (B8)</p> <p>Details: Stagnant water in the deck holes of the bridge should be cleared properly at P53 to P59.</p> <p>Follow up: The stagnant water in the deck holes was cleared by the worker.</p>

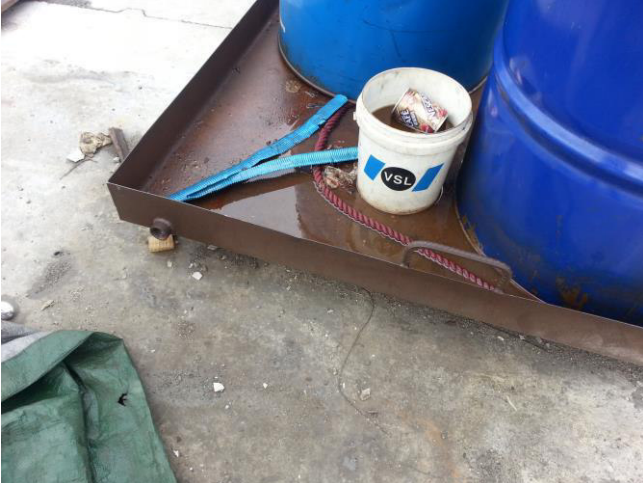
<p>Ref No: 161011-R01</p> <p>Impact: Waste / Chemical Management (F8 & 9)</p> <p>Details: Drip tray for the chemical containers at P72 (deck-surface) should be plugged properly.</p>

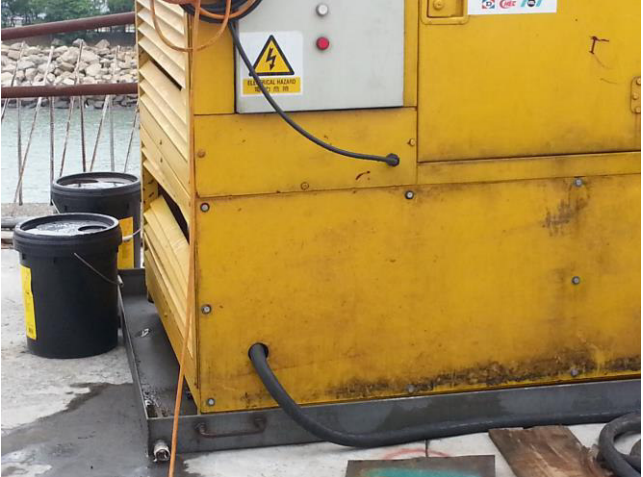
<p>Ref No: 161011-R02</p> <p>Impact: Waste / Chemical Management (F3i)</p> <p>Details: Provide drip tray for the chemical containers at near the power pack at P72 (deck-surface).</p>

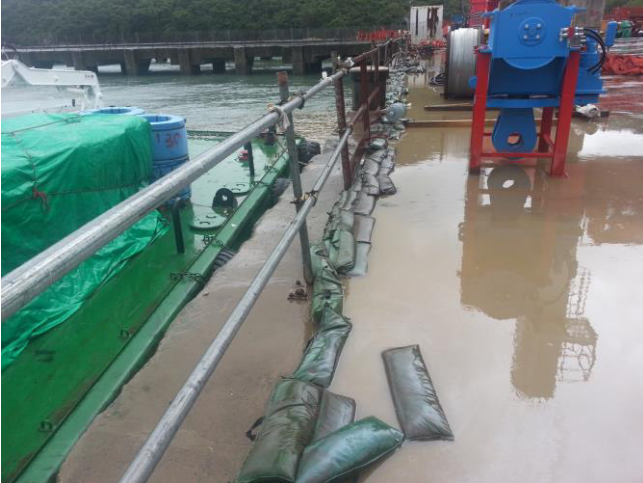
<p>Ref No: 161018-O01</p> <p>Impact: Water Quality (B11i, ii)</p> <p>Details: Muddy Water was discharging to the sea at WA4 during the heavy rainstorm. The contractor was reminded to enhance the sand bag bund and divert the muddy water for treatment before discharging out.</p>

Parameters	Date	Observations and Recommendations	Follow-up
<i>Water Quality</i>	18/10/2016	Muddy water was discharging to the sea at WA4 during the heavy rainstorm. The contractor was reminded to enhance the sand bag bund and divert the muddy water for treatment before discharging out.	Rectification/improvement was observed during the follow-up audit session on 25 October 2016.
	18/10/2016	Provide designated concrete washout area to avoid the concrete wash water discharging to the nearby marine water at between P82 and P83.	Rectification/improvement was observed during the follow-up audit session on 25 October 2016.
	25/10/2016	Silt curtain should be properly maintained (P109).	Rectification/improvement was observed during the follow-up audit session on 1 November 2016.
<i>Ecology</i>	N/A ⁽¹⁾	N/A ⁽¹⁾	N/A ⁽¹⁾
<i>Air Quality</i>	04/10/2016	NRMM labels should be provided for equipment at Portion C (P112).	Rectification/improvement was observed during the follow-up audit session on 11 October 2016.

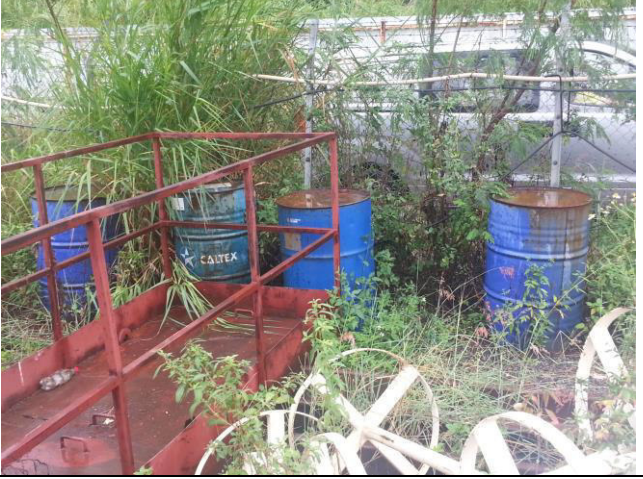
<p>Ref No: 161018-R02</p> <p>Impact: Waste / Chemical Management (F4ii)</p> <p>Details: To remove the oil drum at near the sedimentation tank at WA4.</p>

18/10/2016	To remove the oil drum at near the sedimentation tank at WA4.	Rectification/improvement was observed during the follow-up audit session on 25 October 2016.
<i>Landscape & Visual Impact</i>	N/A ⁽¹⁾	N/A ⁽¹⁾	N/A ⁽¹⁾
<i>Permits/Licences</i>	N/A ⁽¹⁾	N/A ⁽¹⁾	N/A ⁽¹⁾
<i>Other</i>	N/A ⁽¹⁾	N/A ⁽¹⁾	N/A ⁽¹⁾
<i>Cultural Heritage (Sha Lo Wan (West) Archaeological Site)</i>	N/A	N/A ⁽¹⁾	N/A ⁽¹⁾

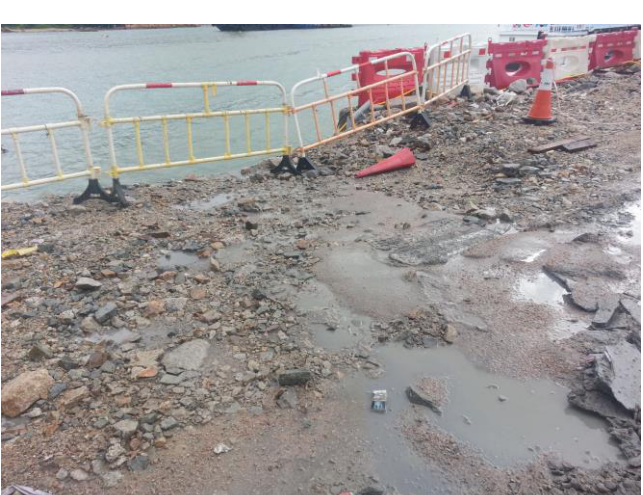
<p>Ref No: 161018-R03</p> <p>Impact: Water Quality (B28)</p> <p>Details: Provide designated concrete washout area to avoid the concrete wash water discharging to the nearby marine water at between P82 and P83.</p>

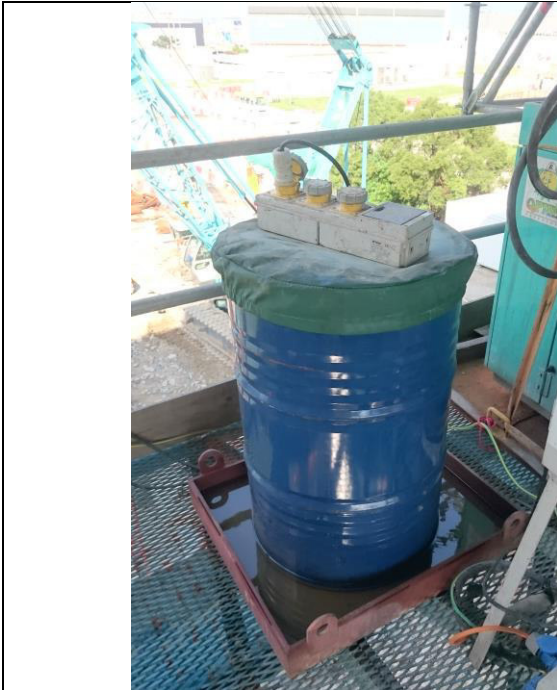
Ref No: 161025-R01

25/10/2016	Dusty material on the deck should be cleared (P83).	Rectification/improvement was observed during the follow-up audit session on 1 November 2016.
<i>Noise</i>	N/A ⁽¹⁾	N/A ⁽¹⁾	N/A ⁽¹⁾
<i>Waste / Chemical Management</i>	25/10/2016	Oily water in the drip tray should be removed (P83, P109).	Rectification/improvement was observed during the follow-up audit session on 1 November 2016.
	04/10/2016	Accumulated waste at P83 should be cleared properly.	Rectification/improvement was observed during the follow-up audit session on 11 October 2016.
	11/10/2016	Drip tray for the chemical containers at P72 (deck-surface) should be plugged properly.	Rectification/improvement was observed during the follow-up audit session on 18 October 2016.
	11/10/2016	Provide drip tray for the chemical containers at near the power pack at P72 (deck-surface).	Rectification/improvement was observed during the follow-up audit session on 18 October 2016.
