Contract No. HY/2011/09
Hong Kong-Zhuhai-Macao Bridge
Hong Kong Link Road – Section between HKSAR Boundary and Scenic Hill

Submission under Environmental Permit (EP-352/2009/D – Condition 4.4)
Monthly EM&A Report – November 2016

**Contract No. HY/2011/09 HZMB Hong Kong Link Road –
Section between HKSAR Boundary and Scenic Hill
Revised Monthly EM&A Report for November 2016 (EP-352/2009/D)**

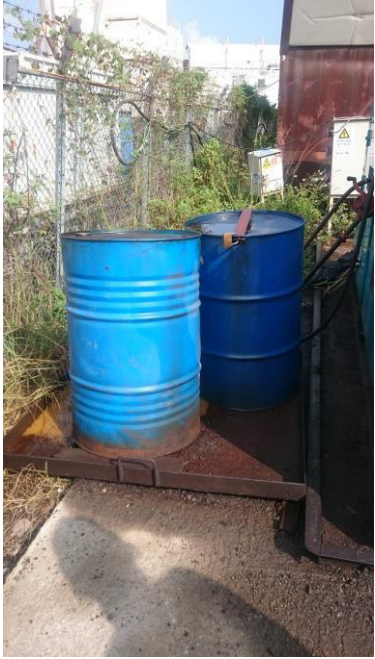
<p>Ref No: 161108-R01</p> <p>Impact: Waste / Chemical Management (F8&9)</p> <p>Details: The oily water in the drip tray and oil stain should be cleared. (WA4)</p>

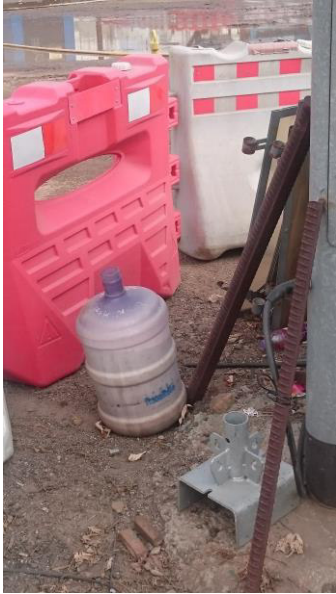
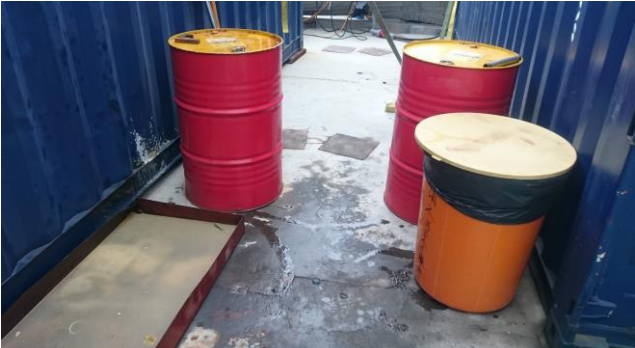
<p>Ref No: 161108-R02</p> <p>Impact: Waste / Chemical Management (F2i)</p> <p>Details: The chemical containers should be properly stored or removed. (WA4, P47)</p>
