Contract No. HY/2011/09

Hong Kong-Zhuhai-Macao Bridge

Hong Kong Link Road – Section between HKSAR Boundary and Scenic Hill

Monthly EM&A Report – December 2016

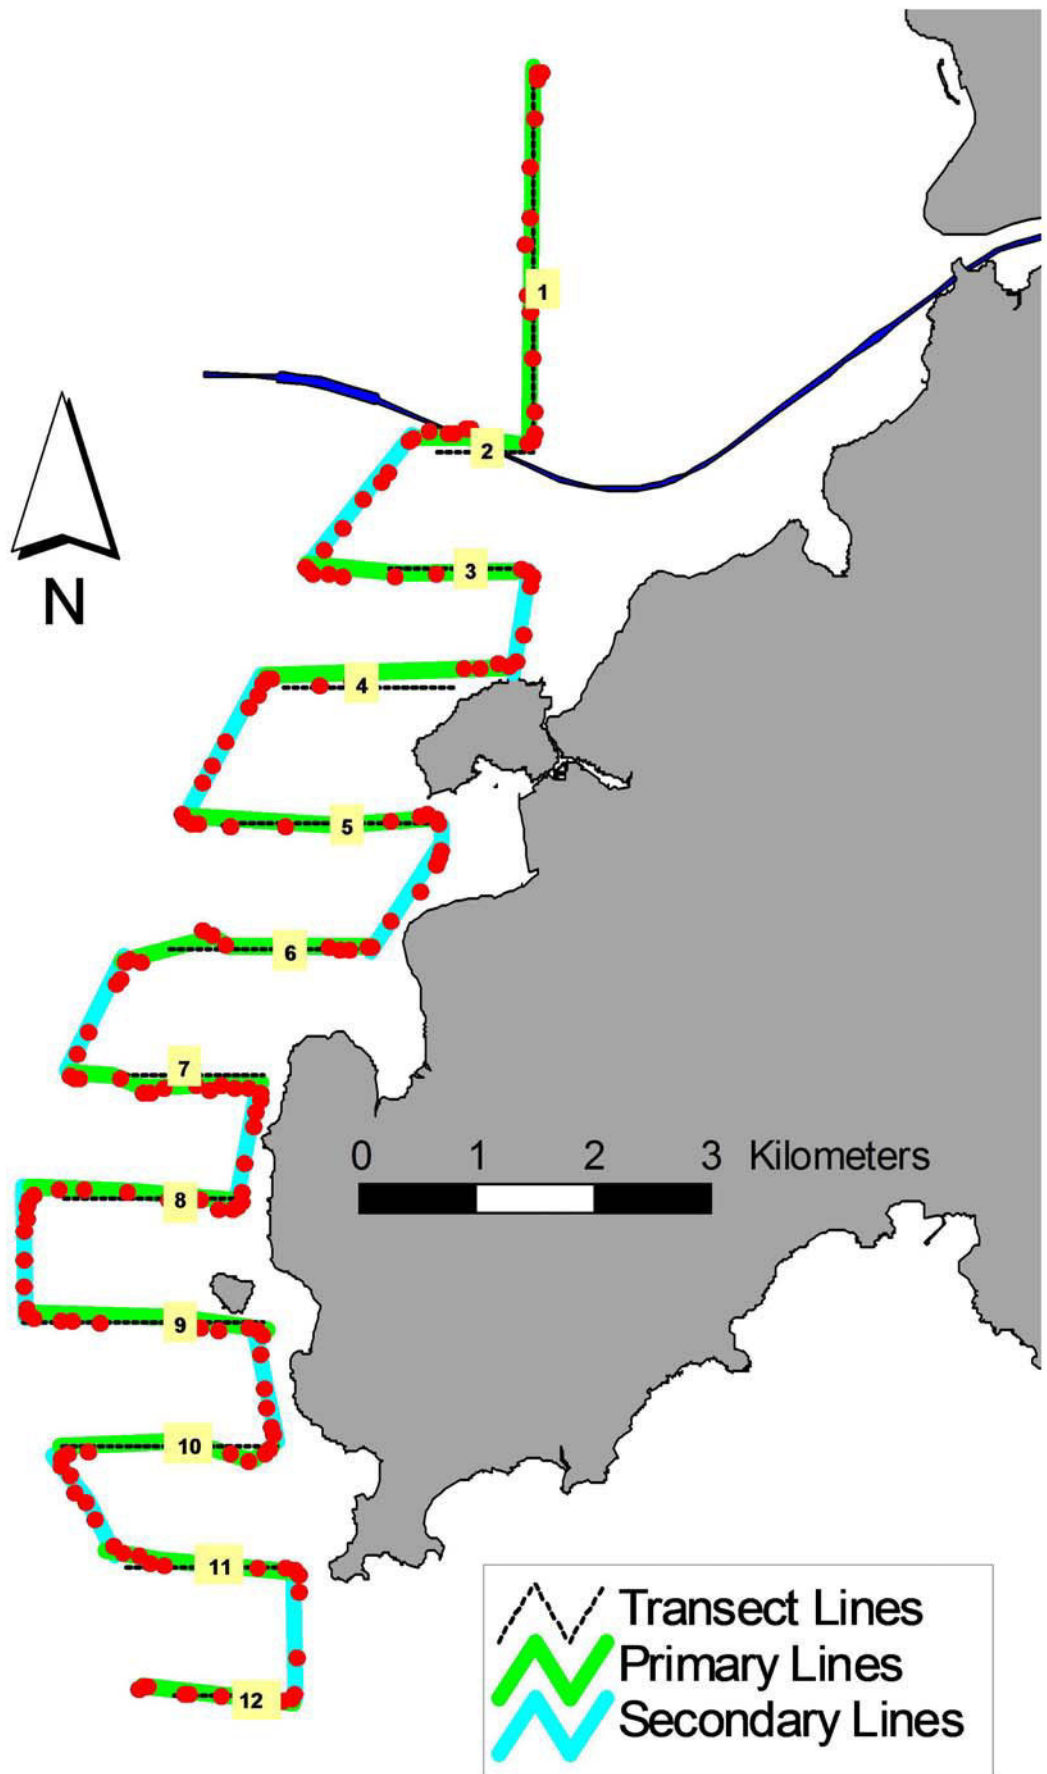
Figure 2. Survey Route on December 2nd, 2016 (note: red dots represent the tracked positions of survey boat logged continuously by GPS throughout the course of the survey)

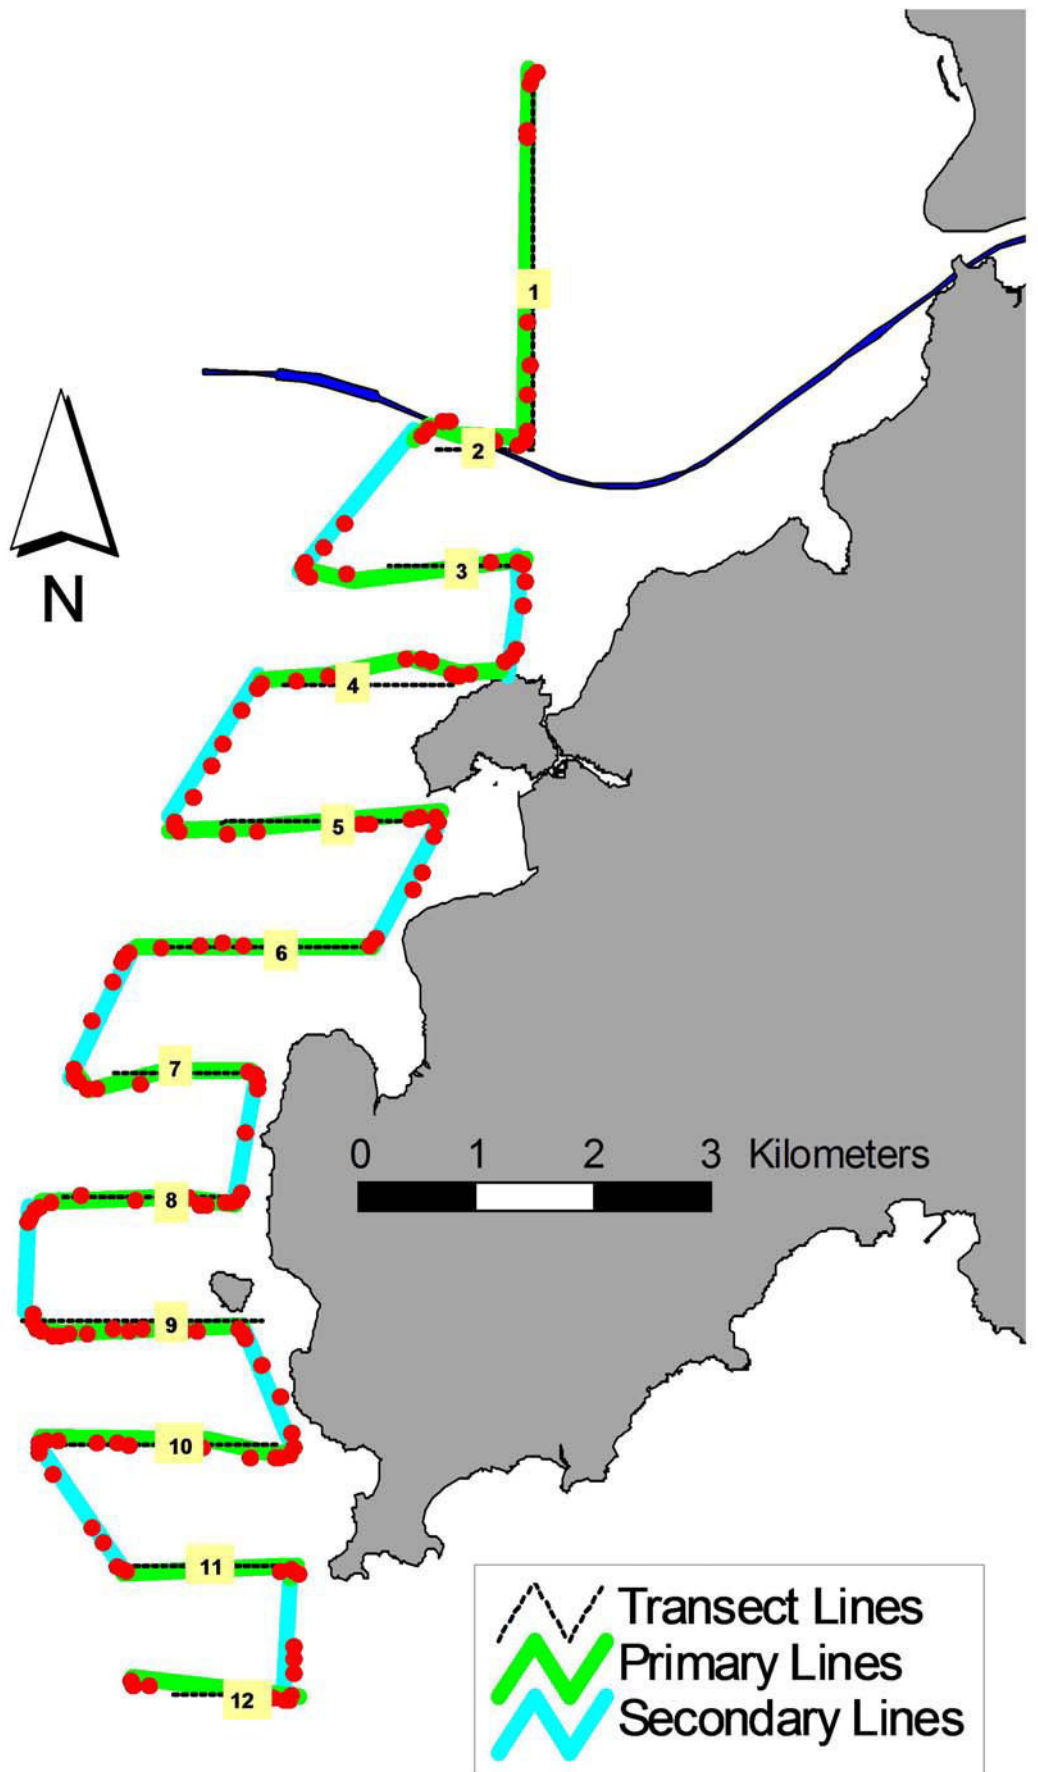
Figure 3. Survey Route on December 12th, 2016 (note: red dots represent the tracked positions of survey boat logged continuously by GPS throughout the course of the survey)

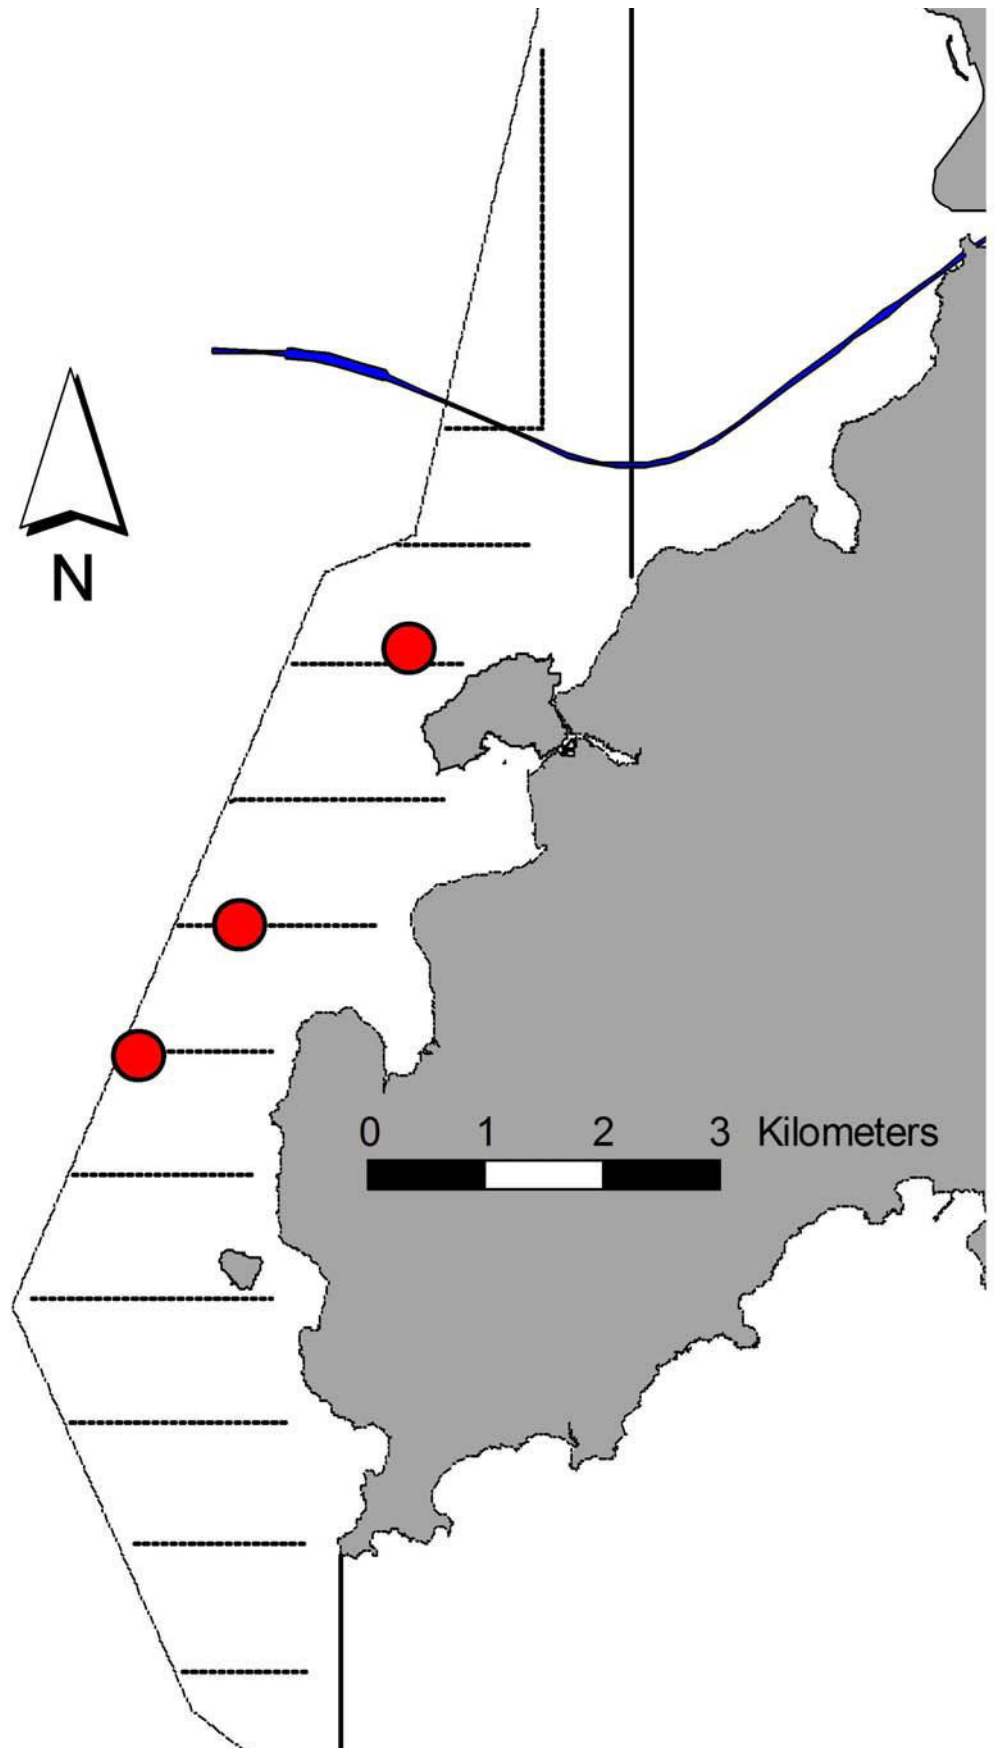
Figure 4. Distribution of Chinese White Dolphin Sighting during December 2016 HKLR09 Monitoring Surveys

- 6.12 Two of three dolphin groups were small in size with only two animals each, while the other group was moderate in size with four animals.
- 6.13 During this month of dolphin monitoring, marine construction activities have continued under this contract. However, no adverse impact on Chinese white dolphins was noticeable from general observations.
- 6.14 Evaluation of impacts on dolphins due to construction work will be conducted in the quarterly EM&A report.
- 6.15 Detailed monitoring methodology and results can be found in **Appendix I**.

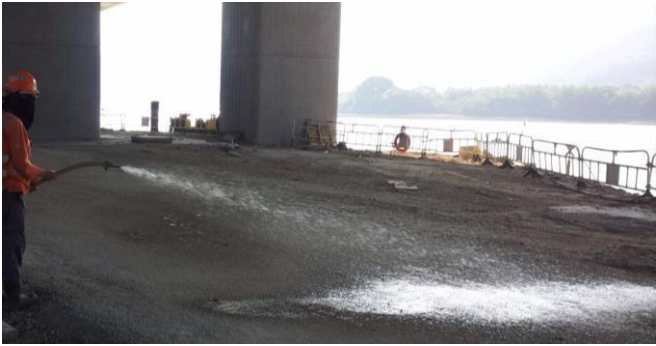
<p>Ref No: 161206-R05</p> <p>Impact: Air Quality (D5)</p> <p>Details: Haul roads at portion a (P89) and portion c should be sprayed with water regularly.</p> <p>Follow-up: The haul roads at portion a (P89) and portion c were observed wet.</p>

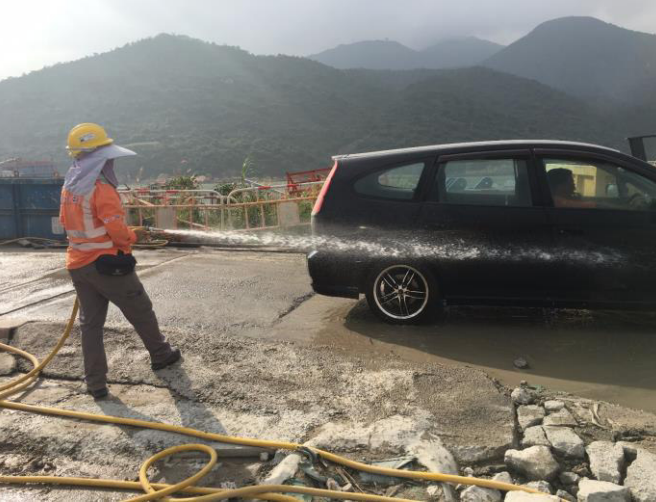
<p>Ref No: 161213-O01</p> <p>Impact: Air Quality (D9)</p> <p>Details: Site vehicles should be wheel washed before leaving the site at P81.</p> <p>Follow-up: The site vehicle was observed being washed before leaving the site at P81.</p>
