Contract No. HY/2011/09
Hong Kong-Zhuhai-Macao Bridge
Hong Kong Link Road – Section between HKSAR Boundary and Scenic Hill

Submission under Environmental Permit (EP-352/2009/D – Condition 4.4)
Monthly EM&A Report – March 2017

**Contract No. HY/2011/09 HZMB Hong Kong Link Road –
Section between HKSAR Boundary and Scenic Hill
Revised Monthly EM&A Report for March 2017 (EP-352/2009/D)**

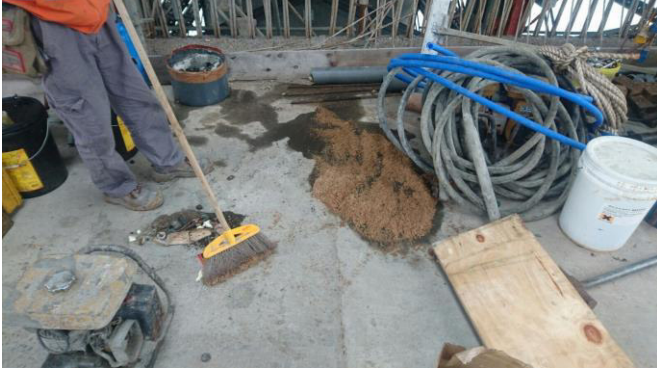
<p>Ref No: 170307-R01</p> <p>Impact: Waste / Chemical Management (F8,9)</p> <p>Details: Chemical containers at P56 should be provided with drip tray and oil stain should be removed.</p> <p>Follow-up: Chemical containers at P56 and oil stain was removed.</p>

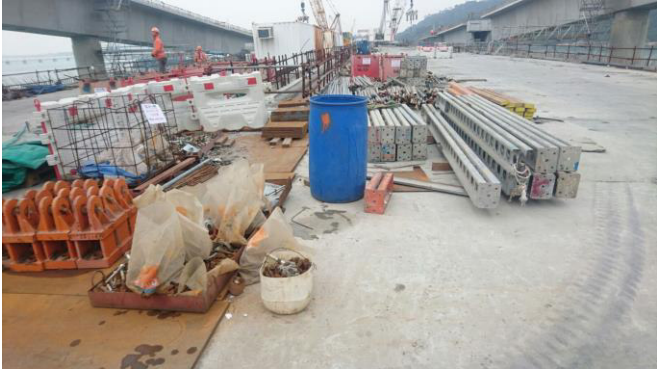
<p>Ref No: 170307-R02</p> <p>Impact: Waste / Chemical Management (F1i.iii)</p> <p>Details: General refuse at P56 should be cleared.</p> <p>Follow-up: General refuse at P56 was cleared.</p>
