Contract No. HY/2011/09
Hong Kong-Zhuhai-Macao Bridge
Hong Kong Link Road – Section between HKSAR Boundary and Scenic Hill

Submission under Environmental Permit (EP-352/2009/D – Condition 4.4)
Monthly EM&A Report – May 2017

**Contract No. HY/2011/09 HZMB Hong Kong Link Road –
Section between HKSAR Boundary and Scenic Hill
Revised Monthly EM&A Report for May 2017 (EP-352/2009/D)**

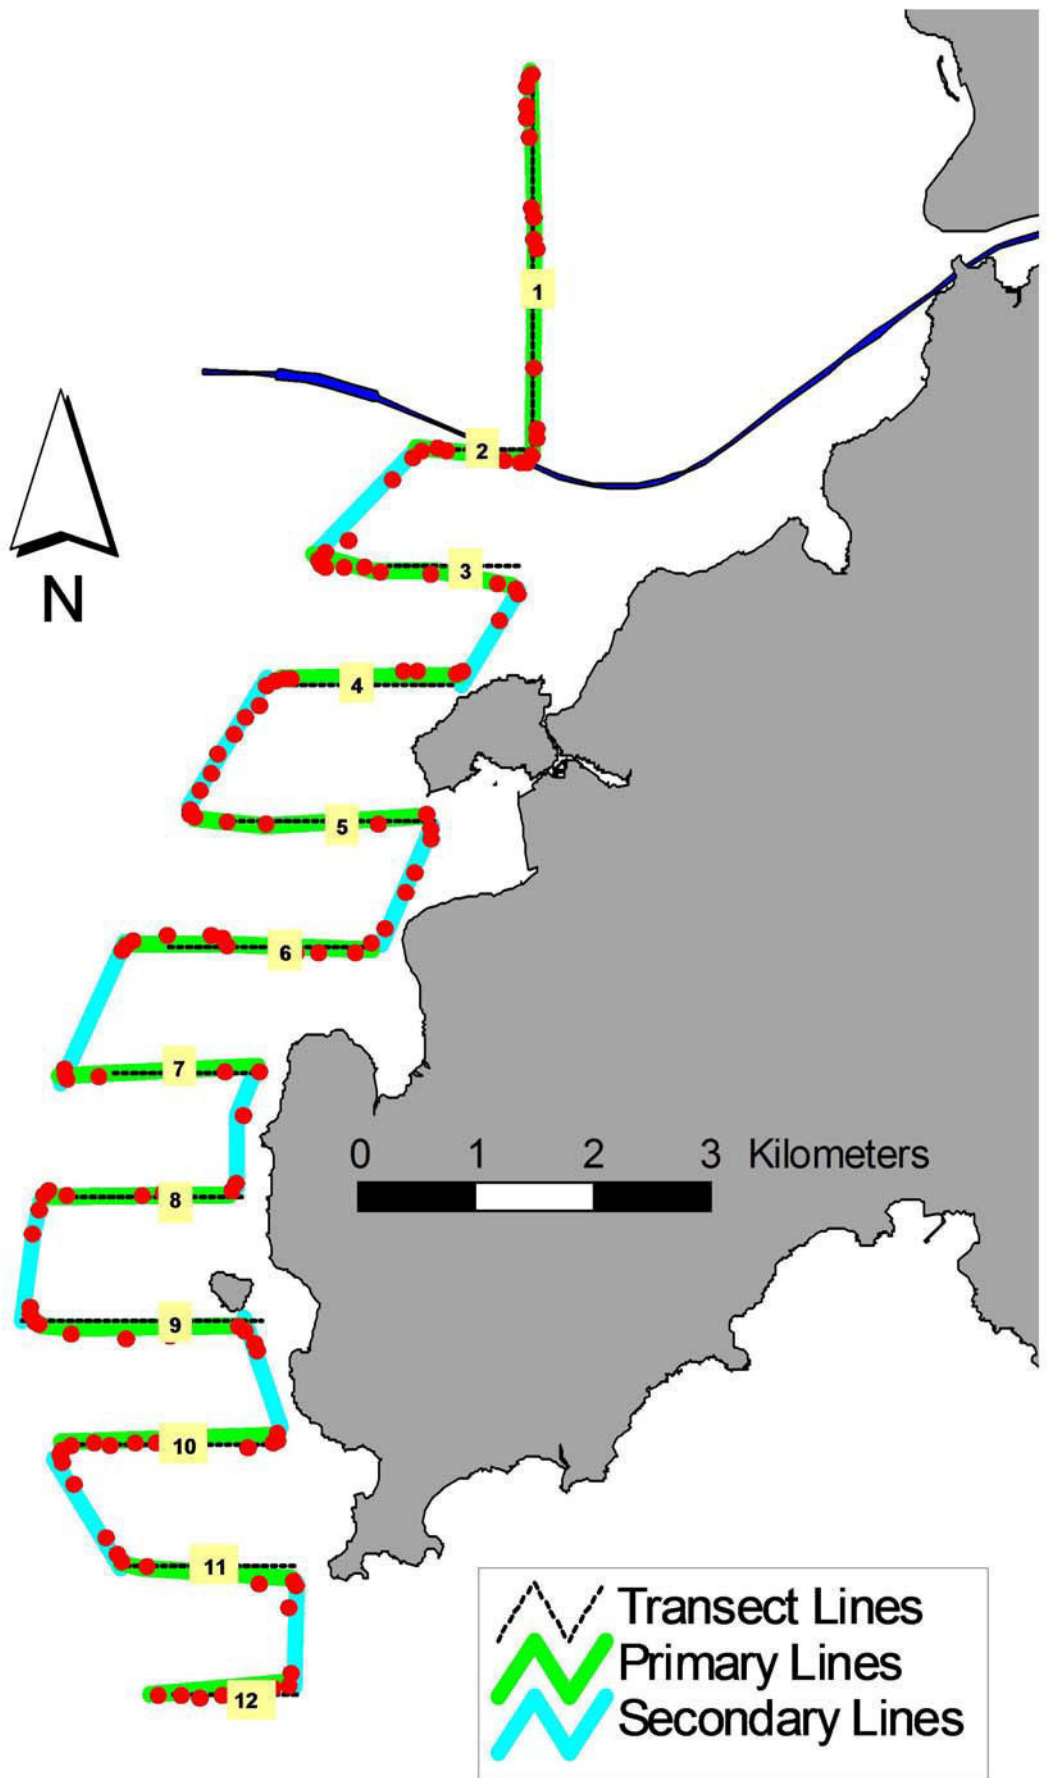
Figure 2. Survey Route on May 8th, 2017 (note: red dots represent the tracked positions of survey boat logged continuously by GPS throughout the course of the survey)

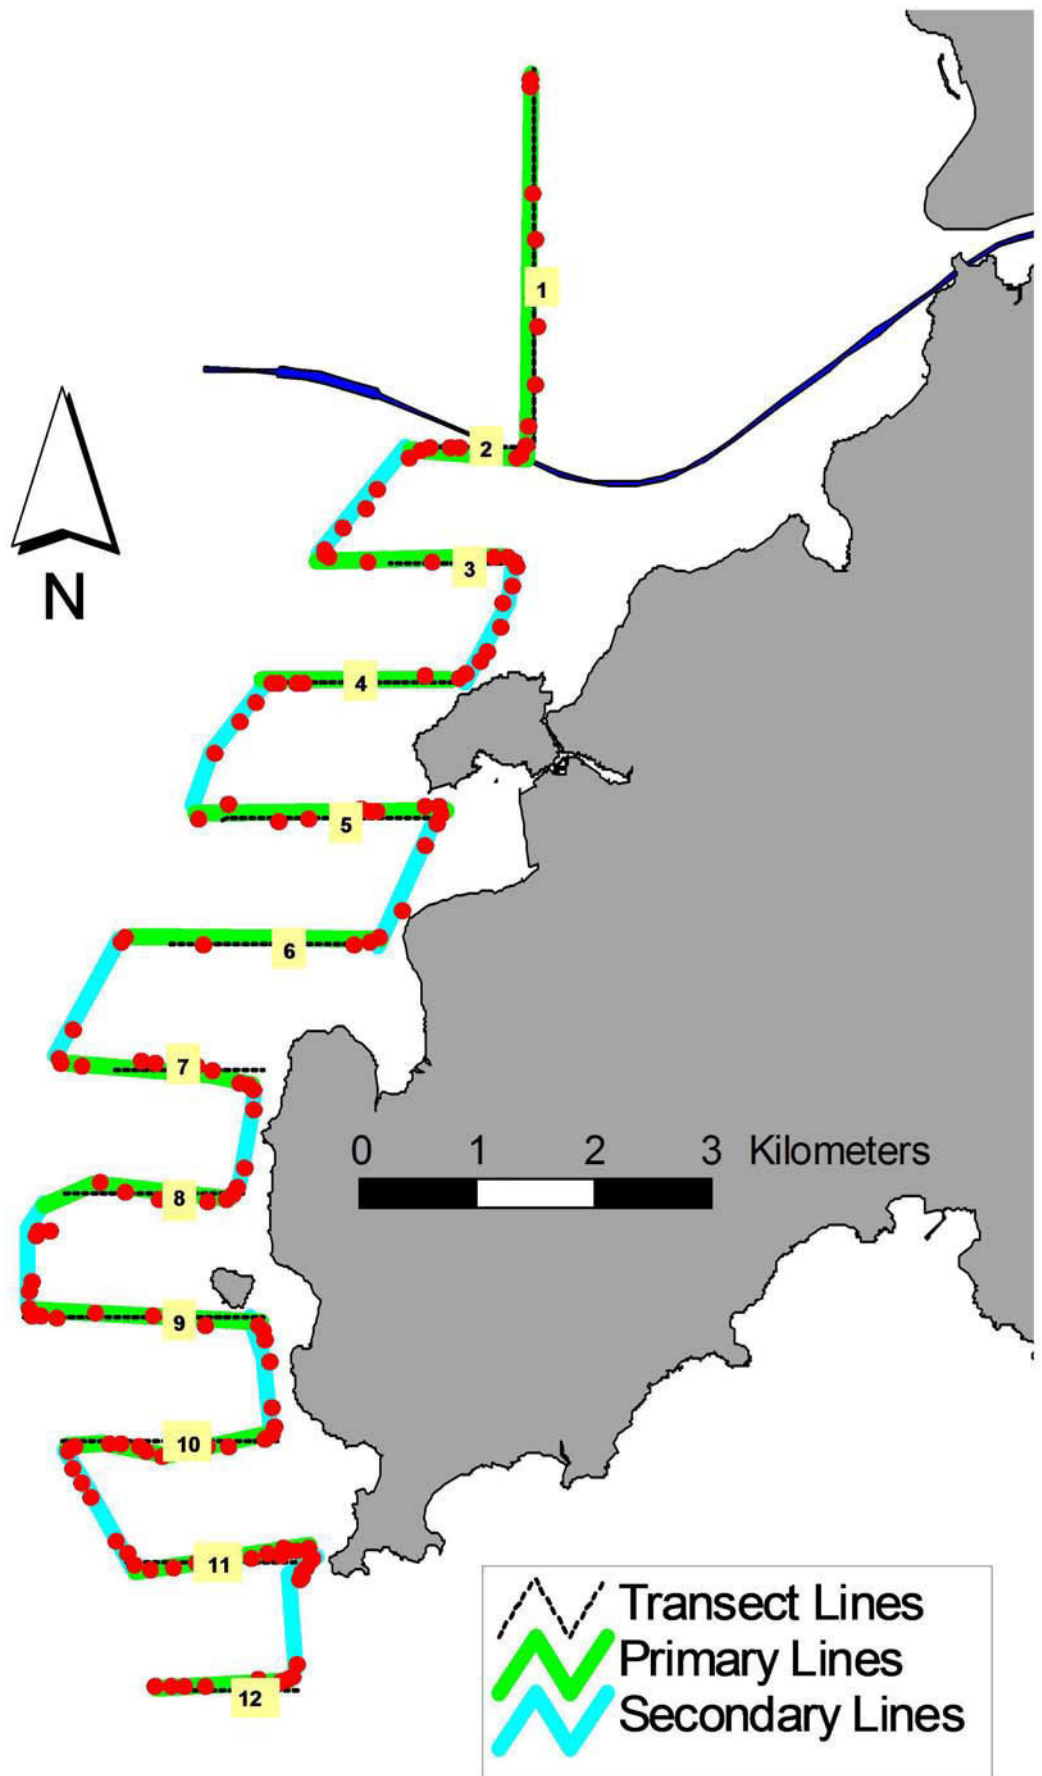
Figure 3. Survey Route on May 19th, 2017 (note: red dots represent the tracked positions of survey boat logged continuously by GPS throughout the course of the survey)

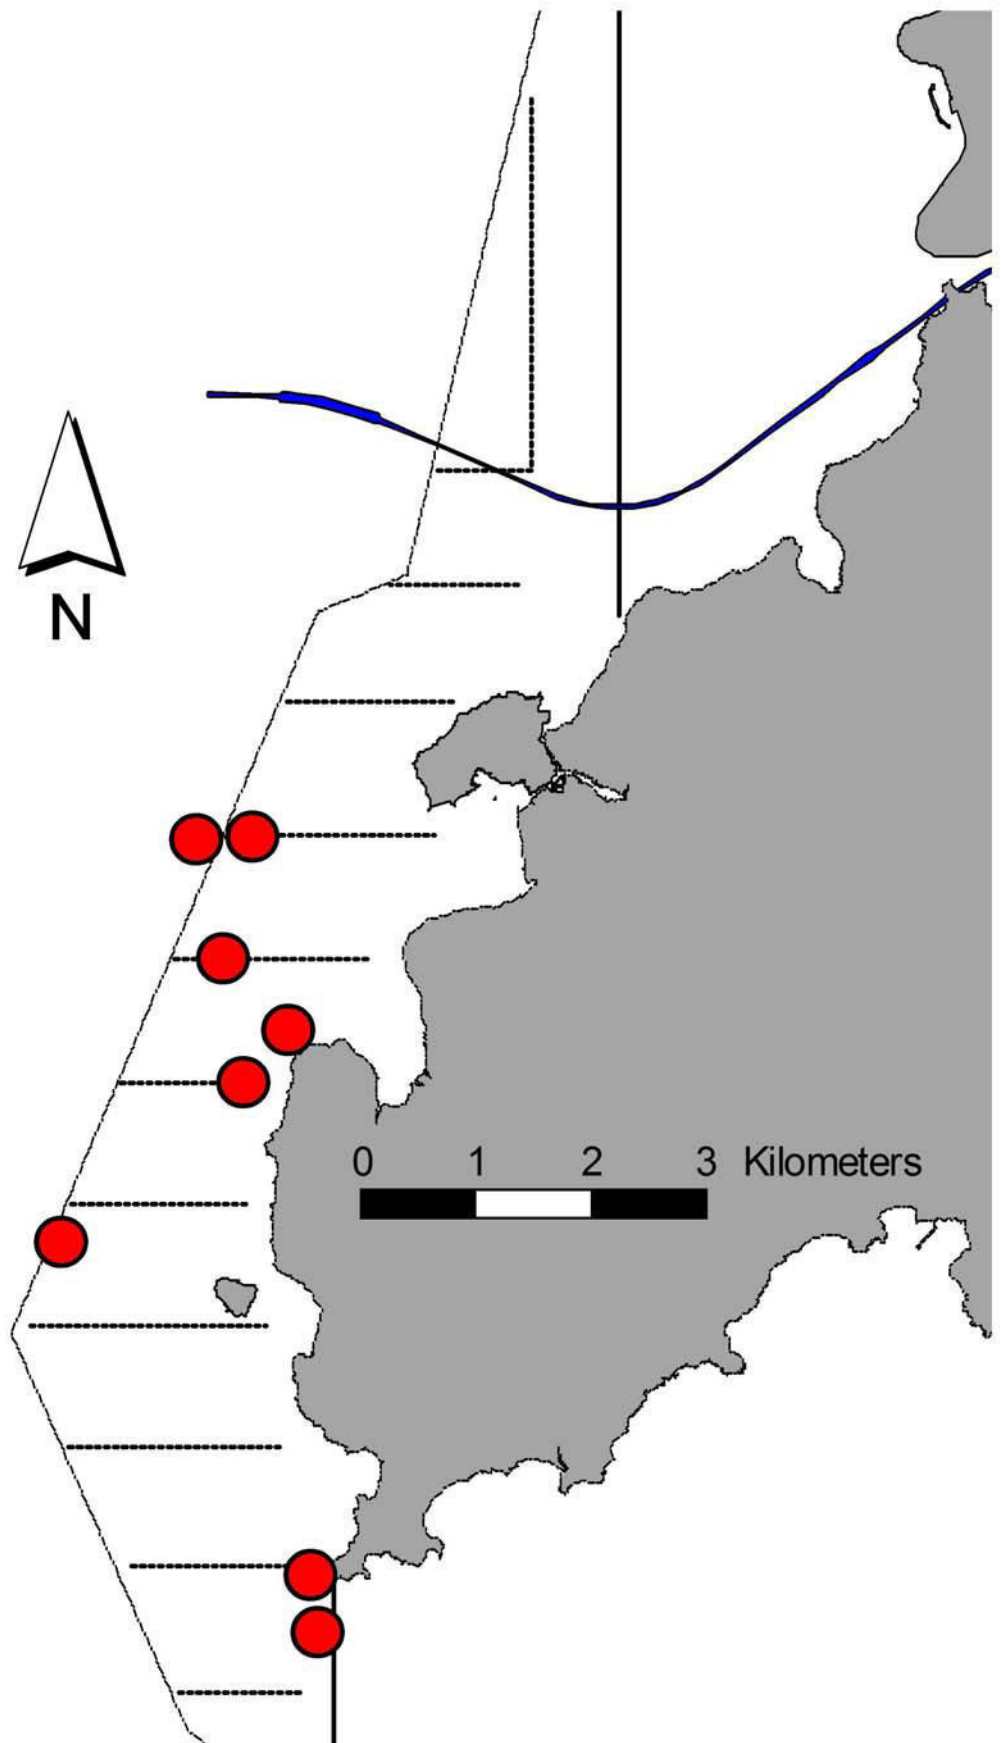
Figure 4. Distribution of Chinese White Dolphin Sighting during May 2017 HKLR09 Monitoring Surveys

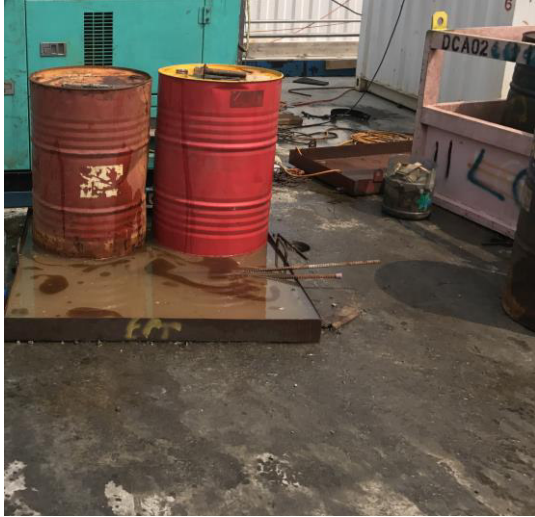
Ref No: 170509-R01

Oil stain and oily water at P44 should be removed and hole on the drip tray should be plugged to prevent oil leakage.

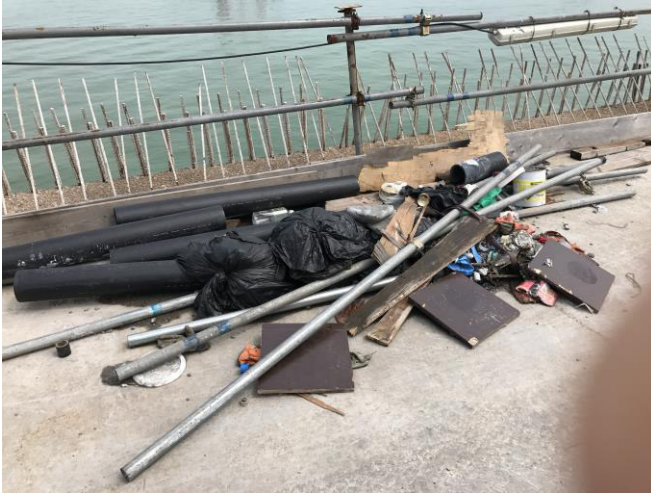
Ref No: 170509-R03

Housekeeping should be enhanced at P44, 47.

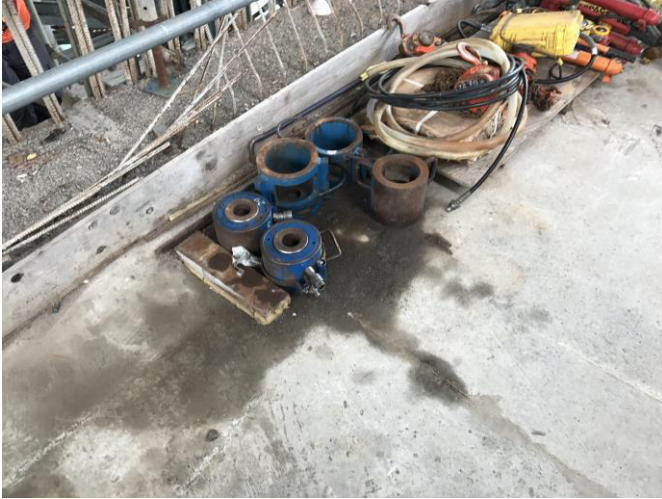
Ref No: 170523-R01

Oil stain at P65, 67 should be removed and oil absorbent should be cleared as chemical waste.

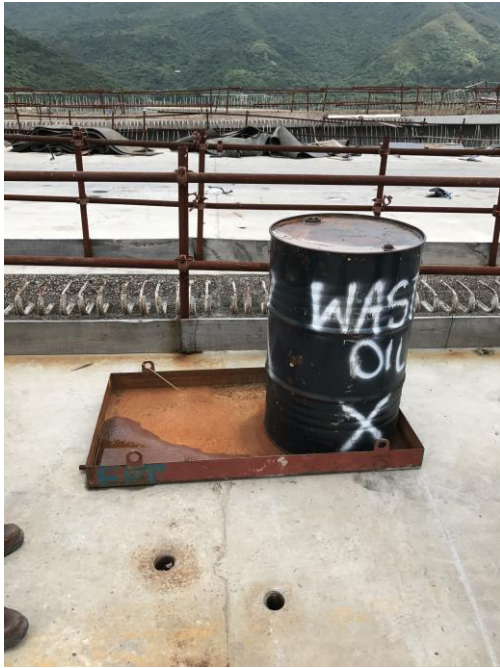
Ref No: 170523-R04

Proper chemical label should be provided to the chemical container at P59.

170523-R02	Drip tray should be provided to the chemical containers at P57.	Rectification/improvement will be reported in next reporting month.
	170523-R03	The chemical waste store at P57 should be provided with lock.	Rectification/improvement will be reported in next reporting month.
	170523-R04	Proper chemical label should be provided to the chemical container at P59.	Rectification/improvement will be reported in next reporting month.
	170523-R05	Housekeeping should be enhanced at P61.	Rectification/improvement will be reported in next reporting month.
	170531-R03	Oil stain at P77 should be removed as chemical waste.	Rectification/improvement will be reported in next reporting month.
<i>Landscape &</i>	N/A ⁽¹⁾	N/A ⁽¹⁾	N/A ⁽¹⁾
