**Contract No. HY/2011/09**  
**Hong Kong-Zhuhai-Macao Bridge**  
**Hong Kong Link Road – Section between HKSAR Boundary and Scenic Hill**

**Submission under Environmental Permit (EP-352/2009/D – Condition 4.4)**  
**Monthly EM&A Report – April 2018**

**Contract No. HY/2011/09 HZMB Hong Kong Link Road –  
Section between HKSAR Boundary and Scenic Hill  
Monthly EM&A Report for April 2018 (EP-352/2009/D)**

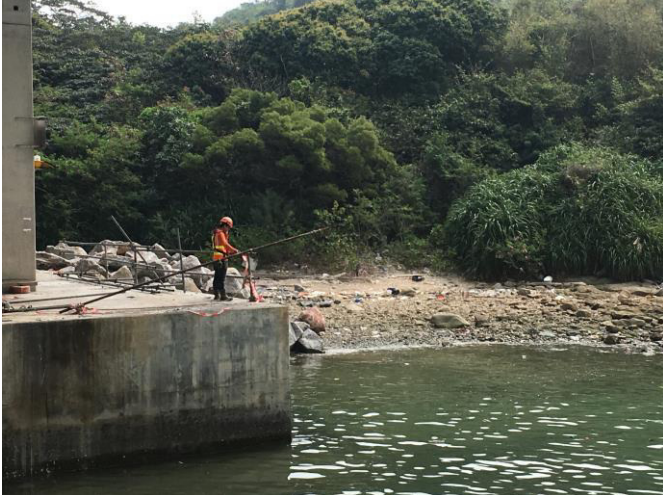
<p><b>Ref No:</b> 180327-R01</p> <p><b>Impact:</b> Waste/Chemical Management (F 1i, 1iii, 4ii)</p> <p><b>Details:</b> To clear the accumulated traffic barrier at P68 regularly.</p> <p><b>Follow-up:</b> The accumulated traffic barrier was removed.</p>

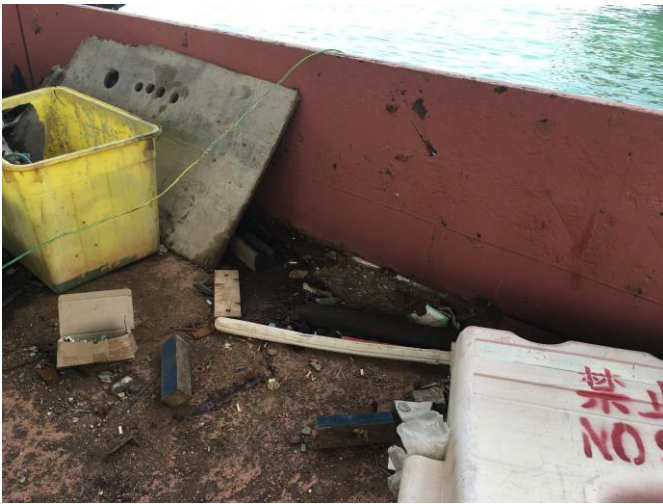
<p><b>Ref No:</b> 180327-R02</p> <p><b>Impact:</b> Waste/Chemical Management (F 2i, 2ii, 4ii)</p> <p><b>Details:</b> To clear the chemical containers as chemical waste at P68.</p> <p><b>Follow-up:</b> The chemical containers were removed.</p>

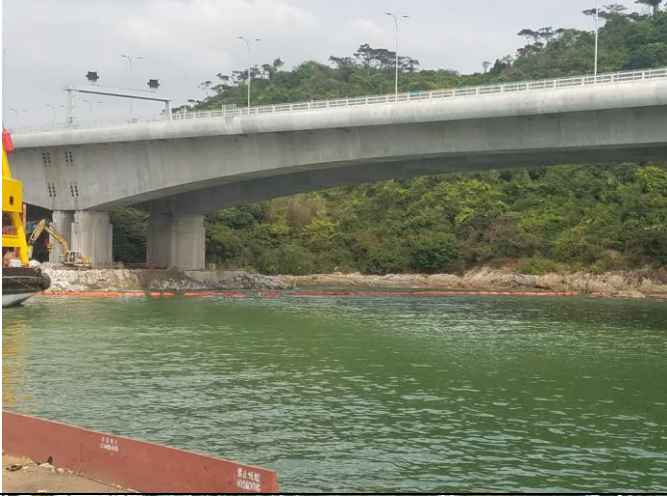
<p><b>Ref No:</b> 180410-R01</p> <p><b>Impact:</b> Water Quality (B 25)</p> <p><b>Details:</b> To properly deploy the silt curtain at P68.</p> <p><b>Follow-up:</b> Silt curtain was properly deployed.</p>

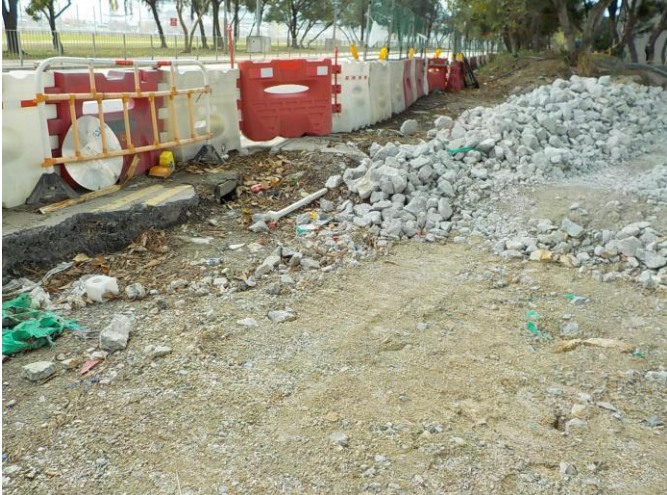
<p><b>Ref No:</b> 180410-F02</p> <p><b>Impact:</b> Waste/Chemical Management (F 1i, 1iii, 4i)</p> <p><b>Details:</b> To clear the accumulated rubbish at P84 and P109.</p> <p><b>Follow-up:</b> The accumulated rubbish was cleared.</p>
<p style="text-align: center;"><b><u>P84</u></b></p>
