Contract No. HY/2011/03

**Hong Kong-Zhuhai-Macao Bridge Hong Kong Link Road
Section between Scenic Hill and Hong Kong Boundary Crossing
Facilities**

Monthly EM&A Report No.143 (August 2024)

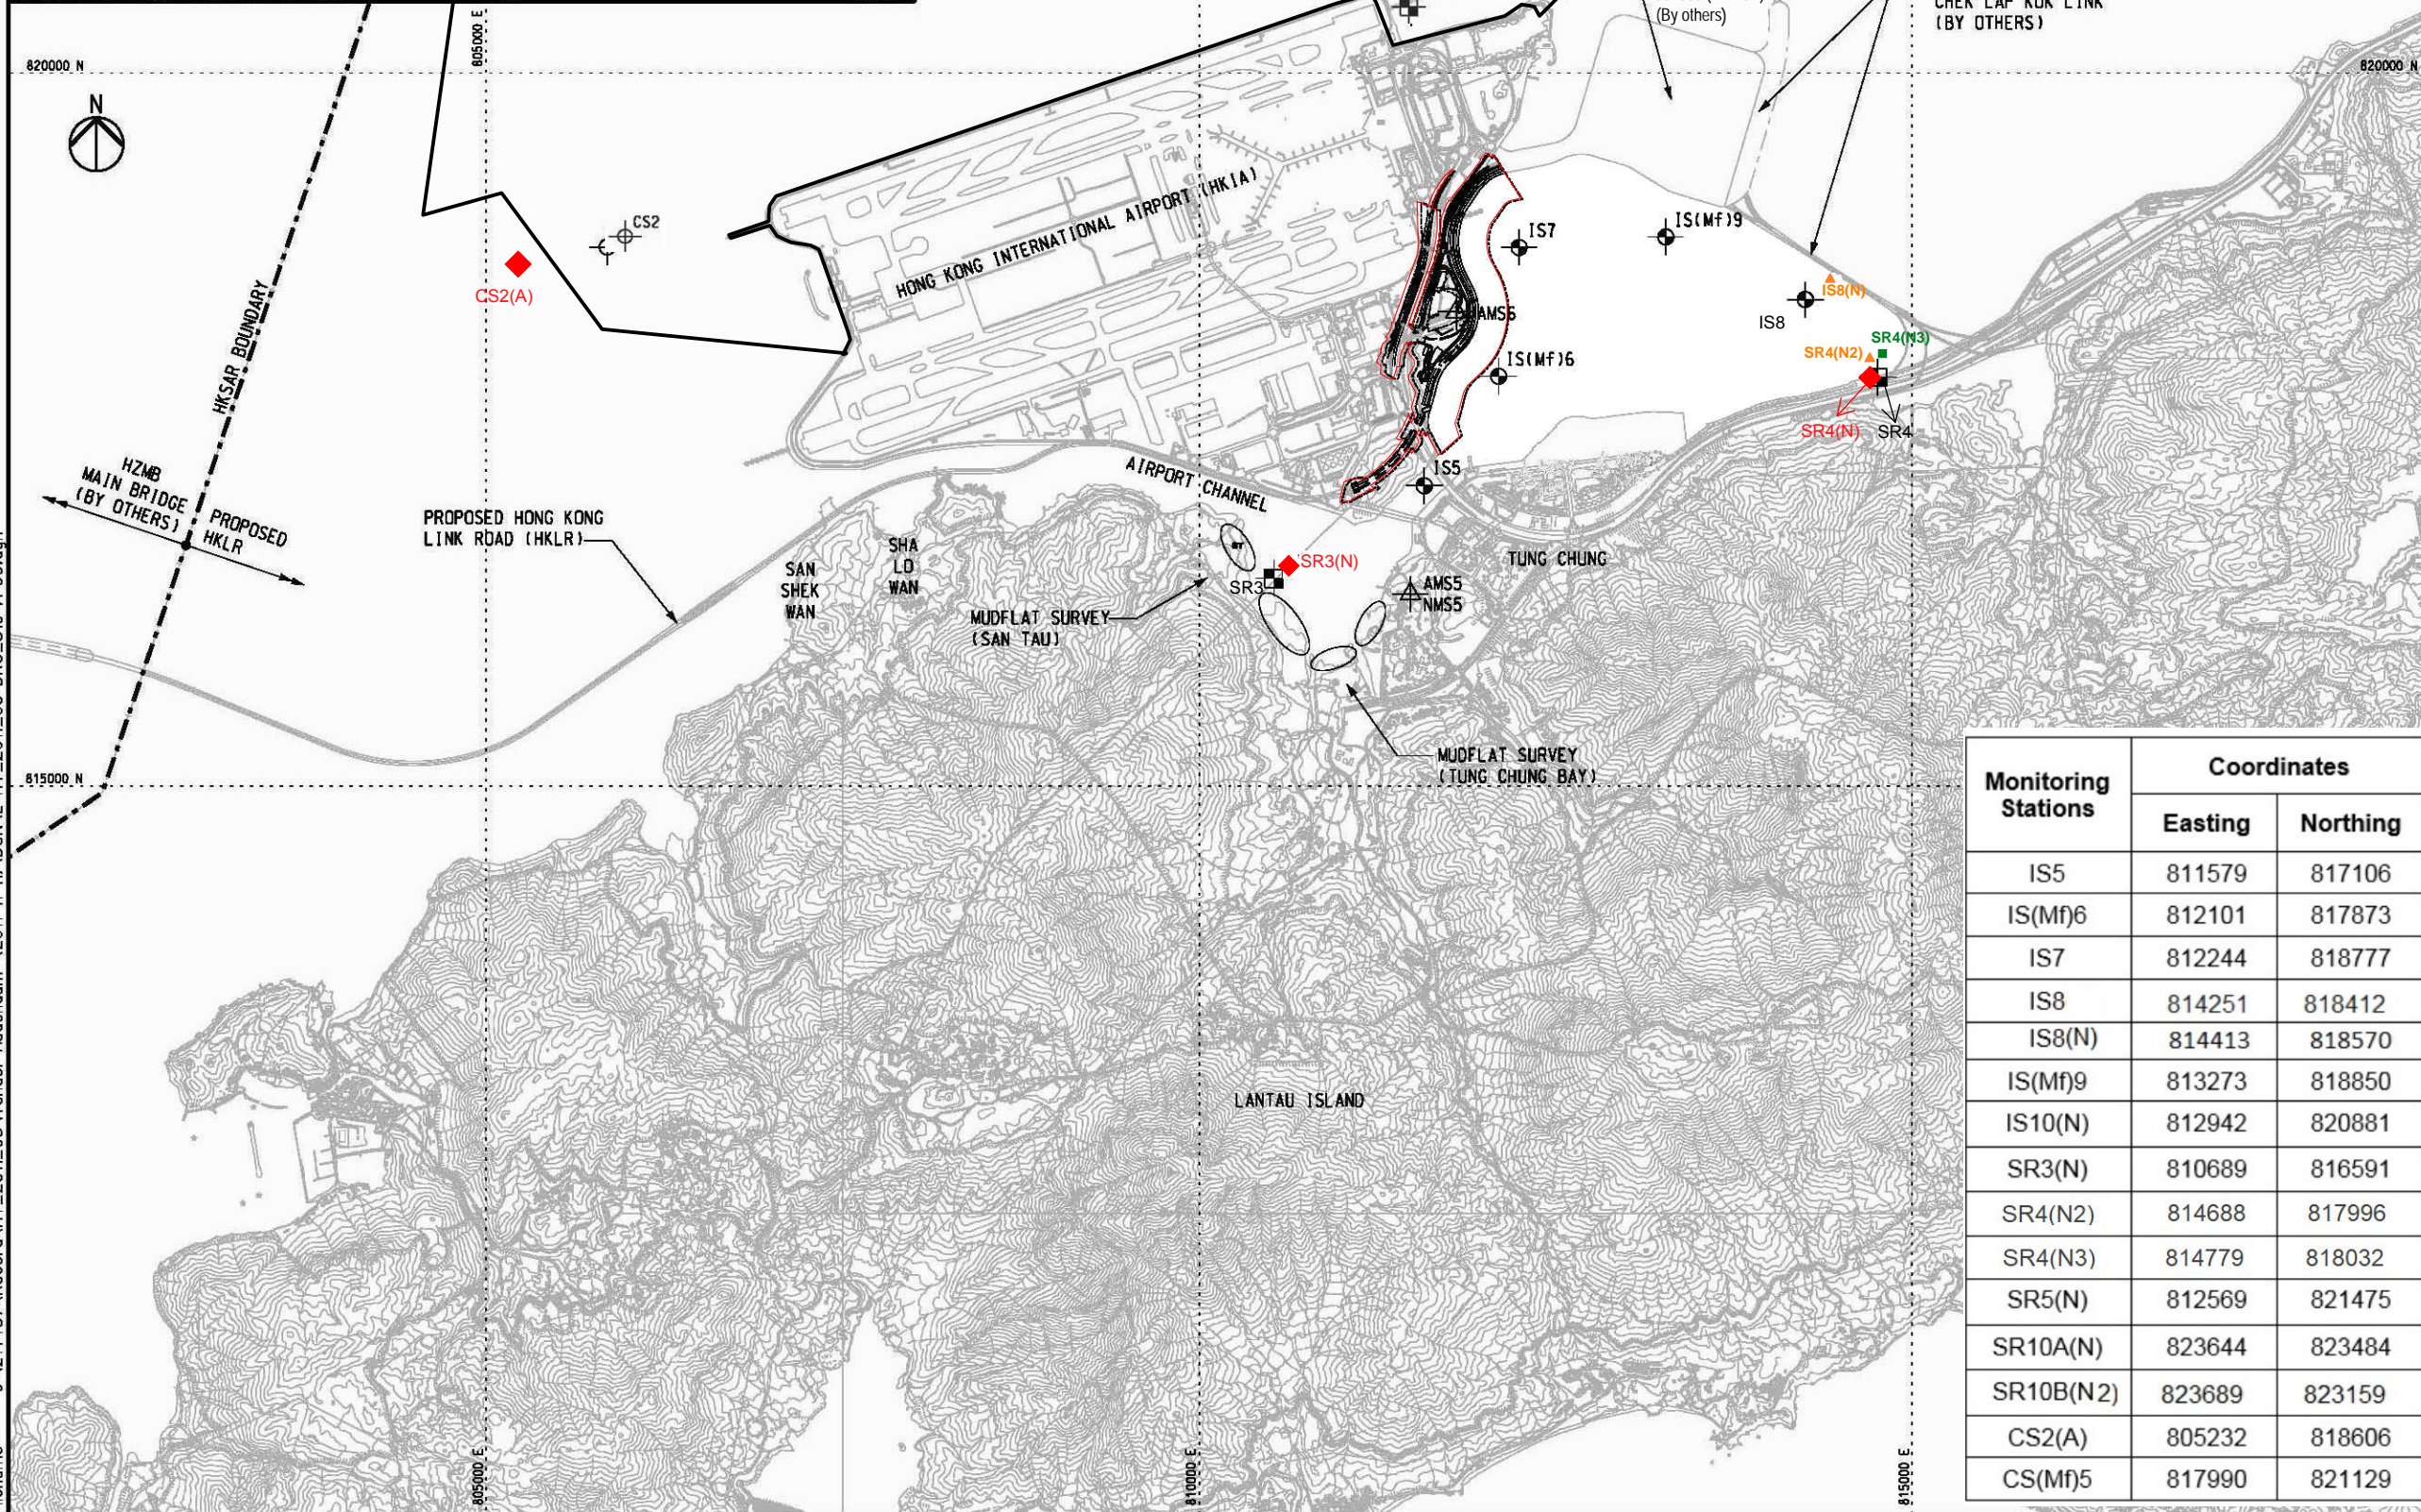
Monitoring Stations	Coordinates	
	Easting	Northing
IS5	811579	817106
IS(Mf)6	812101	817873
IS7	812244	818777
IS8	814251	818412
IS8(N)	814413	818570
IS(Mf)9	813273	818850
IS10(N)	812942	820881
SR3(N)	810689	816591
SR4(N2)	814688	817996
SR4(N3)	814779	818032
SR5(N)	812569	821475
SR10A(N)	823644	823484
SR10B(N2)	823689	823159
CS2(A)	805232	818606
CS(Mf)5	817990	821129

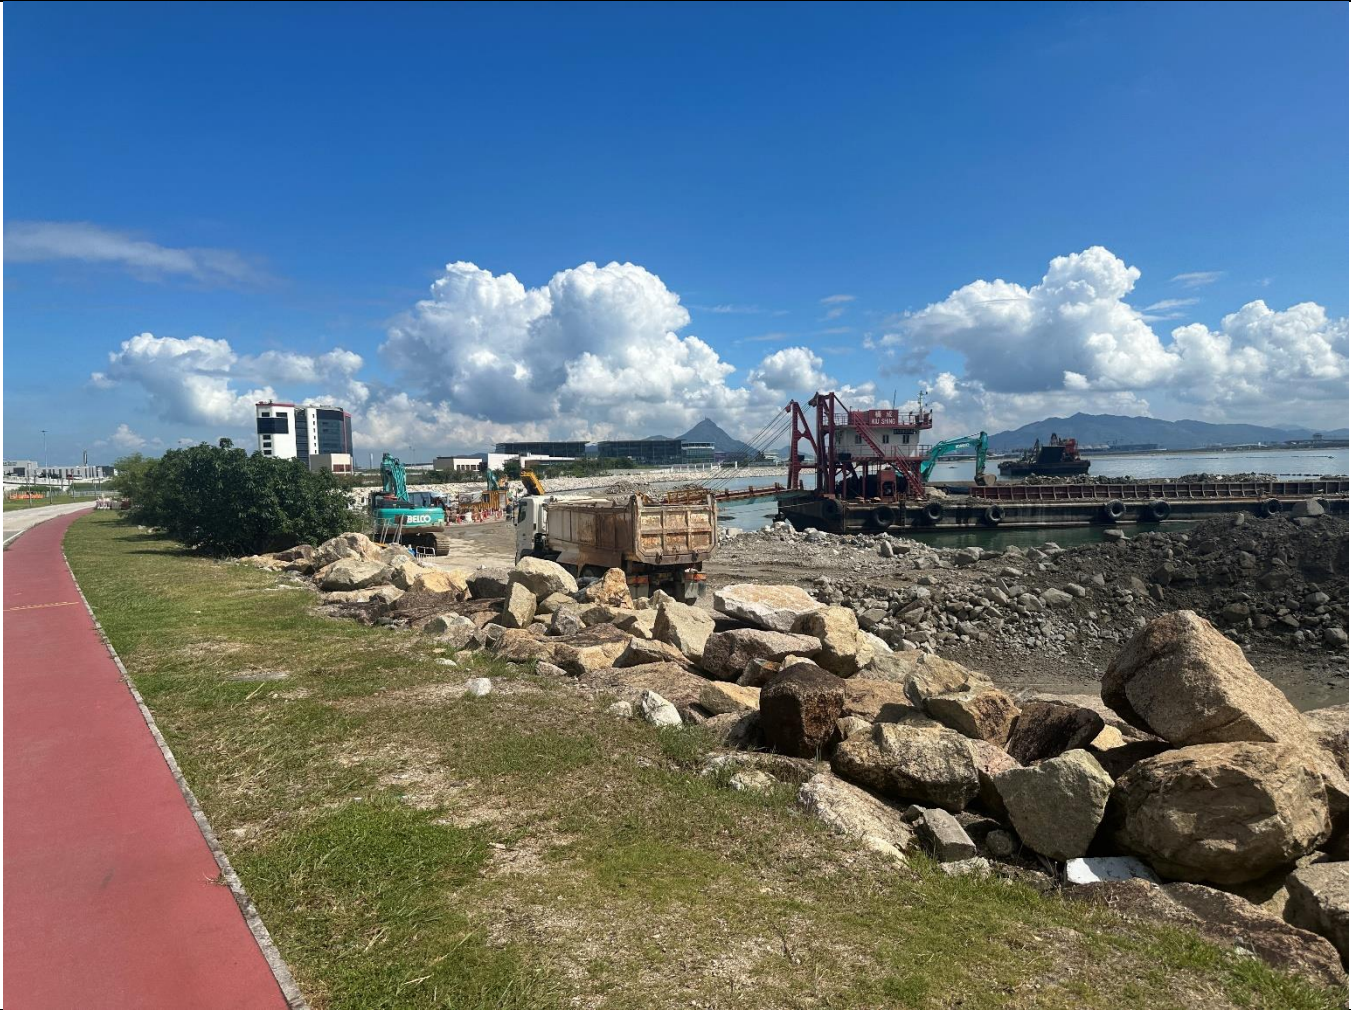
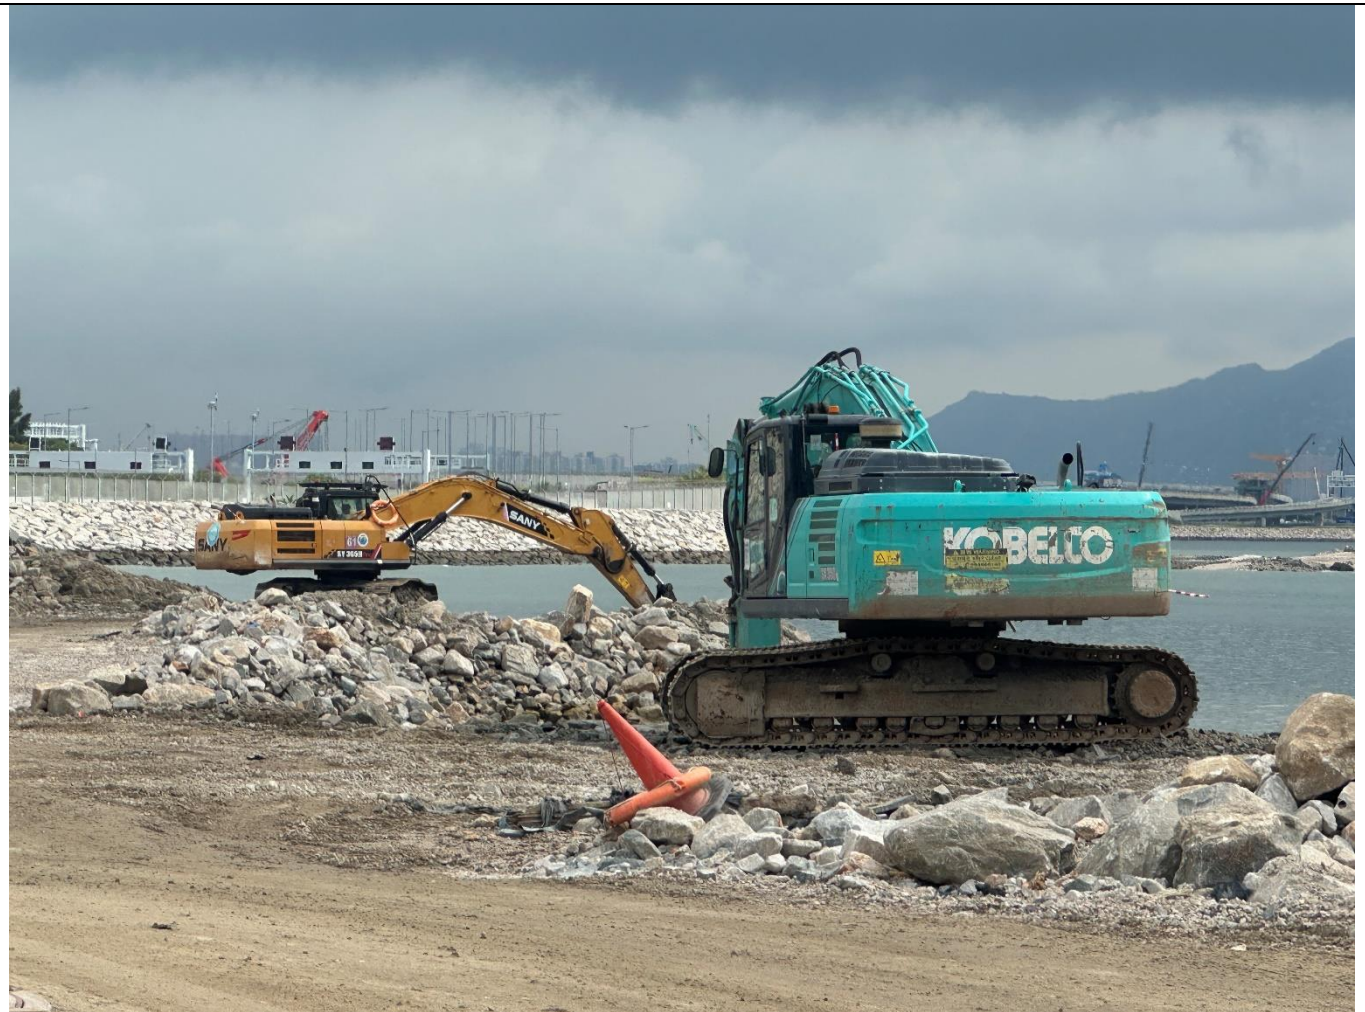
Site Observation Photos during Site Inspection on 23 August 2024

Date of Audit	Observations	Actions Taken by Contractor / Recommendation	Date of Observations Closed
7 August 2024	No particular environmental issue was recorded during the site inspection.	N.A.	N.A.
14 August 2024	No particular environmental issue was recorded during the site inspection.	N.A.	N.A.
23 August 2024	No particular environmental issue was recorded during the site inspection.	N.A.	N.A.
30 August 2024	No particular environmental issue was recorded during the site inspection.	N.A.	N.A.
