Central Police Station Conservation and Revitalisation Project

Monthly EM&A Report No. 101
(1 July to 31 July 2024)

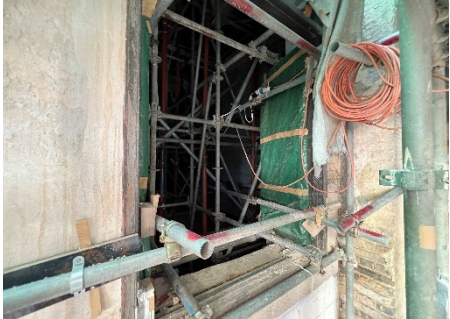
<p>Protections to existing timber windows.</p>

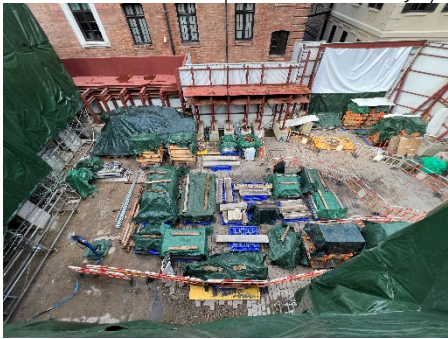
<p>Condition of salvaged CDEs stored at ground level dated 12th July.</p>	<p>[Inspections dated 3rd, 12th, 18th and 25th July 2024] The Stage 2 and 3 removal works have been completed during this reporting period.</p> <p>Based on the observation on site, the work sequence and methodology have followed the approved method statement(s).</p> <p>Selected CDEs have been salvaged during the period. These have subsequently been protected and placed in the temporary storage space at ground level. These items are awaiting transfer by the contractor to the offsite storage.</p>
--	--	--	---

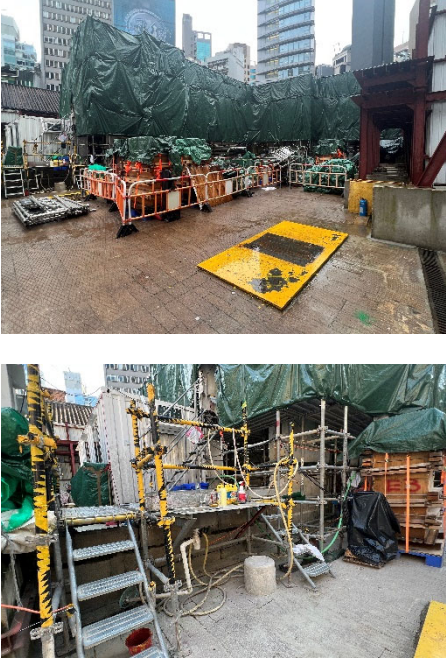
<p>The site is generally being kept tidy.</p>	[Inspections dated 3 rd , 12 th , 18 th and 25 th July 2024] The site is kept in tidy condition during this reporting period. The contractor was reminded to maintain site tidiness as well as ensuring sufficient protection is provided to the full extent of the fabric to be retained.

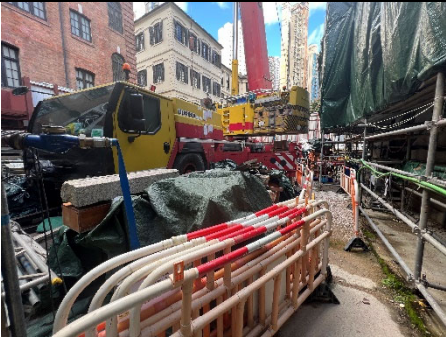
<p>Mobile crane on site with working area fenced off.</p>

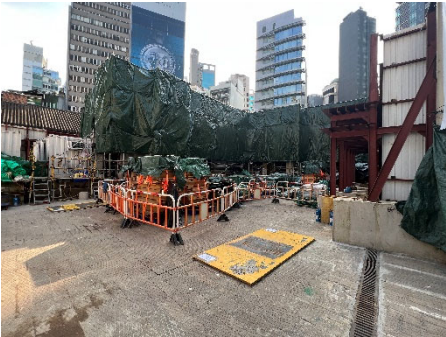
<p>Site condition dated 25 July after the moving out of mobile crane.</p>	<p>[Inspections dated 3rd, 12th, 18th and 25th July 2024] The mobile crane removed from the site on 9th July 2024 following the completion of Phase 2 and 3 works.</p>
4.4	Are site rules applied effectively?	9/10

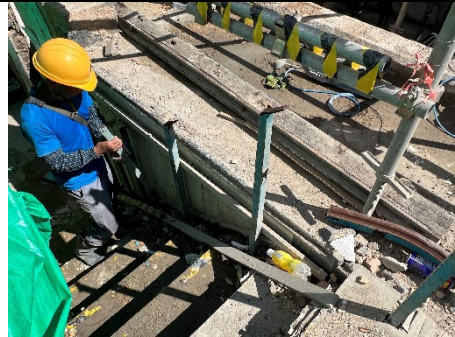
<p>[Inspections dated 3rd, 12th, 18th and 25th July 2024] There was no evidence of smoking happening onsite during all site inspections.</p> <p>The site-based staff were all observed to be wearing the required Personal Protective Equipment (PPE), including being clipped on to the fall arrest line.</p>

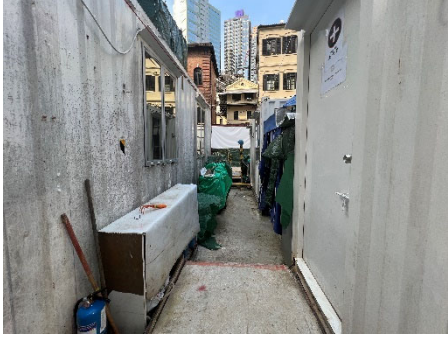
<p>The site hut was kept tidy and clean.</p>	<p>[Inspections dated 3rd, 12th, 18th and 25th July 2024] The contractors site hut is being kept reasonably clean, tidy, and organised.</p>
4.6	Is the site managed in a safe manner?	8/10

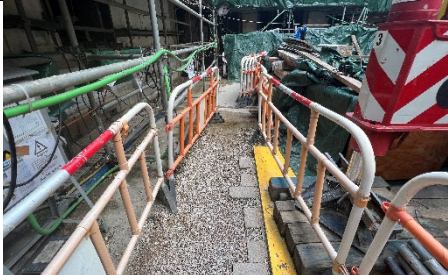
<p>Working area has been fenced off.</p>

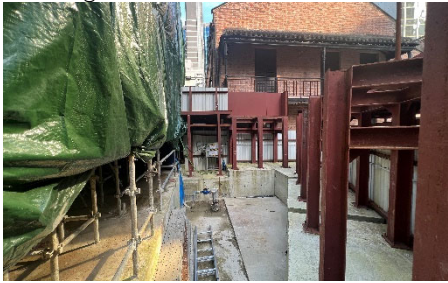
<p>Hoarding condition near Blk 6&7</p>	No adverse comments.

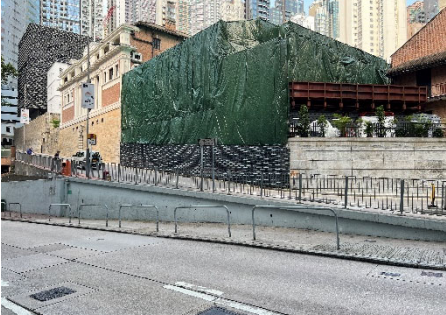
<p>Scaffolding and hoarding arrangement are maintained along Arbutnot Road</p>	
	Sub-Total	49/60
