Central Police Station Conservation and Revitalisation Project

Monthly EM&A Report No. 102
(1 August to 31 August 2024)

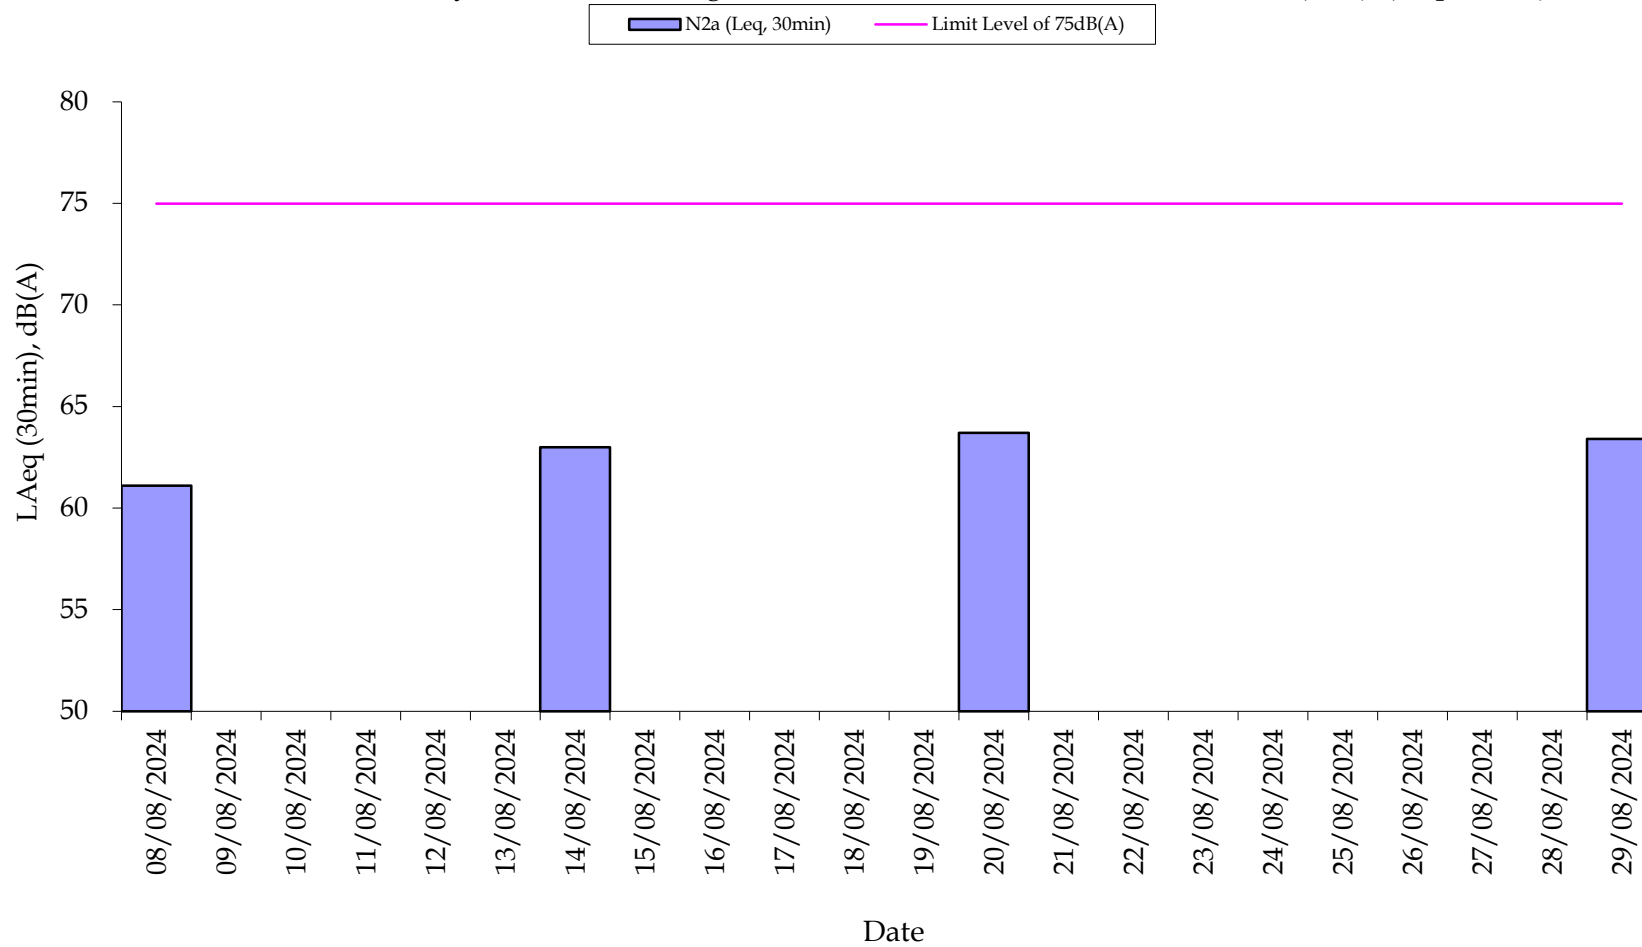
Normal Weekdays Noise Monitoring Results at 2nd Floor of Block 3 at Tai Kwun (N2a) (Leq, 30min)

- 75dB(A) was adopted as the Limit Level during normal weekdays in the reporting period

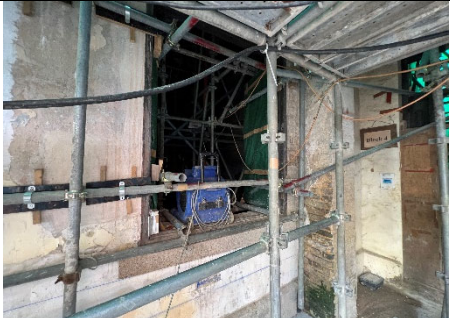
<p>Protections to existing timber windows.</p>

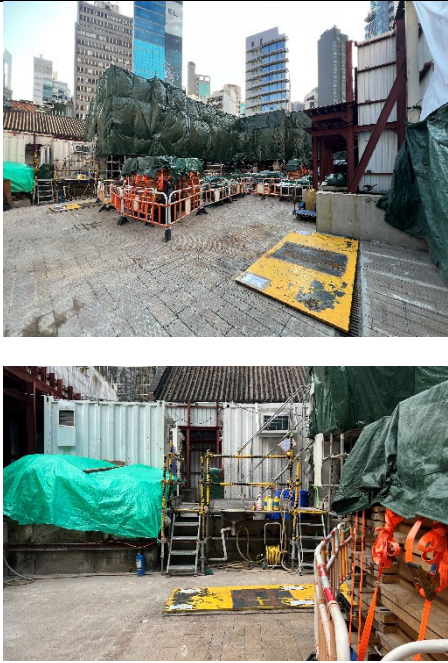
<p>The site is generally being kept tidy.</p>	[Inspections dated 2 nd , 8 th , 13 th , 23 rd and 29 th Aug 2024] The site is kept in tidy condition during this reporting period. The contractor was reminded to maintain site tidiness as well as ensuring sufficient protection is provided to the full extent of the fabric to be retained.

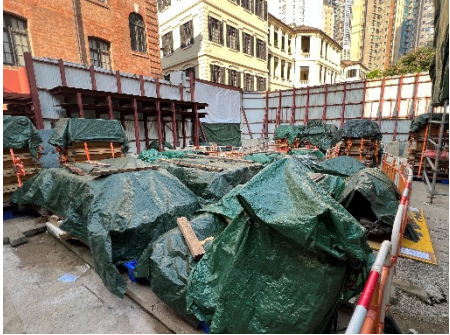
<p>Site condition dated 8th August with salvaged CDEs protected and fenced off.</p>

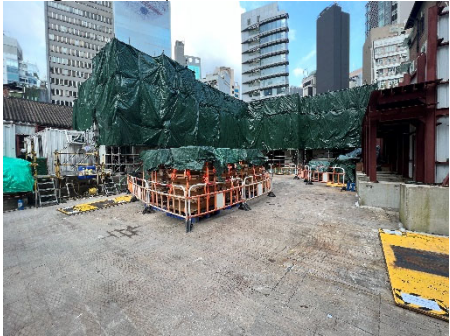
<p>Site condition dated 29th August after the relocation of salvaged CDEs.</p>	<p>[Inspections dated 2nd, 8th, 13th, 23rd and 29th Aug 2024] Loose salvaged CDEs were well protected and fenced off before being relocated to the offsite storage on 13th and 14th August.</p>
4.4	Are site rules applied effectively?	9/10		<p>[Inspections dated 2nd, 8th, 13th, 23rd and 29th Aug 2024] There was no evidence of smoking happening onsite during all site inspections.</p>

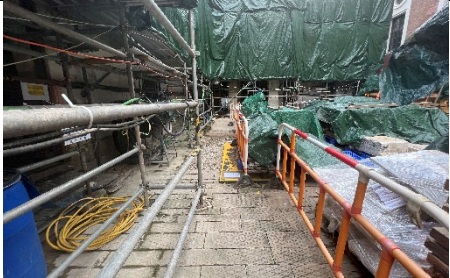
<p>Working area has been fenced off.</p>

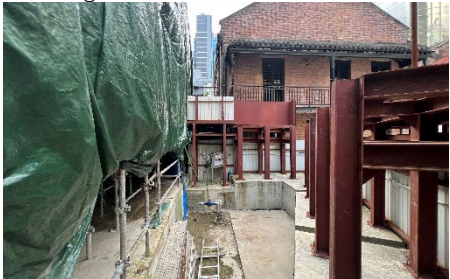
<p>Hoarding condition near Blk 6&7</p>	No adverse comments.
