Development at West Kowloon Cultural District

Monthly Environmental Monitoring and Audit (EM&A) Report
for September 2024

Part-1: EM&A at Lyric Theatre Complex

**Part-2: EM&A for ELS Works for The
Integrated Basement and
Underground Road in Zones 2A, 2B
& 2C**

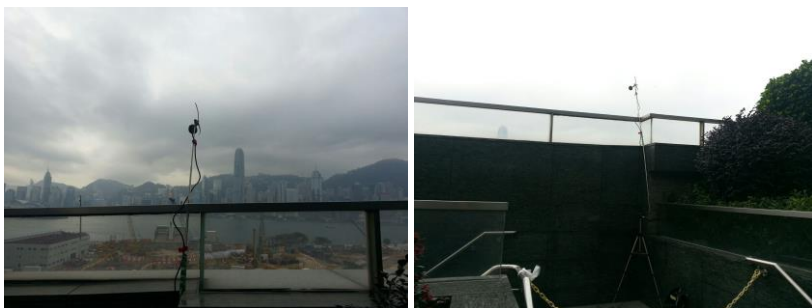
Graphical Presentation Noise Monitoring Result at Station NM1A

The station set-up of a free-field measurement at Station NM1A.

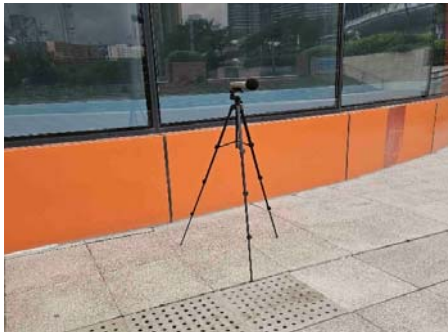
Graphical Presentation of Noise Monitoring Result at Station NM2A

The station set-up of a façade measurement at station NM2A.

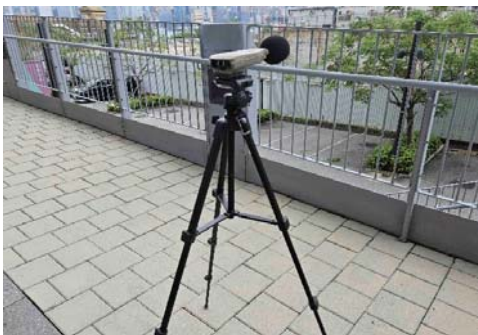
Graphical Presentation of Noise Monitoring Result at Station NM3A

The station set-up of a façade measurement at station NM3A.

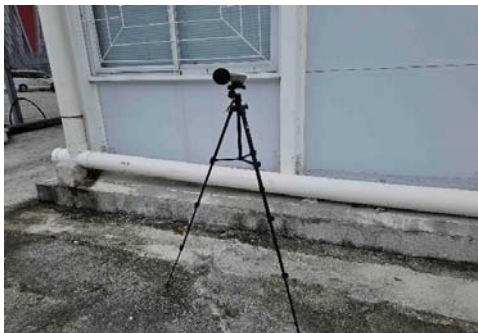
Graphical Presentation of Noise Monitoring Result at Station NM4A

The station set-up of a façade measurement at station NM4A.

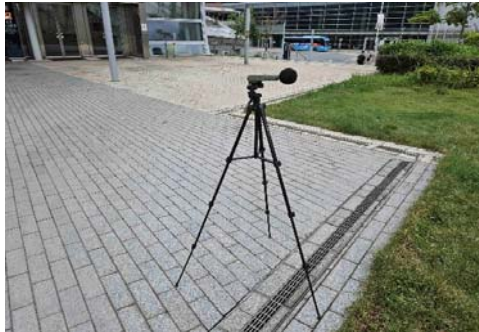
Graphical Presentation of Noise Monitoring Result at Station NM5A

The station set-up of a free-field measurement at station NM5A.
