**Central Kowloon Route**

**Yau Ma Tei West**

**Contract No. HY/2014/20**

Monthly EM&A Report No. 24

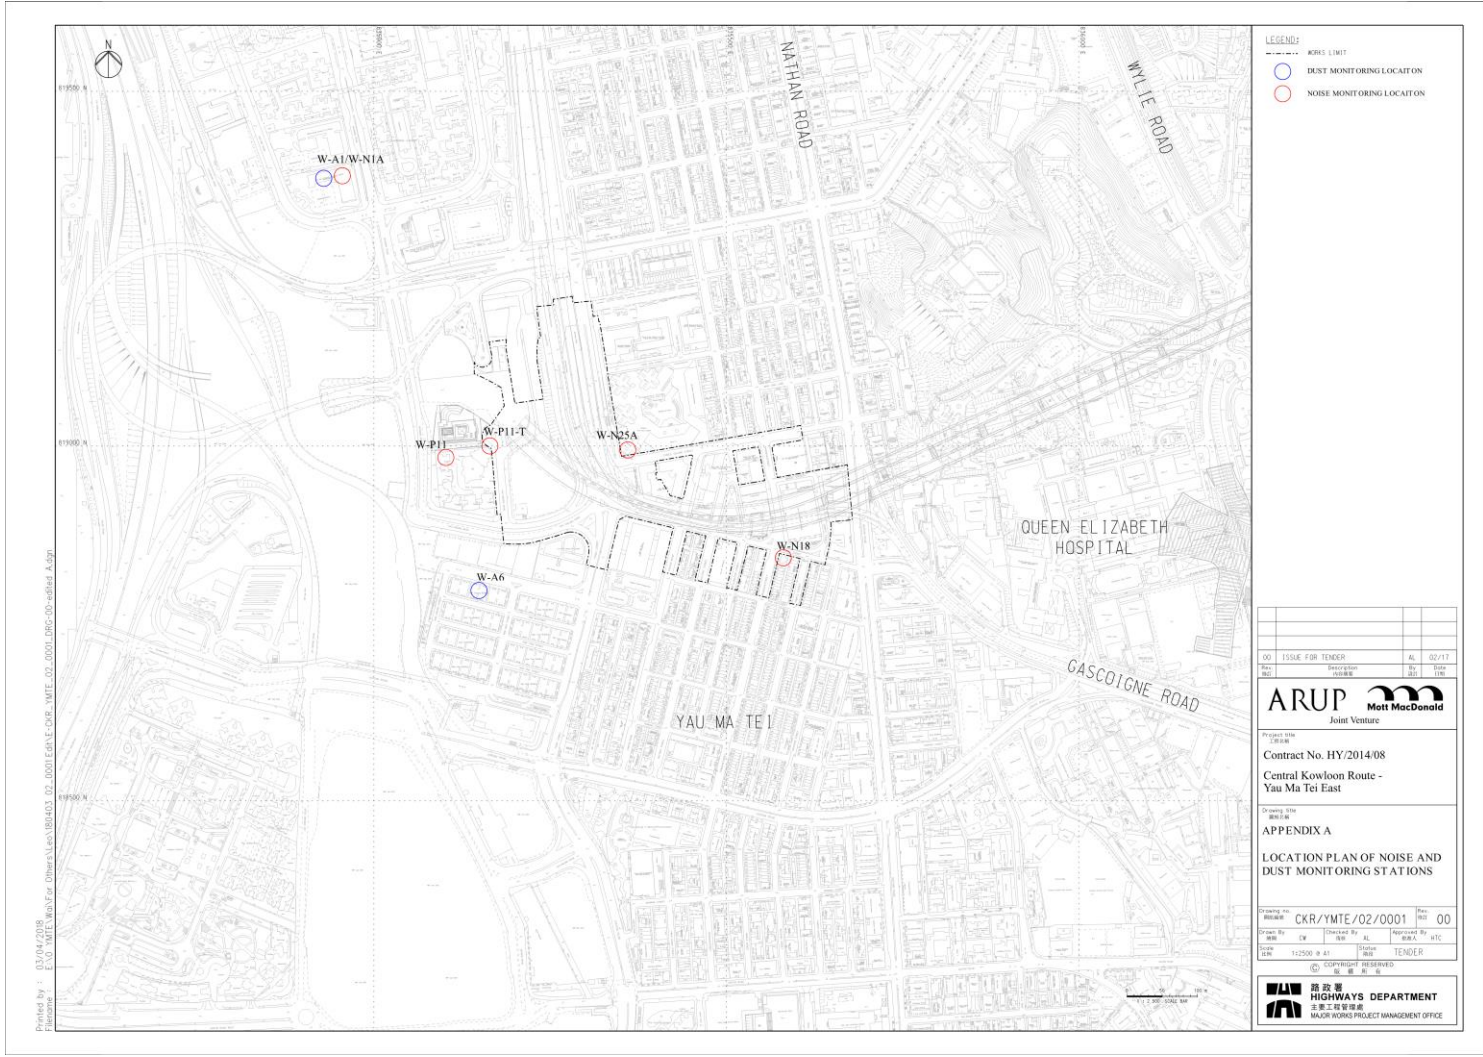
## Location Plan of Noise and Air Quality Monitoring Station

- 3.4.1. During the site visit, both of the original proposed dust monitoring locations were rejected due to the condition at The Coronation was not favorable for monitoring and the access was declined by the management office of Hong Kong Community College (HKCC) of PolyU. Two alternative air monitoring stations Yau Ma Tei Catholic Primary School (Hoi Wang Road) and Man Cheong Building had been proposed by ET and approved by IEC. 2 designated air monitoring locations were identified and agreed with IEC and EPD. Details of air monitoring stations are described in Table 3.3. The location plan of air quality monitoring stations is shown in Appendix K.

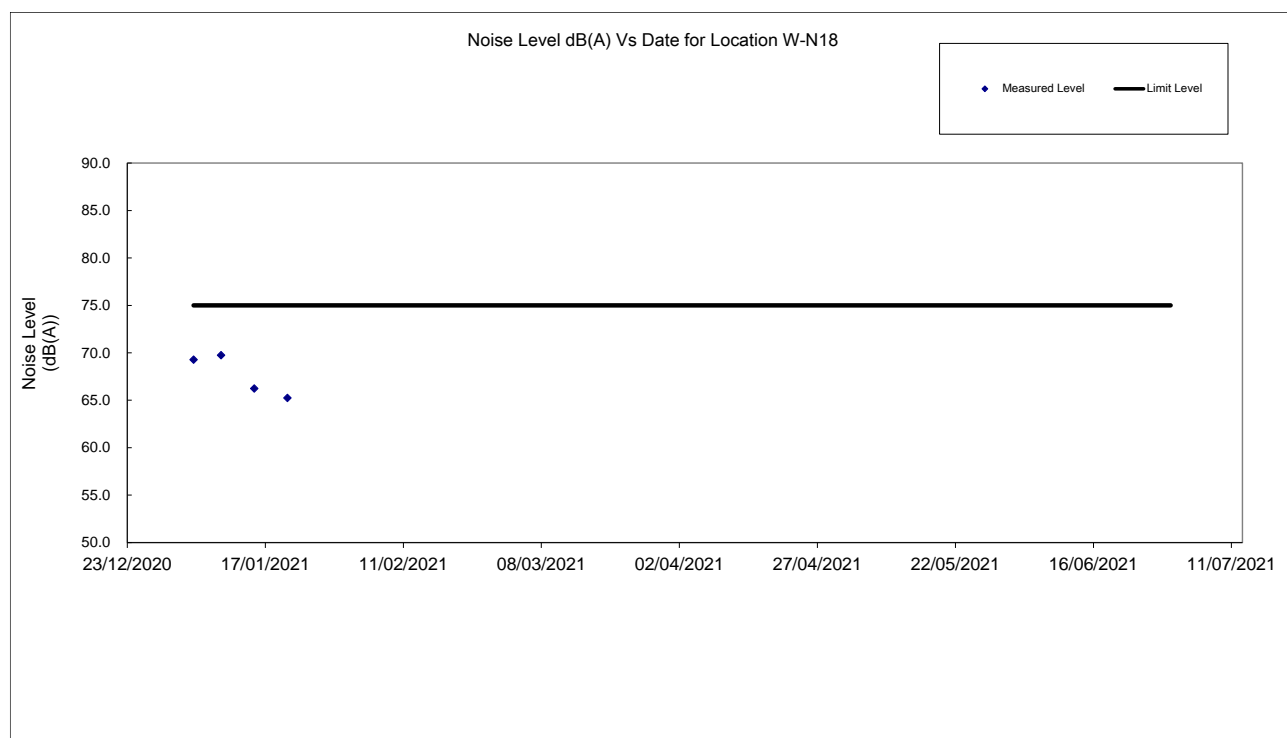
Figure 2: Graphical Illustration of Measured Noise Levels at W-N18

Remark: Noise monitoring at W-N18 was temporarily suspended from 27 January 2021 to 9 February 2021 as this station was located inside the specified area of lock down due to COVID-19.
