Central Kowloon Route

Yau Ma Tei West

Contract No. HY/2014/20

December 2021

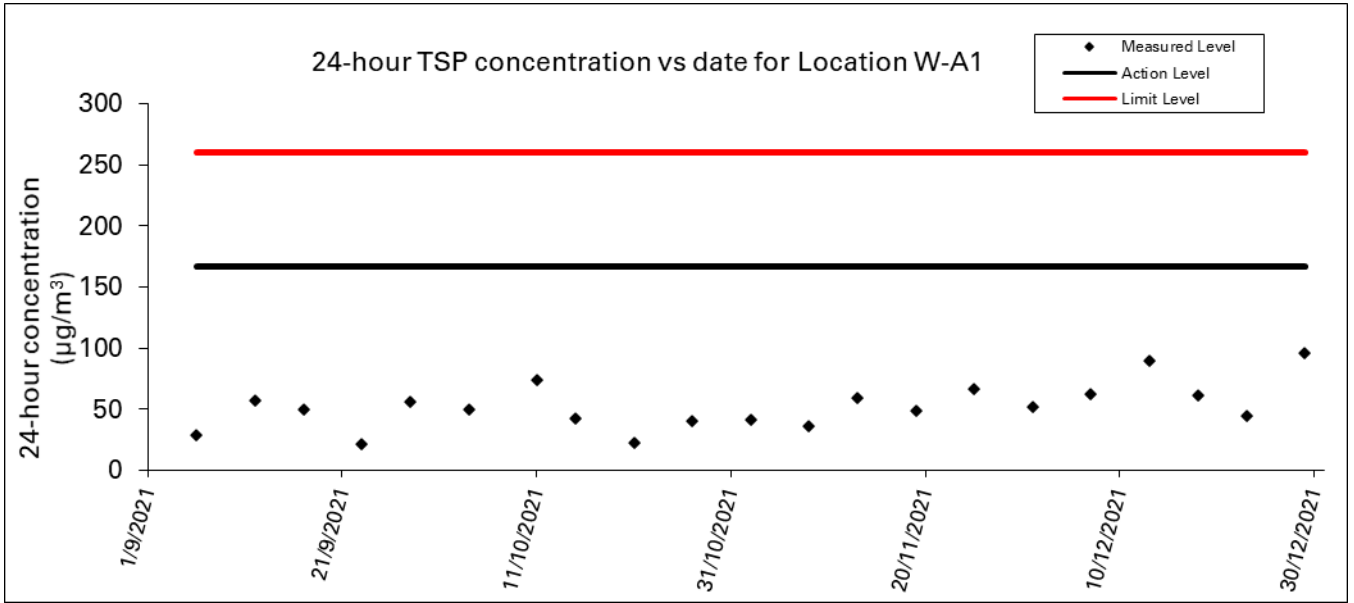
Figure 3: Graphical Illustration of Measured 24-hour TSP ($\mu\text{g}/\text{m}^3$) Levels at W-A1

Location: Yau Ma Tei Catholic Primary School (Hoi Wang Road) (W-A1)
 Monitoring date: 1, 7, 13, 18, 23 and 29 December 2021
 Parameter : TSP 24-hour
 Other Factors Nearby traffic
