**Central Kowloon Route**

**Yau Ma Tei West**

Monthly EM&A Report No. 67

(Period from 1 to 31 August 2024)

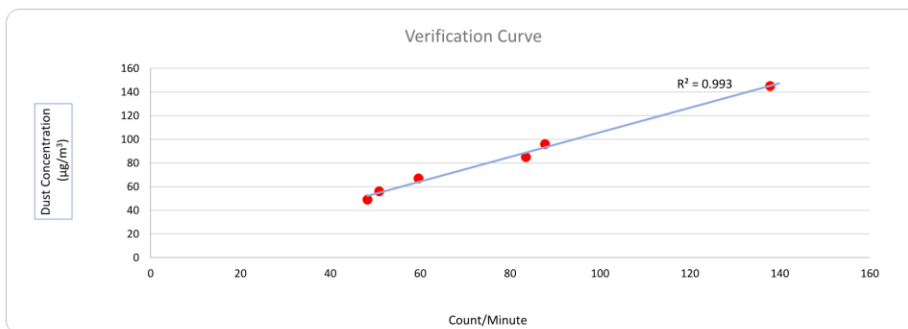
**Linear Regression of y on x**

Slope, K factor:	<b>1.0388</b>	Intercept:	<b>1.9869</b>	*Correlation Coefficient, R:	<b>0.9965</b>
Verification Test Result:	<b>Strong Correlation, Results were accepted.</b>			* If the Correlation Coefficient, R is <0.5. Checking and Re-verification are required.

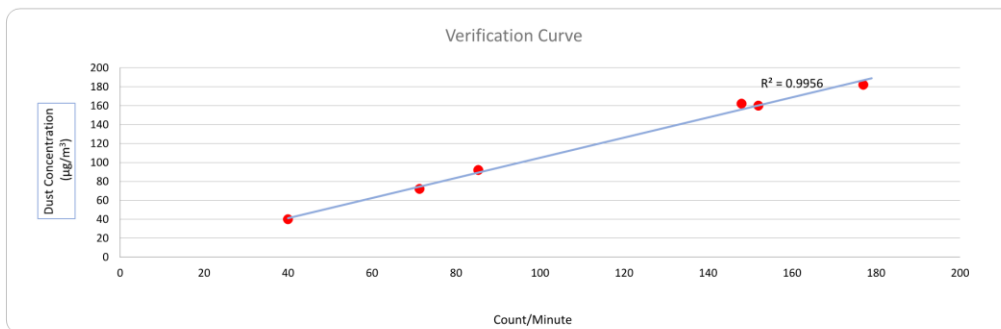
**Linear Regression of y on x**

Slope, K factor:	<u>1.0635</u>	Intercept:	<u>-1.4006</u>	*Correlation Coefficient,R:	<u>0.9978</u>
Verification Test Result:	<u>Strong Correlation, Results were accepted.</u>			* If the Correlation Coefficient, R is <0.5. Checking and Re-verification are required.

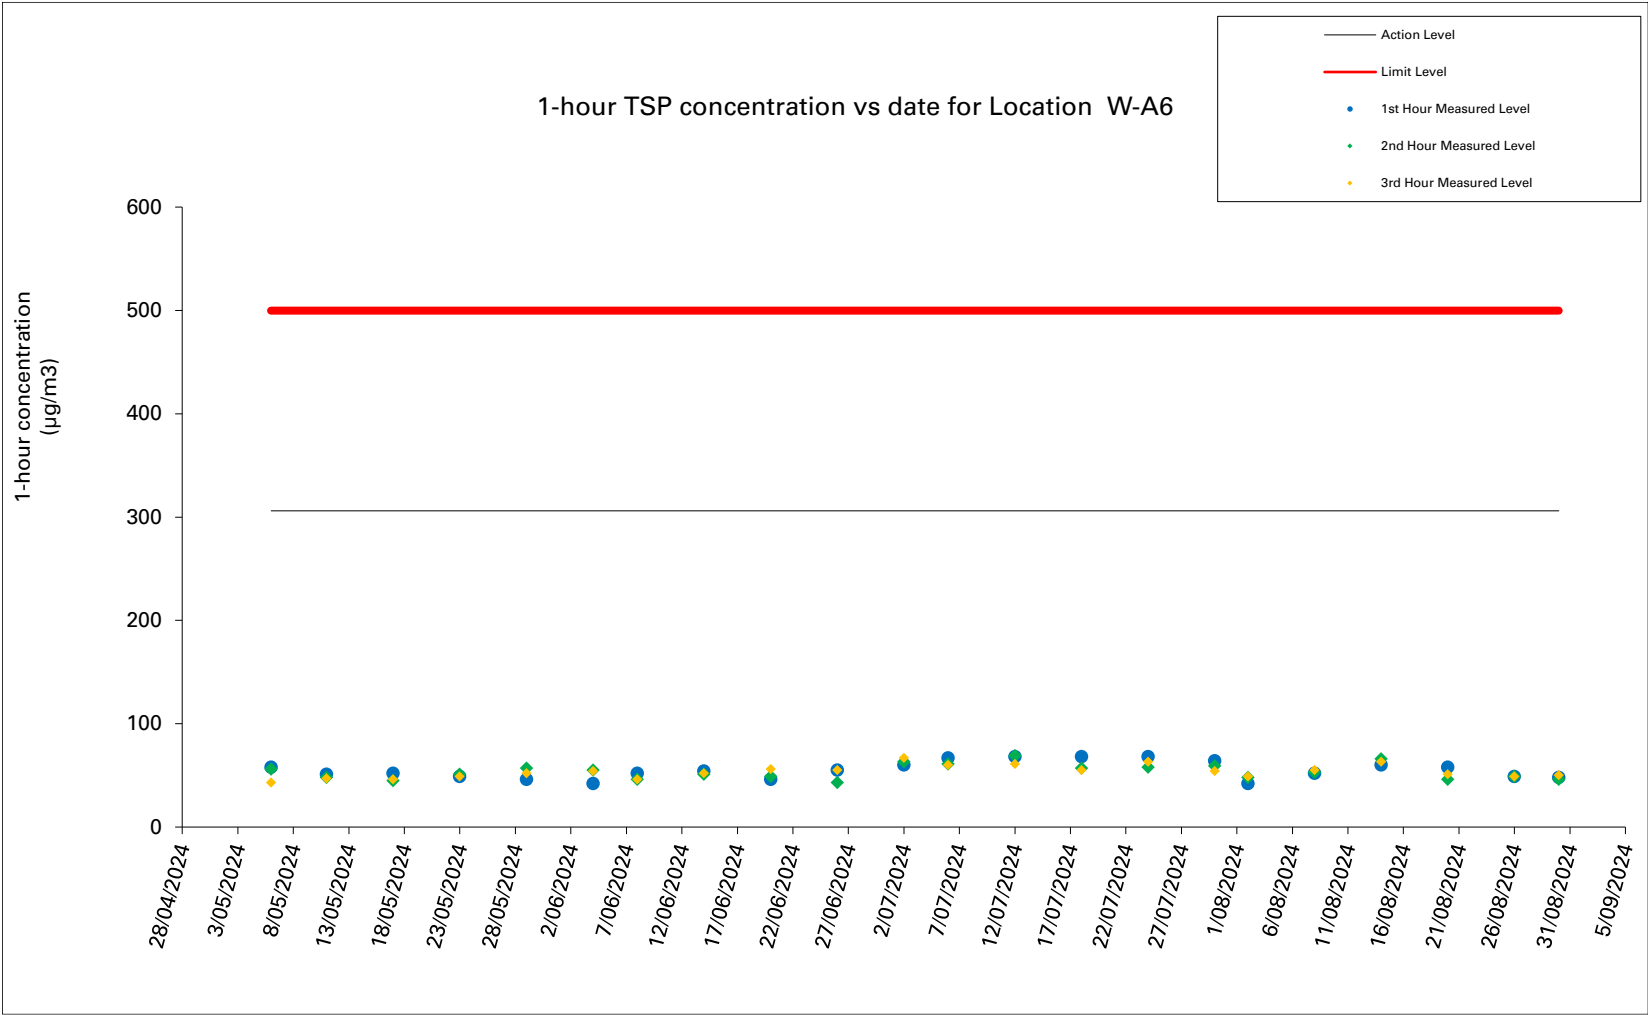
Figure 2: Graphical Illustration of Measured 1-hour TSP ( $\mu\text{g}/\text{m}^3$ ) Levels at W-A6

Date	1-hour TSP ( $\mu\text{g}/\text{m}^3$ )				
	Weather	Start Time	1 <sup>st</sup> Hour ( $\mu\text{g}/\text{m}^3$ )	2 <sup>nd</sup> Hour ( $\mu\text{g}/\text{m}^3$ )	3 <sup>rd</sup> Hour ( $\mu\text{g}/\text{m}^3$ )
2/8/2024	Fine	11:13	42	48	49
8/8/2024	Fine	11:16	52	53	55
14/8/2024	Fine	11:15	60	66	63
20/8/2024	Fine	11:18	58	46	51
26/8/2024	Fine	11:15	49	49	49
30/8/2024	Fine	11:15	48	46	50
Minimum: 42 $\mu\text{g}/\text{m}^3$			Maximum: 66 $\mu\text{g}/\text{m}^3$

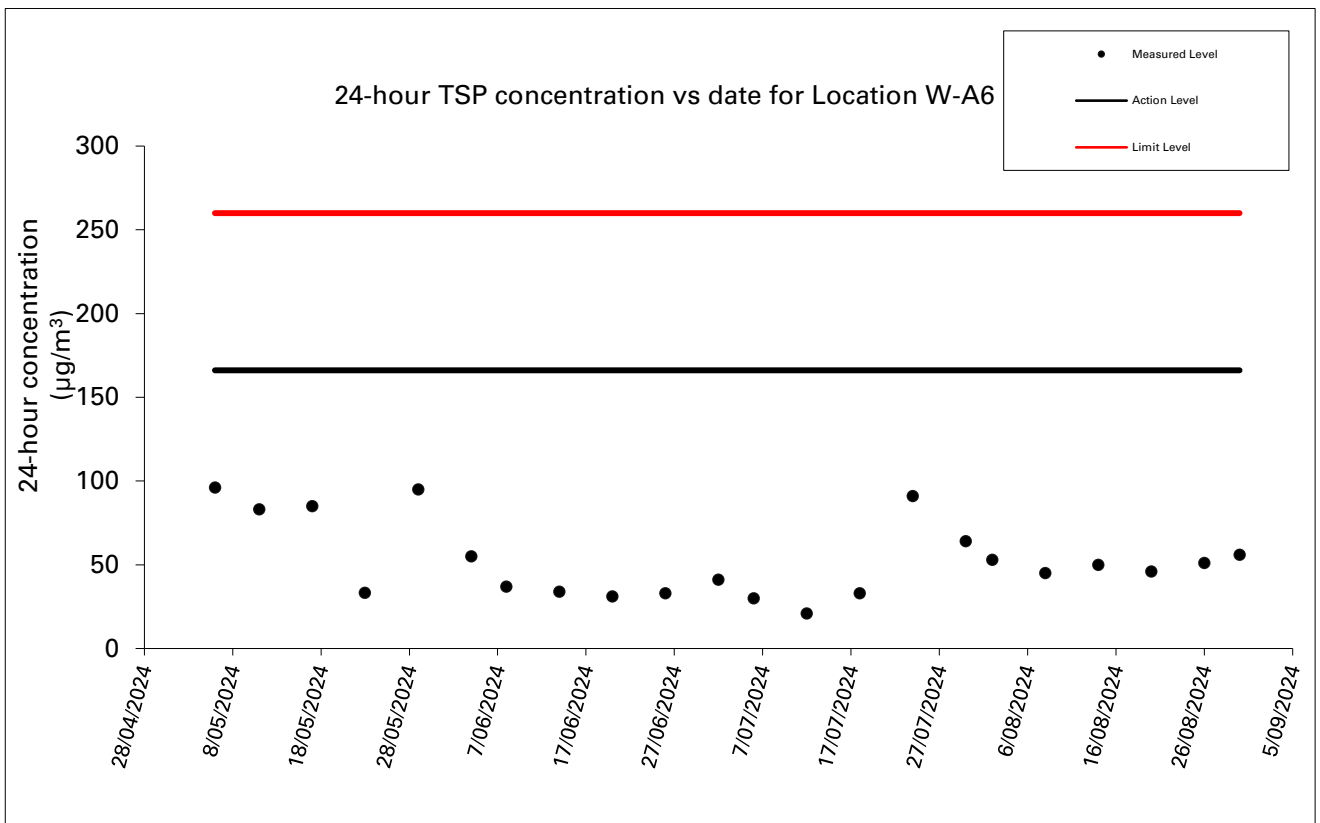
Figure 4: Graphical Illustration of Measured 24-hour TSP ( $\mu\text{g}/\text{m}^3$ ) Levels at W-A6

Start Date	Weather Condition	Elapse Time			Chart Reading			Avg Air Temp (°C)	Avg Atmospheric Pressure (hPa)	Flow Rate (m <sup>3</sup> /min)	Standard Air Volume (m <sup>3</sup> )	Filter Weight (g)		Particulate weight (g)	Conc. (µg/m <sup>3</sup> )	
		Initial	Final	Actual (min)	Min	Max	Avg					Initial	Final			
2/08/2024	Fine	11802.4	11826.4	1440.00	41	41	41.0	30.5	1009.2	0.98	1409	2.6925	2.7678	0.0753	53	
8/08/2024	Fine	11826.4	11850.4	1440.00	41	41	41.0	31.2	1008.6	0.98	1406	2.6965	2.7602	0.0637	45	
14/08/2024	Fine	11850.4	11874.4	1440.00	41	41	41.0	30.1	1005.1	0.97	1402	2.6731	2.7432	0.0701	50	
20/08/2024	Fine	11874.4	11898.4	1440.00	40	41	40.5	28.7	1008.3	0.87	1257	2.7329	2.7903	0.0574	46	
26/08/2024	Fine	11898.4	11922.4	1440.00	41	41	41.0	30.6	994.6	0.87	1247	2.7105	2.7739	0.0634	51	
30/08/2024	Fine	11922.4	11946.4	1440.00	40	40	40.0	27.9	1006.9	0.85	1230	2.6869	2.7556	0.0687	56	
											Maximum:	56 µg/m <sup>3</sup>		Minimum:	45 µg/m <sup>3</sup>

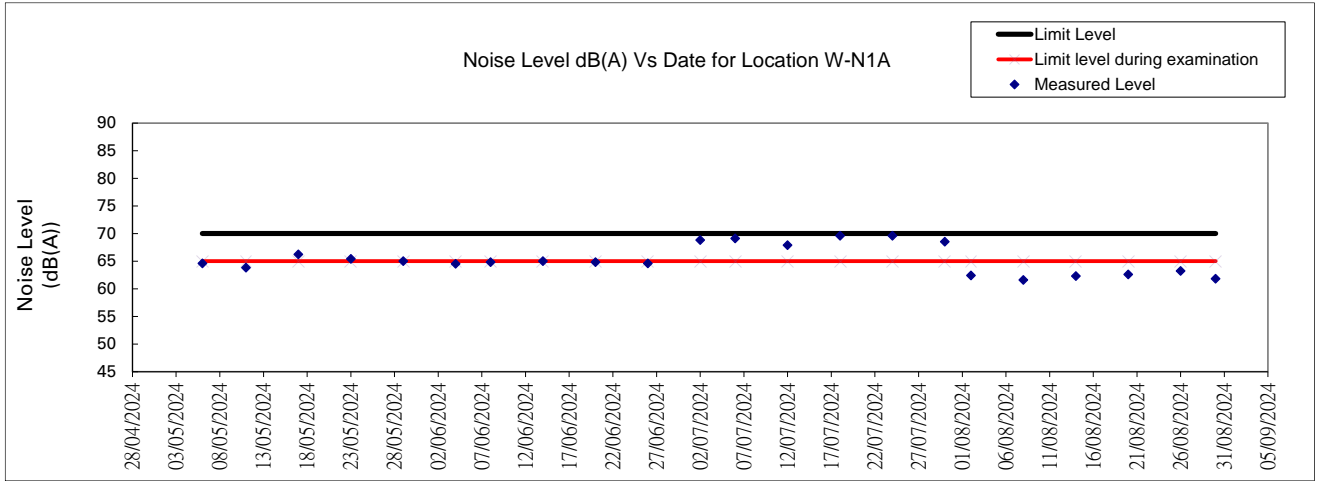
Figure 1: Graphical Illustration of Measured Noise Levels at W-N1A

Date	Weather	Start Time - End Time	$L_{eq}$	$L_{10}$	$L_{90}$	Wind speed (m/s)	Limit level
2/8/2024	Fine	9:41 - 10:11	64.7	68.8	62.2	2.5	75.0
8/8/2024	Fine	9:45 - 10:15	64.9	68.2	62.8	3.7	75.0
14/8/2024	Fine	13:50 - 14:20	66.2	67.8	62.7	3.9	75.0
20/8/2024	Fine	9:50 - 10:20	65.6	68.4	62.5	3.4	75.0
26/8/2024	Fine	9:48 - 10:18	64.1	68.8	62.5	2.7	75.0
30/8/2024	Fine	12:50 - 13:20	64.3	68.1	62.6	3.9	75.0
