Central Kowloon Route

Kai Tak West

Contract No. HY/2014/07

Central Kowloon Route
Works Contract HY/2014/07 –
Central Kowloon Route – Kai Tak West
Monthly EM&A Report for September 2024

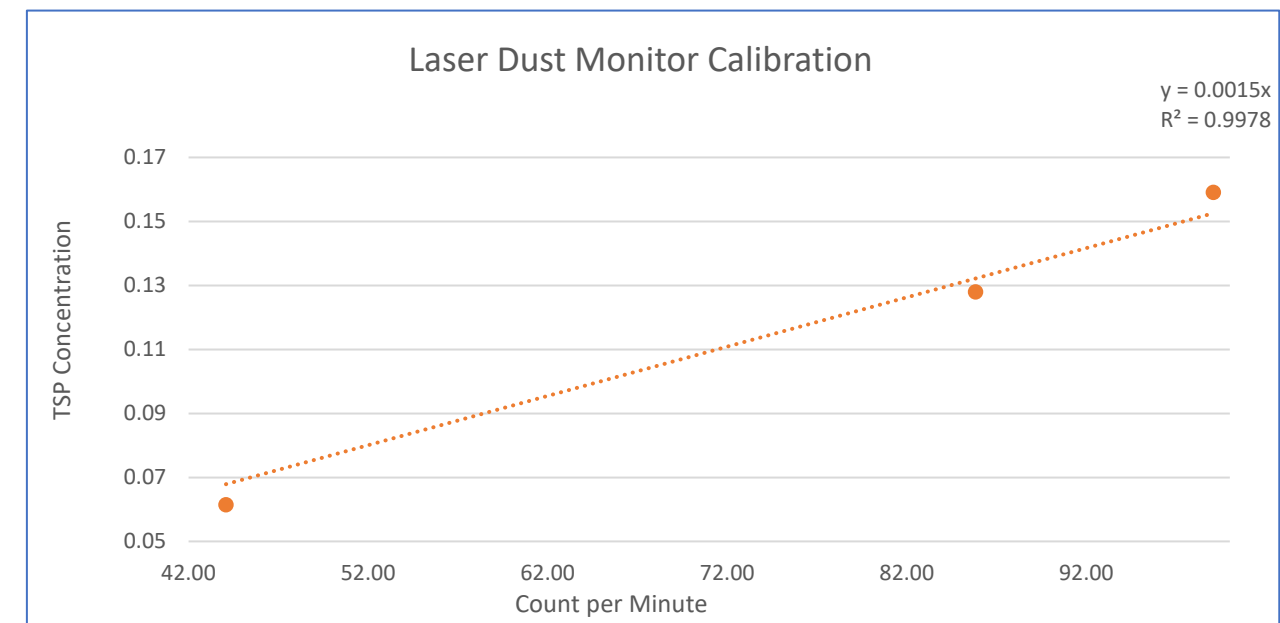
Type: Laser Dust Monitor
 Manufacturer/Brand: SIBATA
 Model No.: LD-3
 Equipment No.: A.005.11a
 Sensitivity Adjustment Scale Setting: 799 CPM

Hour	Count/Minute X-axis	Concentration (mg/m3) Y-axis
1	85.83	0.1280
2	44.08	0.0615
3	99.08	0.1590

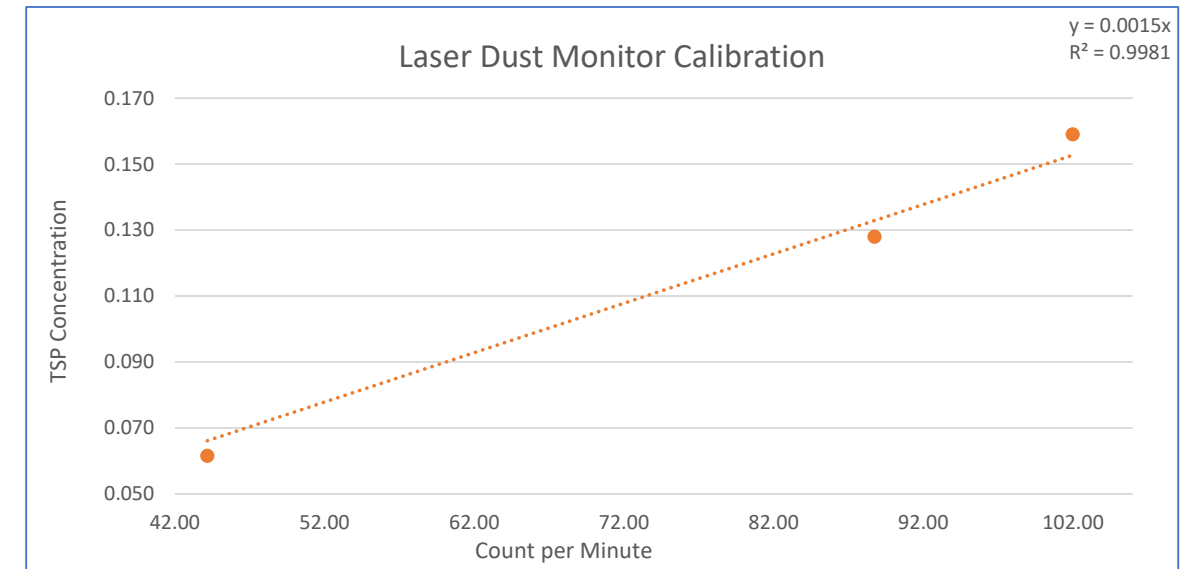
Type: Laser Dust Monitor
 Manufacturer/Brand: SIBATA
 Model No.: LD-3B
 Equipment No.: A.005.13a
 Sensitivity Adjustment Scale Setting: 643 CPM

Hour	Count/Minute	Concentration (mg/m3)
	X-axis	Y-axis
1	88.75	0.1280
2	44.17	0.0615
3	102.00	0.1590

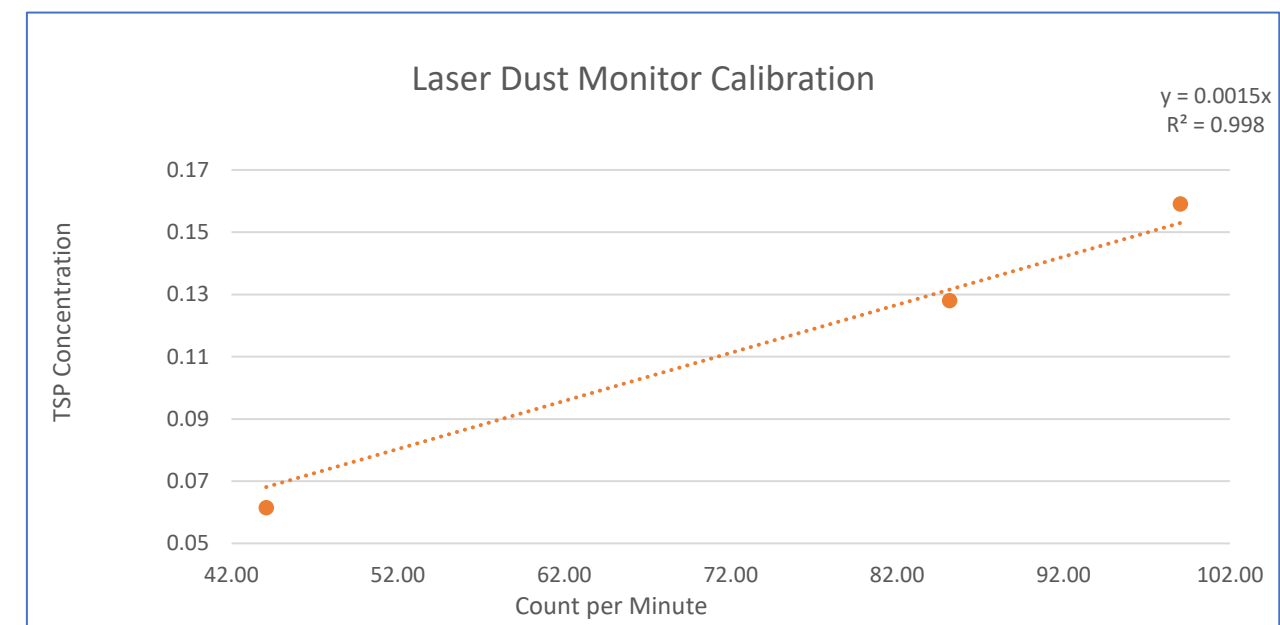
Type: Laser Dust Monitor
 Manufacturer/Brand: SIBATA
 Model No.: LD-3B
 Equipment No.: A.005.16a
 Sensitivity Adjustment Scale Setting: 521 CPM

Hour	Count/Minute X-axis	Concentration (mg/m3) Y-axis
1	85.17	0.1280
2	44.08	0.0615
3	99.03	0.1590

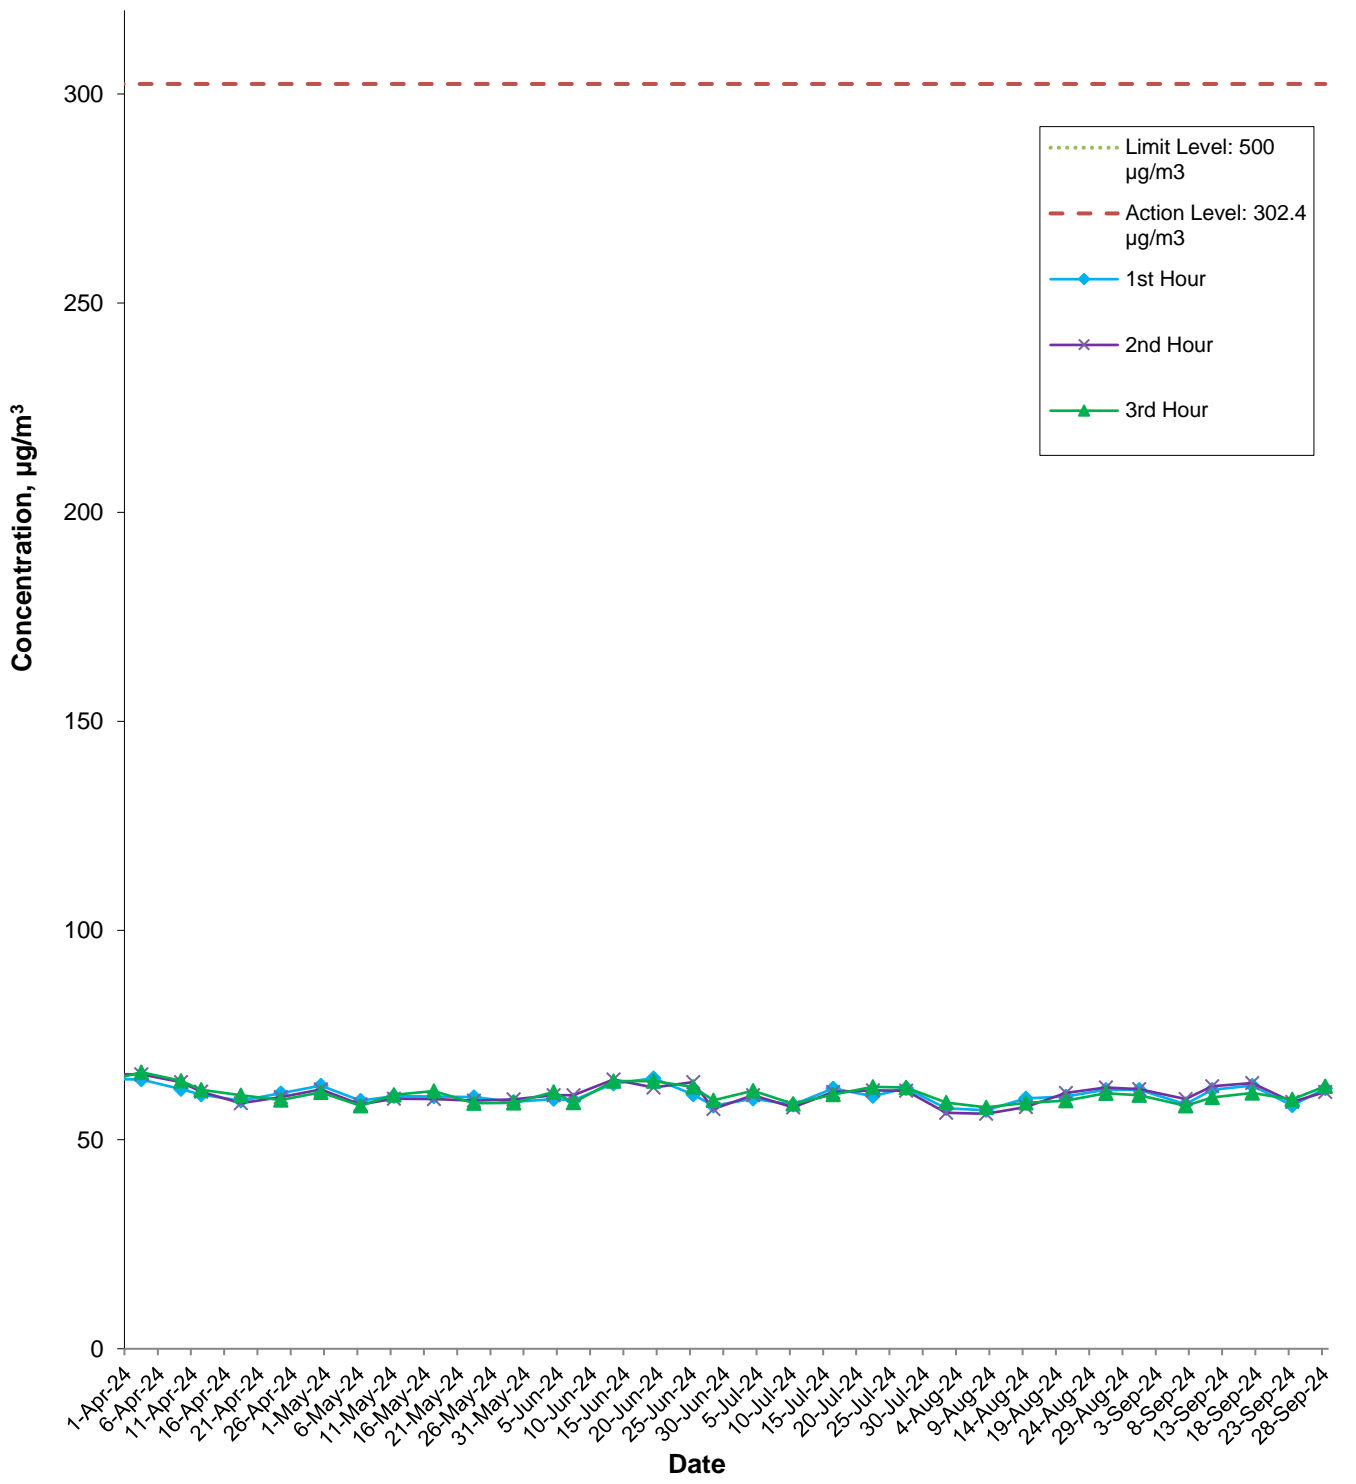
E-A14a

Date	Start Time	Weather	1st Hour	2nd Hour	3rd Hour
			Conc. ($\mu\text{g}/\text{m}^3$)	Conc. ($\mu\text{g}/\text{m}^3$)	Conc. ($\mu\text{g}/\text{m}^3$)
7-Sep-24	13:00	Sunny	58.5	59.7	58.1
11-Sep-24	13:05	Sunny	61.9	62.8	60.1
17-Sep-24	13:05	Sunny	62.9	63.5	61.2
23-Sep-24	13:00	Cloudy	58.2	59.0	59.6
28-Sep-24	10:40	Fine	62.2	61.4	62.8
				Average	60.8
				Min	58.1
				Max	63.5

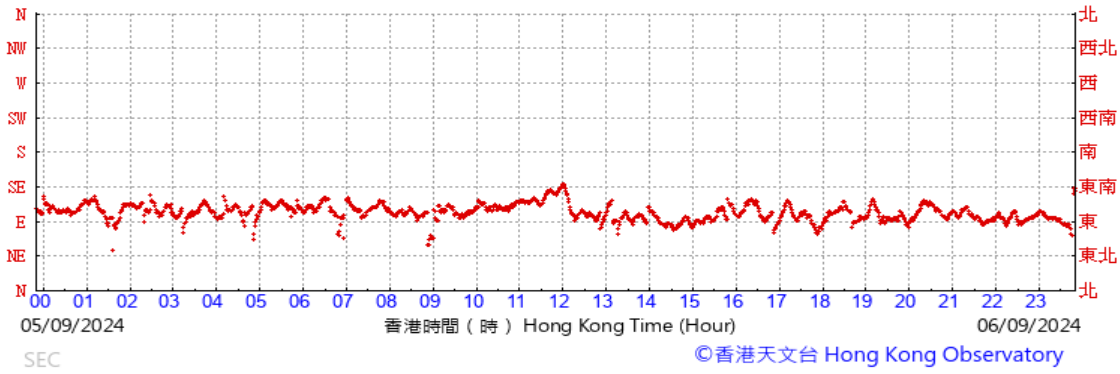
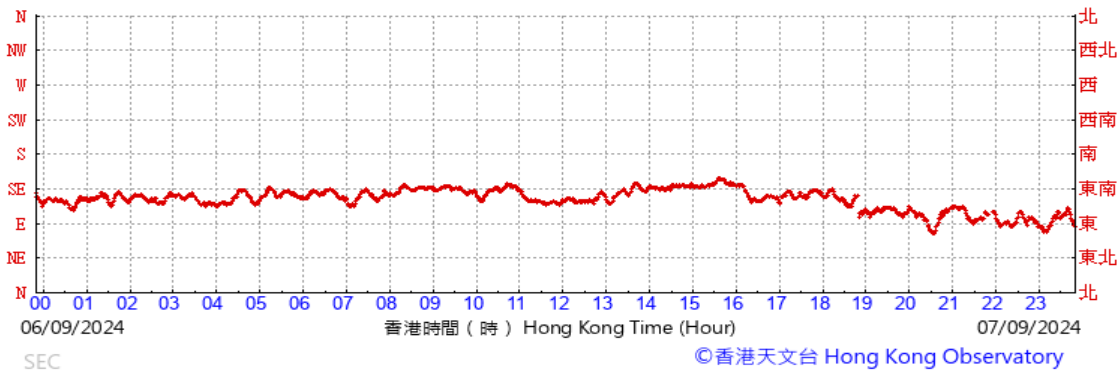
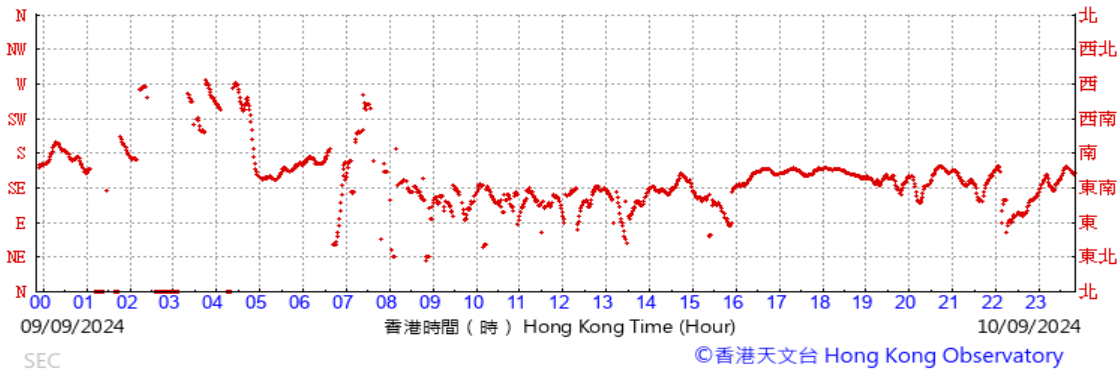
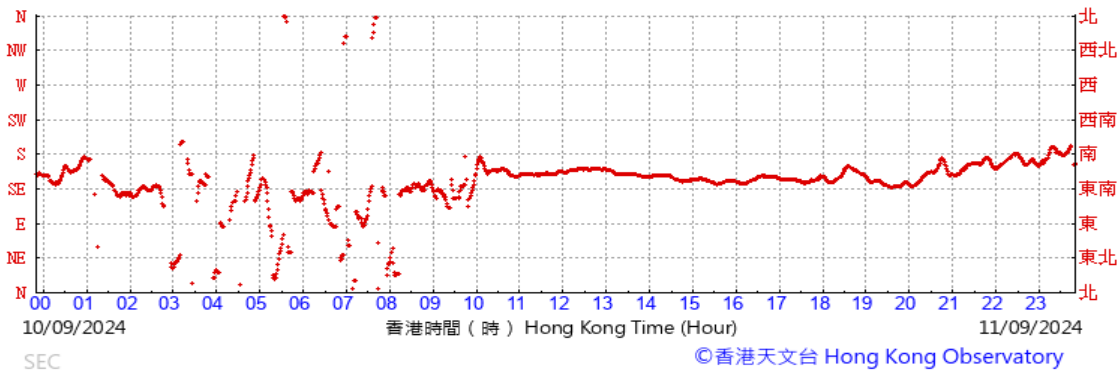
Data of Wind Direction Extracted from Kai Tak Wind Station of the Hong Kong Observatory September 2024

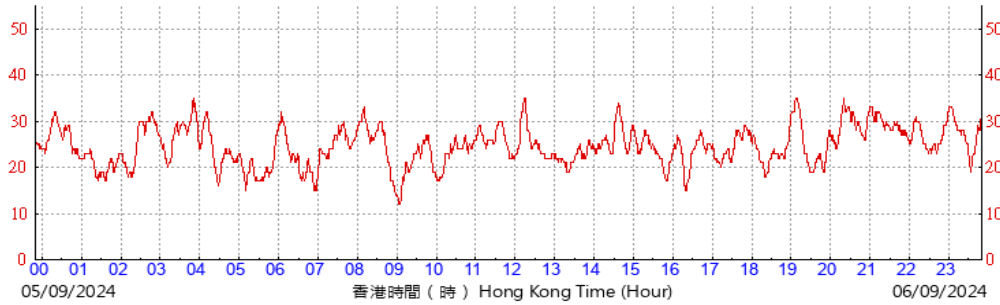
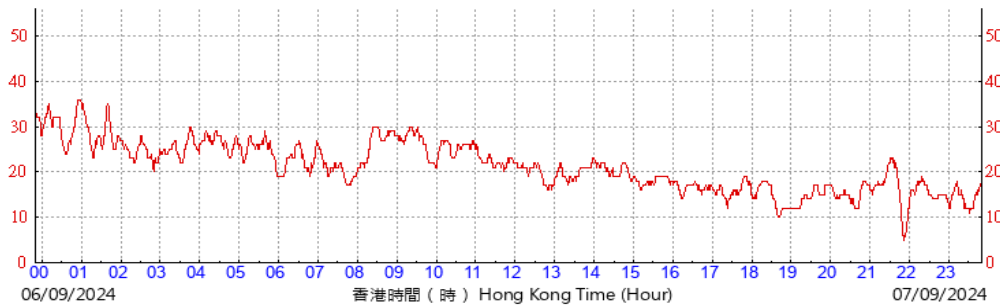
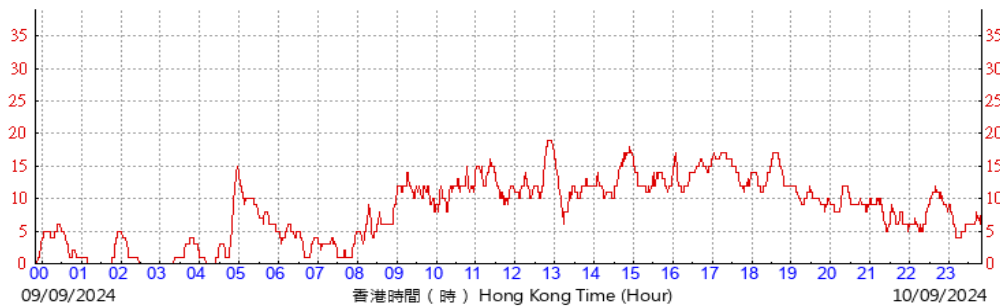
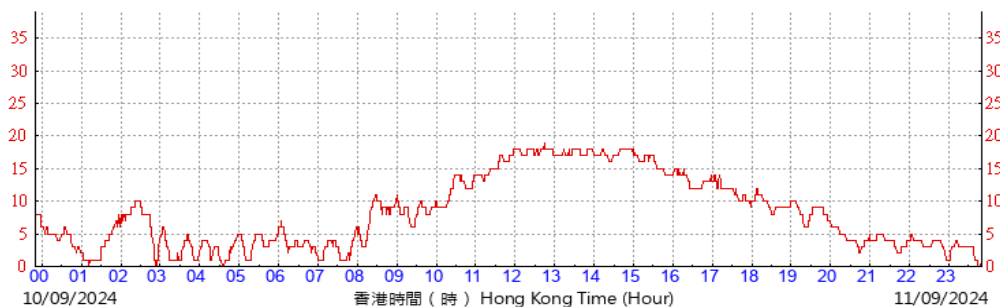
Data of Wind Speed Extracted from Kai Tak Wind Station of the Hong Kong Observatory September 2024
