**Agreement No. CE 59/2015 (EP)
Environmental Team for
Tseung Kwan O – Lam Tin Tunnel
Design and Construction**

**Monthly Environmental Monitoring and
Audit Report for
April 2024
(Version 1.0)**

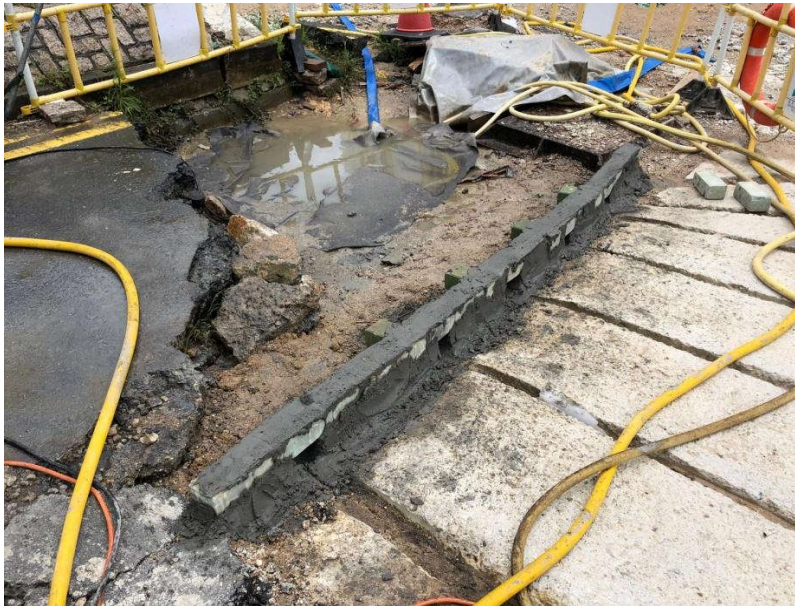
Surface runoff collection

Height difference between the road and site area to form a natural flow. Sump pit was provided for wastewater collection.

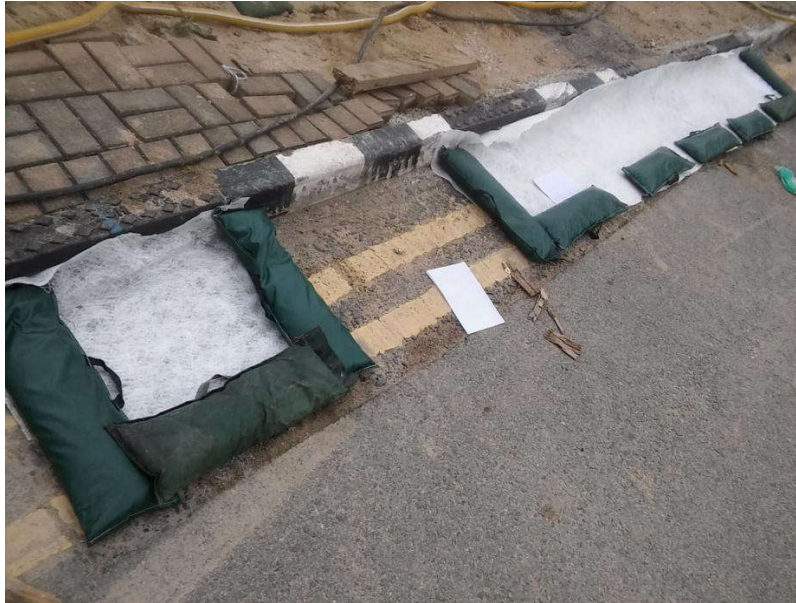
Gully Protection

Gully were protected and covered by geotextile.

5.27 The existing manhole cover are covered with geotextile to prevent muddy water from entering the existing U-channels along the side of Po Shun Road. Manhole inspection is carried out by taking silt measurement regularly in case if silt enters the channel, and silt shall be removed from the manhole if silt were found.

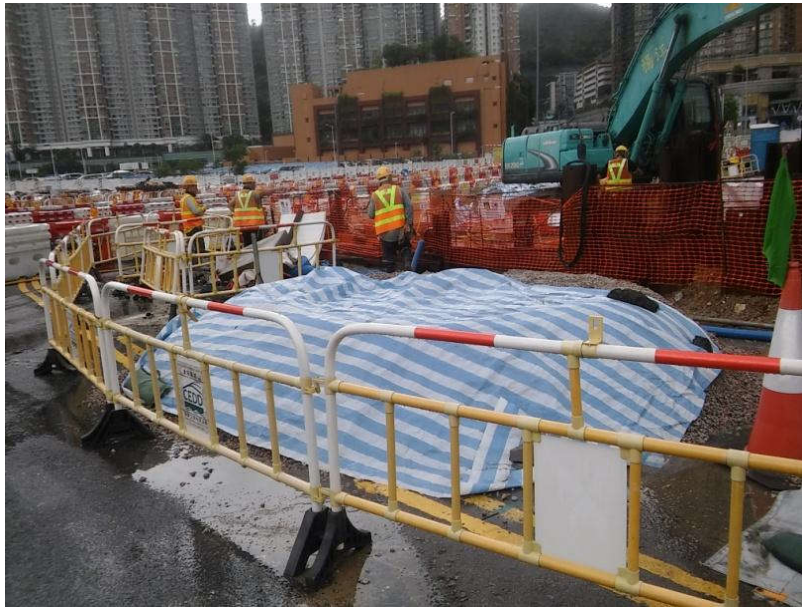
Stockpile Cover

Stockpile Should be proper cover with tarpaulin.
