**Agreement No. CE 59/2015 (EP)
Environmental Team for
Tseung Kwan O – Lam Tin Tunnel
Design and Construction**

**Monthly Environmental Monitoring and
Audit Report for
June 2024
(Version 1.0)**

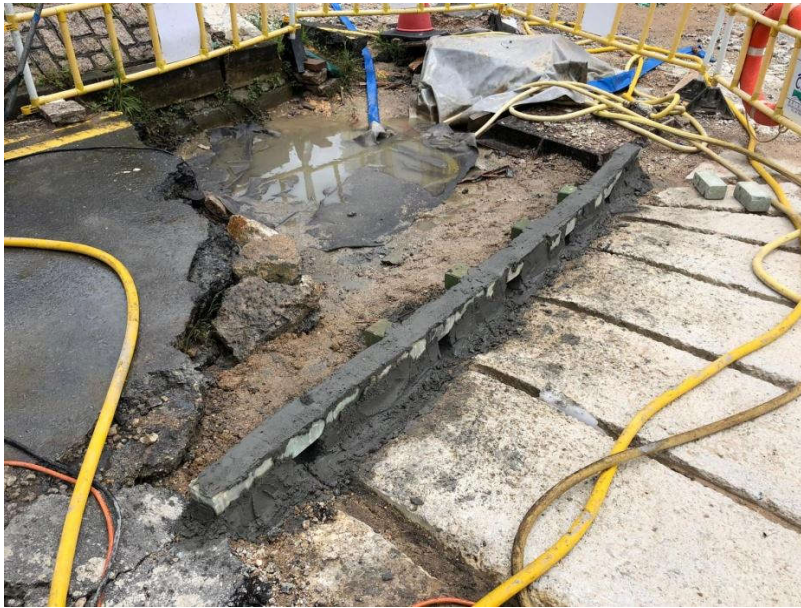
Surface runoff collection

Height difference between the road and site area to form a natural flow. Sump pit was provided for wastewater collection.
