**Agreement No. CE 59/2015 (EP)
Environmental Team for
Tseung Kwan O – Lam Tin Tunnel
Design and Construction**

**Monthly Environmental Monitoring and
Audit Report for
July 2024
(Version 1.0)**

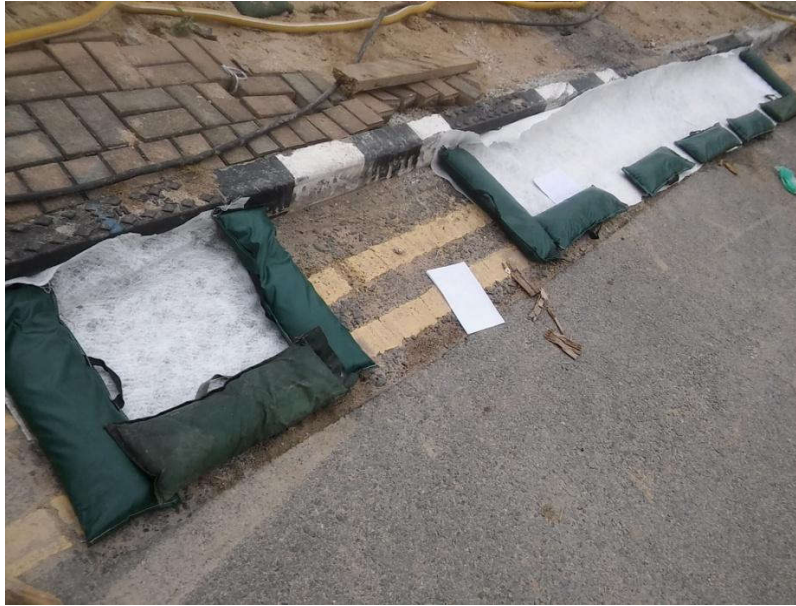
Gully Protection

Gully were protected and covered by geotextile.
