Civil Engineering and Development Department

**Agreement No. CE 59/2015 (EP)
Environmental Team for
Tseung Kwan O – Lam Tin Tunnel
Design and Construction**

**Monthly Environmental Monitoring and
Audit Report for
December 2024**

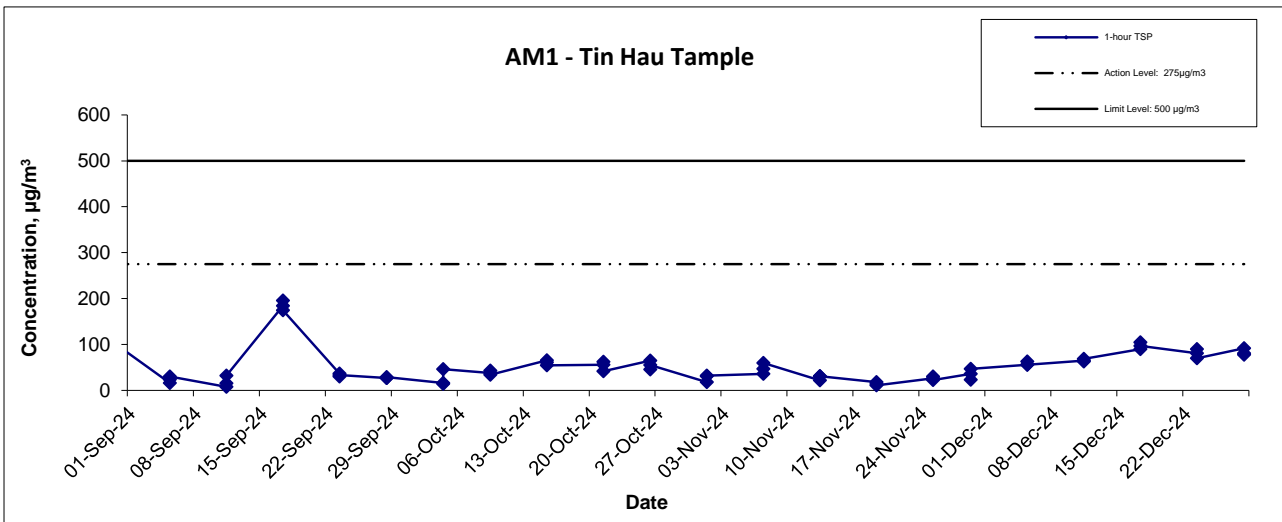
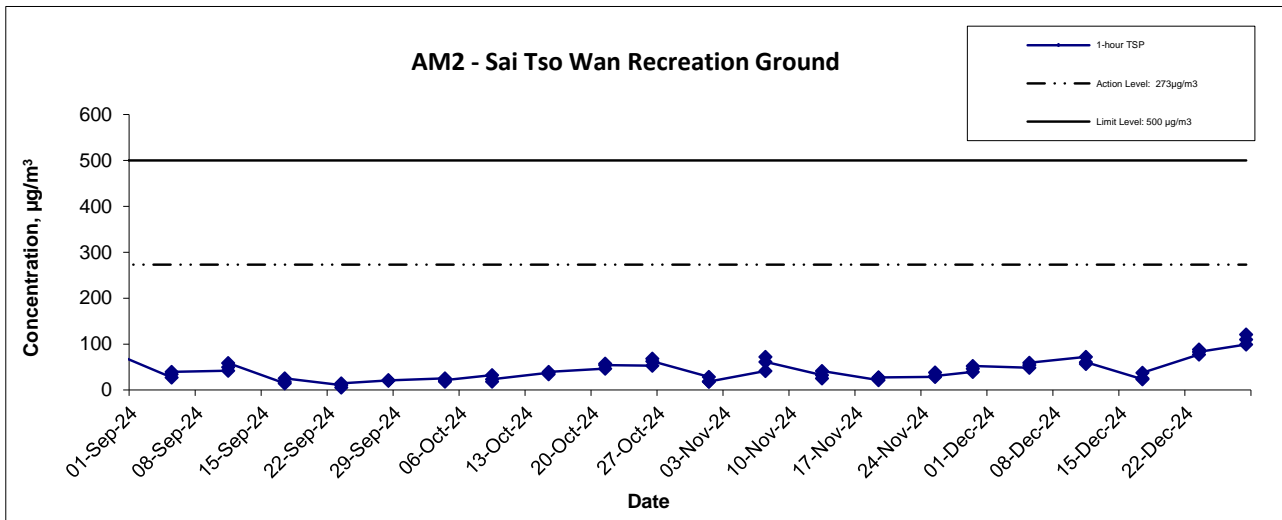
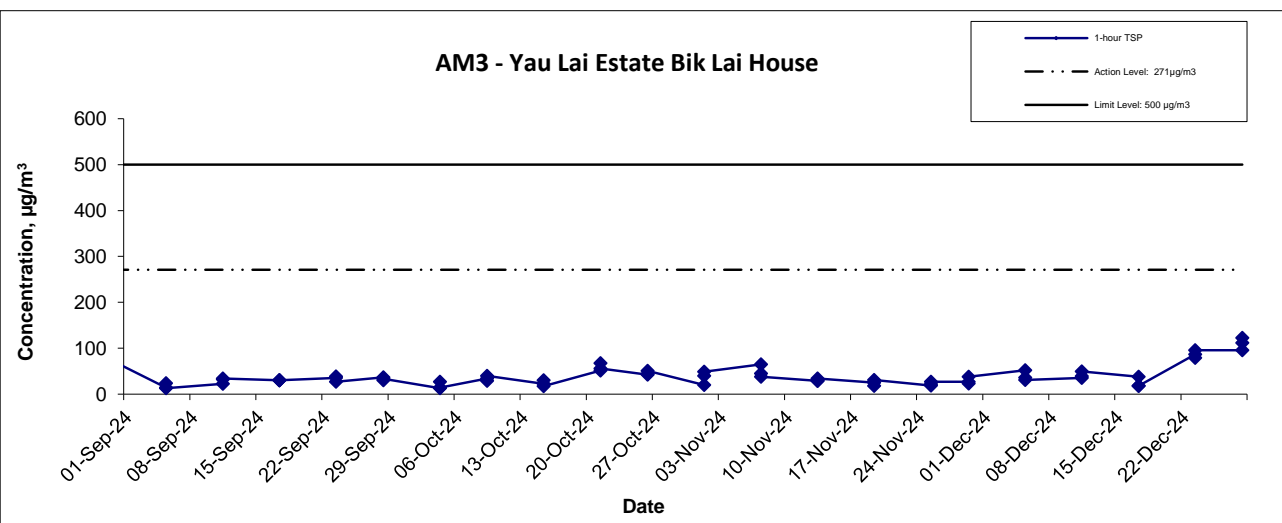
1-hr TSP Concentration Levels

Agreement No. CE/59/2015 (EP) Environmental Team for Tseung Kwan O - Lam Tin Tunnel - Design and Construction Graphical Presentation of 1-hour TSP Monitoring Results	Scale	N.T.S	Project No.	MA16034
	Date	Dec-24	Appendix	E

- 3.21 No Action/Limit Level exceedance was recorded for 1-hour TSP monitoring.
- 3.22 No Action Level and No Limit Level exceedance was recorded for 24-hour TSP monitoring.
- 3.23 The air temperature, precipitation and the relative humidity data was obtained from Hong Kong Observatory where the wind speed and wind direction were recorded by the installed Wind Anemometer at rooftop of Yau Lai Estate Bik Lai House (41/F). The location is shown in **Figure 2**. This weather information for the reporting month is summarized in **Appendix C**.
- 3.24 The monitoring data and graphical presentations of 1-hour and 24-hour TSP monitoring results are shown in **Appendix E** and **Appendix F** respectively.
- 3.25 According to our field observations, the major dust source identified at the designated air quality monitoring stations are as follows:

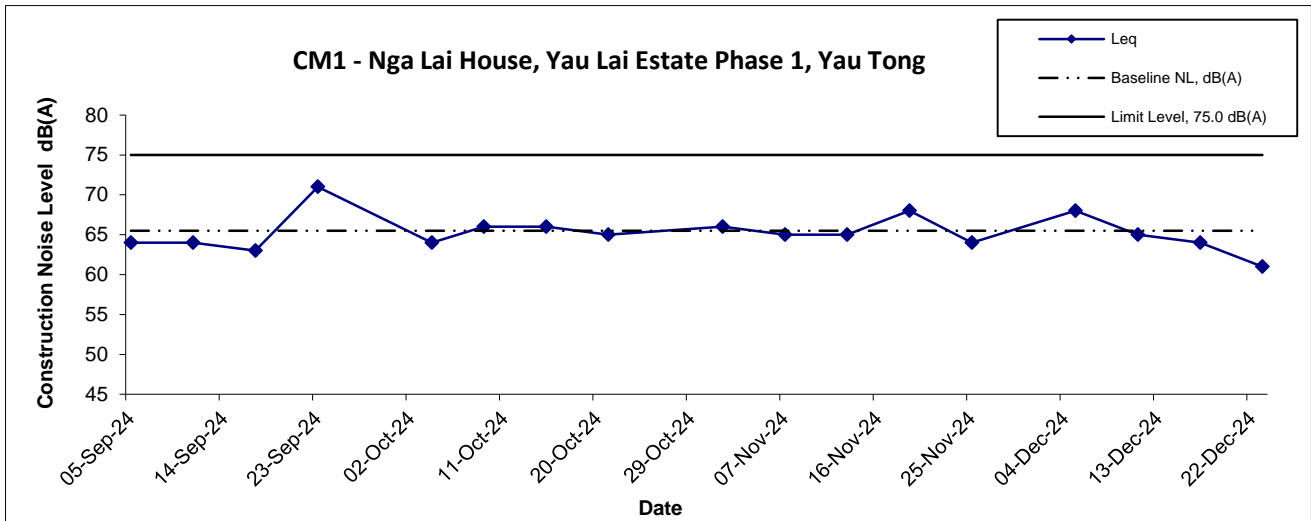
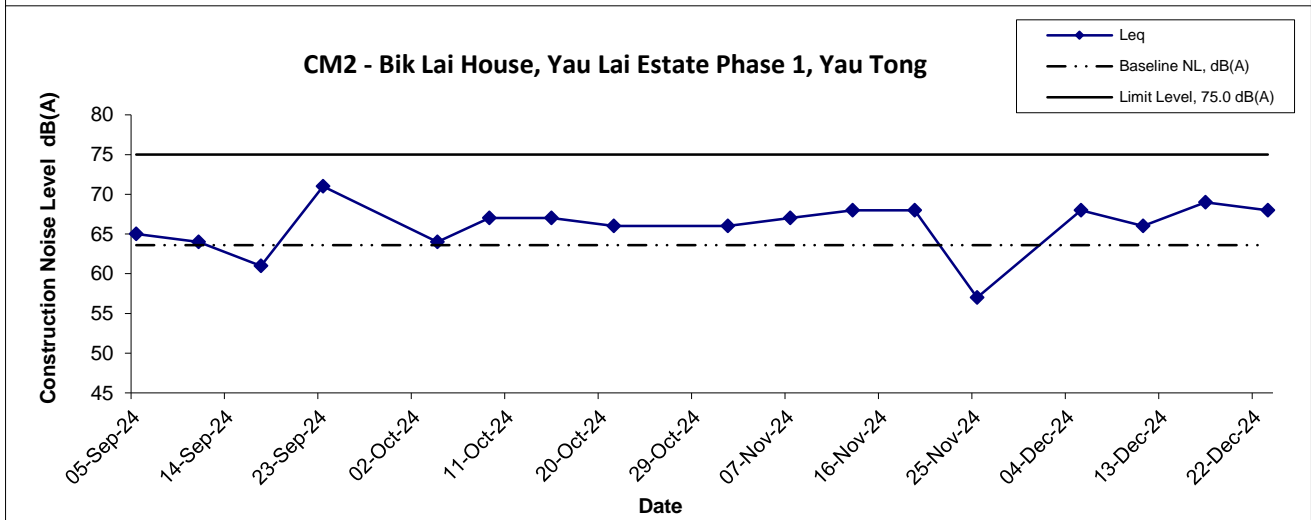
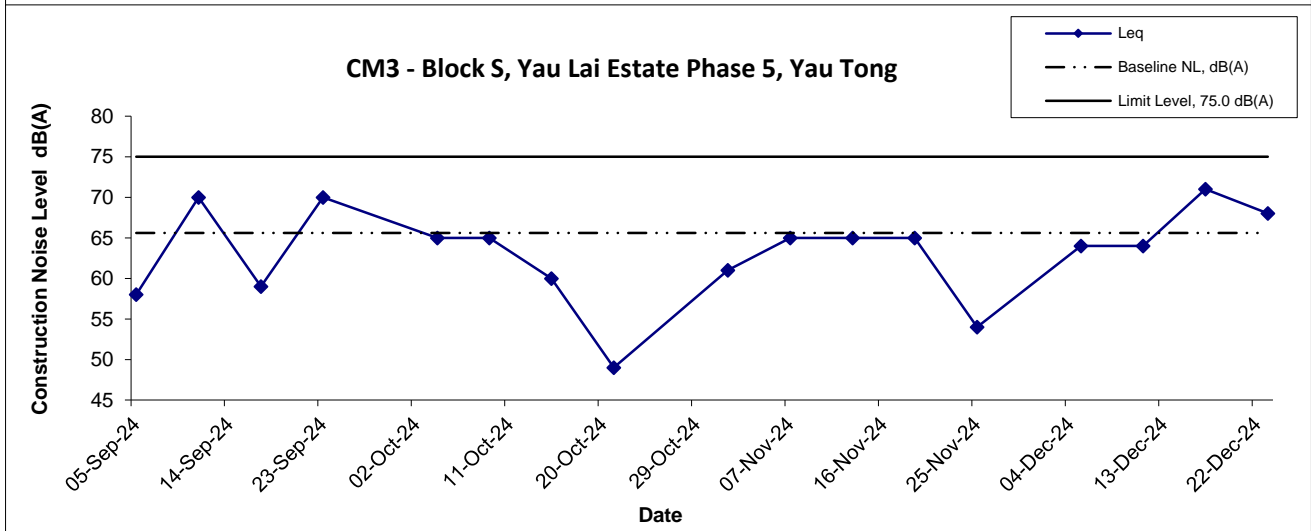
Noise Levels

Title Agreement No. CE/59/2015 (EP) Environmental Team for Tseung Kwan O - Lam Tin Tunnel - Design and Construction Graphical Presentation of Construction Noise Monitoring Results	Scale N.T.S	Project No. MA16034	
	Date Dec-24	Appendix G

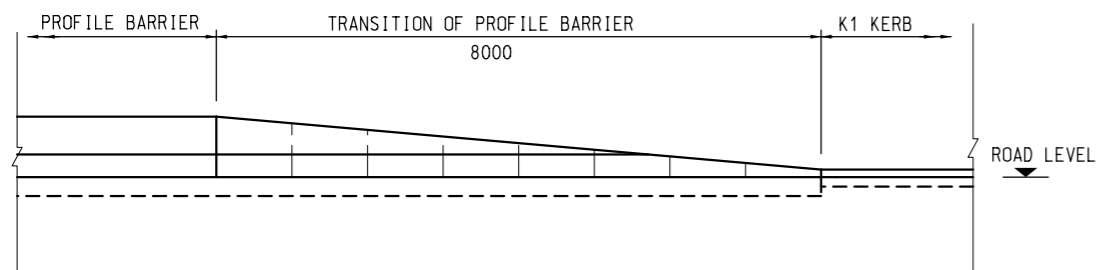
PROFILE BARRIER TERMINATION SECTION
SCALE 1 : 200

ELEVATION OF CONCRETE PROFILE BARRIER TERMINATION
SCALE 1 : 100
