Contract No. SS H504
Design and
Construction of Chai
Wan Government
Complex and Vehicle
Depot

30th Monthly EM&A Report **Yau Lee Construction Co, Ltd**2024-06-06

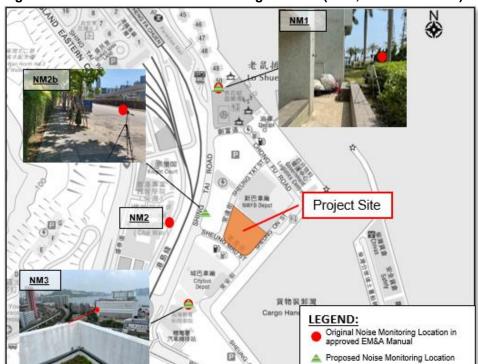
Figure 3-1 Location of Noise Monitoring Stations (NM1, NM2b and NM3)

Due to the adjustment of the location of NM2a to NM2b, the measured noise level at NM2b would represent the noise levels at NM2.
