# Environmetnal Team Services for Contract No. SS H504 Design and Construction of Chai Wan Government Complex and Vehicle Depot

34<sup>th</sup> Monthly EM&A Report (August 2024)

Contract No. SS H504 Design and Construction of Chai Wan Government Complex and Vehicle Depot

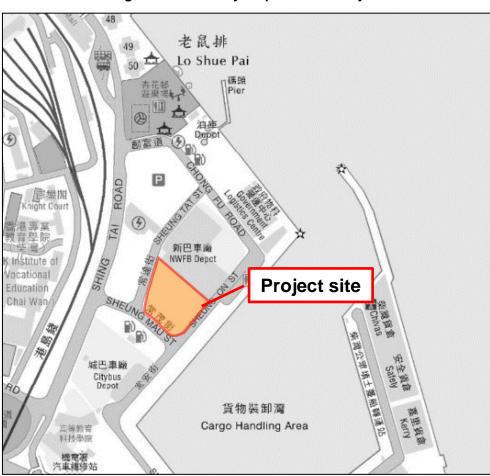
Figure 1-1 A layout plan of the Project

2.2.1 The scope of works of the Project, which is a Designated Project under the EIA Ordinance (EIAO), will construct joint user building comprising the government office, store, laboratory, transport pool and vehicle depot facilities in Chai Wan District. The Site is bounded by NWFB Depot to the north, Sheung On Street to the east, Sheung Mau Street to the south and Sheung Tat Street to the west. A layout plan of the Project is provided in **Figure 1-1**.

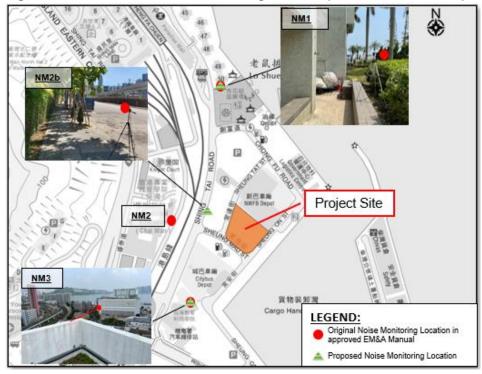
Figure 3-1 Location of Noise Monitoring Stations (NM1, NM2b and NM3)

To respond to the comment raised by EPD on monitoring location of NM2a by email dated 23 May 2022 and site meeting on 6 June 2022, the monitoring location of NM2a was adjusted to the pedestrian road at Shing Tai Road (NM2b) which is located between project site and original noise monitoring location, Hong Kong Institute of Vocational Education (Chai Wan) - Academic Block (NM2). Compared with NM2a, NM2b is far away from the traffic light and therefore should be able to minimise the traffic noise issue. This arrangement was started from 28 June 2022 and has been agreed by the Independent Environmental Checker (IEC). Noise measurement at NM2b will be considered as free-field and a correction of +3dB(A) would be made to the noise monitoring results.

Due to the adjustment of the location of NM2a to NM2b, the measured noise level at NM2b would represent the noise levels at NM2.

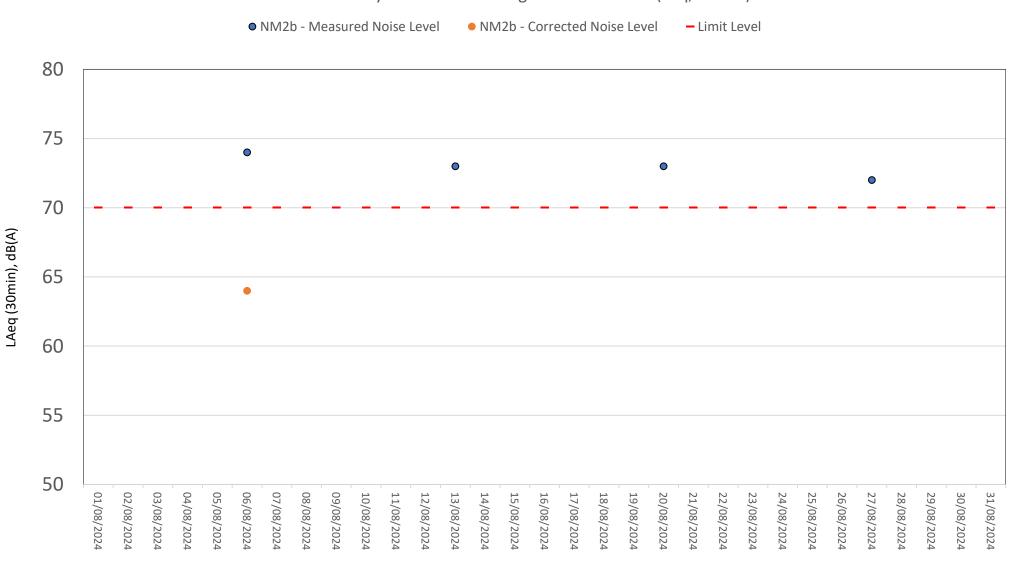
### Normal Weekdays Noise Monitoring Results at NM2b(Leq, 30min)

^On 13, 20 and 27 August 2024, the measured noise levels of NM2b exceeded the limit level of 70dB(A). However, they were lower than the baseline level of 73.4 dB(A). Therefore, they are not considered as an limit level exceedance.

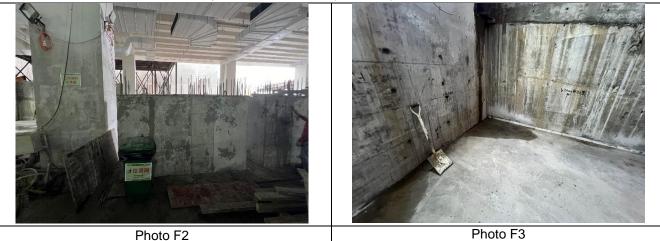
- 1. The segregation area was provided. (Photo F2)
- 2. The accumulation of waste was disposed and cleaned. (Photo F3)

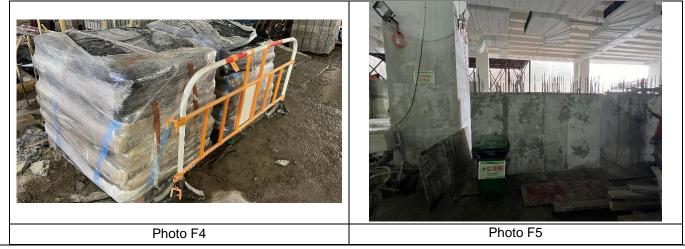
- 1. The dry PFA was covered by shelter on the top and 3 sides. (Photo F4)
- 2. The segregation area of C&D waste and general waste was provided. (Photo F5)

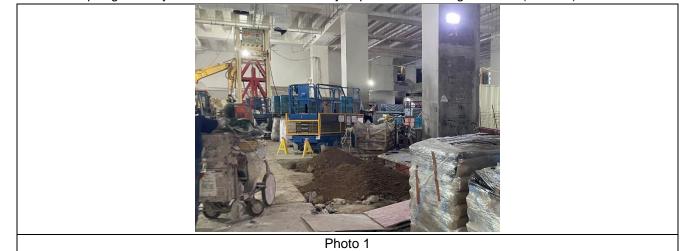
The stockpiling of dusty materials without covered by impervious sheeting was found. The Contractor has been reminded that stockpiling of dusty material should be covered by impervious sheeting.

1. The stockpiling of dusty materials without covered by impervious sheeting is found. (Photo 1)

1. The Contractor has been reminded that stockpiling of dusty materials should be covered by impervious sheeting entirely.

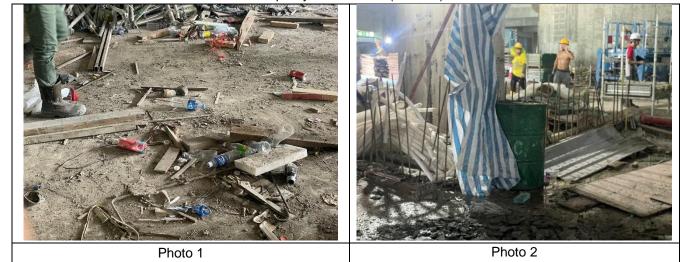
- General wastes were identified on the floor without proper disposal and collection. The Contractor has been advised that site cleaning should ne arranged frequently to prevent general waste from accumulating on the floor, in order to ensure the site is kept clean and tidy.
- Oil drum without the chemical label and drip tray was observed. The Contractor has been reminded that chemical labels should be affixed to the oil drums, and a drip tray should be provided for chemical storage to prevent chemical spillage.

- 1. General wastes are identified on the floor without proper disposal and collection. (Photo 1)
- 2. Oil drum without the chemical label and drip tray is observed. (Photo 2)

- 1. The Contractor has been advised that site cleaning should be arranged frequently to prevent general waste from accumulating on the floor, in order to ensure the site is kept clean and tidy.
- 2. The contractor has been reminded that chemical labels should be affixed to the oil drums, and a drip tray should be provided for chemical storage to prevent chemical spillage.

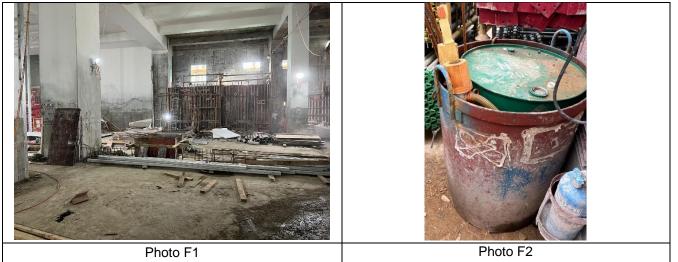
- 08 August 2024 Observation
- 1. The general waste on the floor was cleaned. (Photo F1)
- 2. The oil drum was placed in the chemical drip tray. (Photo F2)

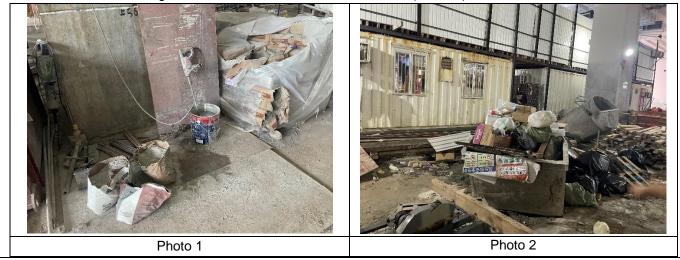
- The activities of handling of dry PFA were observed in the open area. The Contractor has been advised that activities of loading, unloading, transfer, handing or storage of bulk cement or dry PFA should ne carried out in a totally enclosed system or facility to prevent dust dispersion.
- Mixed C&D waste and general waste was accumulated on the floor. The Contractor has been recommended to arrange the segregation area for general waste and C&D waste segregation to facilitate proper recycling and disposal of the waste.

- 1. The activities of handling of dry PFA is observed in the open area. (Photo 1)
- 2. Mixed C&D waste and general waste is accumulated on the floor. (Photo 2)

- 1. The Contractor has been advised that the activities of loading, unloading, transfer, handing or storage of bulk cement or dry PFA should be carried out in a totally enclosed system or facility to prevent dust dispersion.
- 2. The Contractor has been recommended to arrange the segregation area for general waste and C&D waste segregation to facilitate proper recycling and disposal of the waste.

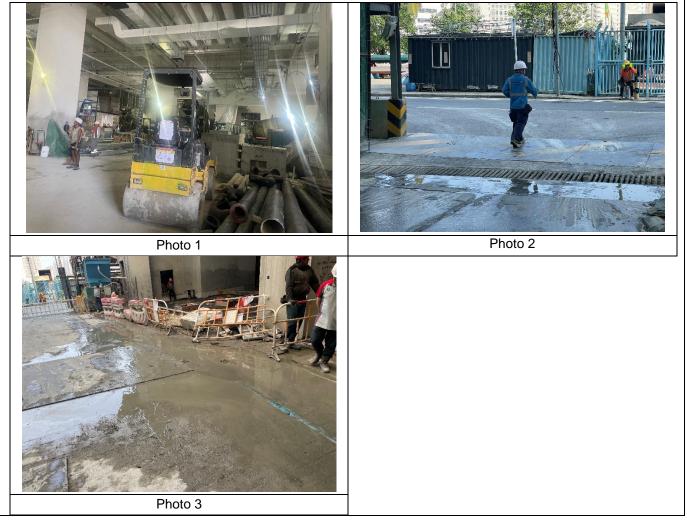
- NRMM label not affixed to the forklift was observed. The Contractor has been reminded that NRMM label should be affixed on the forklift.
- Wheel washing shall be provided at the site exit. The Contractor has been advised to provide wheel washing facilities with a high-pressure water jet at the exits to ensure that vehicles were cleaned before exiting the site.

Surface runoff and silt accumulation were observed. The Contractor has been advised to install temporary channels, earth bunds, or sandbag barriers on site to properly direct surface runoff to the silt removal facilities.

- 1. NRMM label not affixed to the forklift is observed. (Photo 1)
- 2. Wheel washing shall be provided at the site exit. (Photo 2)
- 3. Surface runoff and silt accumulation are observed. (Photo 3)

- 1. The Contractor has been reminded that NRMM label should be affixed on the forklift.
- 2. The Contractor has been advised to provide wheel washing facilities with a high-pressure water jet at the exits to ensure that vehicles were cleaned before exiting the site.
- 3. The Contractor has been advised to install temporary channels, earth bunds, or sandbag barriers on site to properly direct surface runoff to the silt removal facilities.
