**Service Contract No. WD/04/2020  
Development of Lok Ma Chau Loop:  
Main Works Package 1 –  
Environmental Team**

**Environmental Permit No.: EP-477/2013/B –  
Development of Lok Ma Chau Loop**

**Quarterly Environmental Monitoring and  
Audit Report for January to March 2024  
(Version 1.0)**

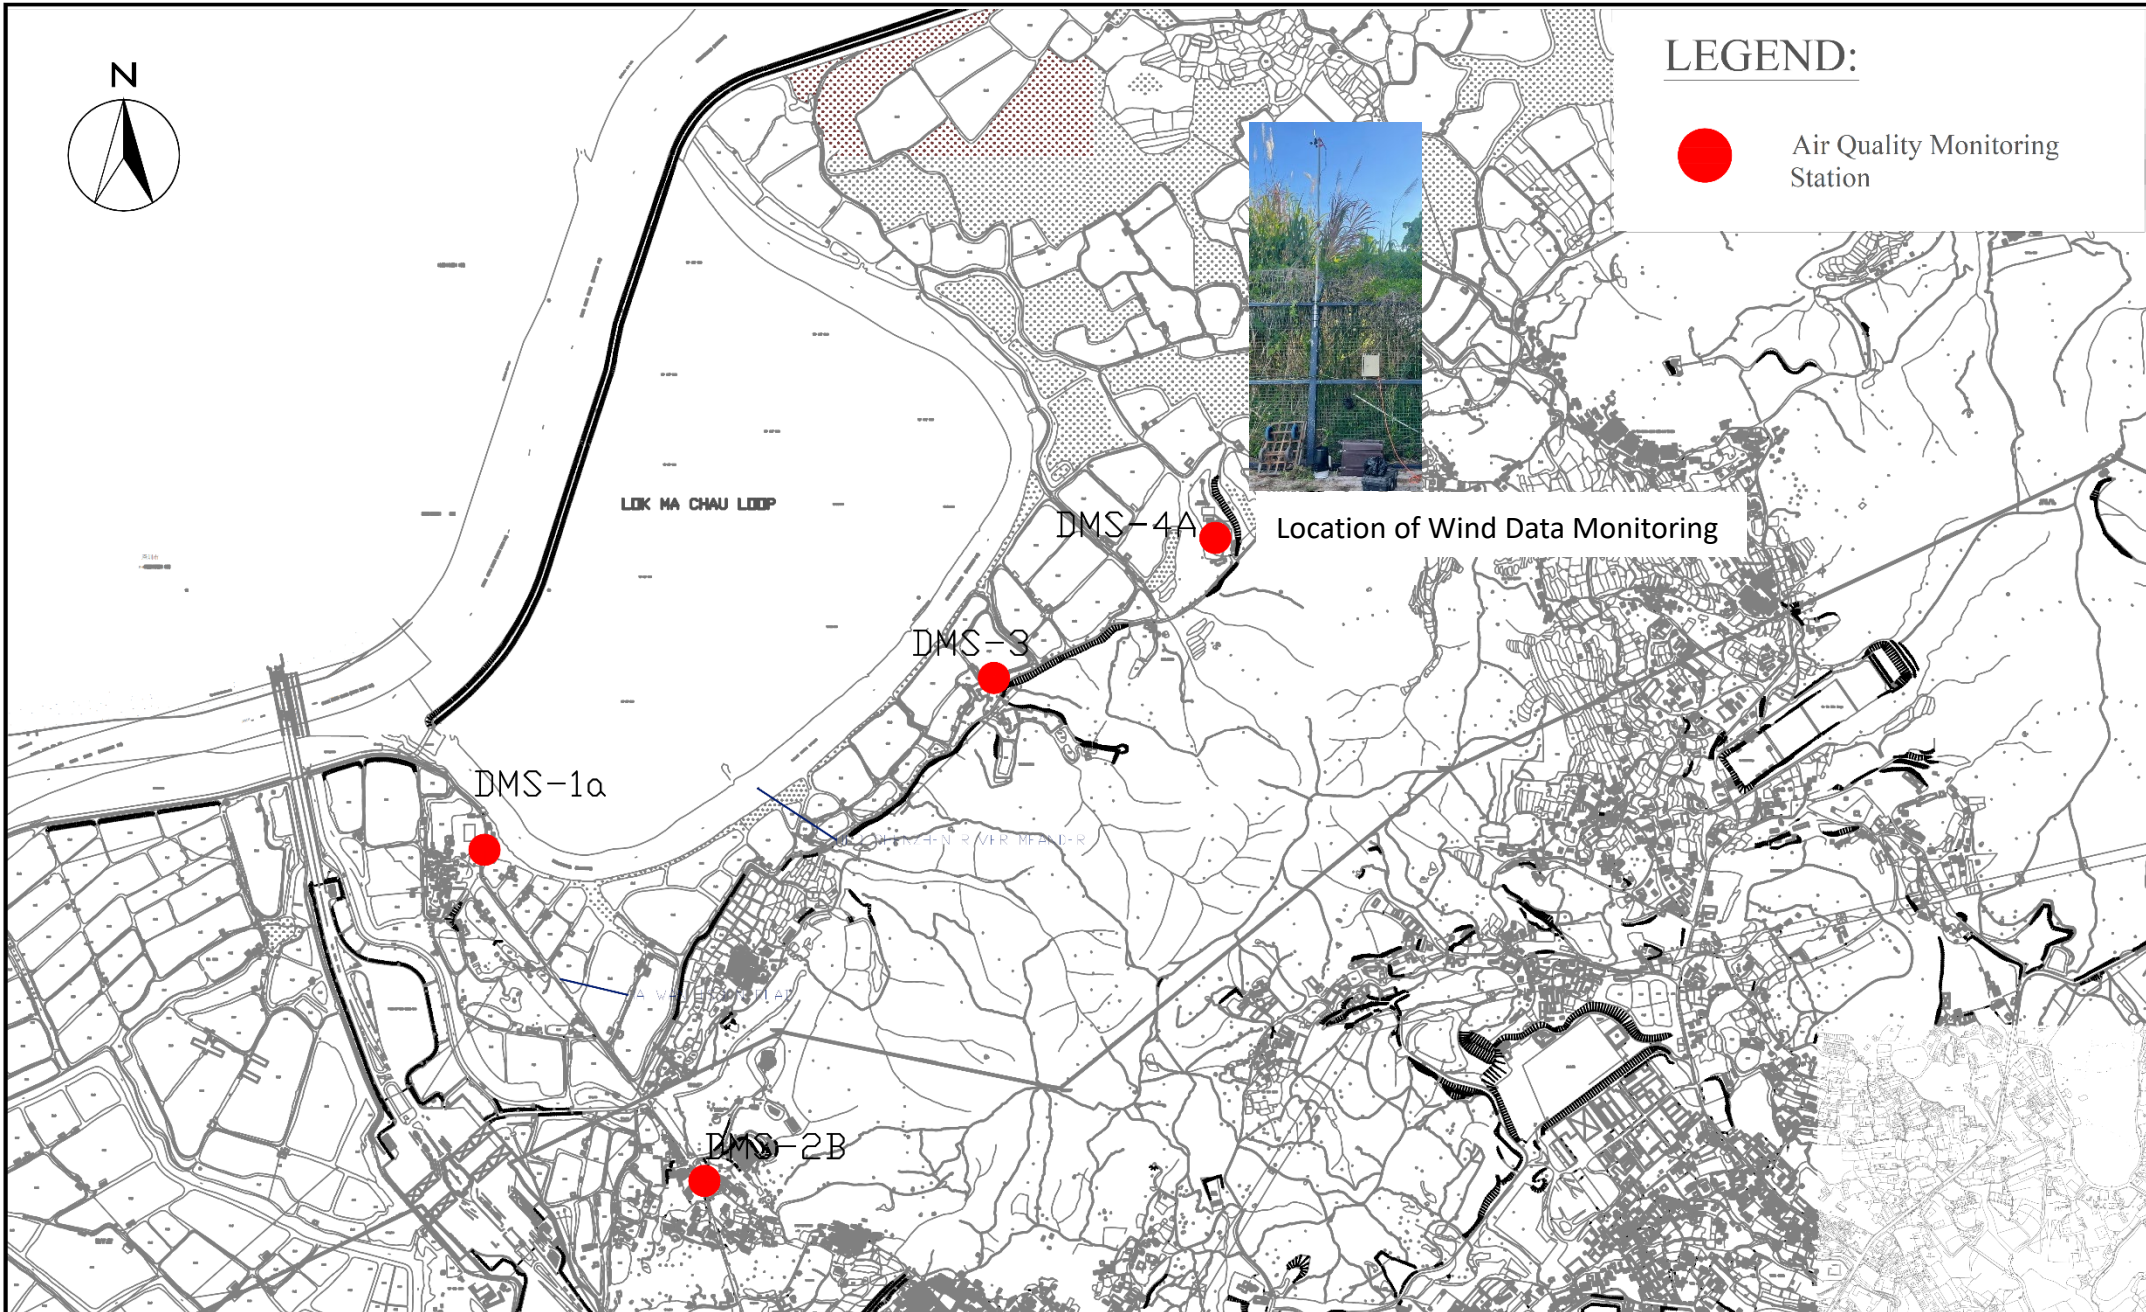
SCALE	1:400 A4	DATE	FEB 2023
CHECK	PC	DRAWN	IT
JOB No.	WMA21009	FIGURE NO.	Fig 2
		REV	-

Location of Wind Data Monitoring

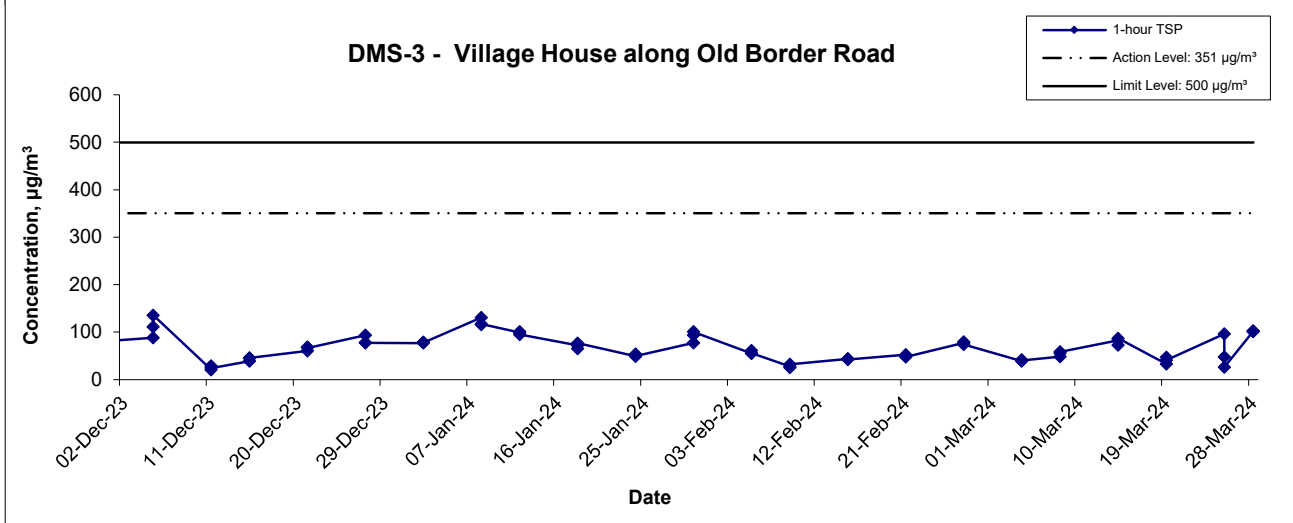
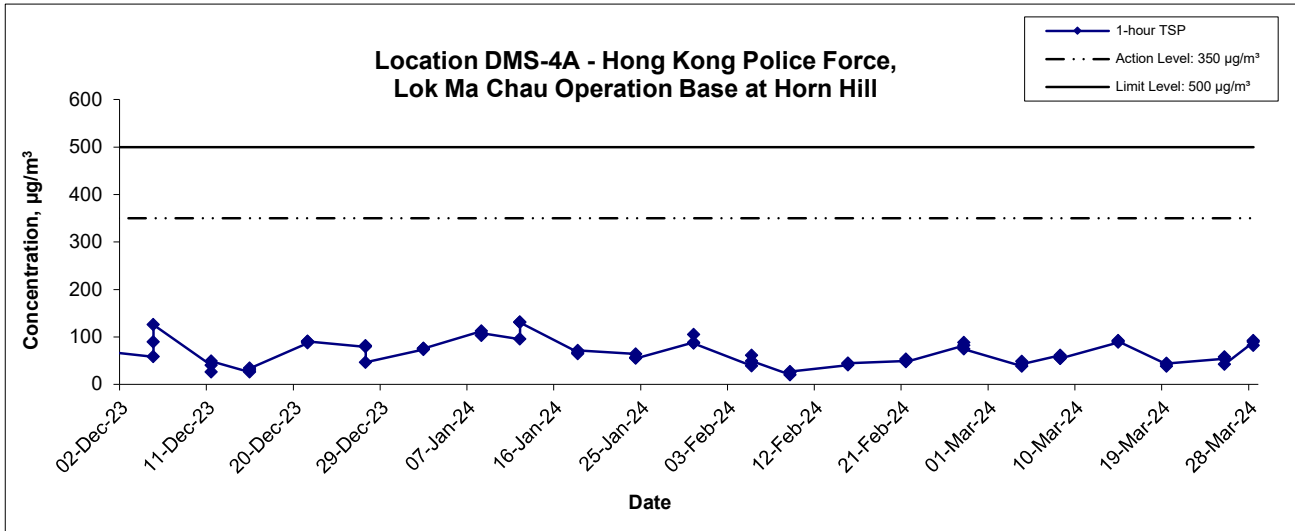
# 1-hour TSP Concentration Levels

consulting . testing . research
	Development of Lok Ma Chau Loop: Main Works Package 1 - Environmental Team			Date		Mar 24	
Graphical Presentation of 1-hour TSP Monitoring Results

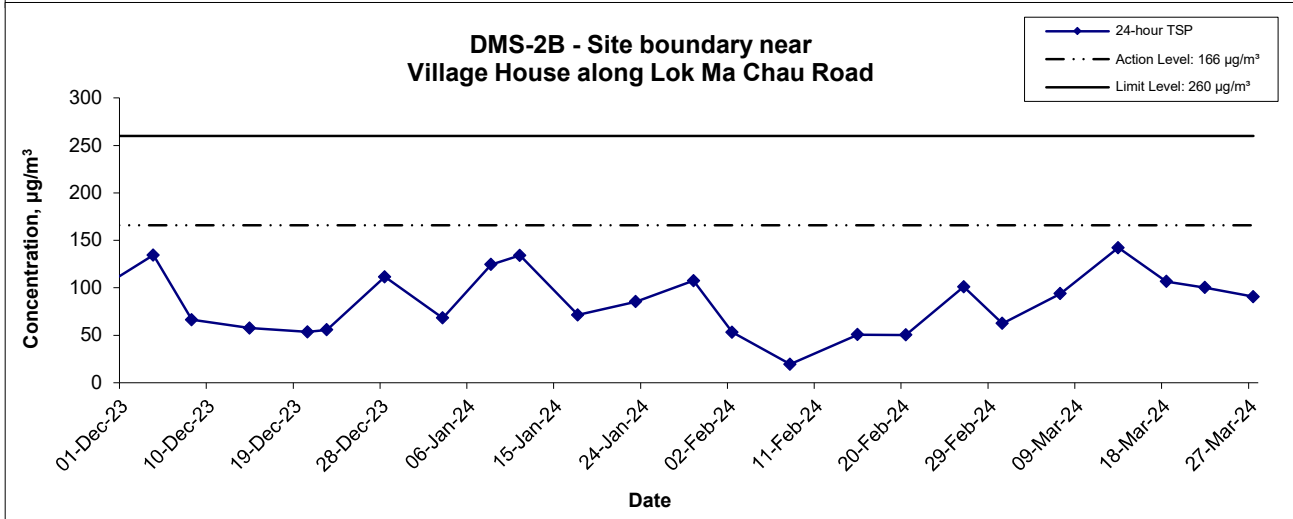
## 24-hour TSP Concentration Levels

Title Service Contract No. WD/04/2020 Development of Lok Ma Chau Loop: Main Works Package 1 - Environmental Team Graphical Presentation of 24-hour TSP Monitoring Results	Scale	N.T.S	Project No.	WMA21009	匯力 consulting . testing . research
	Date	Mar 24	Appendix	C

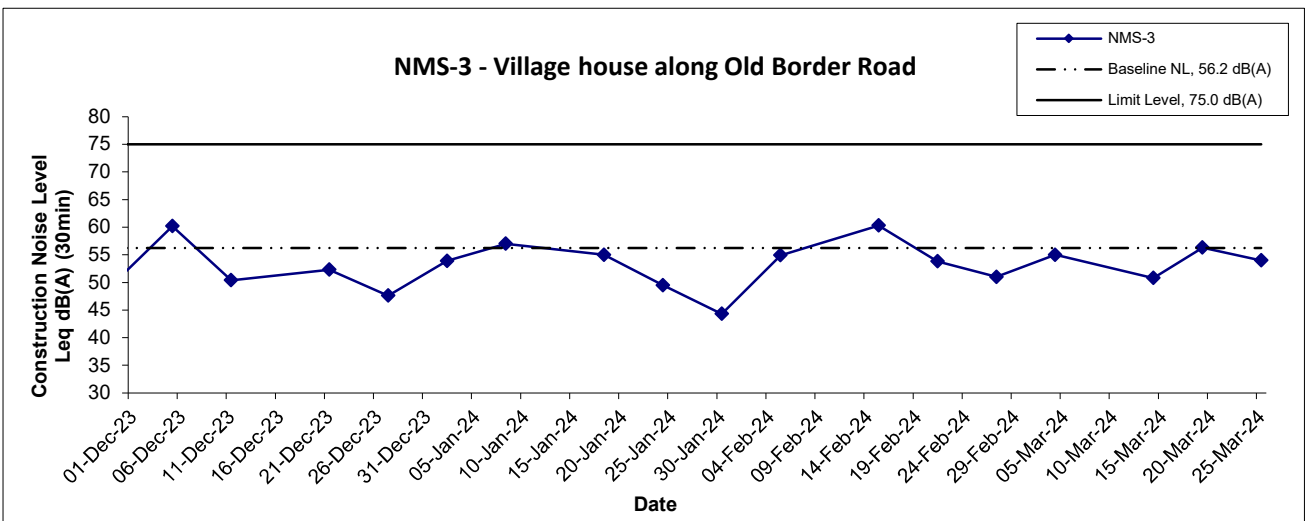
## Noise Levels

Title Service Contract No. WD/04/2020 Development of Lok Ma Chau Loop: Main Works Package 1 - Environmental Team Graphical Presentation of Construction Noise Monitoring Results	Scale N.T.S	Project No. WMA21009	consulting . testing . research
	Date Mar 24	Appendix D

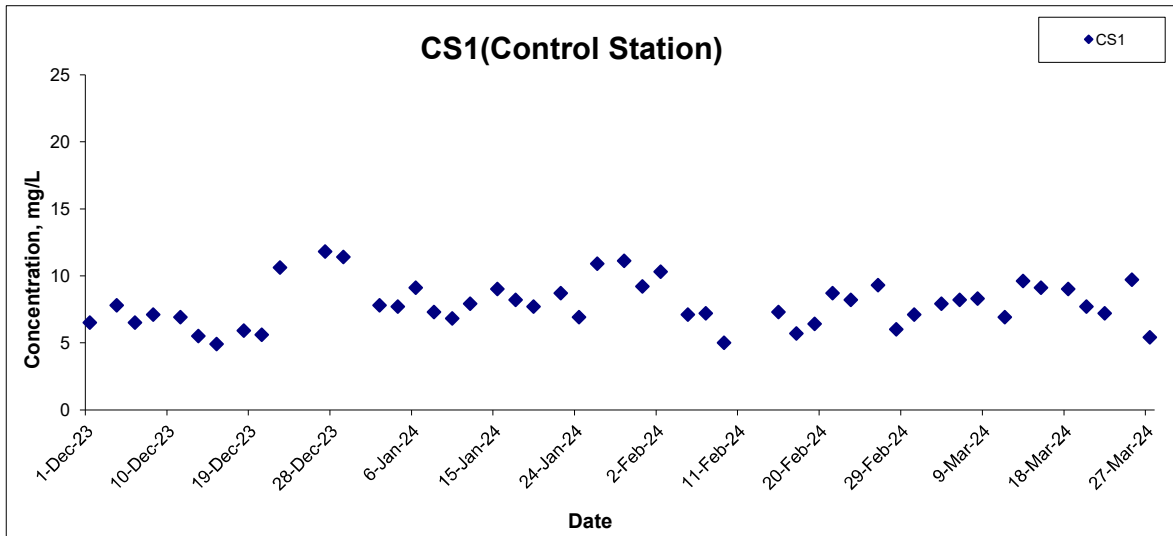
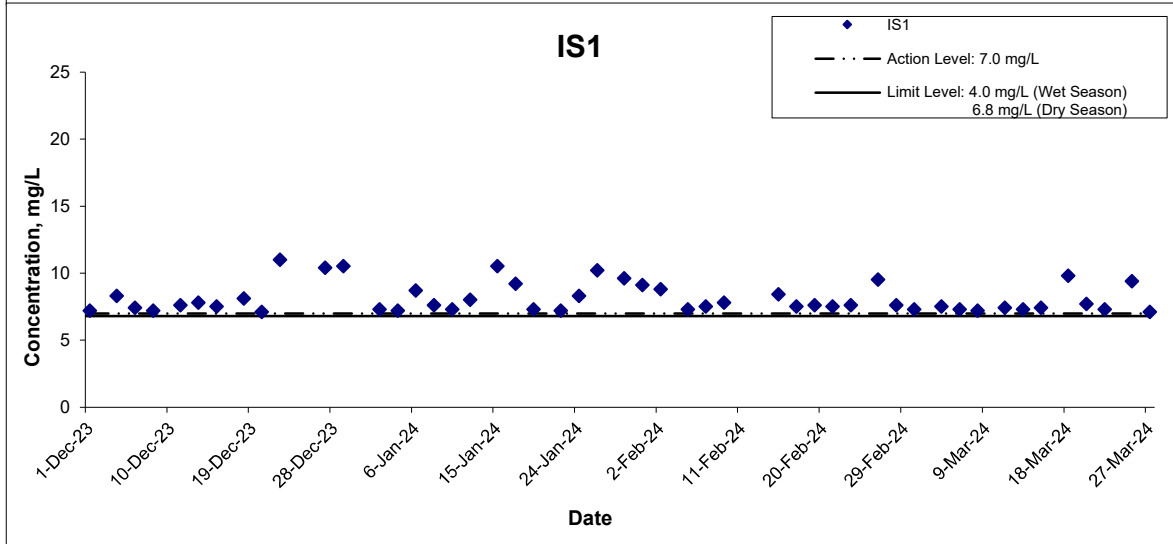
## Dissolved Oxygen

Title      Service Contract No. WD/04/2020  
 Development of Lok Ma Chau Loop:  
 Main Works Package 1 - Environmental Team  
**Graphical Presentation of Water Quality Monitoring Results**

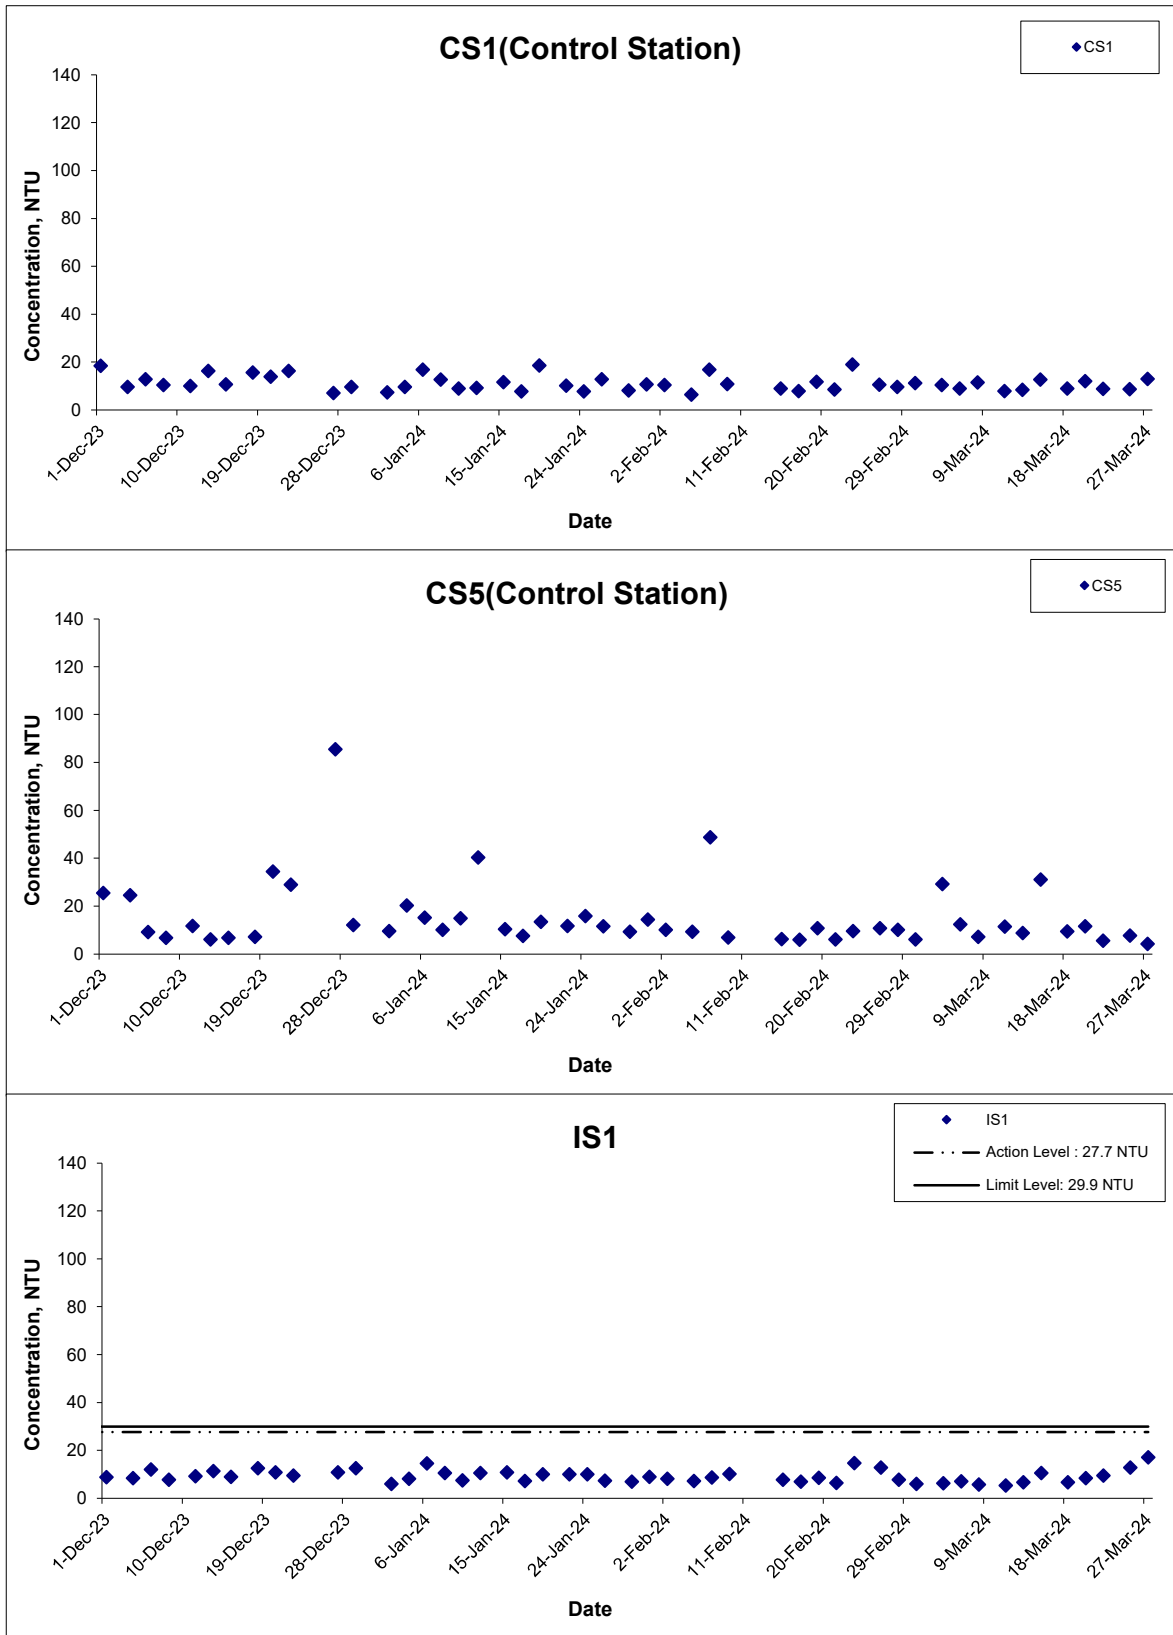
## Turbidity

Title  
 Service Contract No. WD/04/2020  
 Development of Lok Ma Chau Loop:  
 Main Works Package 1 - Environmental Team  
**Graphical Presentation of Water Quality Monitoring Results**

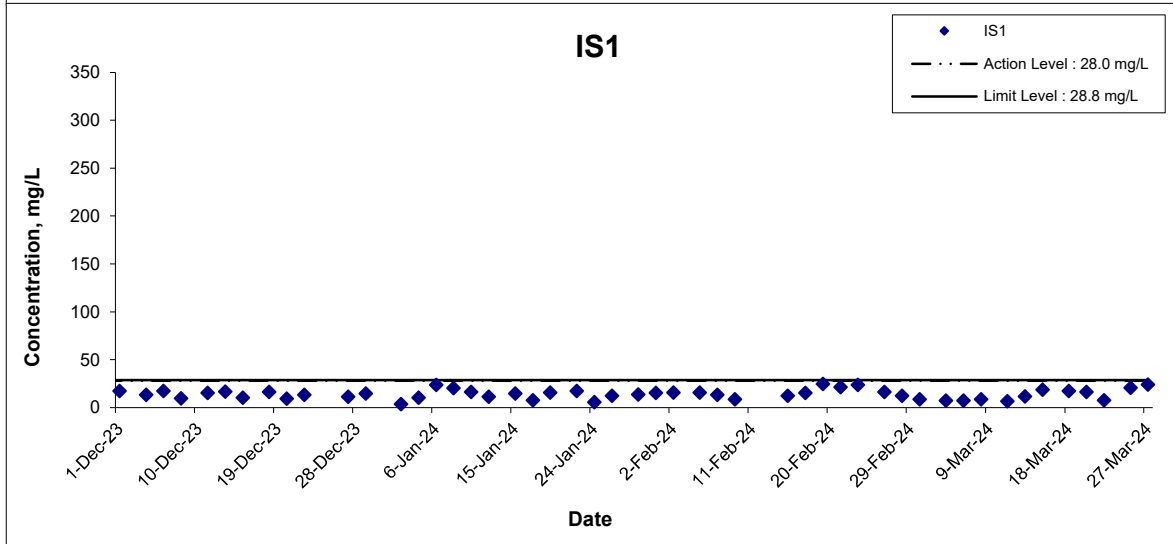
## Suspended Solids

Title  
 Service Contract No. WD/04/2020  
 Development of Lok Ma Chau Loop:  
 Main Works Package 1 - Environmental Team  
**Graphical Presentation of Water Quality Monitoring Results**

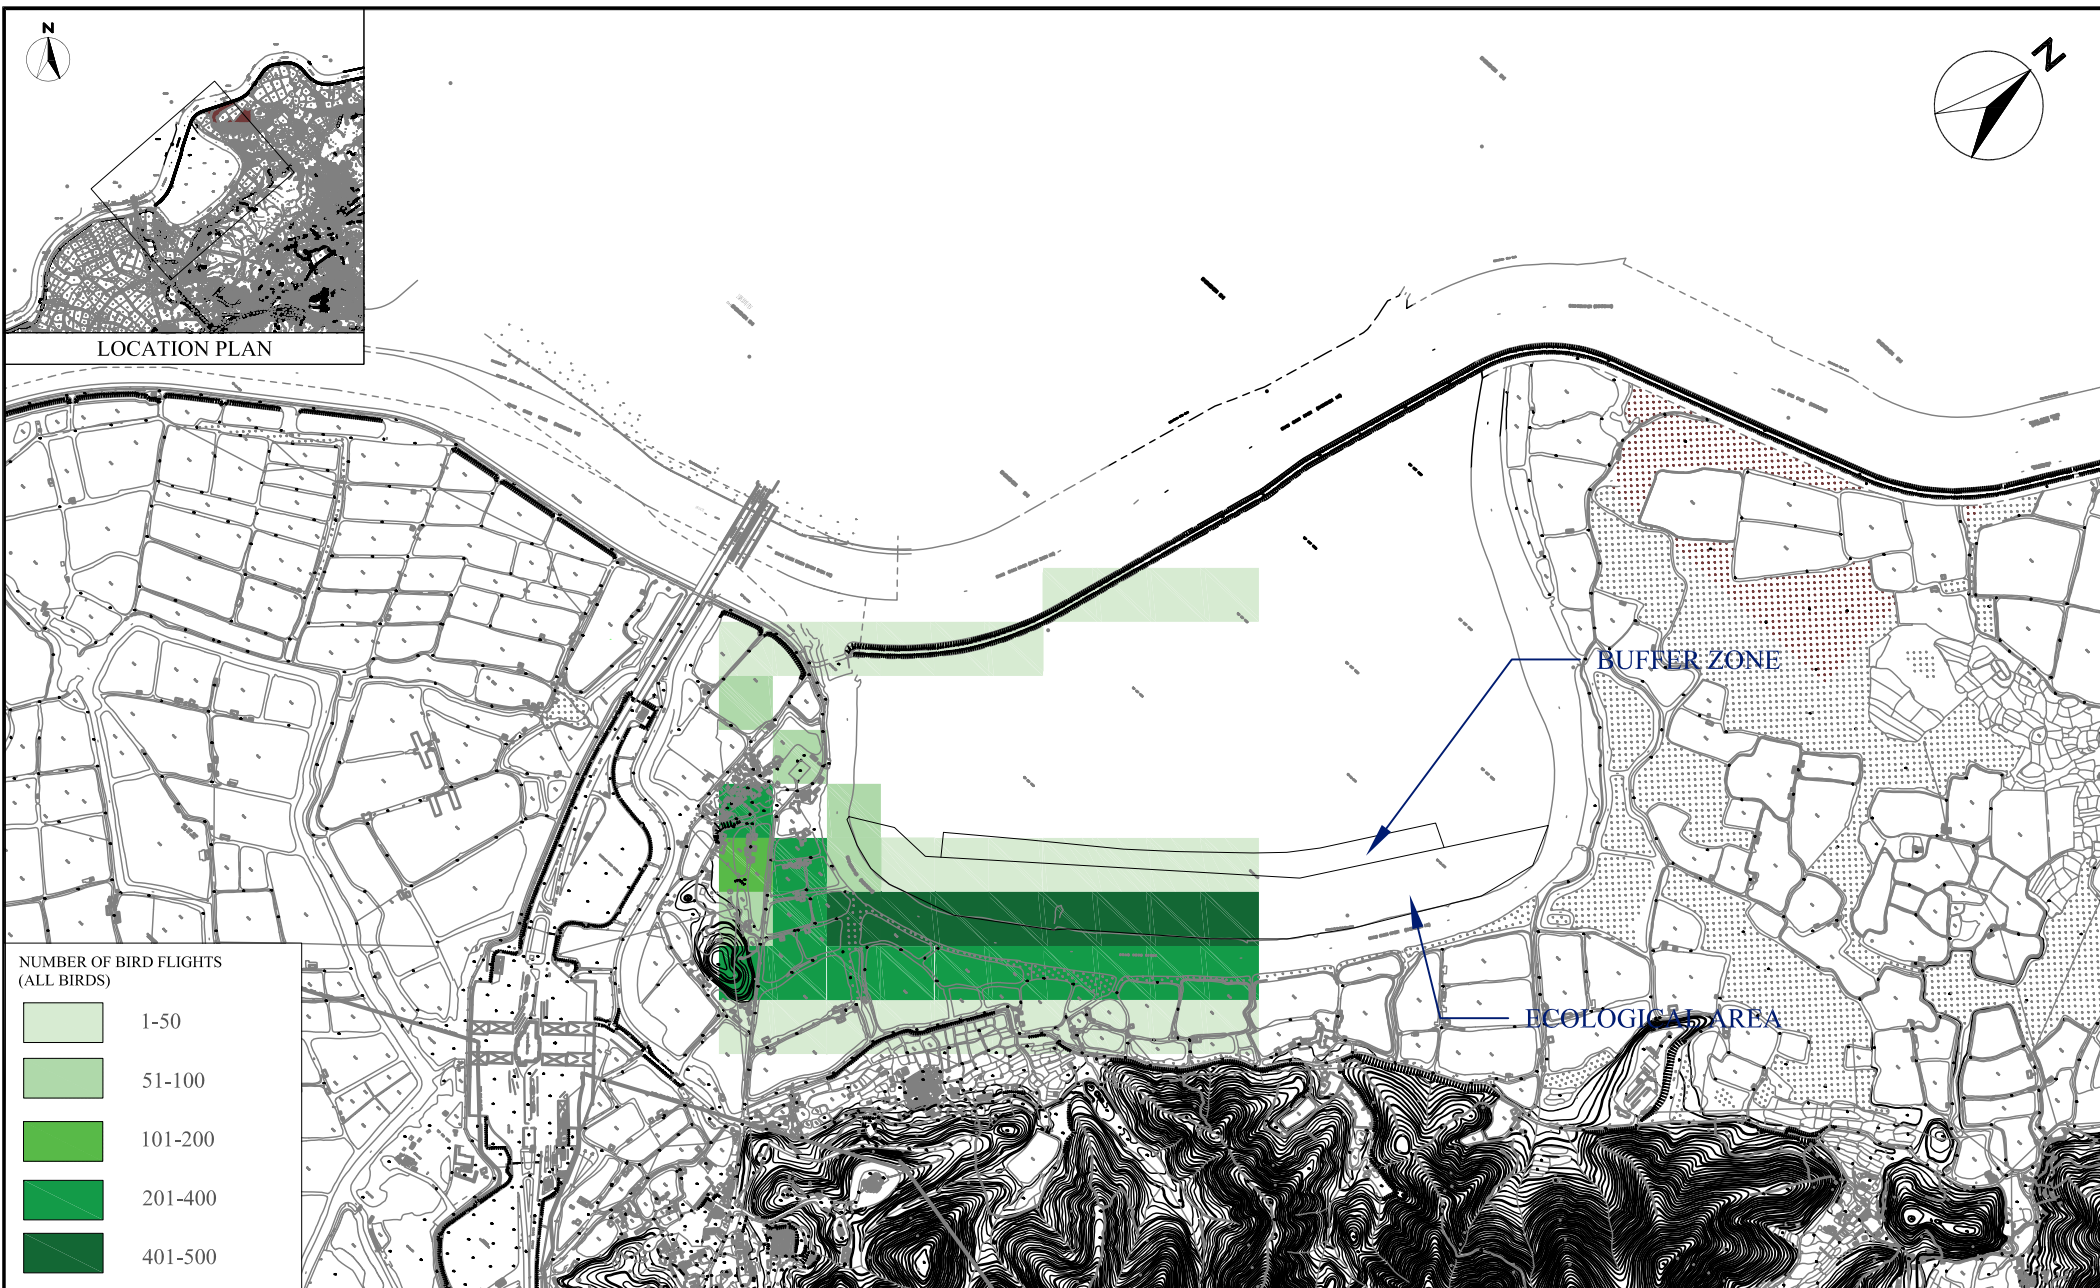
SCALE	1:14000 @A4	DATE	February 2024
CHECK	IT	DRAWN	ML
JOB No.	WMA 21009	FIGURE NO.	Fig 6
		REV	-

NUMBER OF BIRD FLIGHTS  
(ALL BIRDS)

- 4.15 **Table 4.5** shows the summary of flight line survey results including the number of birds observed and the number of bird-flights for the species in the reporting quarter.
