## Sheung Shui to Lok Ma Chau Spur Line

Monthly EM&A Report for Kwu Tung Station

(April 2024)

### Kwu Tung Station on East Rail Line

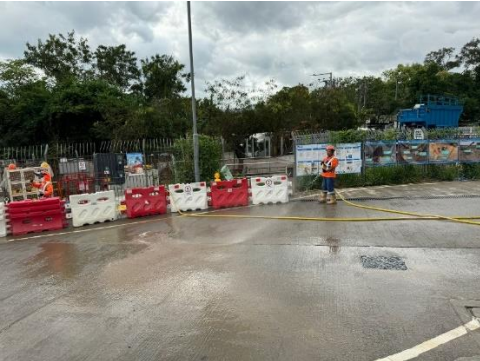
Date	Environmental Observation(s) / Recommendation(s)	Rectification Photos	Close-out Date / Status
2024 - 4 - 03	<p>Observation:</p>

<p>1. Wheel washing should be implemented at haul road near EAP3 such that muddy water generated can be diverted within the site for proper treatment in order to avoid potential substandard discharge. (Lower platform)</p>	<p>Action Taken:</p>

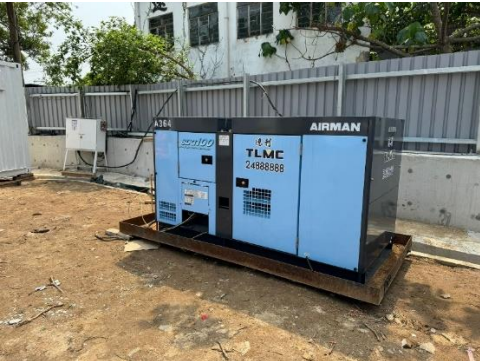
<p>1. NRMM Label of AIRMAN was observed missing at W4 area.</p>	<p>Action Taken:</p>

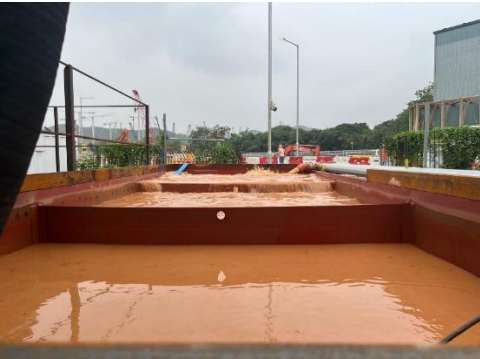
<p>1. Regular inspection and cleaning should be provided to the sedimentation tanks of Wetsep system to maintain the efficiency as well as to avoid overflow. (Lower platform)</p>	<p>Action Taken:</p>

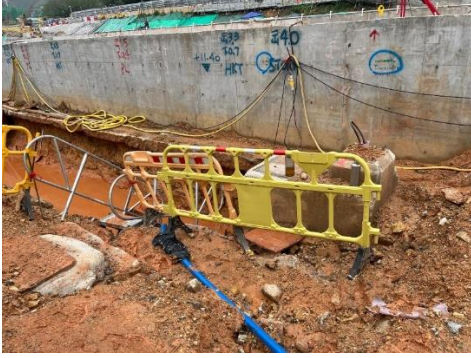
Observation:

2. Construction site runoff / muddy water should be diverted properly within the site area to nearby soakaway pits or Wetsep for treatment to avoid any substandard discharge. (Lower platform)
