## Sheung Shui to Lok Ma Chau Spur Line

Monthly EM&A Report for Kwu Tung Station

(May 2024)

### Kwu Tung Station on East Rail Line

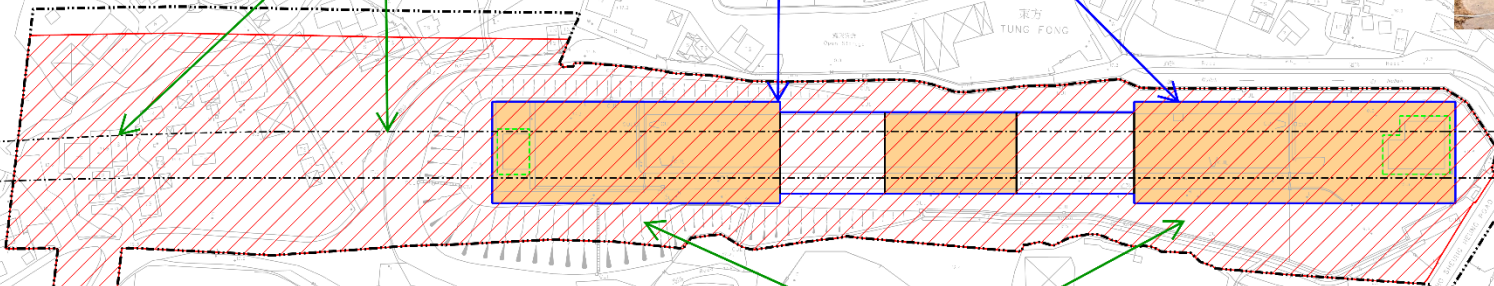
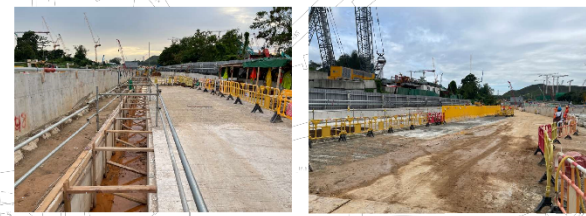
**Upper Platform**  
 - Site installation (Drainage)  
 - Erection of hoarding  
 - Formation of haul road

**Station Tunnel Box**  
 Under-ground Works:  
 - A&A and E&M works inside the tunnel  
 Above-ground Works:  
 - Reconstruction of D-wall and erection of flood barrier  
 - Station excavation work  
 - Strutting for ELS

**W4 Area**  
 (No construction works)

**Lower platform (North & South)**  
 - Site installation (Drainage)  
 - Formation of haul road

**Upper platform**  
 - Temporary drainage
