Sheung Shui to Lok Ma Chau Spur Line

Monthly EM&A Report for Kwu Tung Station

(June 2024)

Kwu Tung Station on East Rail Line

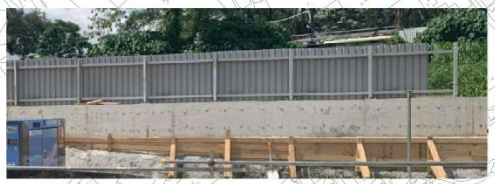
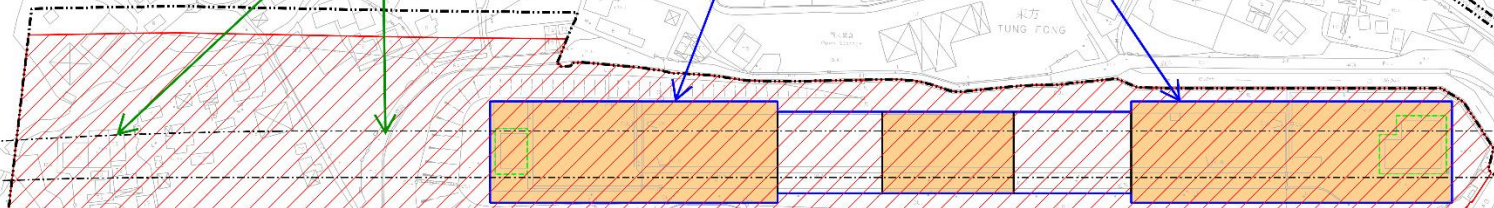
Upper Platform
- Hoarding Erection
- Haul Road Formation

Station Tunnel Box
Under-ground Works:
- A&A and E&M works
- Civil works provision for PSD installation
- Track level wall & slab construction
Above-ground Works:
- Reconstruction of D-wall and erection of flood barrier
- Station excavation work
- Strutting for ELS

W4 Area
(No construction works)

Lower platform (North & South)
- Site installation (Drainage)
- Retaining wall erection
- Formation of haul road
- Hoarding erection
- Drilling for de-watering well

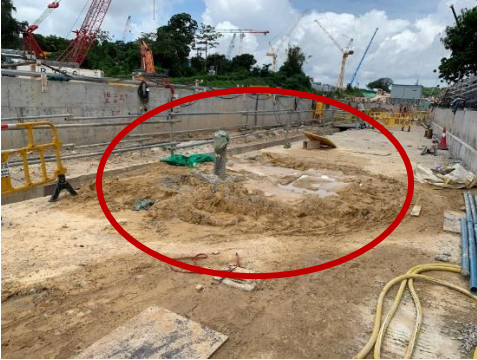
Date	Environmental Observation(s) / Recommendation(s)	Rectification Photos	Close-out Date / Status
2024 - 6 - 19	<p>Observation:</p>

<p>1. Bunding should be provided for drainage protection. (Lower platform)</p>	<p>Action Taken:</p>

<p>1. Sandbags were placed near the drainage system and soil was covered with impervious sheets to protect the drainage system. (Lower platform)</p>	Rectified and inspected on 26 June 2024.
