Sheung Shui to Lok Ma Chau Spur Line

Monthly EM&A Report for Kwu Tung Station

(July 2024)

Kwu Tung Station on East Rail Line

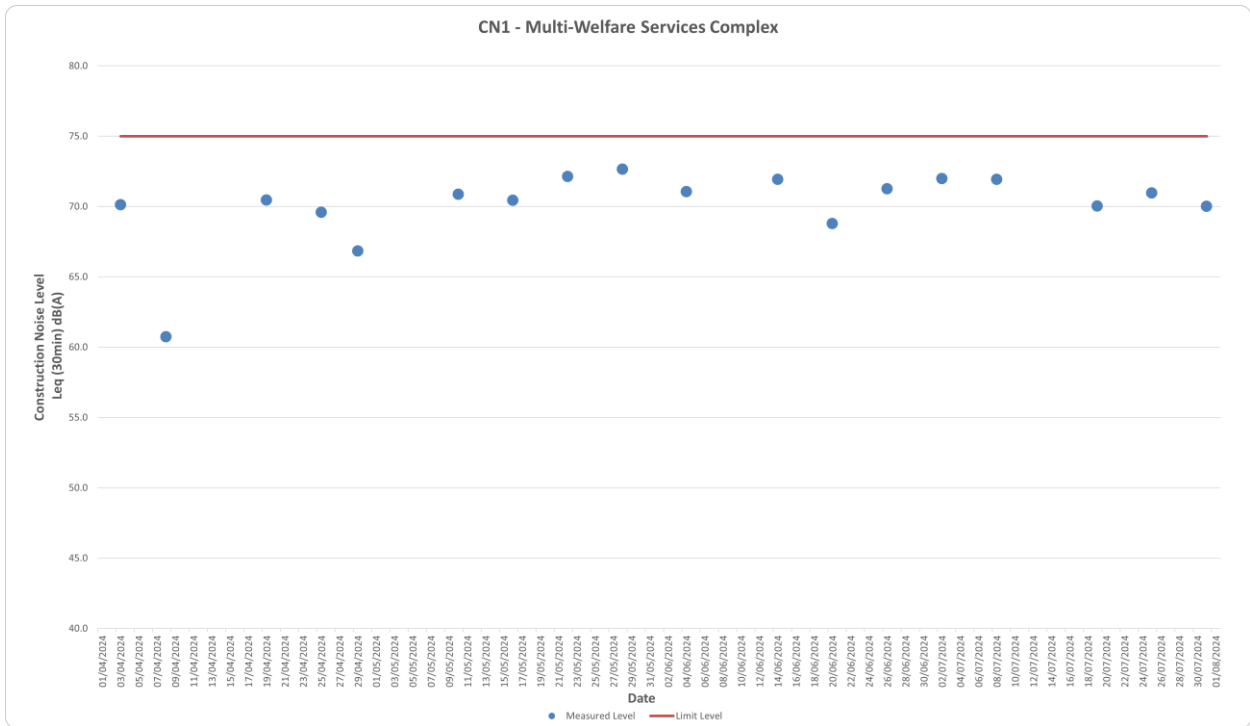
Noise Monitoring Results

9:11	68.9	71.2	68.0		
		9:16	69.2	72.2	69.3		
		9:21	69.9	73.1	69.9		
		9:26	71.6	73.4	68.8		
		9:31	70.6	73.6	68.9
