Contract No. 13/WSD/17

Design, Build and Operate First Stage of Tseung Kwan O Desalination Plant

Quarterly EM&A Report No.18 (Period from 1 June 2024 to 31 August 2024)

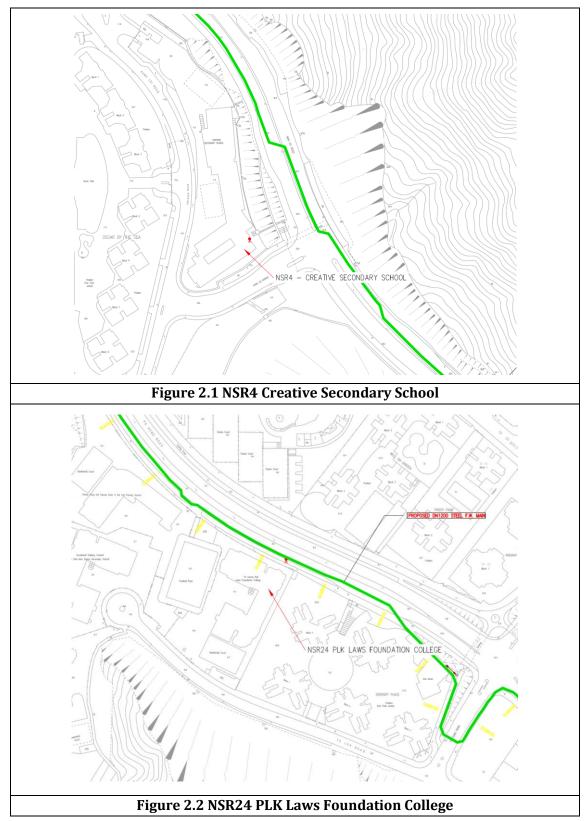
The monitoring locations should normally be made at a point 1m from the exterior of the NSRs building façade and be at a position 1.2m above the ground. A correction of +3dB(A) should be made to the free-field measurements. Three noise monitoring locations for impact monitoring at the nearby sensitive receivers are shown in **Figure 2.1-2.3**.

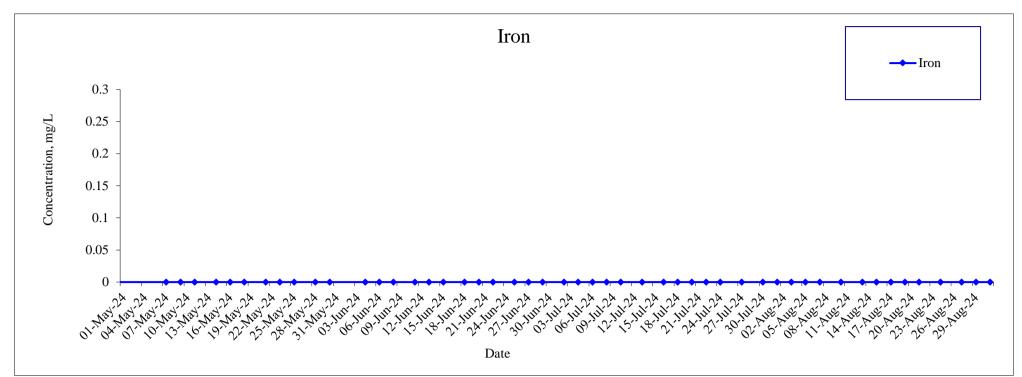
Monitoring Location: CE

Remark: The lowest detection limit of the Iron is 0.1mg/L. All result of iron monitoring are lower than the detection limit.
