Figure 4.12

Photomontage from VPd
(Medium/High Rise Level Residential Building(s) on Chancery Lane)

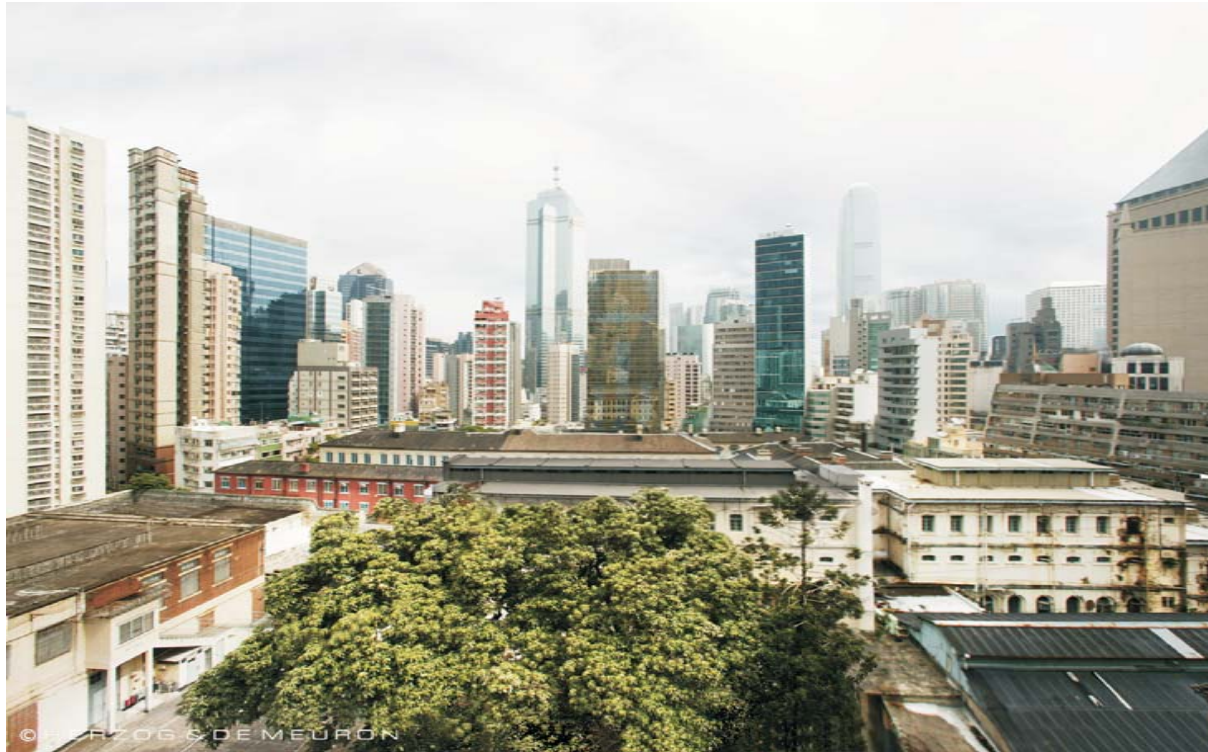
Existing view towards Project Site

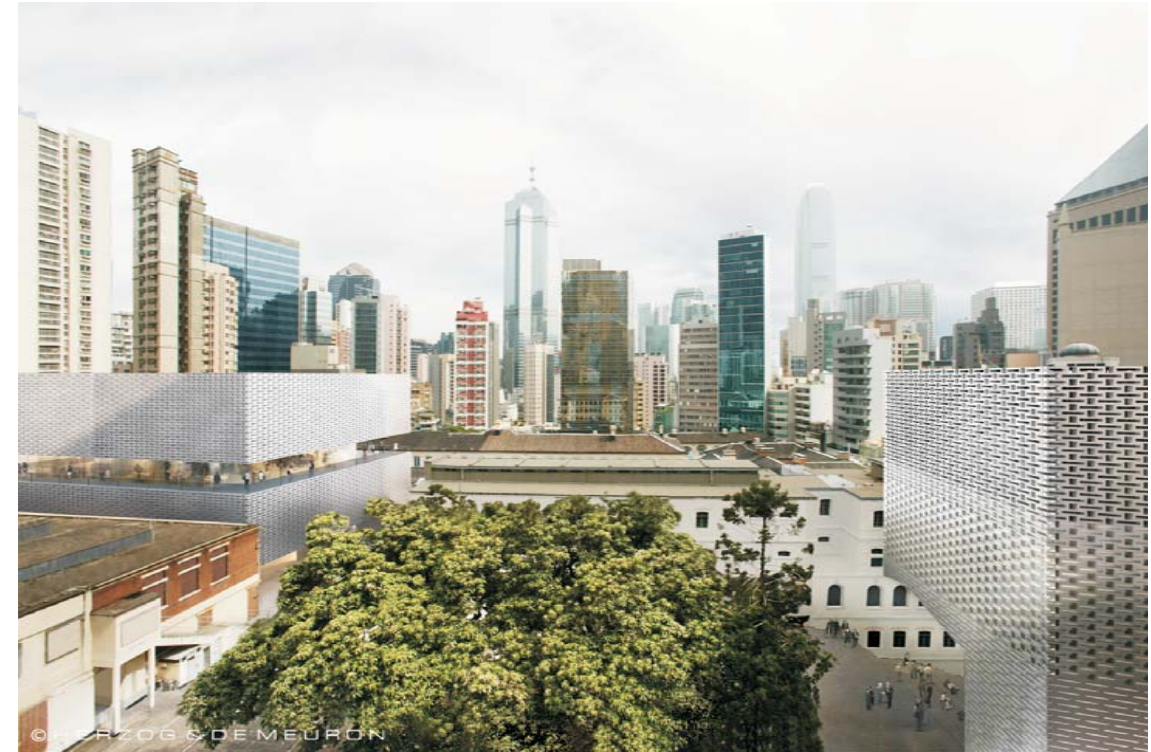
View towards Project Site with Mitigation Measures on Day 1 of Operation*

*Design features incorporated and additional mitigation labelled.
With hard landscape maintenance, the view at Day 1 and Year 10 are expected to show little significant difference.

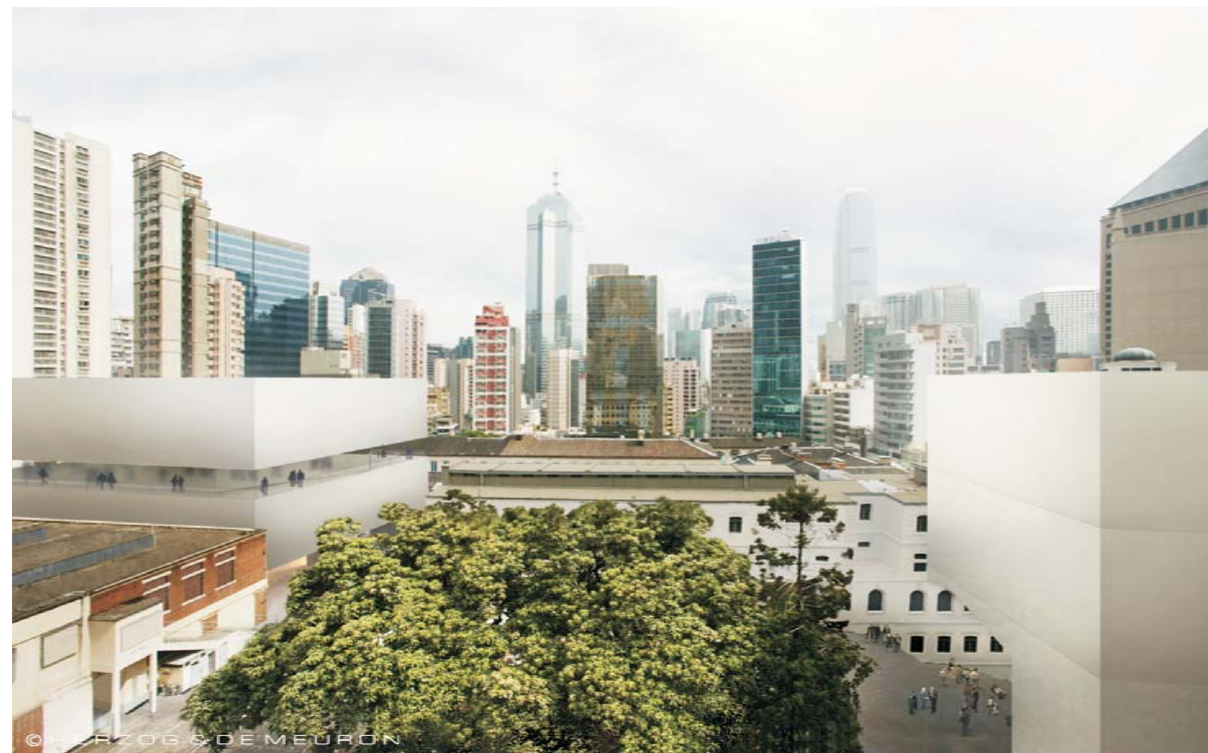
View towards Project Site without Mitigation Measures on Day 1 of Operation

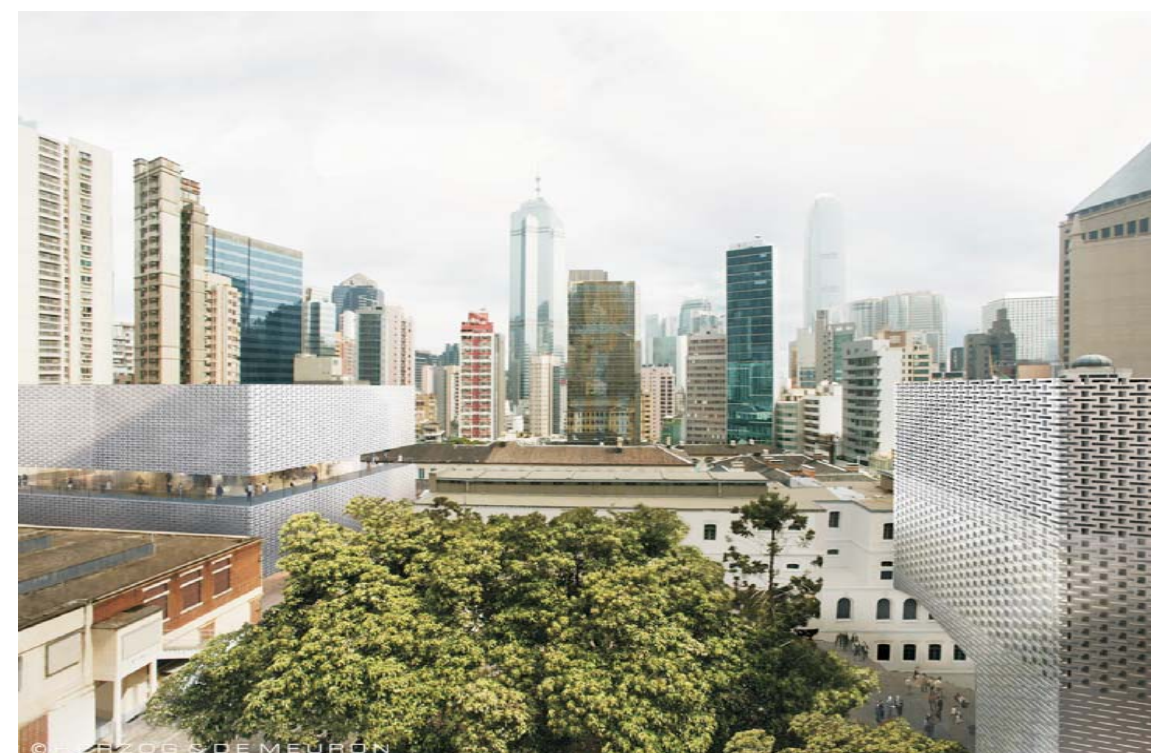
View towards Project Site with Mitigation Measures at Year 10 of Operation*
