Agreement No. CE 6/2019 (DS) Hung Shui Kiu Effluent Polishing Plant and Yuen Long South Effluent Polishing Plant – Investigation Water Level, Depth Averaged Current Velocity and Direction at DM2 in Dry Season Model results – Red: Base Case; Dashed Blue: Repeat Model Run	Dry Season	Oct 2021
	Appendix 5.3 – 01	
AECOM	/GPP/	Spchk.ssn

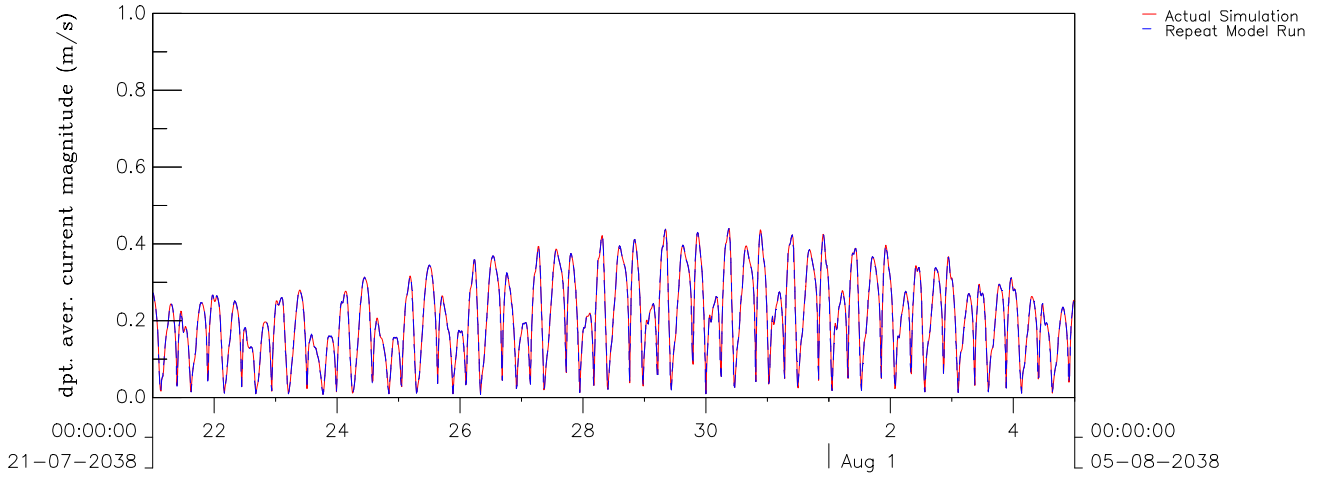
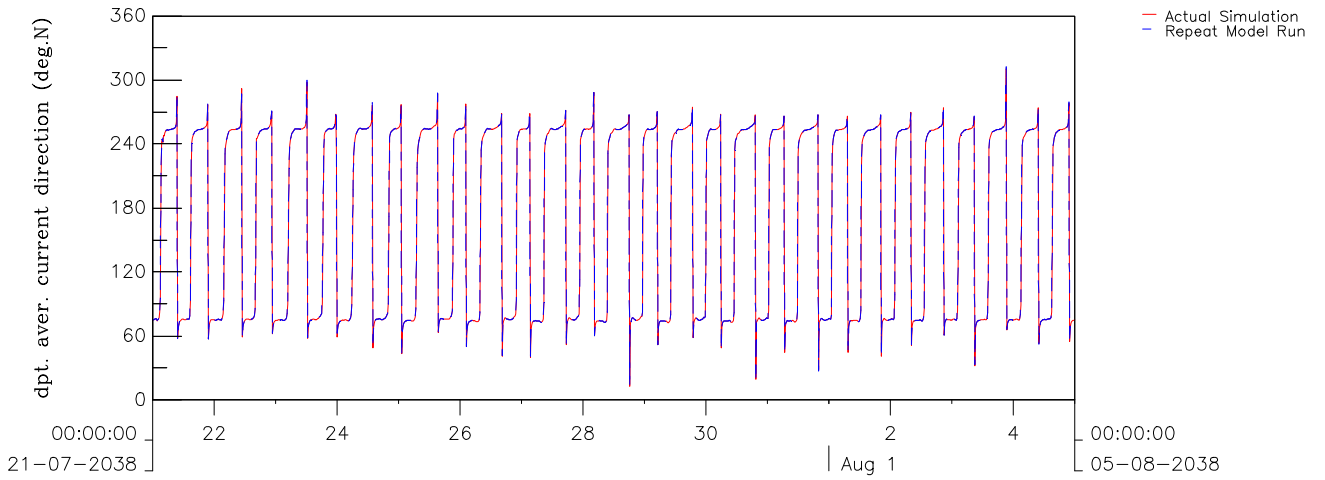
Agreement No. CE 6/2019 (DS) Hung Shui Kiu Effluent Polishing Plant and Yuen Long South Effluent Polishing Plant – Investigation Water Level, Depth Averaged Current Velocity and Direction at DM2 in Wet Season Model results – Red: Base Case; Dashed Blue: Repeat Model Run	Wet Season	Oct 2021
	Appendix 5.3 – 03	
AECOM	/GPP/	Spchk.ssn
