Agreement No. CE 6/2019 (DS) Hung Shui Kiu Effluent Polishing Plant and Yuen Long South Effluent Polishing Plant – Investigation Timeseries Plots for Depth Averaged Dissolved Oxygen (mg/L) Blue: Normal Operation of YLSEPP (Scenario 1); Dashed Red: 2-hr Emergency Discharge from YLSEPP (Scenario 2)		Emergency	Wet Season
Appendix 5.7 – 01			
AECOM		/GPP/	emergency-w.ssn

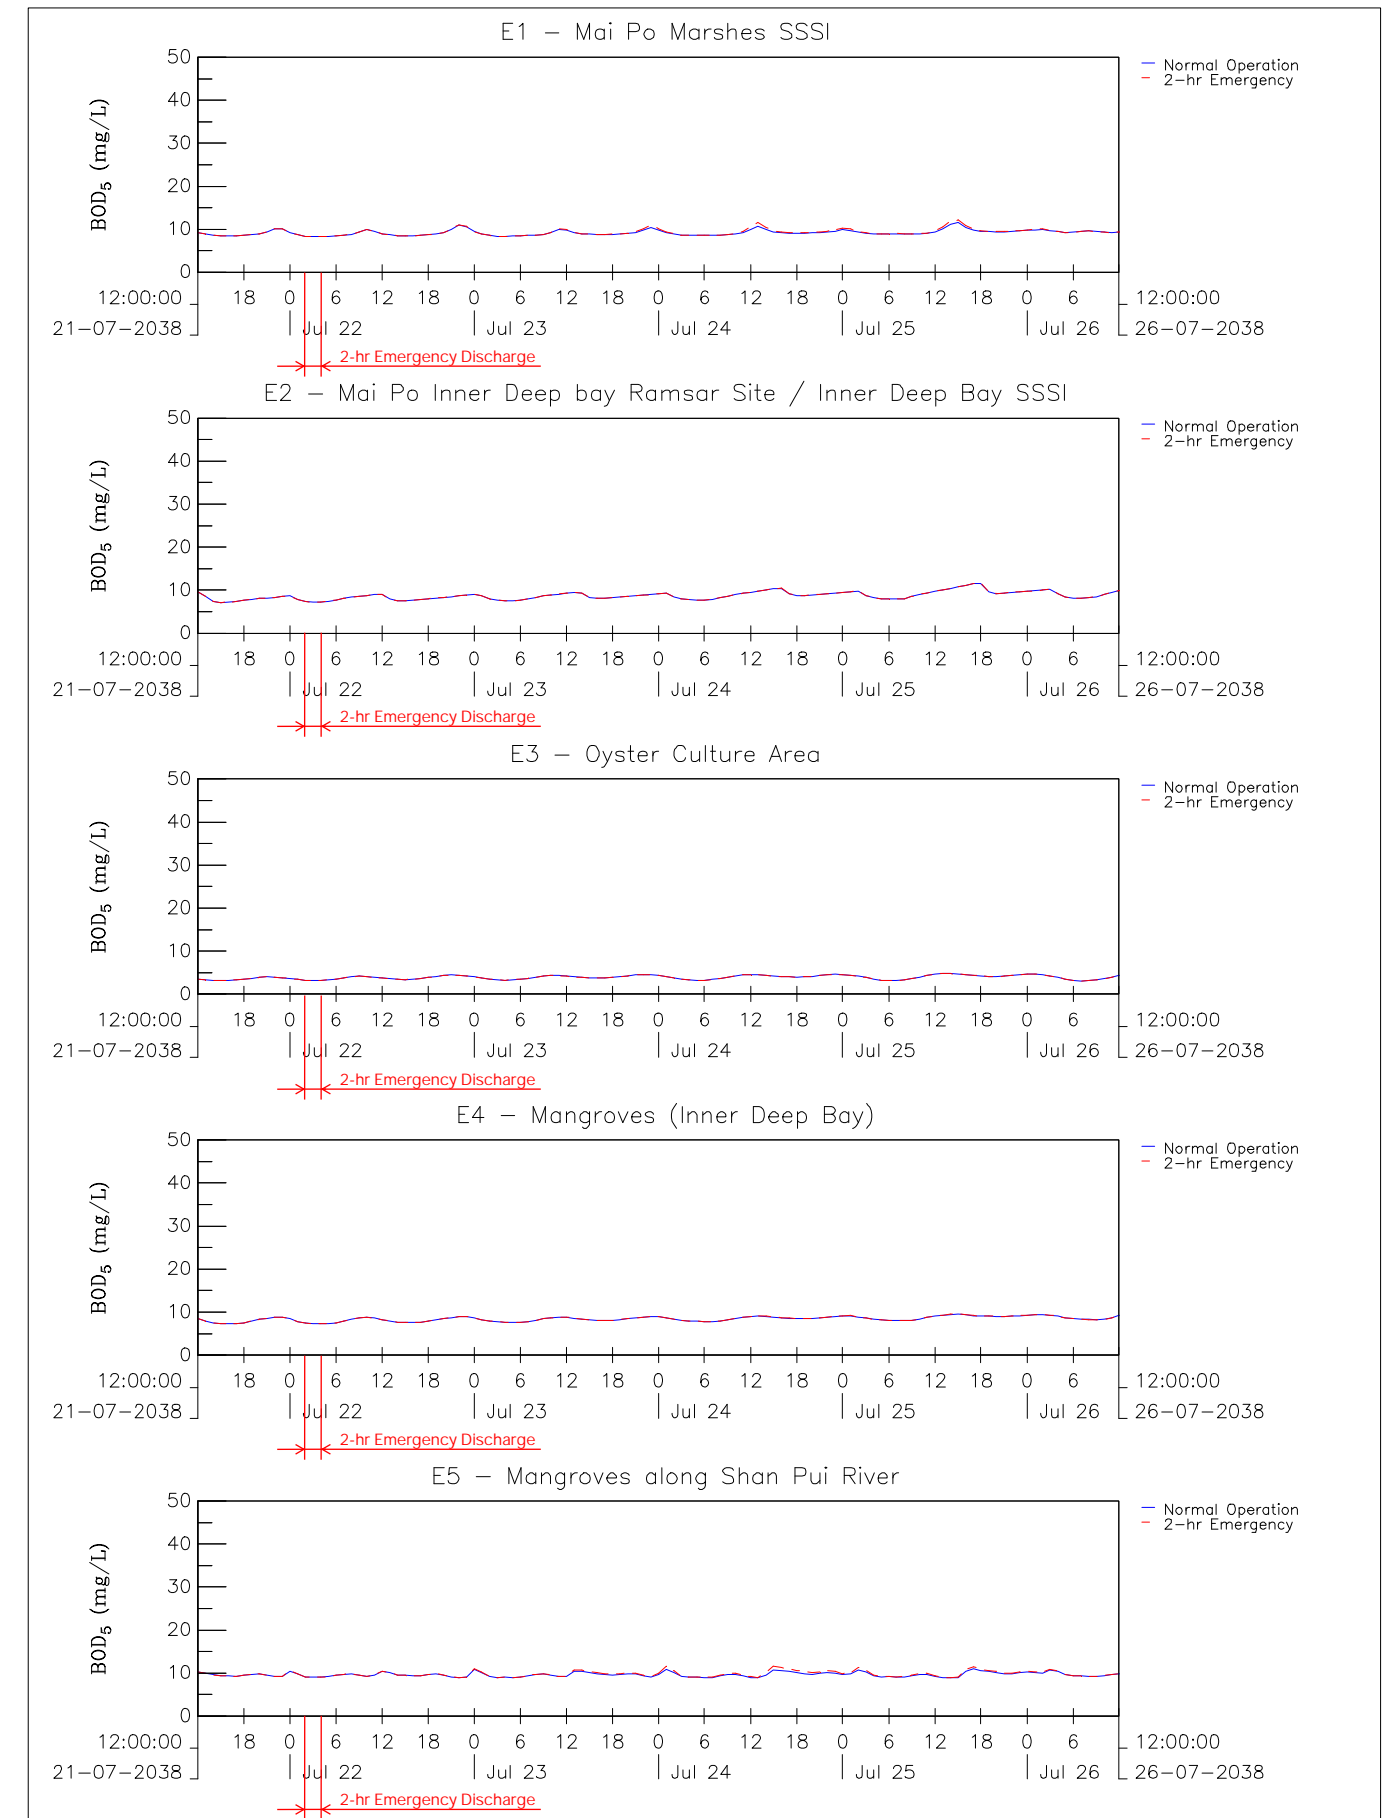
Agreement No. CE 6/2019 (DS) Hung Shui Kiu Effluent Polishing Plant and Yuen Long South Effluent Polishing Plant – Investigation Timeseries Plots for Depth Averaged 5-Day Biochemical Oxygen Demand (mg/L) Blue: Normal Operation of YLSEPP (Scenario 1); Dashed Red: 2-hr Emergency Discharge from YLSEPP (Scenario 2)		Emergency	Wet Season
Appendix 5.7 – 02			
AECOM		/GPP/	emergency-w.ssn

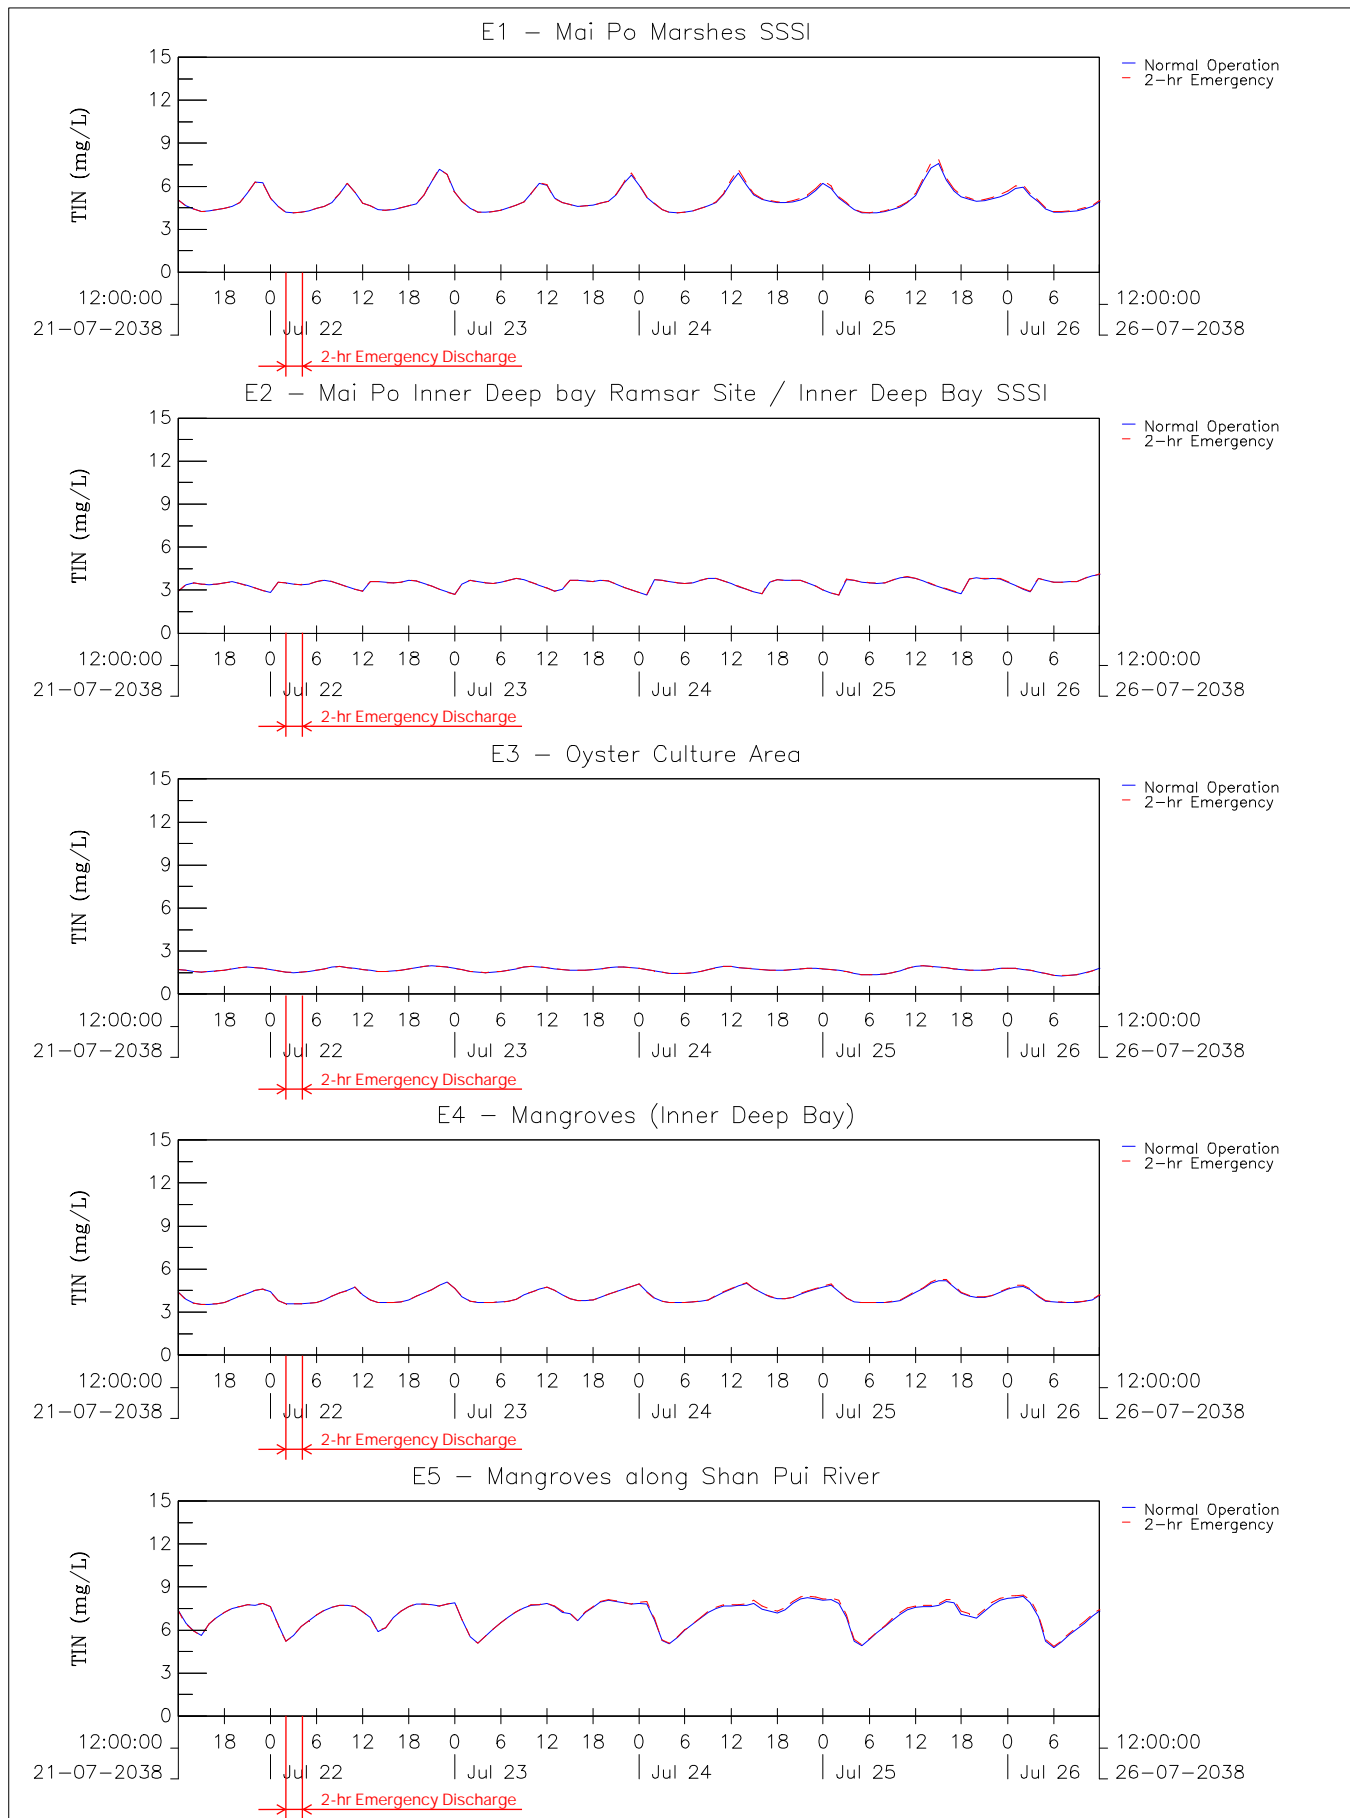
Agreement No. CE 6/2019 (DS) Hung Shui Kiu Effluent Polishing Plant and Yuen Long South Effluent Polishing Plant – Investigation Timeseries Plots for Depth Averaged Total Inorganic Nitrogen (mg/L) Blue: Normal Operation of YLSEPP (Scenario 1); Dashed Red: 2-hr Emergency Discharge from YLSEPP (Scenario 2)	Emergency	Wet Season
	Appendix 5.7 – 03	
AECOM	/GPP/	emergency-w.ssn

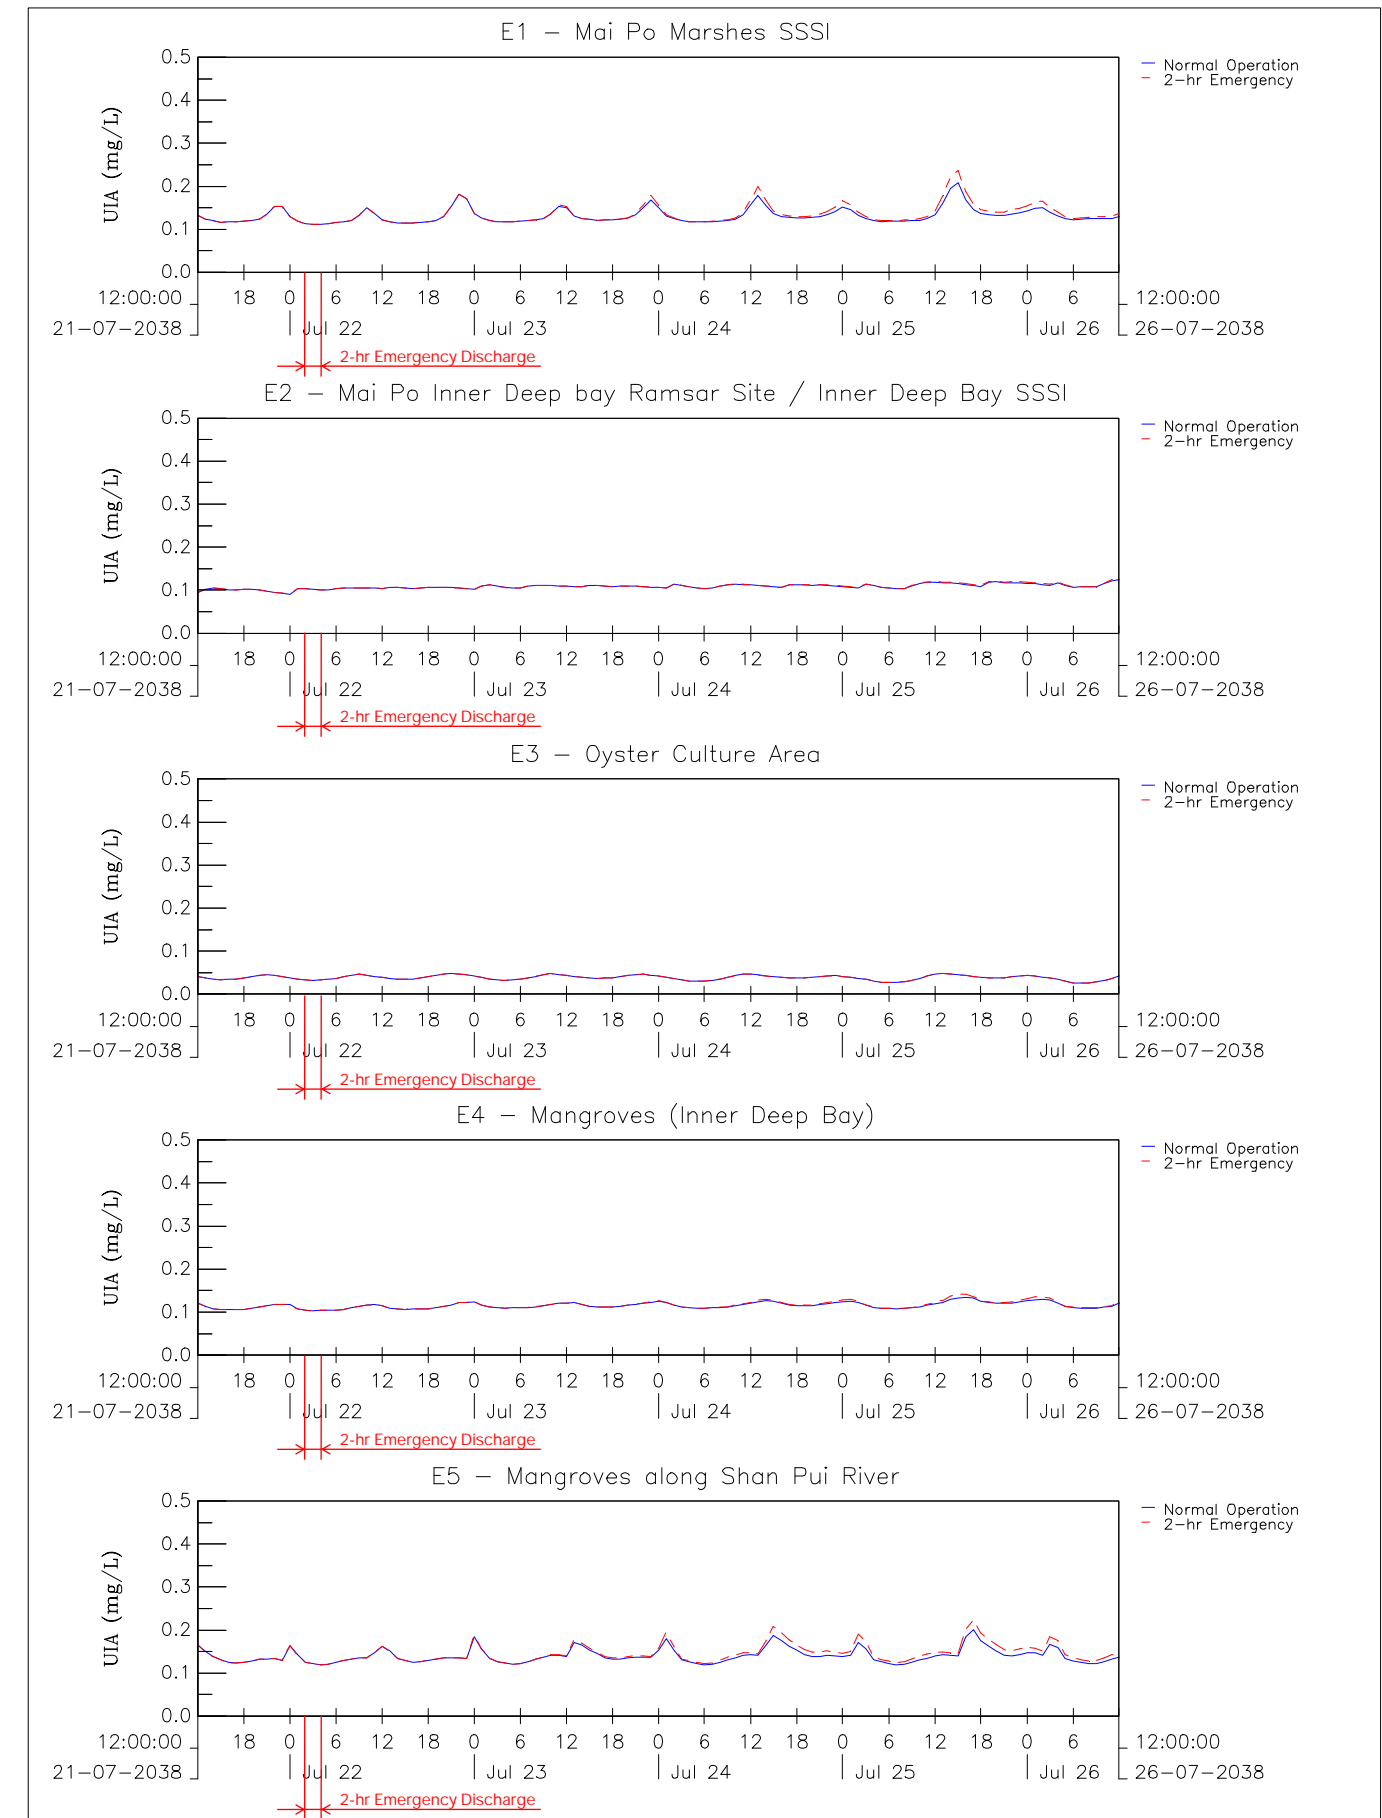
Agreement No. CE 6/2019 (DS) Hung Shui Kiu Effluent Polishing Plant and Yuen Long South Effluent Polishing Plant – Investigation Timeseries Plots for Depth Averaged Unionised Ammonia (mg/L) Blue: Normal Operation of YLSEPP (Scenario 1); Dashed Red: 2-hr Emergency Discharge from YLSEPP (Scenario 2)	Emergency	Wet Season
	Appendix 5.7 – 04	
AECOM	/GPP/	emergency-w.ssn

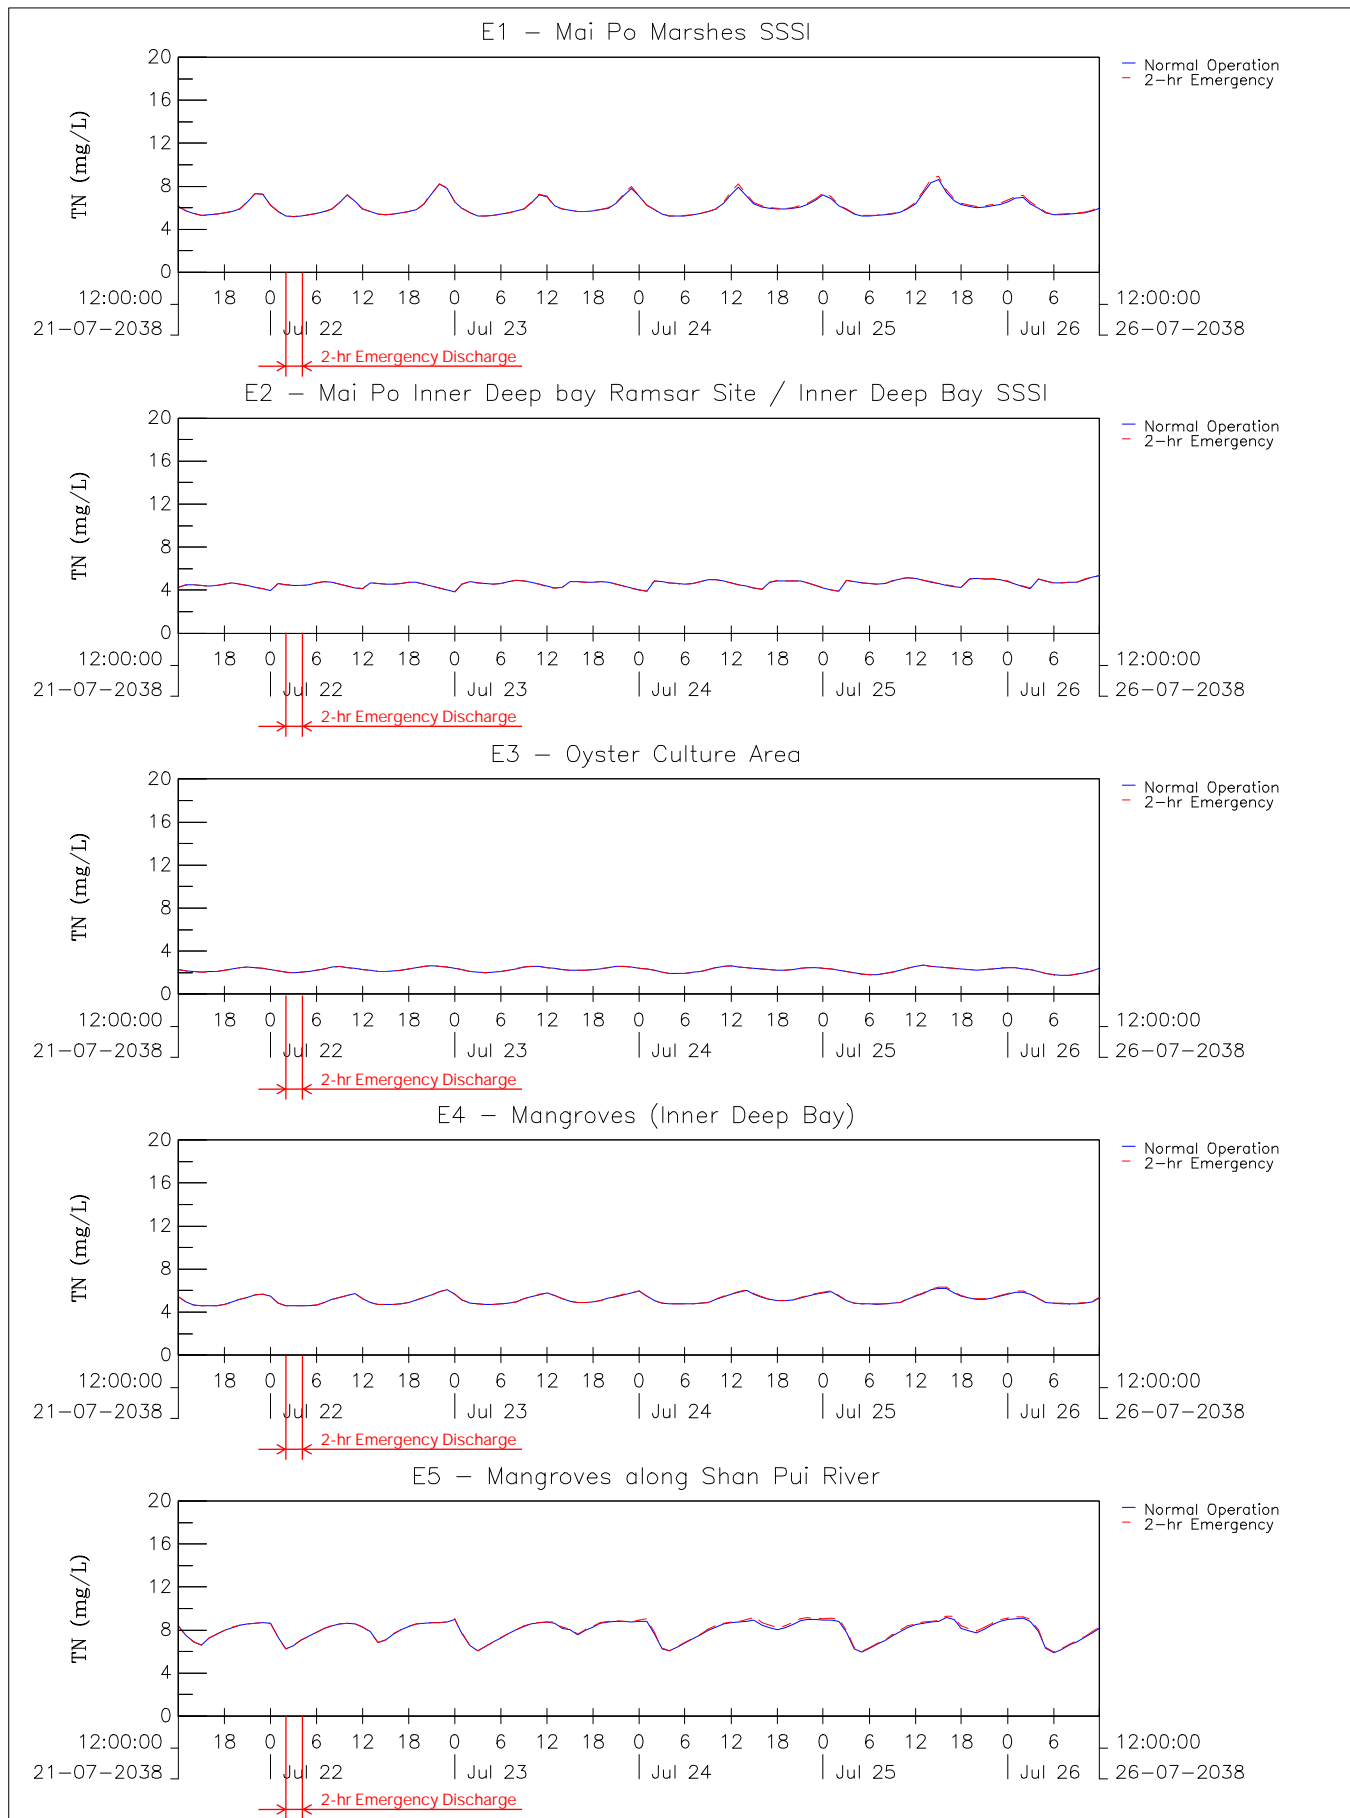
Agreement No. CE 6/2019 (DS) Hung Shui Kiu Effluent Polishing Plant and Yuen Long South Effluent Polishing Plant – Investigation Timeseries Plots for Depth Averaged Total Nitrogen (mg/L) Blue: Normal Operation of YLSEPP (Scenario 1); Dashed Red: 2-hr Emergency Discharge from YLSEPP (Scenario 2)		Emergency	Wet Season
Appendix 5.7 – 05			
AECOM		/GPP/	emergency-w.ssn

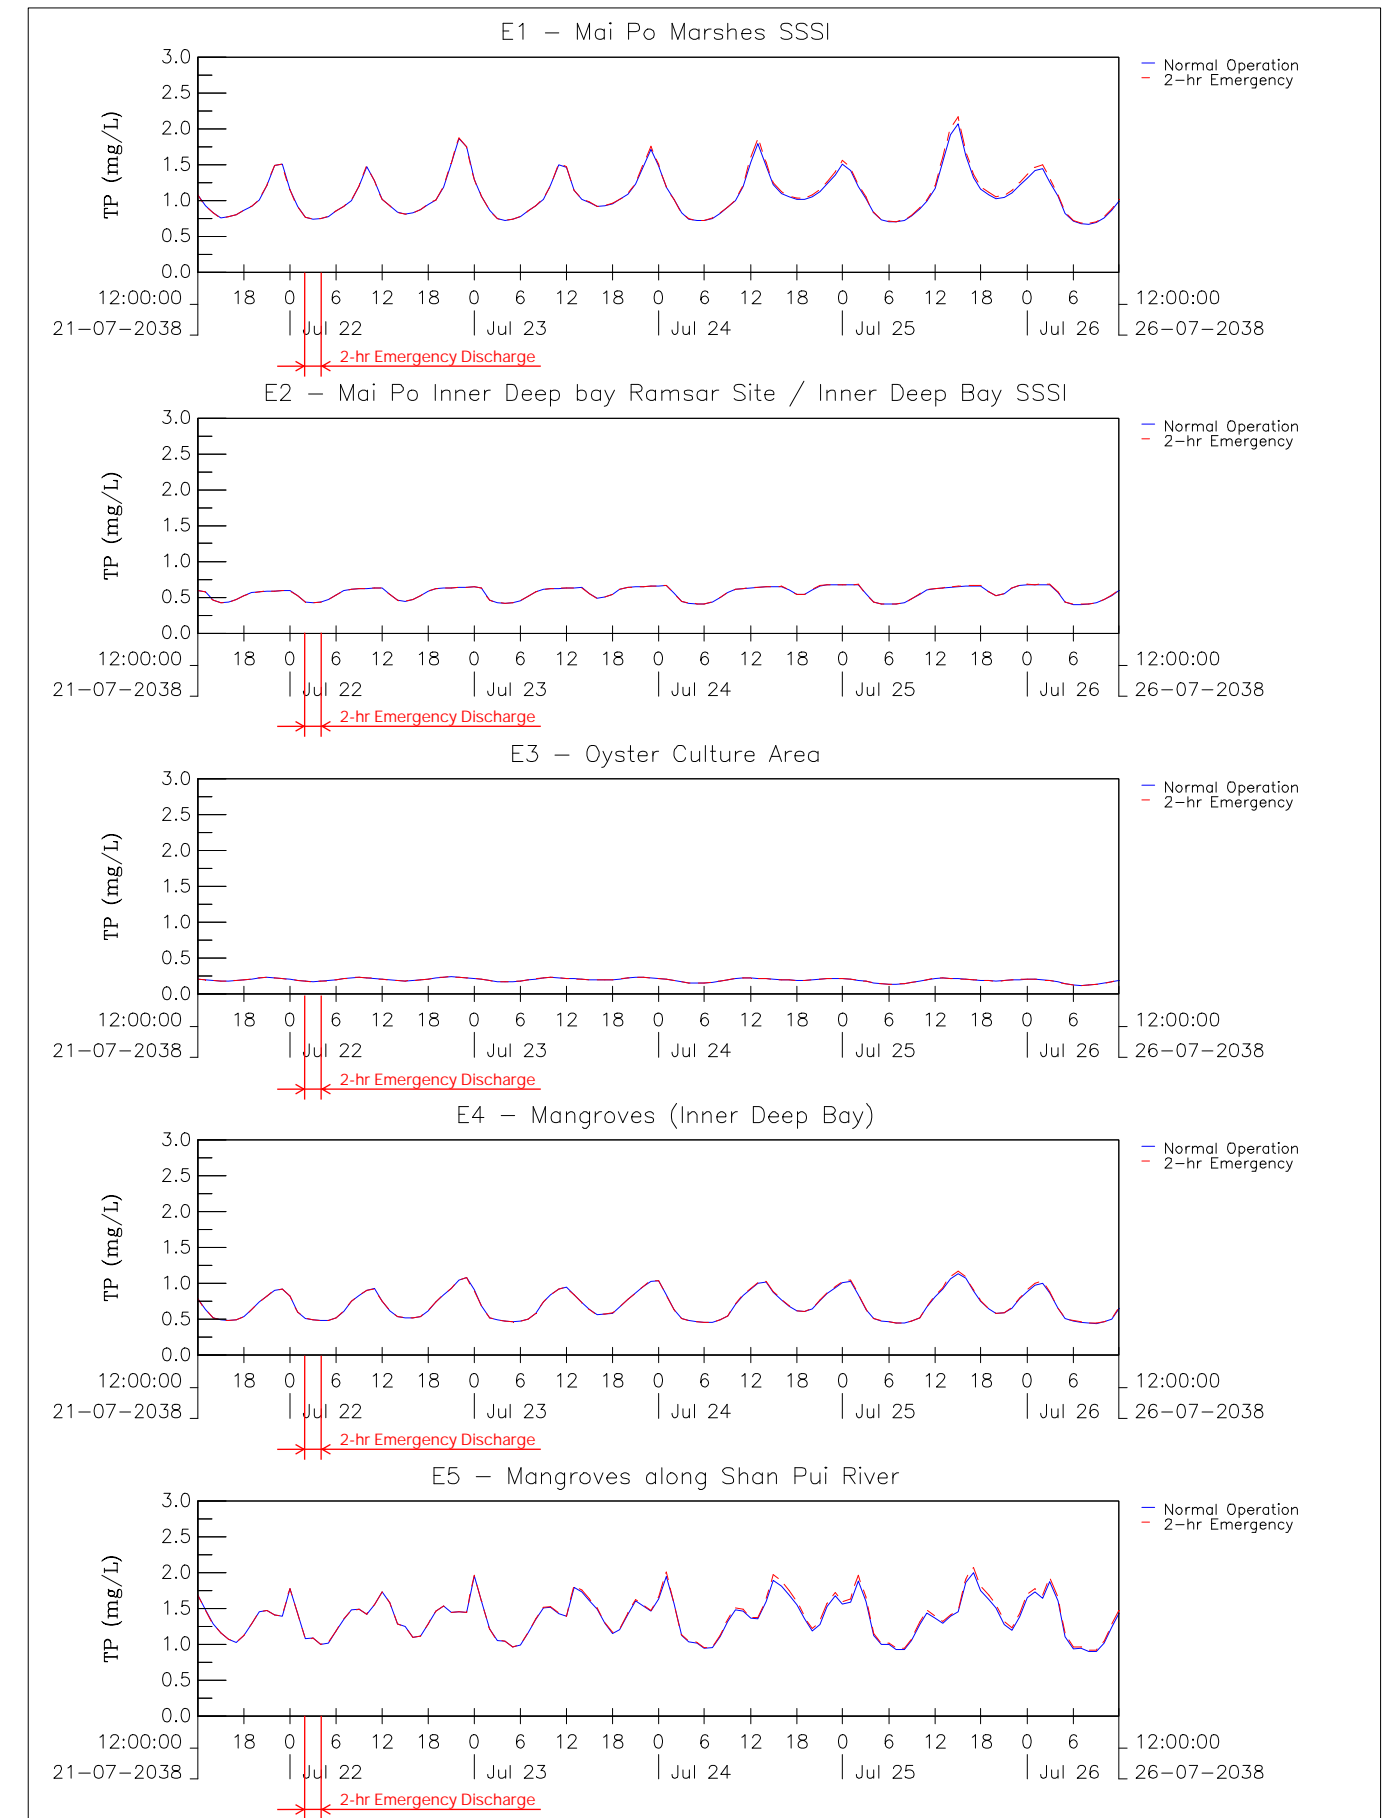
Agreement No. CE 6/2019 (DS) Hung Shui Kiu Effluent Polishing Plant and Yuen Long South Effluent Polishing Plant – Investigation Timeseries Plots for Depth Averaged Total Phosphorus (mg/L) Blue: Normal Operation of YLSEPP (Scenario 1); Dashed Red: 2-hr Emergency Discharge from YLSEPP (Scenario 2)		Emergency	Wet Season
Appendix 5.7 – 06			
AECOM		/GPP/	emergency-w.ssn

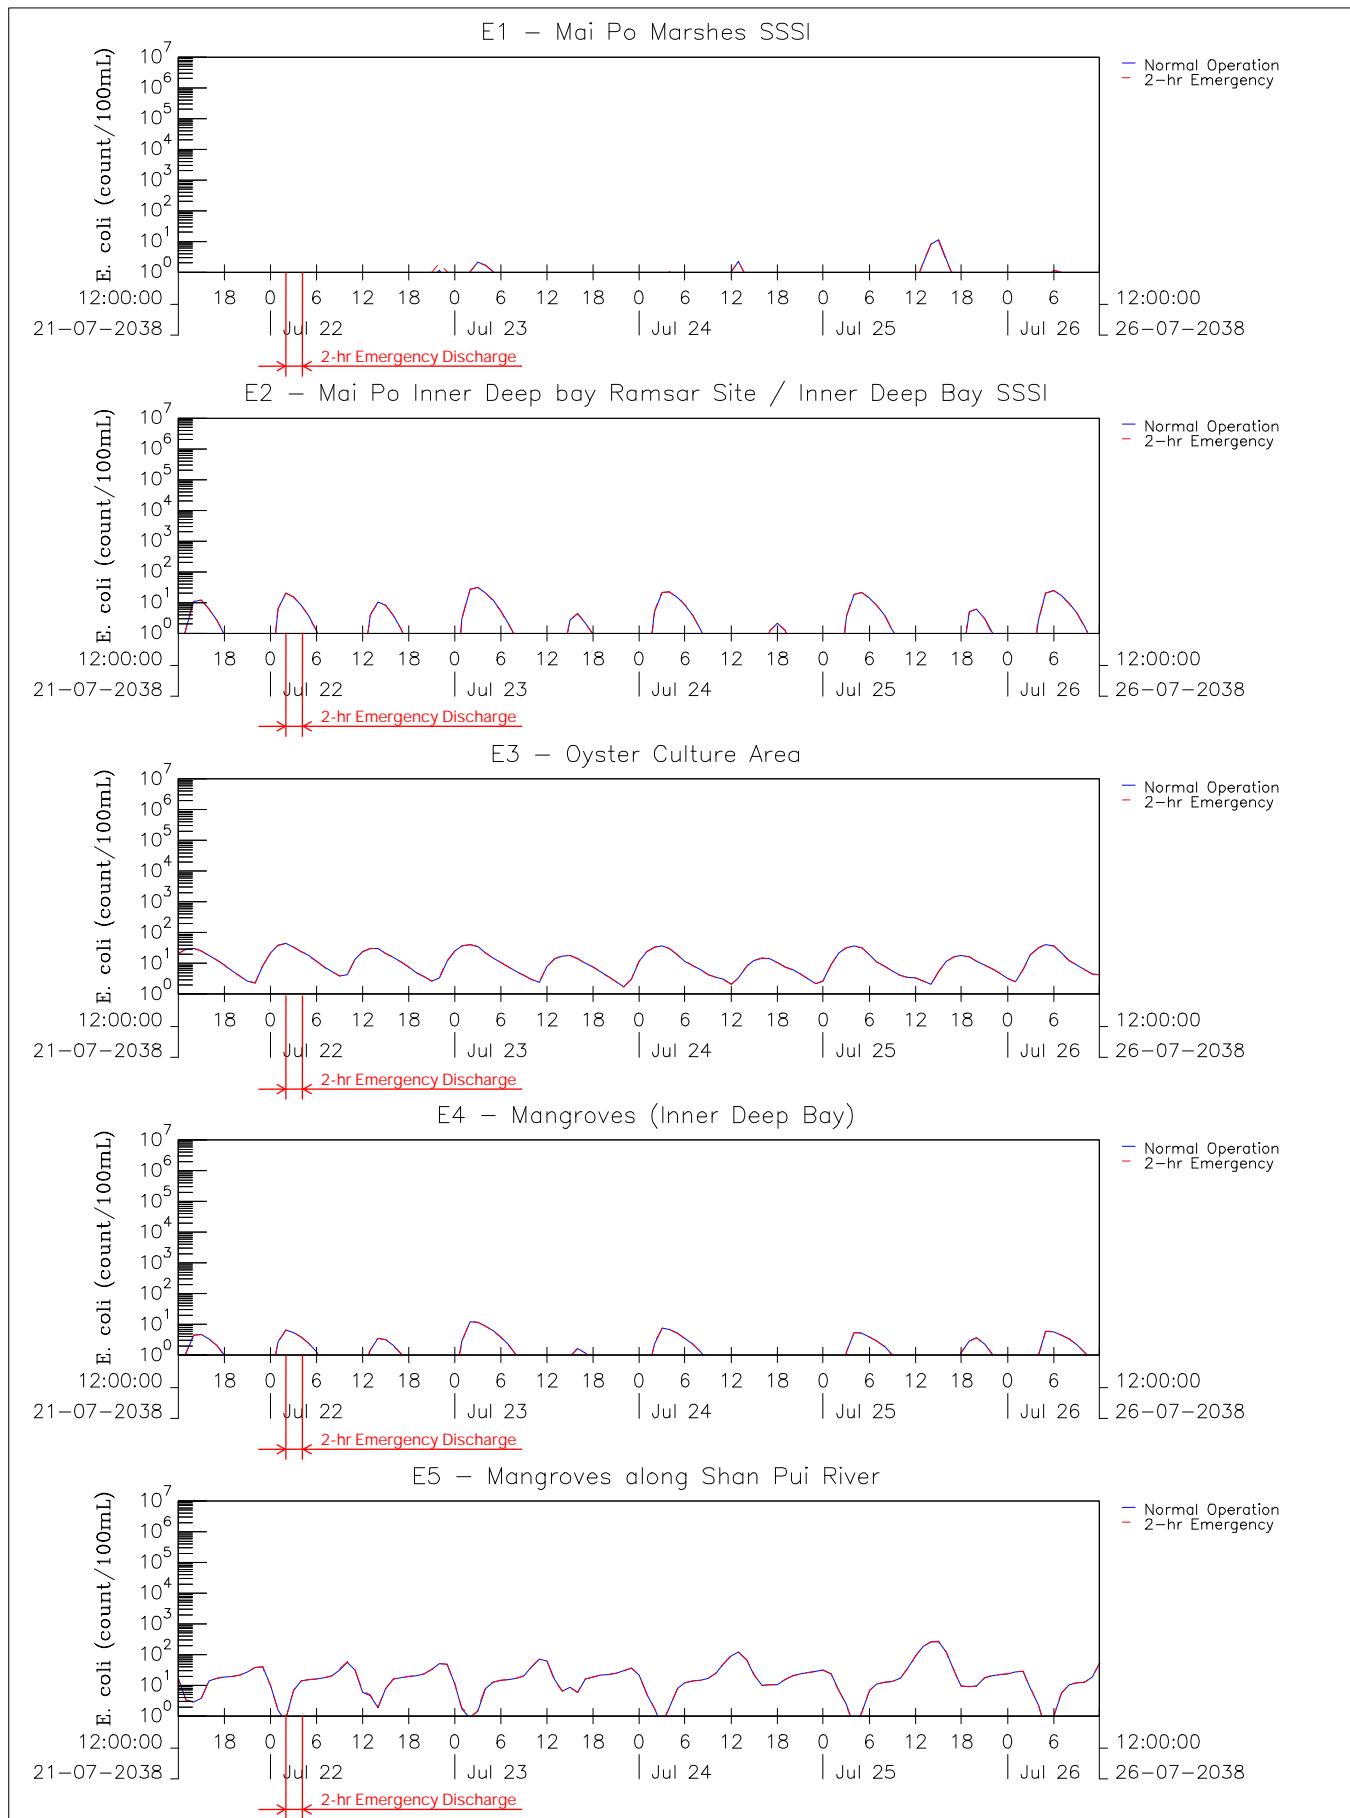
Agreement No. CE 6/2019 (DS) Hung Shui Kiu Effluent Polishing Plant and Yuen Long South Effluent Polishing Plant – Investigation Timeseries Plots for Depth Averaged E.coli (count/100mL) Blue: Normal Operation of YLSEPP (Scenario 1); Dashed Red: 2-hr Emergency Discharge from YLSEPP (Scenario 2)	Emergency	Wet Season
	Appendix 5.7 – 07	
AECOM	/GPP/	emergency-w.ssn

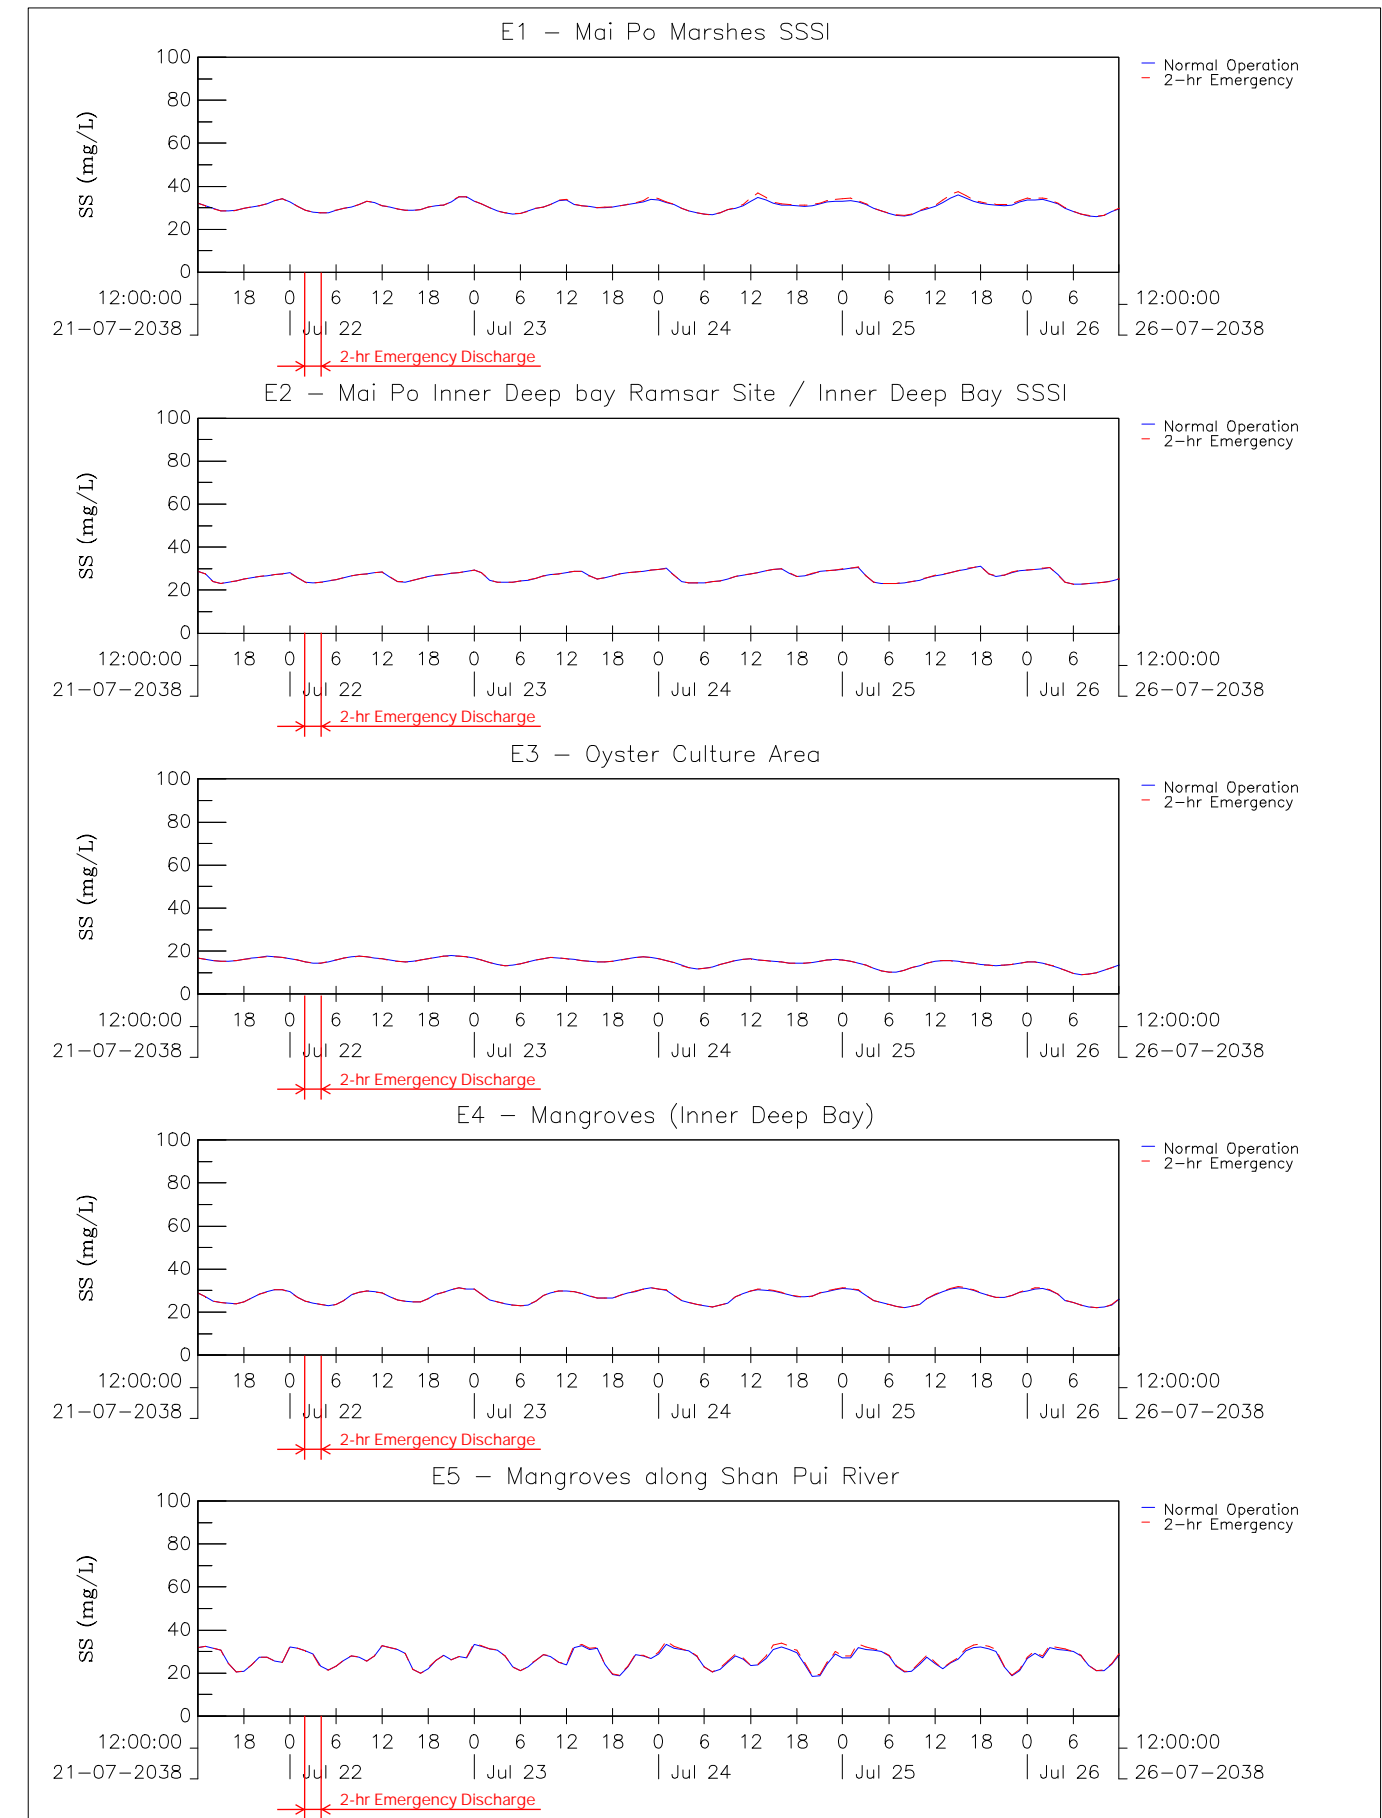
Agreement No. CE 6/2019 (DS) Hung Shui Kiu Effluent Polishing Plant and Yuen Long South Effluent Polishing Plant – Investigation Timeseries Plots for Depth Averaged Suspended Solids (mg/L) Blue: Normal Operation of YLSEPP (Scenario 1); Dashed Red: 2-hr Emergency Discharge from YLSEPP (Scenario 2)	Emergency	Wet Season
	Appendix 5.7 – 08	
AECOM	/GPP/	emergency-w.ssn
