Project title
Agreement No. CE 13/2021 (HY)
Route 11 (Section between Yuen Long and North Lantau)
- Investigation.

Drawing title
PHOTOMONTAGE OF VP-LT10 TRAIL WALKERS ON FU TEI COUNTRY TRAIL AND LAM TEI IRRIGATION RESERVOIR

Drawing no. FIGURE 11.10.10		Rev. B	
Drawn RY	Date 10/21	Checked IL	Approved SK
Scale		Status PRELIMINARY

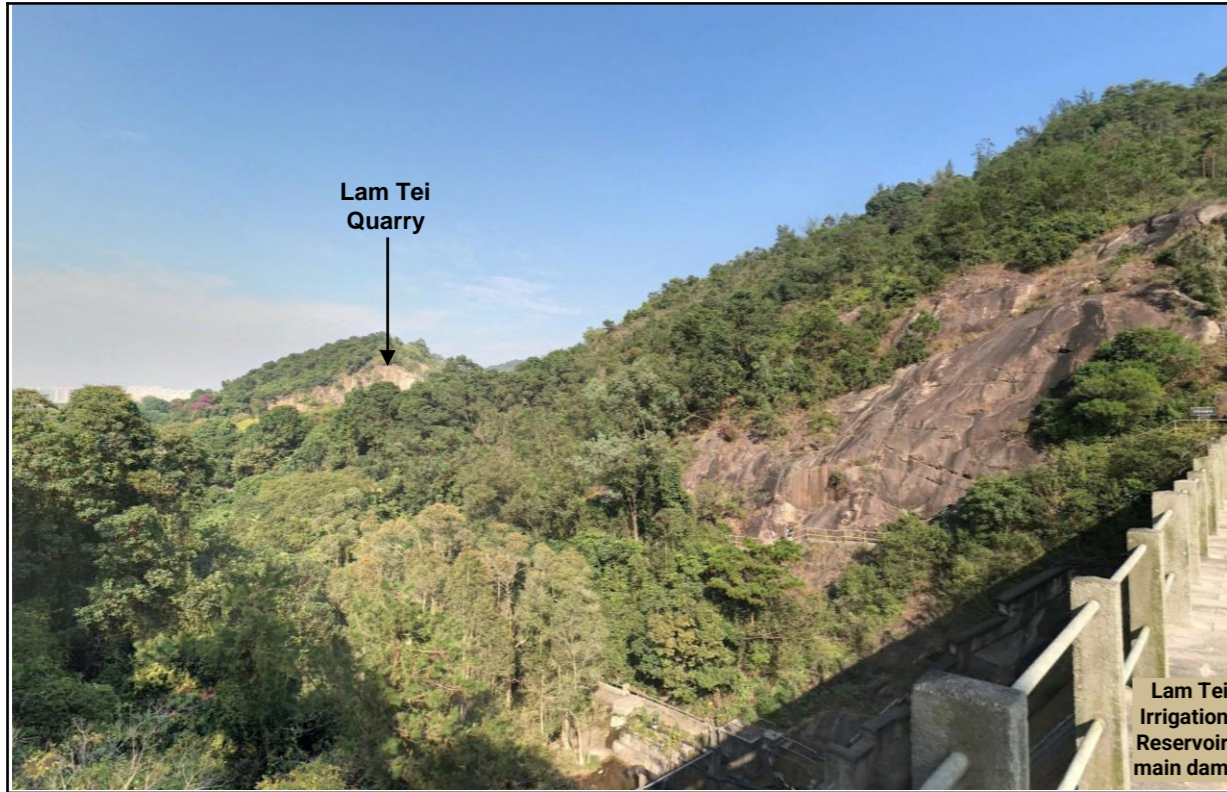
VP-LT10 – EXISTING CONDITION

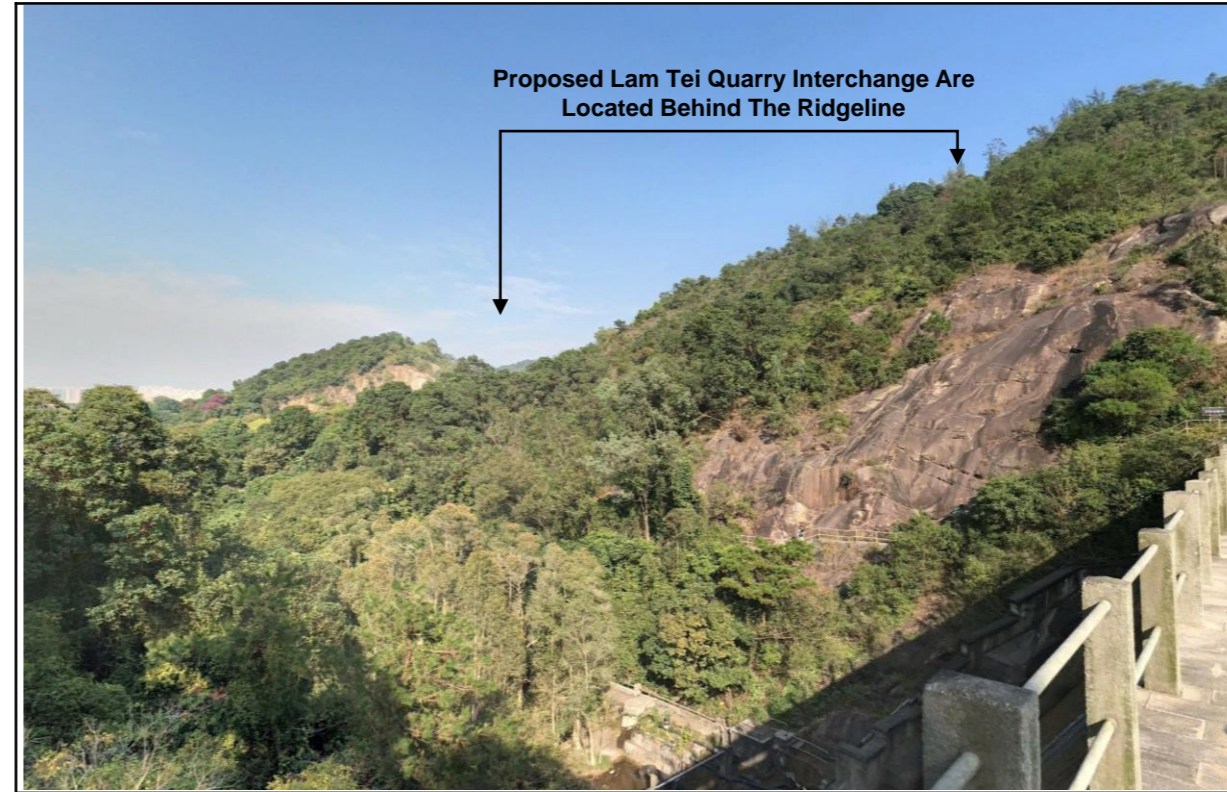
DAY 1 WITHOUT MITIGATION MEASURE

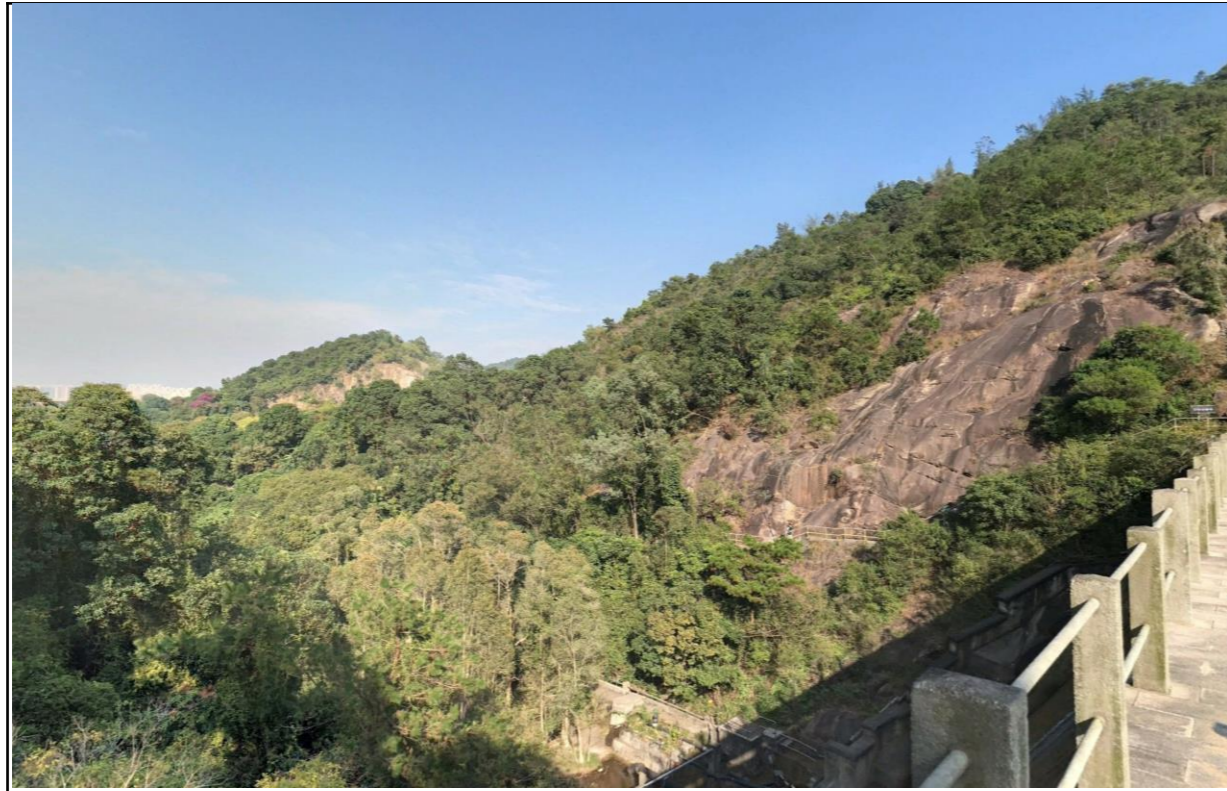
DAY 1 WITH MITIGATION MEASURE

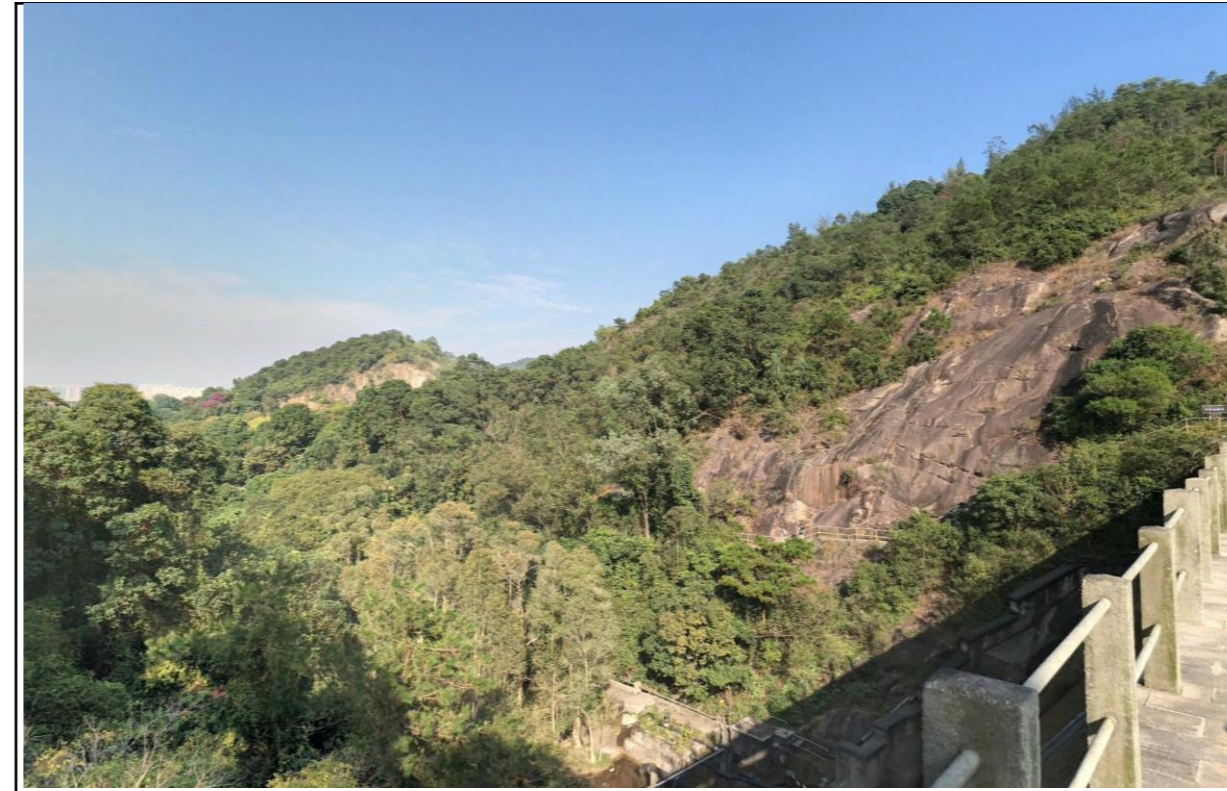
10 YEARS WITH MITIGATION MEASURE
