Project title  
 Agreement No. CE 13/2021 (HY)  
 Route 11 (Section between Yuen Long and North Lantau)  
 - Investigation.

Drawing title  
**PHOTOMONTAGE OF VP-TL2 RESIDENTS OF BELLAGIO AND OCEAN POINTE**

Drawing no.		Rev.	
FIGURE 11.10.17		C	
Drawn	Date	Checked	Approved
RY	10/21	IL	SK
Scale	Status	PRELIMINARY

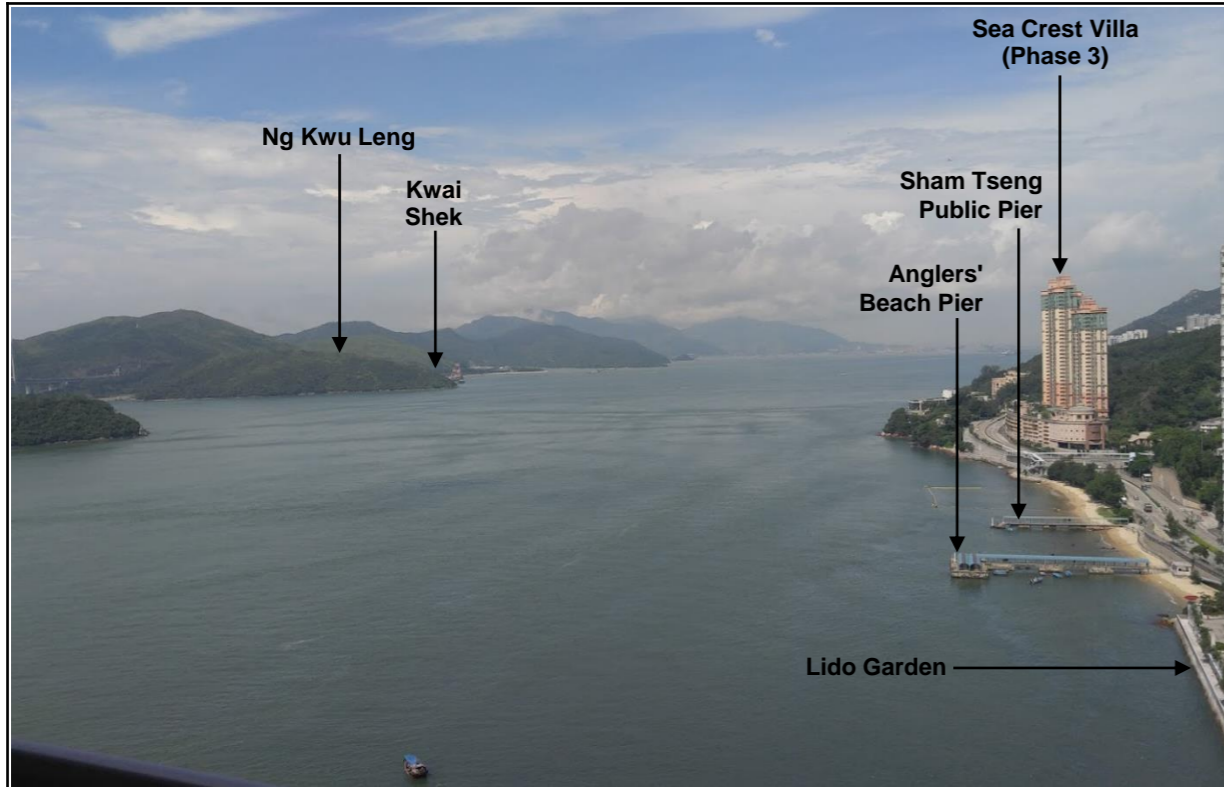
VP-TL2 – EXISTING CONDITION

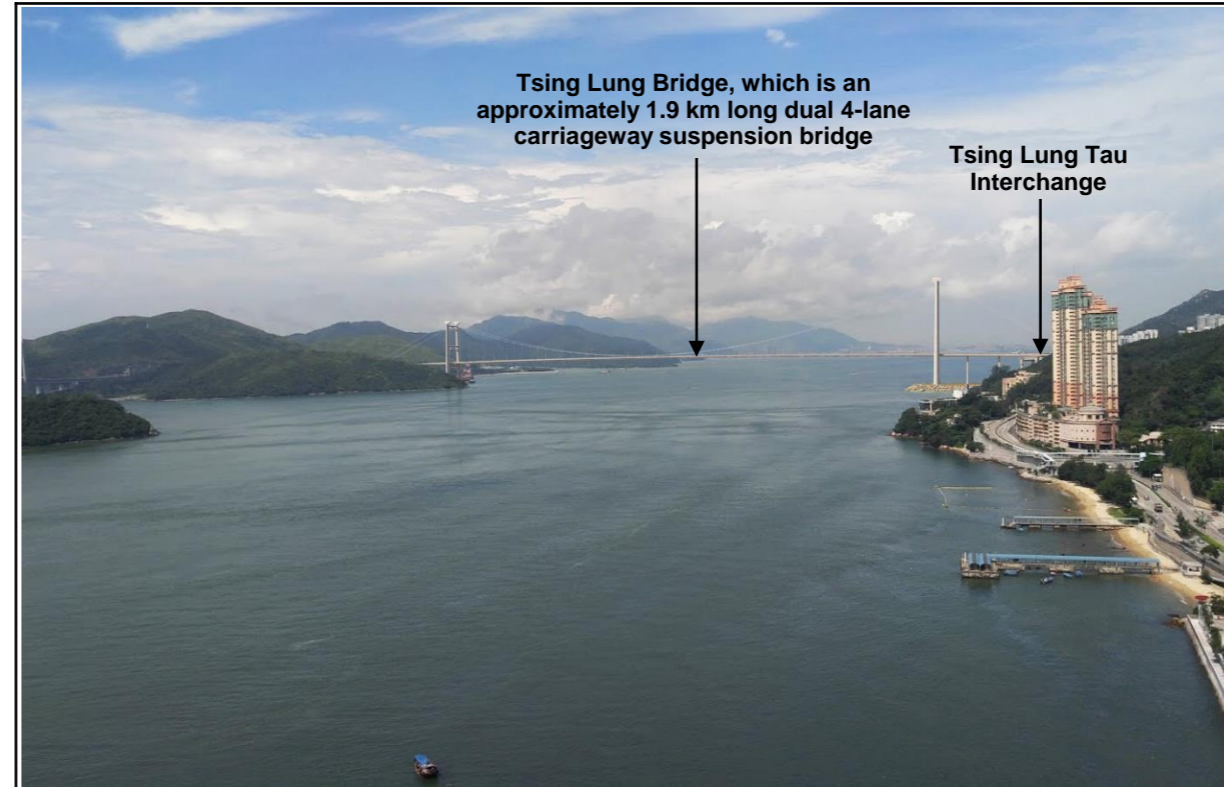
DAY 1 WITHOUT MITIGATION MEASURE

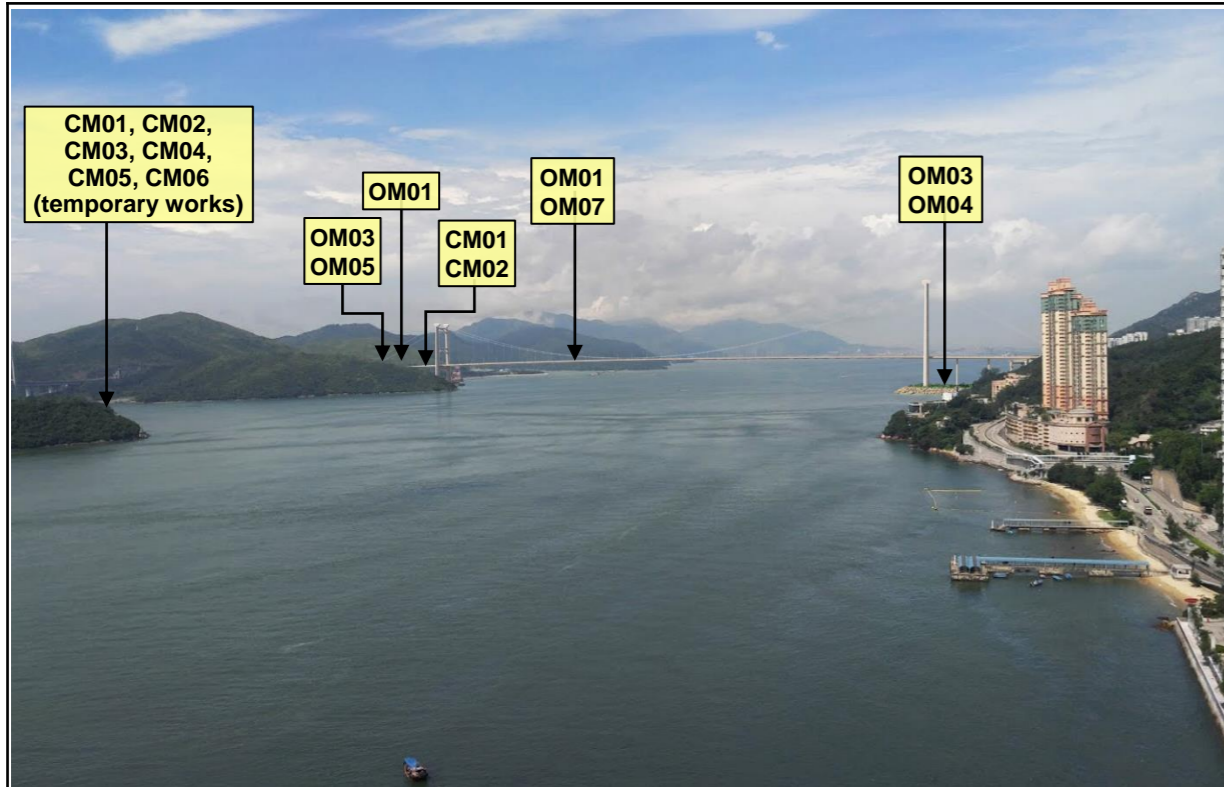
DAY 1 WITH MITIGATION MEASURE

CM01	Tree Protection and Preservation
CM02	Tree Transplantation
CM03	Works Area and Temporary Works Areas
CM04	Advance Implementation of Mitigation Planting
CM05	Decorative Screen Hoarding
CM06	Control of night-time lighting
OM01	Integrated Design Approach
OM02	Roadside Planting
OM03	Compensatory Planting Proposals
OM04	Post-Planting Monitoring
OM05	Greening Works on Slopes and associated Structure
OM06	Design of Tunnel Portals and landscape treatment
OM07	Design of an Elegant Bridge Structure and Approach Roads
OM08	Provision of Visually Pleasing Aesthetic Treatment of Noise Mitigation Measures
OM09	Provision of Green Roof

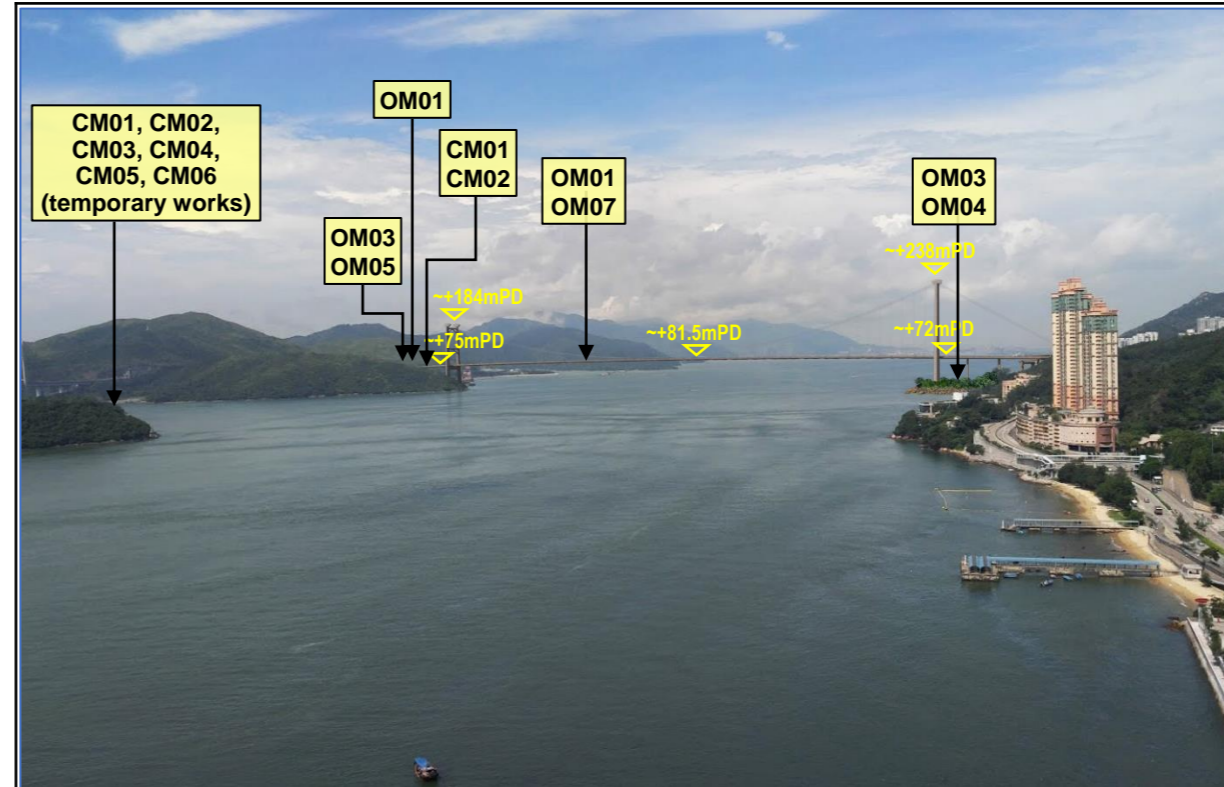
10 YEARS WITH MITIGATION MEASURE
