Project title  
Agreement No. CE 13/2021 (HY)  
Route 11 (Section between Yuen Long and North Lantau)  
- Investigation.

Drawing title  
**PHOTOMONTAGE OF VP-NL2 TRAIL WALKERS ON SUMMIT OF FA PENG TENG**

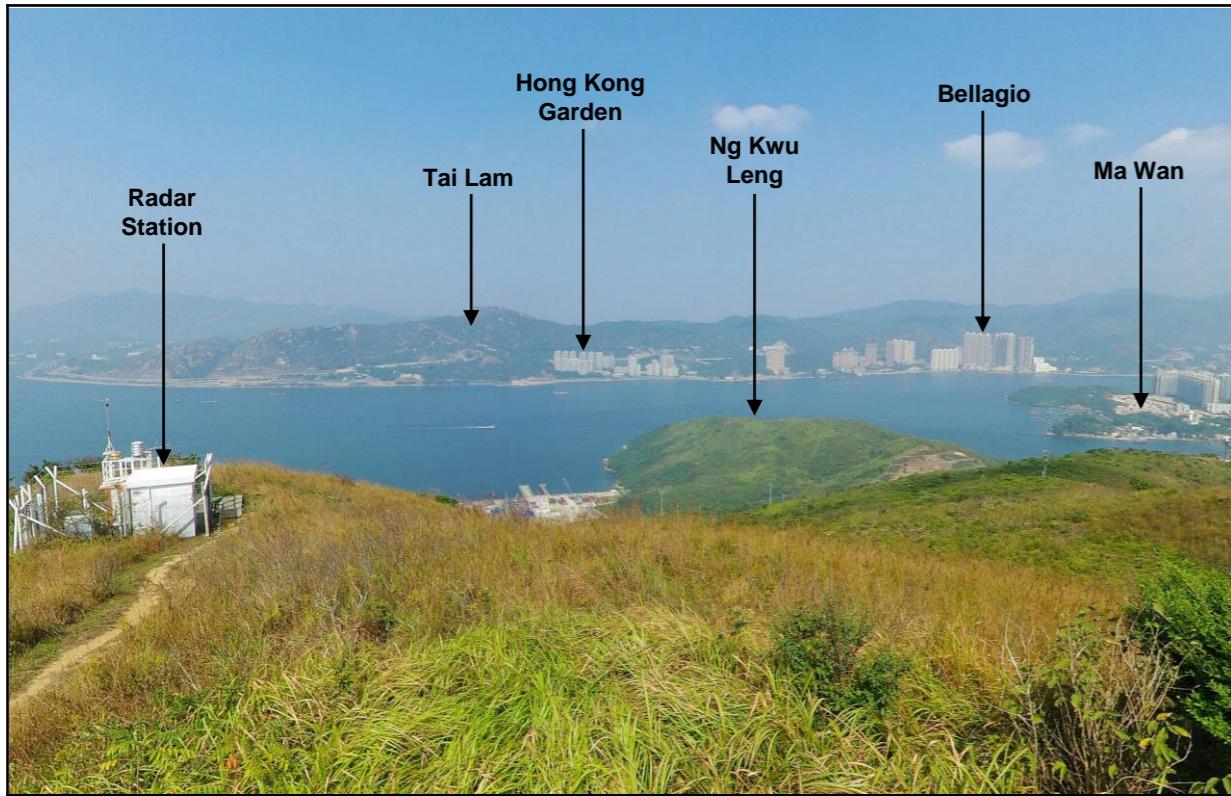
VP-NL2 – EXISTING CONDITION

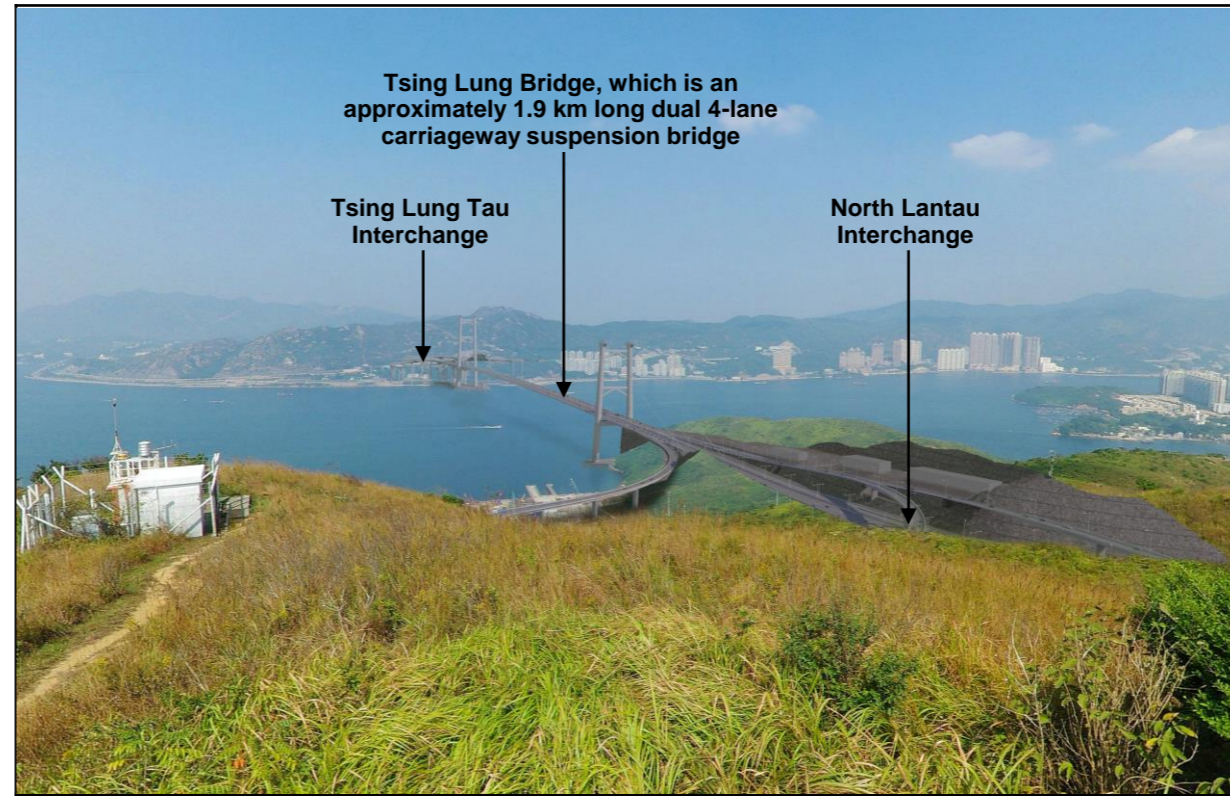
DAY 1 WITHOUT MITIGATION MEASURE

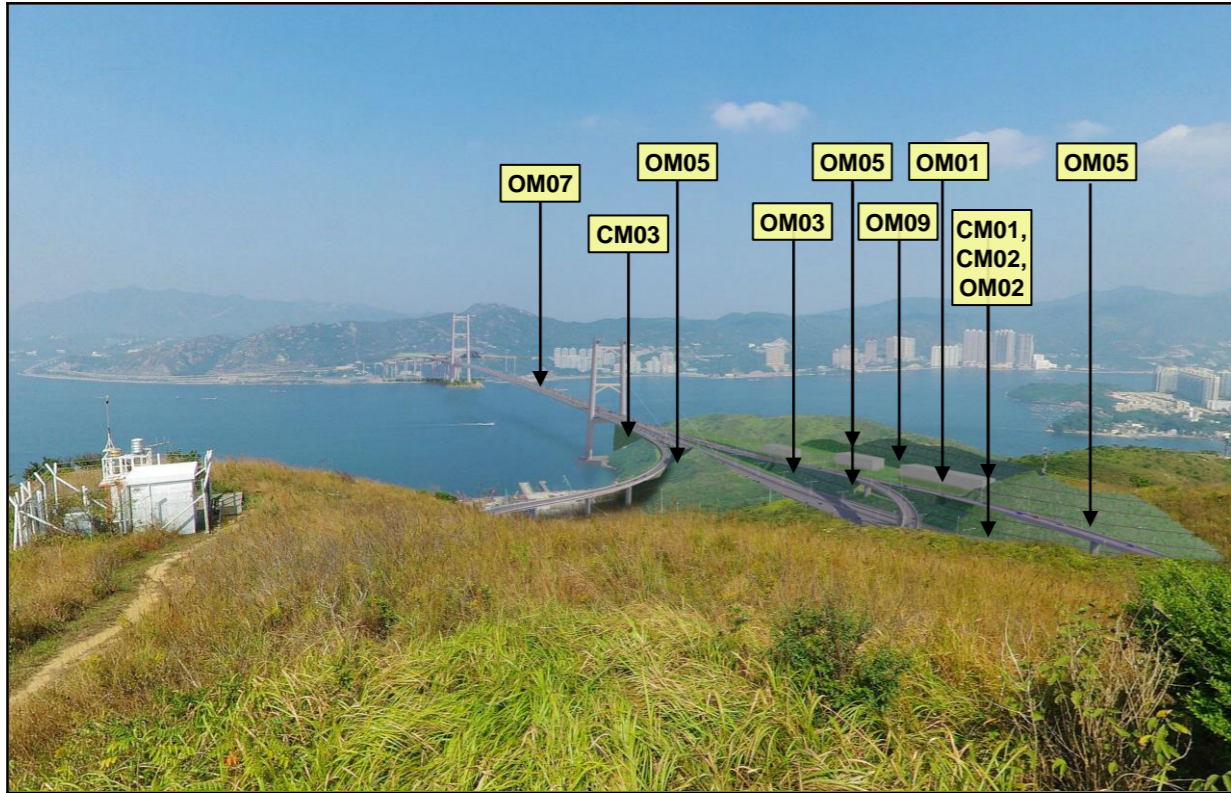
DAY 1 WITH MITIGATION MEASURE

CM01	Tree Protection and Preservation
CM02	Tree Transplantation
CM03	Works Area and Temporary Works Areas
CM04	Advance Implementation of Mitigation Planting
CM05	Decorative Screen Hoarding
CM06	Control of night-time lighting
OM01	Integrated Design Approach
OM02	Roadside Planting
OM03	Compensatory Planting Proposals
OM04	Post-Planting Monitoring
OM05	Greening Works on Slopes and associated Structure
OM06	Design of Tunnel Portals and landscape treatment
OM07	Design of an Elegant Bridge Structure and Approach Roads
OM08	Provision of Visually Pleasing Aesthetic Treatment of Noise Mitigation Measures
OM09	Provision of Green Roof

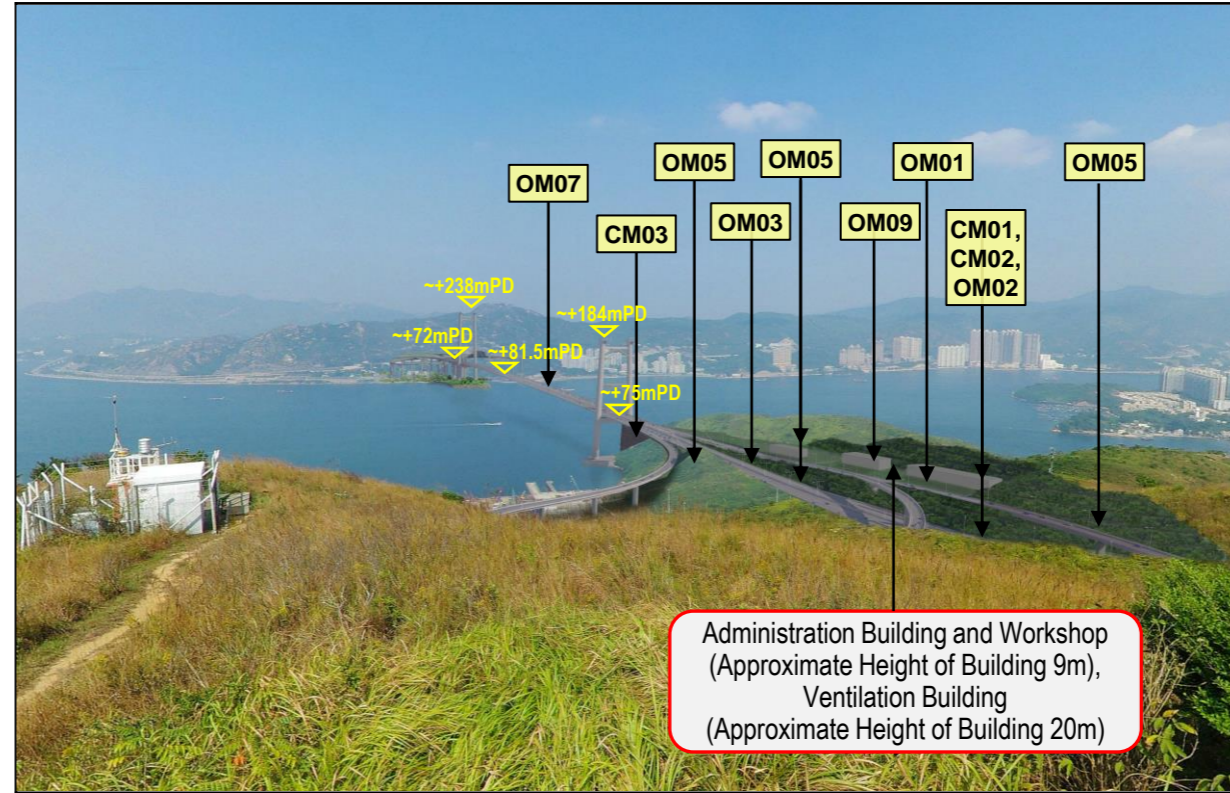
10 YEARS WITH MITIGATION MEASURE
