Project title
Agreement No. CE 13/2021 (HY)
Route 11 (Section between Yuen Long and North Lantau)
- Investigation.

Drawing title
PHOTOMONTAGE OF VP-NL8 RESIDENTS OF PARK ISLAND

Drawing no. FIGURE 11.10.21		Rev. C	
Drawn RY	Date 10/21	Checked IL	Approved SK
Scale		Status PRELIMINARY

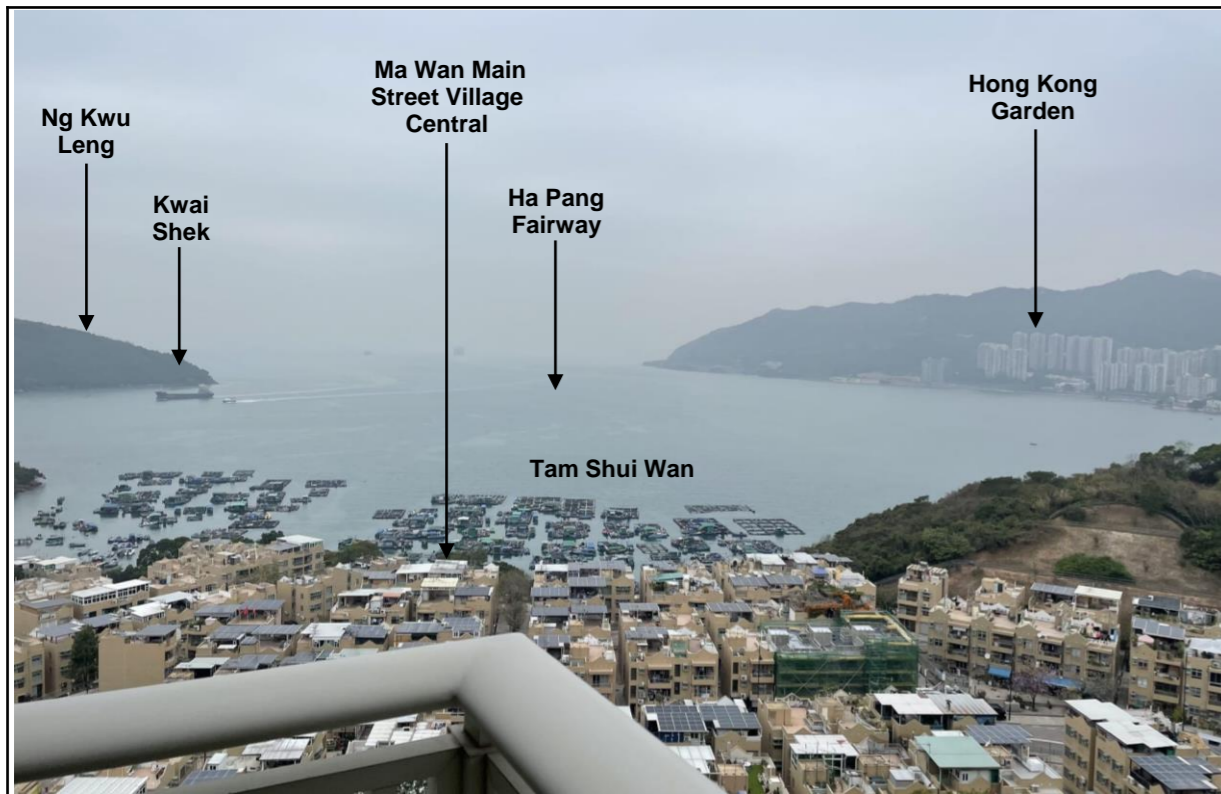
VP-NL8 – EXISTING CONDITION

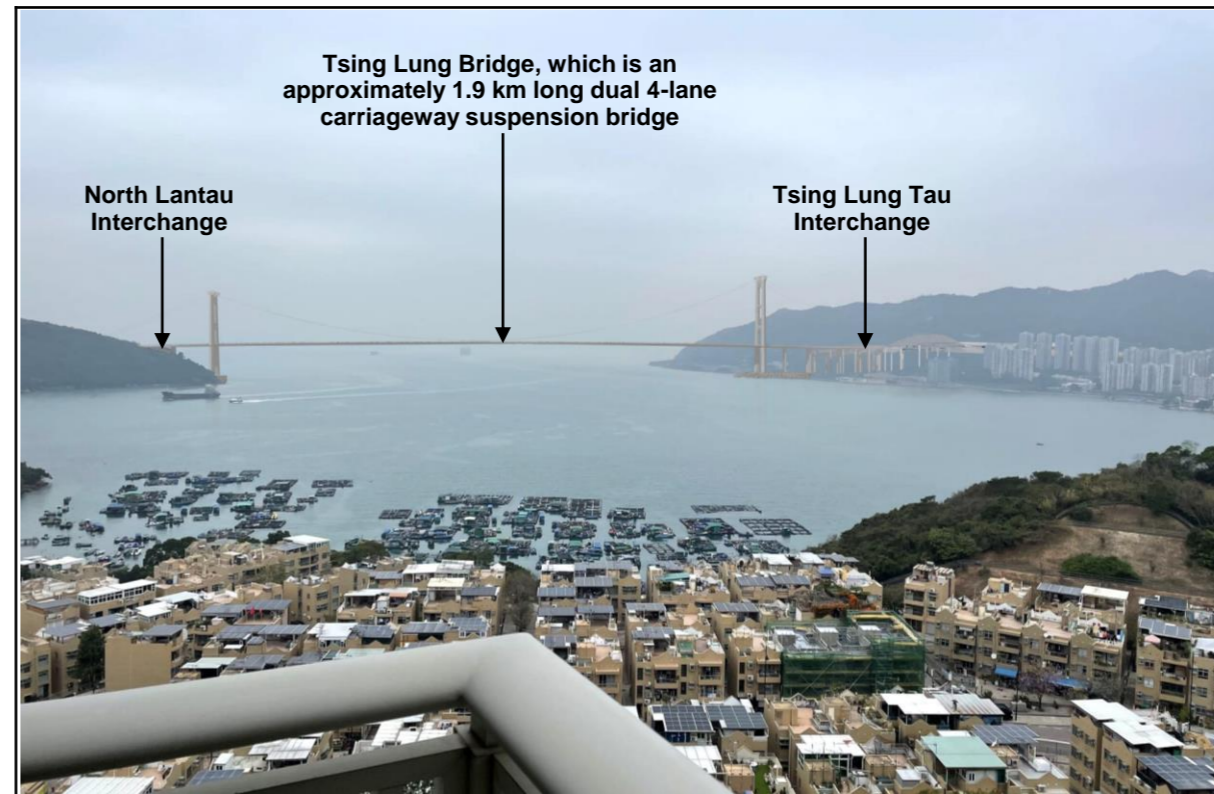
DAY 1 WITHOUT MITIGATION MEASURE

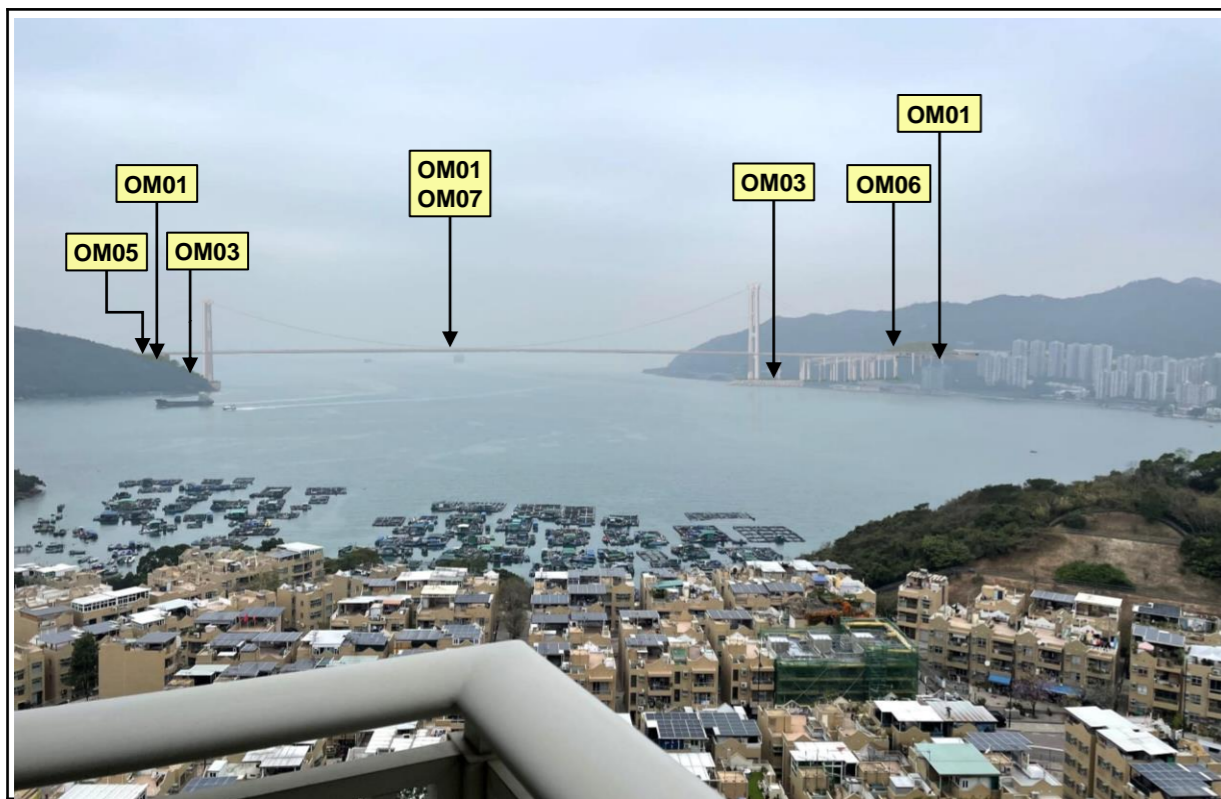
DAY 1 WITH MITIGATION MEASURE

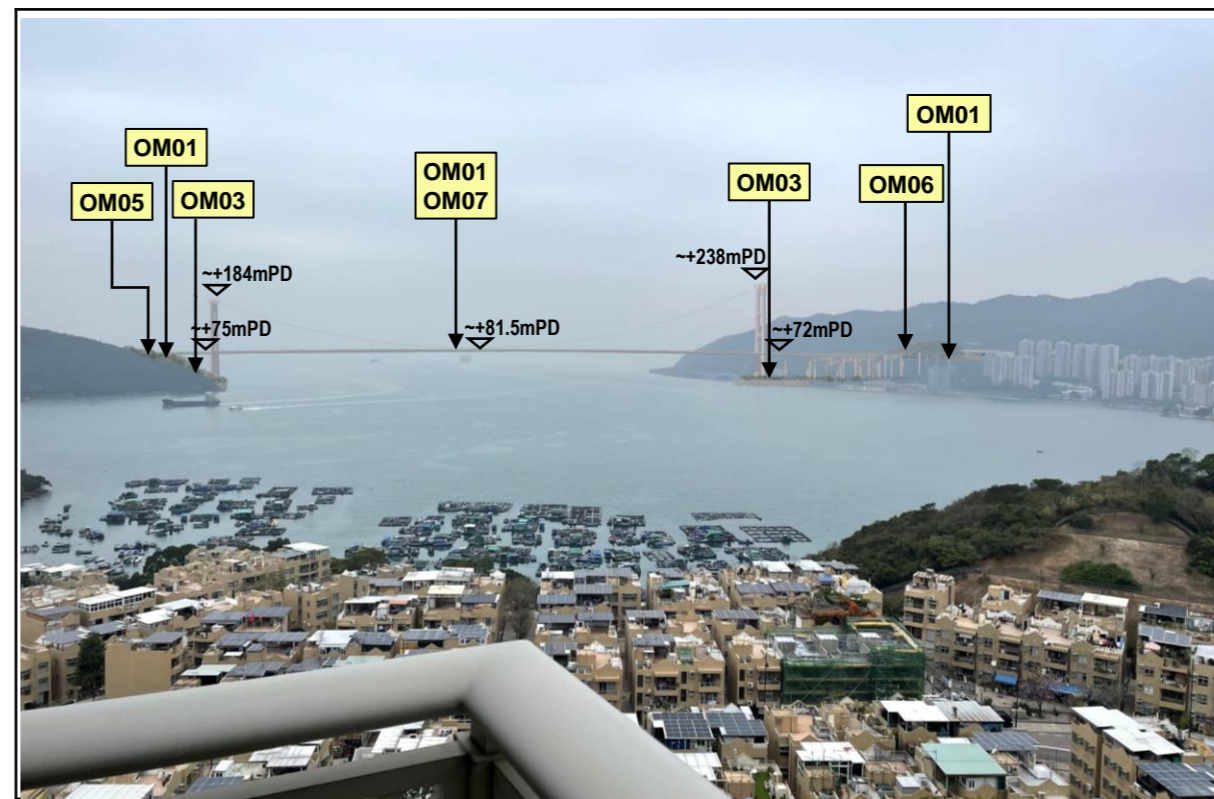
10 YEARS WITH MITIGATION MEASURE

CM01	Tree Protection and Preservation
CM02	Tree Transplantation
CM03	Works Area and Temporary Works Areas
CM04	Advance Implementation of Mitigation Planting
CM05	Decorative Screen Hoarding
CM06	Control of night-time lighting
OM01	Integrated Design Approach
OM02	Roadside Planting
OM03	Compensatory Planting Proposals
OM04	Post-Planting Monitoring
OM05	Greening Works on Slopes and associated Structure
OM06	Design of Tunnel Portals and landscape treatment
OM07	Design of an Elegant Bridge Structure and Approach Roads
OM08	Provision of Visually Pleasing Aesthetic Treatment of Noise Mitigation Measures
OM09	Provision of Green Roof
