Project title
Agreement No. CE 65/2021(HY)
Tuen Mun Bypass - Investigation

Drawing title
PHOTOMONTAGE OF
VP-PP4 – WORKERS AT
TUEN MUN AREA 40

Drawing no.	FIGURE 11.13.4	Rev.	C
Drawn	RY	Date	06/22
Checked	AW	Approved	SK
Scale	N. T. S.	Status	PRELIMINARY

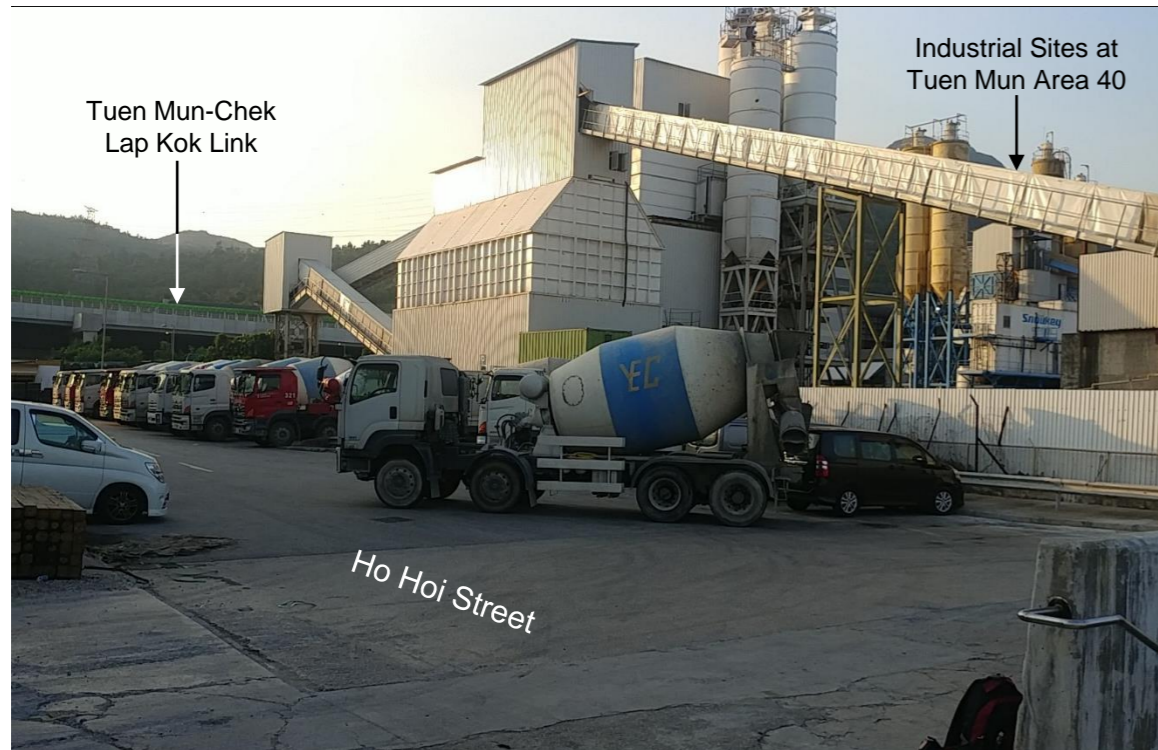
EXISTING CONDITION

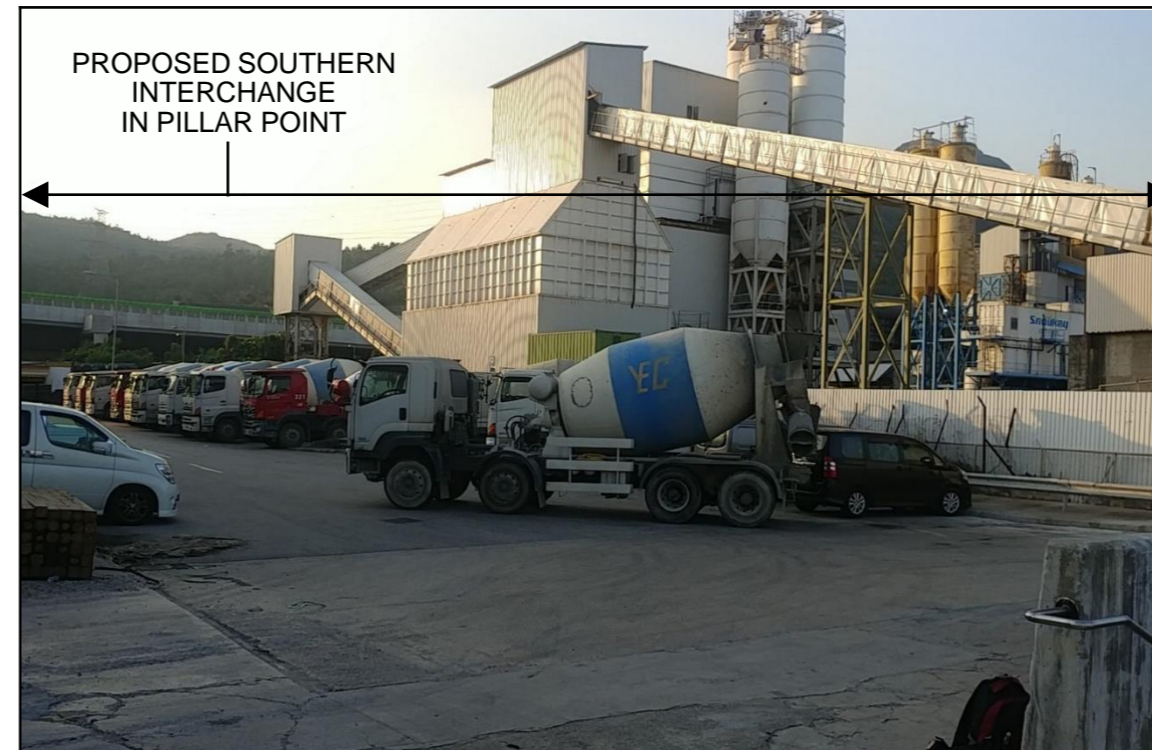
DAY 1 WITHOUT MITIGATION MEASURES

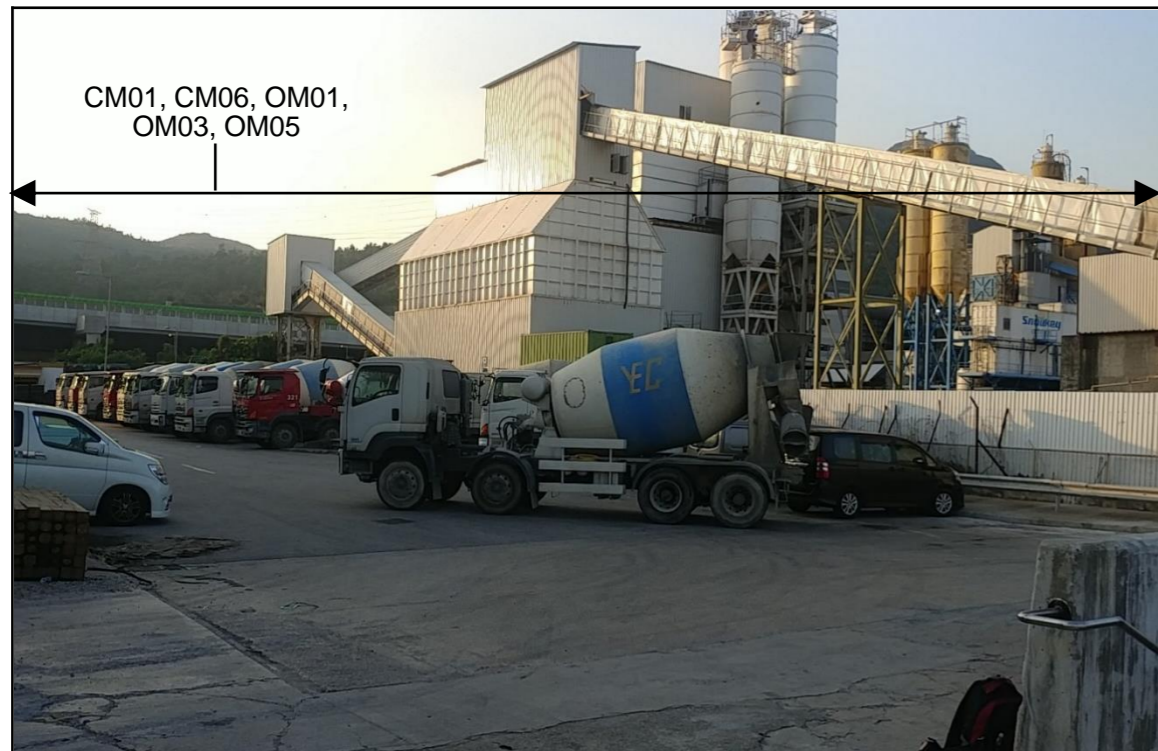
DAY 1 WITH MITIGATION MEASURES

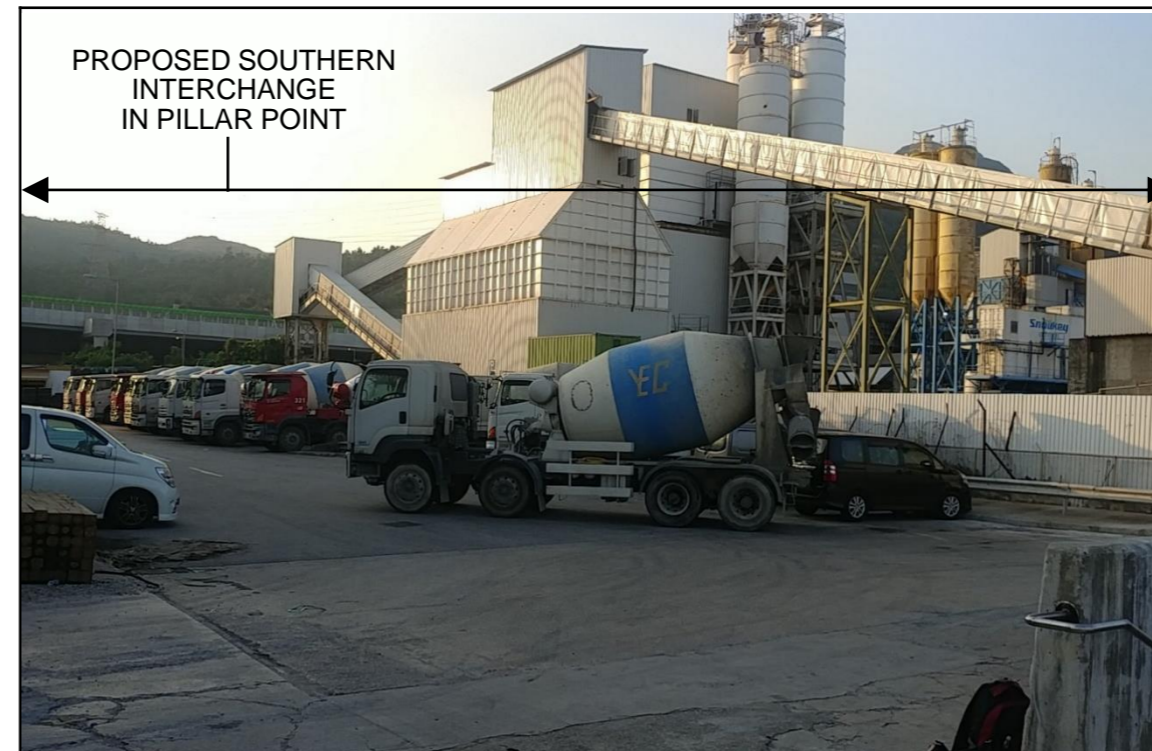
YEAR 10 WITH MITIGATION MEASURES
