Project title  
AGREEMENT NO. CE 1/2021(HY)  
IMPROVEMENT TO SO KWUN PO INTERCHANGE –  
INVESTIGATION, DESIGN AND CONSTRUCTION

Drawing title  
PHOTOMONTAGE VIEWPOINT 03

Drawing no.	FIGURE 9.8.3	Rev.	0
Drawn	Date APR 2022	Checked BN	Approved CL
Scale N.T.S	Status FOR INFORMATION

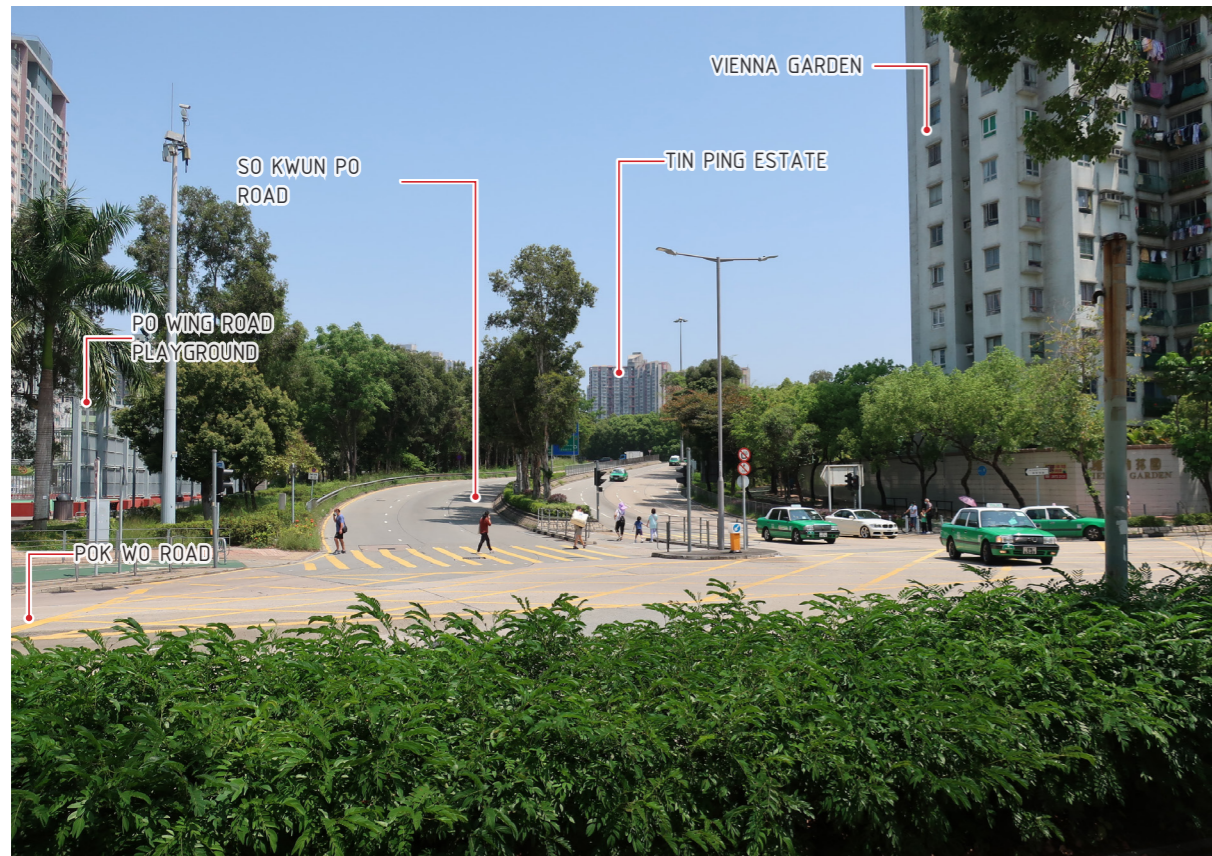
VP03 - WAI HON ROAD GARDEN  
EXISTING CONDITION

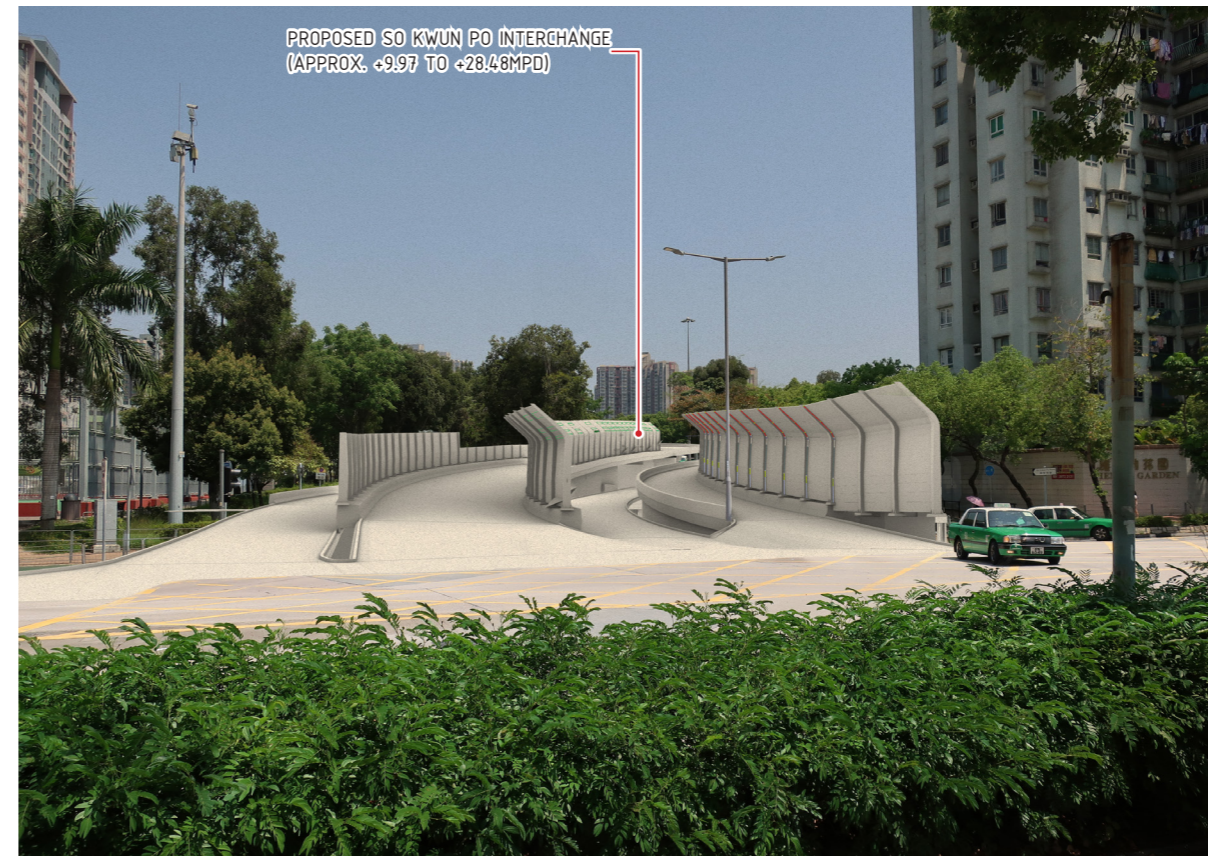
VP03 - WAI HON ROAD GARDEN  
WITHOUT MITGATION MEASURES

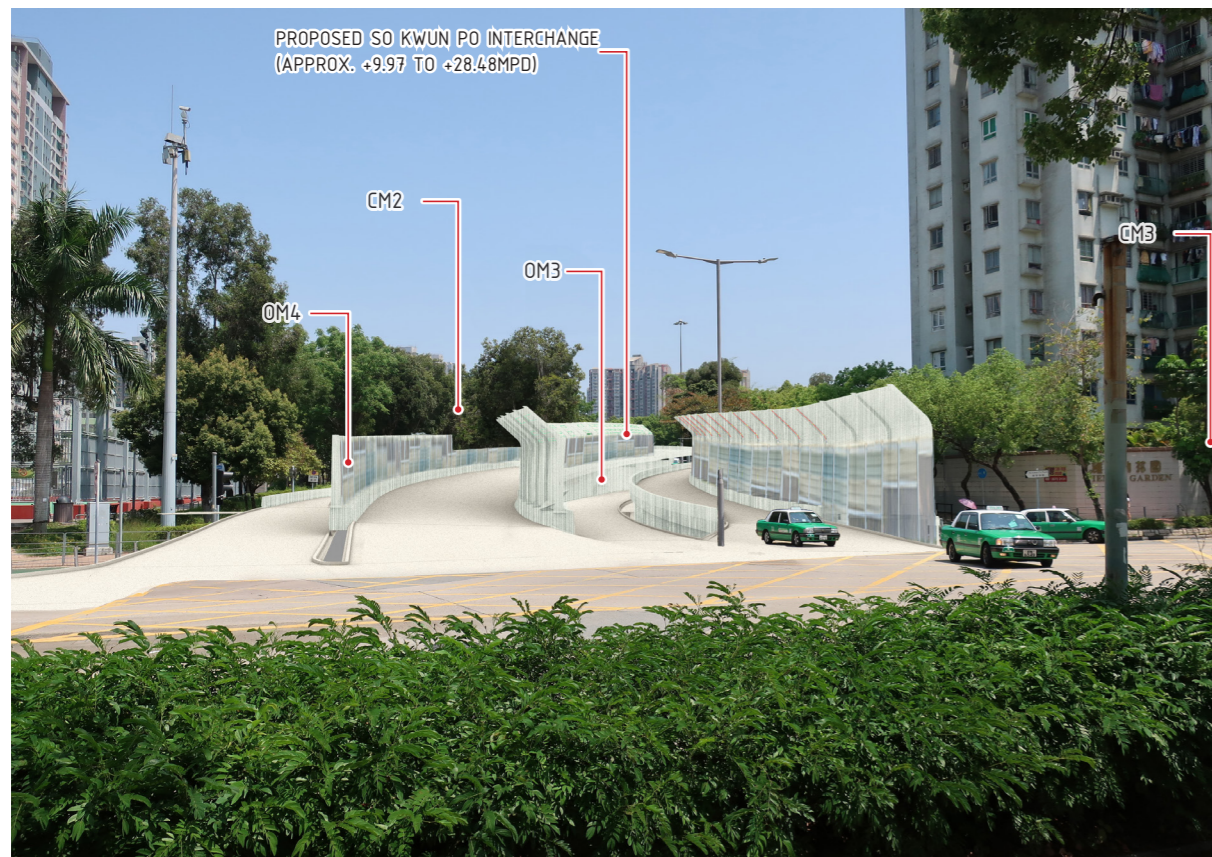
VP03 - WAI HON ROAD GARDEN  
DAY 1 WITH MITGATION MEASURES

MITIGATION MEASURES (CONSTRUCTION PHASE)			
CM1	Re-provisioned Cycle Track and Footpath	CM5	Good Site Practice
CM2	Preservation of Existing Vegetation	CM6	Erection of Decorative Screen Hoarding
CM3	Transplanting of Affected Trees	CM7	Reinstatement of Temporarily Disturbed Landscape Areas
CM4	Control of Night-time Lighting Glare

MITIGATION MEASURES (OPERATION PHASE)	
OM1	Compensatory Tree Planting
OM2	Roadside Planting
OM3	Aesthetically pleasing design for carriageways and other highways structures
OM4	Provision of Aesthetic Pleasing Treatment on Noise Barriers

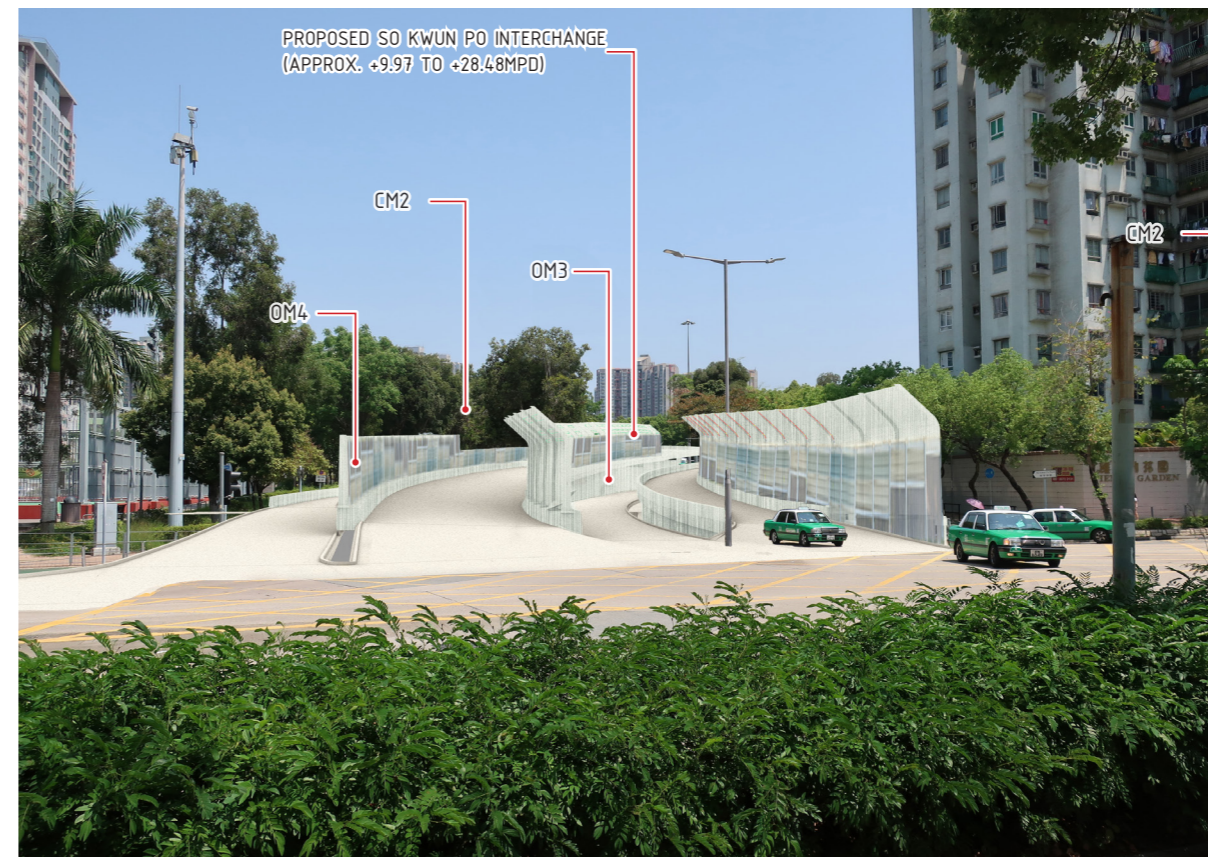
VP03 - WAI HON ROAD GARDEN  
YEAR 10 WITH MITGATION MEASURES
