VP04 - PO WING ROAD PLAYGROUND EXISTING CONDITION

)	DRAFT IS	SSUE 1		BN	APR 22					
Rev	Descrip	tion		Ву	Date					
Consultant										
Project title										
AGREEMENT NO. CE 1/2021(HY)										
MPROVEMENT TO SO KWUN PO INTERCHANGE -										
NVESTIGATION, DESIGN AND CONSTRUCTION										
Drawing title										
PHOTOMONTAGE VIEWPOINT 04										
FIGURE 9.8.4				f	Rev. 0					
Draw		Date APR 2022	Checked BN	App	roved CL					
Scale N.T.S			Status FOR INFORMATION							
© COPYRIGHT RESERVED

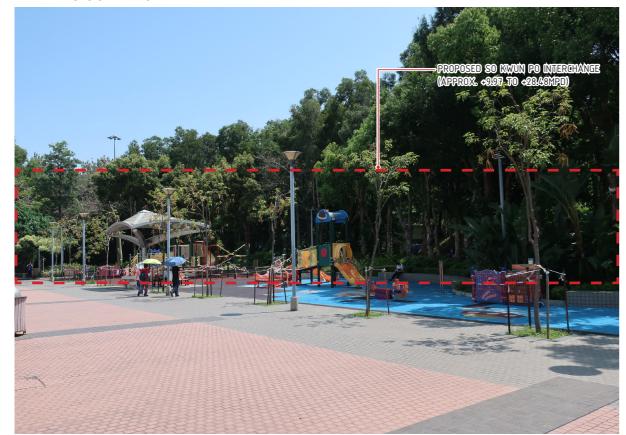
VP04 - PO WING ROAD PLAYGROUND DAY 1 WITH MITGATION MEASURES

MITIGATION MEASURES (CONSTRUCTION PHASE)						
CM1	Re-provisioned Cycle Track and Footpath	CM5	Good Site Practice			
CM2	Preservation of Existing Vegetation	CM6	Erection of Decorative Screen Hoarding			
CM3	Transplanting of Affected Trees	CM7	Reinstatement of Temporarily Disturbed Landscape Areas			
CM4	Control of Night-time Lighting Glare

MITIG	MITIGATION MEASURES (OPERATION PHASE)					
0M1	Compensatory Tree Planting					
OM2	Roadside Planting					
0M3	Aesthetically pleasing design for carriageways and other highways structures					
0M4	Provision of Aesthetic Pleasing Treatment on Noise Barriers

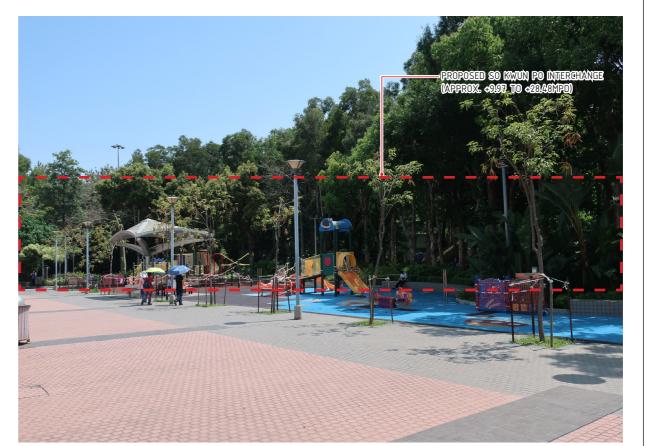
VP04 - PO WING ROAD PLAYGROUND WITHOUT MITGATION MEASURES

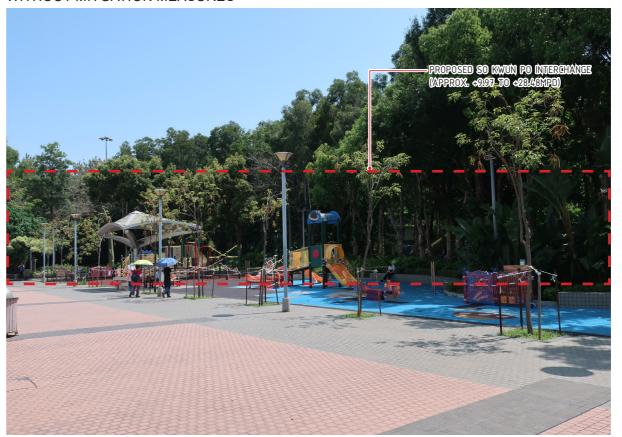
VP04 - PO WING ROAD PLAYGROUND YEAR 10 WITH MITGATION MEASURES
