Project title  
AGREEMENT NO. CE 1/2021(HY)  
IMPROVEMENT TO SO KWUN PO INTERCHANGE –  
INVESTIGATION, DESIGN AND CONSTRUCTION

Drawing title  
PHOTOMONTAGE VIEWPOINT 07

Drawing no.	FIGURE 9.8.7	Rev.	0
Drawn	Date APR 2022	Checked BN	Approved CL
Scale	N.T.S	Status	FOR INFORMATION

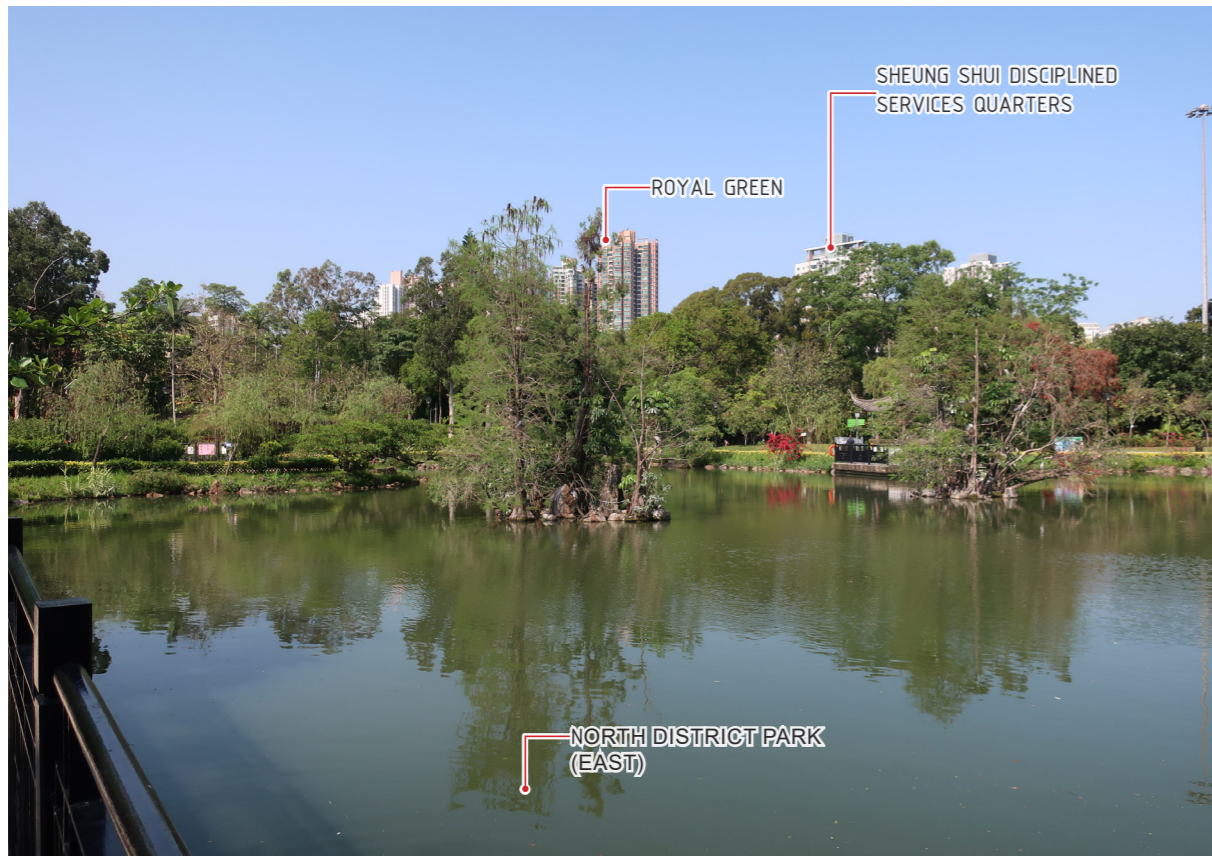
VP07 - NORTH DISTRICT PARK (EAST SIDE)  
EXISTING CONDITION

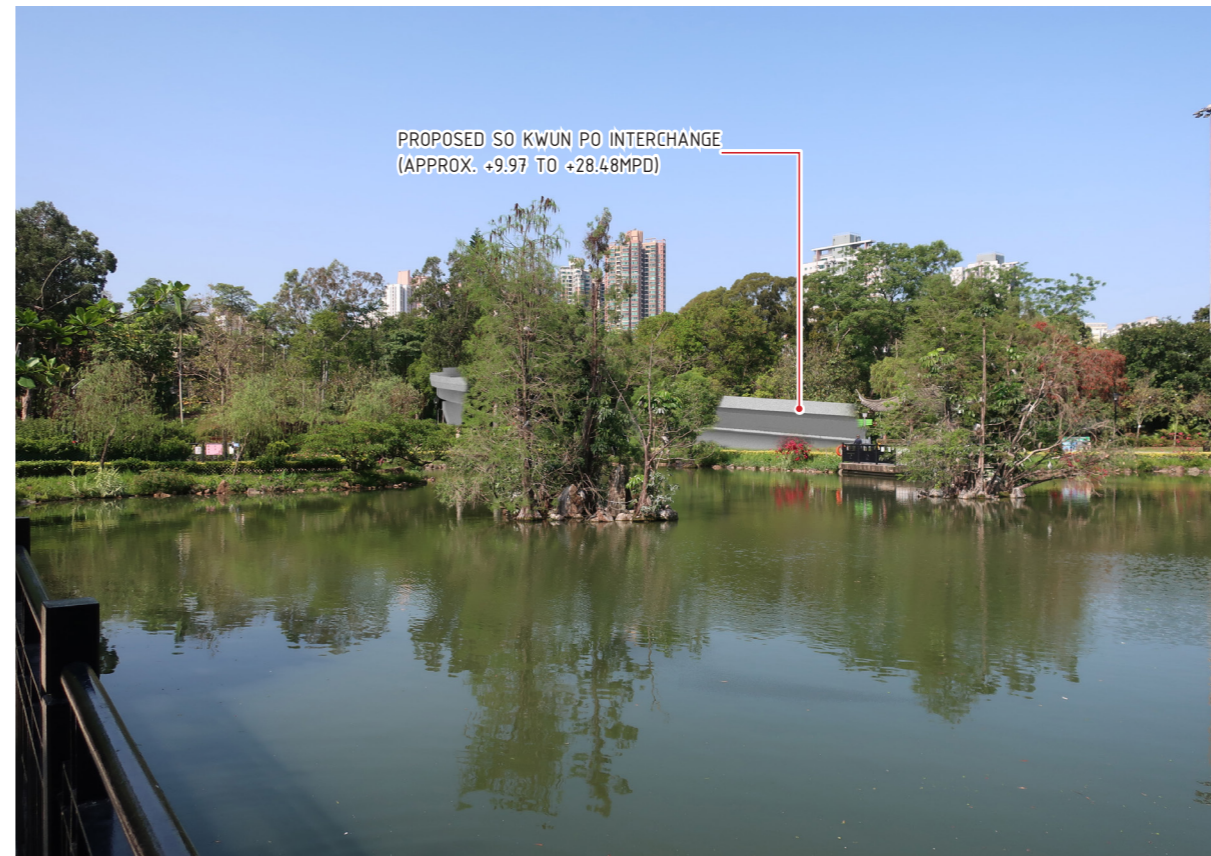
VP07 - NORTH DISTRICT PARK (EAST SIDE)  
WITHOUT MITGATION MEASURES

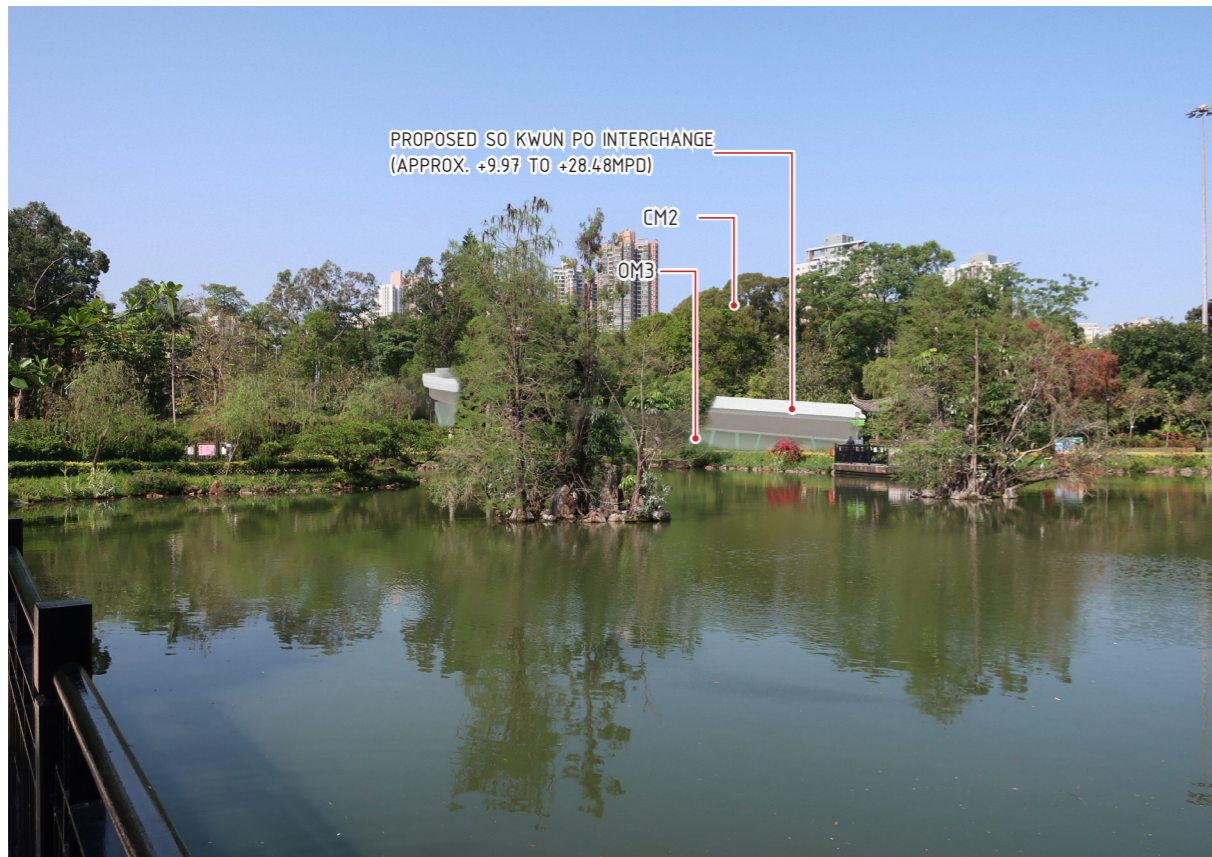
VP07 - NORTH DISTRICT PARK (EAST SIDE)  
DAY 1 WITH MITGATION MEASURES

MITIGATION MEASURES (CONSTRUCTION PHASE)			
CM1	Re-provisioned Cycle Track and Footpath	CM5	Good Site Practice
CM2	Preservation of Existing Vegetation	CM6	Erection of Decorative Screen Hoarding
CM3	Transplanting of Affected Trees	CM7	Reinstatement of Temporarily Disturbed Landscape Areas
CM4	Control of Night-time Lighting Glare

MITIGATION MEASURES (OPERATION PHASE)	
OM1	Compensatory Tree Planting
OM2	Roadside Planting
OM3	Aesthetically pleasing design for carriageways and other highways structures
OM4	Provision of Aesthetic Pleasing Treatment on Noise Barriers

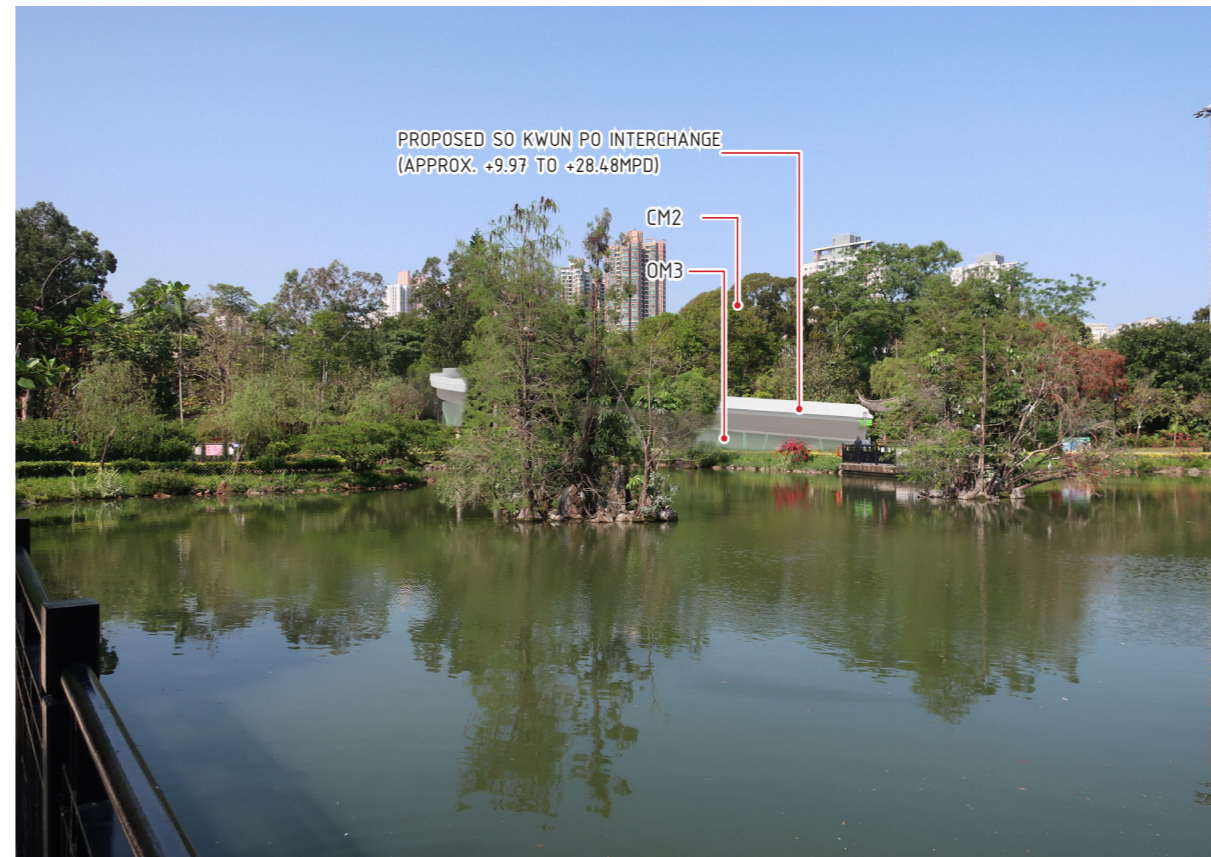
VP07 - NORTH DISTRICT PARK (EAST SIDE)  
YEAR 10 WITH MITGATION MEASURES
