Contract No. and Title  
Agreement No. CE 78/2020 (WS)  
Ngau Tam Mei Water Treatment Works and Primary Service Reservoir Extension - Investigation, Design and Construction

Drawing title  
PHOTOMONTAGE  
VP-A1  
NGAU TAM SHAN  
(SHEET 1 OF 4)

Drawing title  
PHOTOMONTAGE  
VP-A2  
KAI KUNG LENG  
(SHEET 2 OF 4)

Drawing title  
PHOTOMONTAGE  
VP-R2  
FUK HING LEI  
(SHEET 4 OF 4)

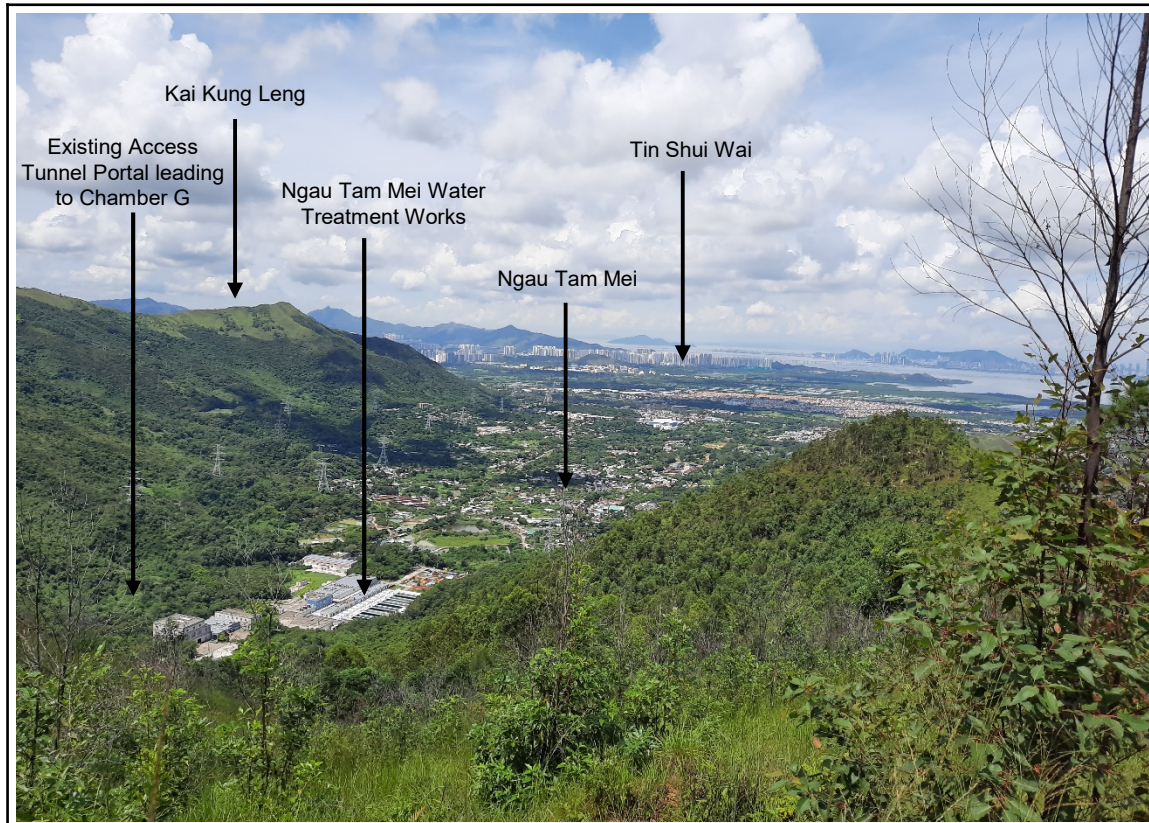
Existing Baseline Conditions

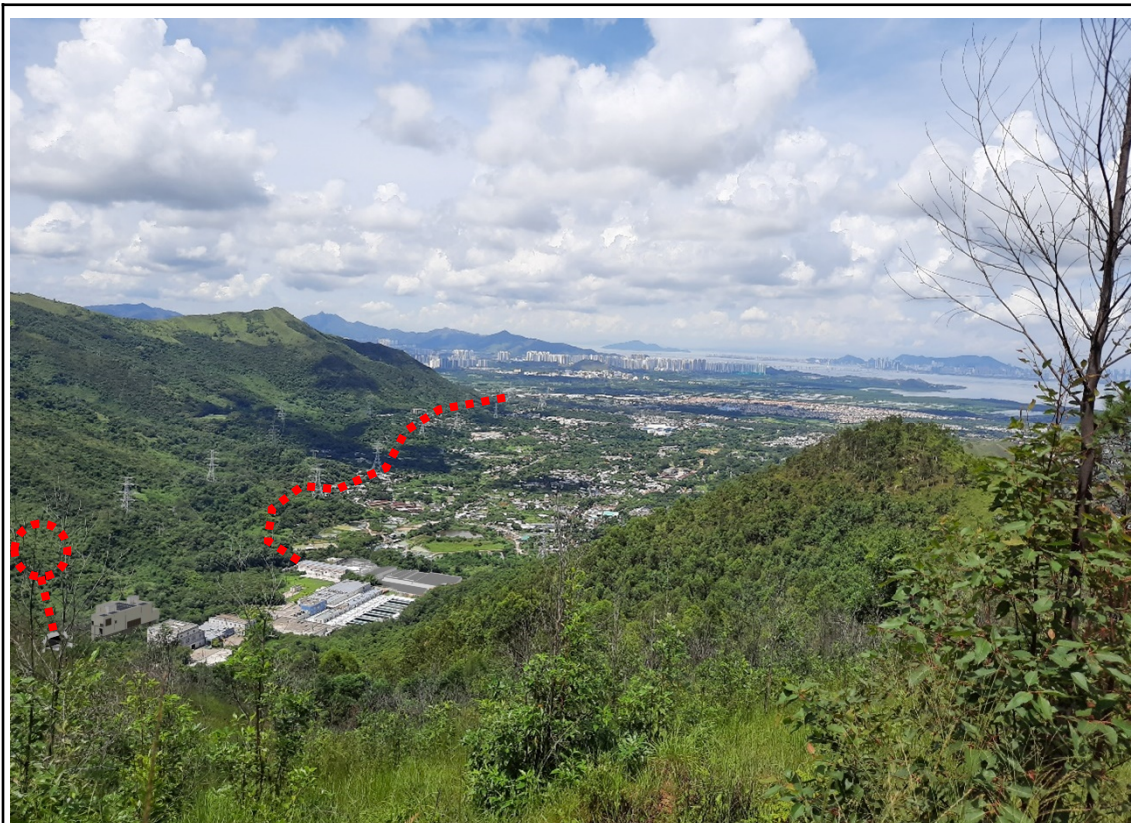
Day 1 in Operation Stage (without Mitigation)

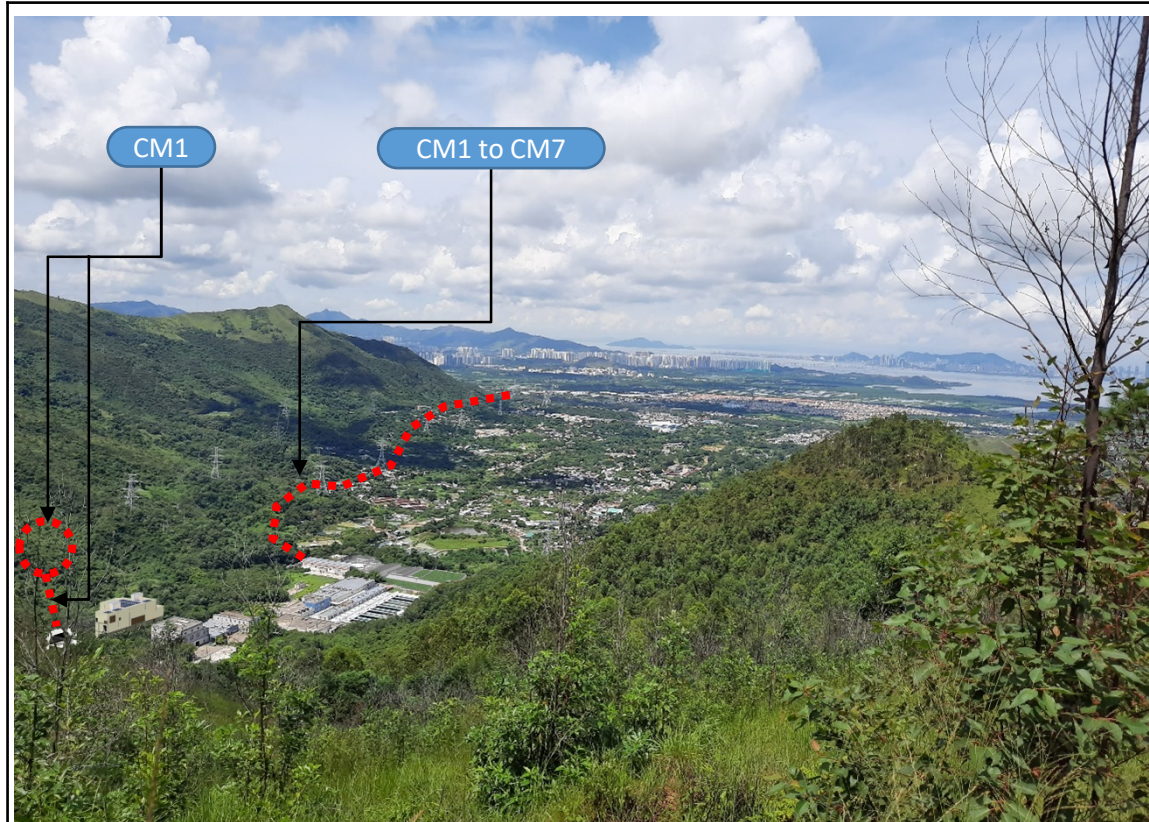
Day 1 in Operation Stage (with Mitigation)

- Construction Phase
- CM1 – Careful Site Planning and Management
  - CM2 – Careful Design of Slope Works
  - CM3 – Tree Preservation
  - CM4 – Tree Transplanting / Compensatory Tree Planting
  - CM5 – Regular Inspection of Retained Trees
  - CM6 – Minimisation of Light Impact
  - CM7 – Reinstatement of Temporarily Disturbed Areas

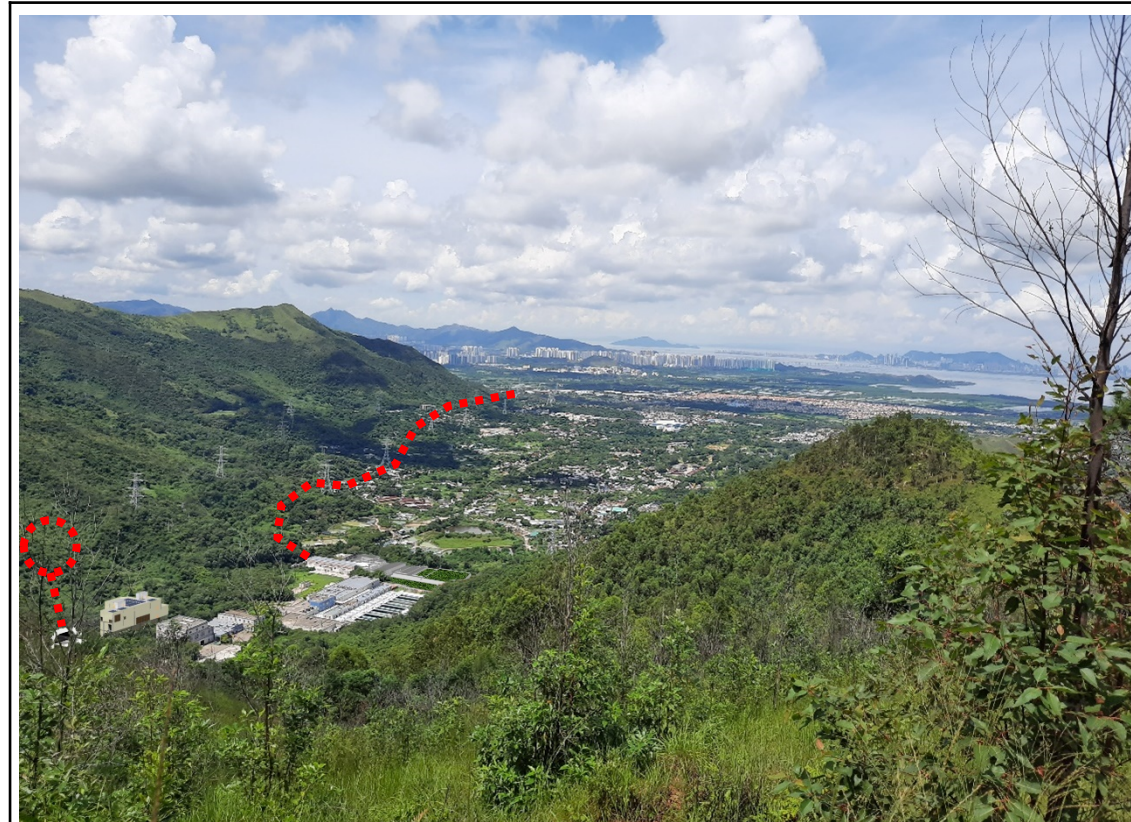
Year 10 in Operation Stage (with Mitigation)

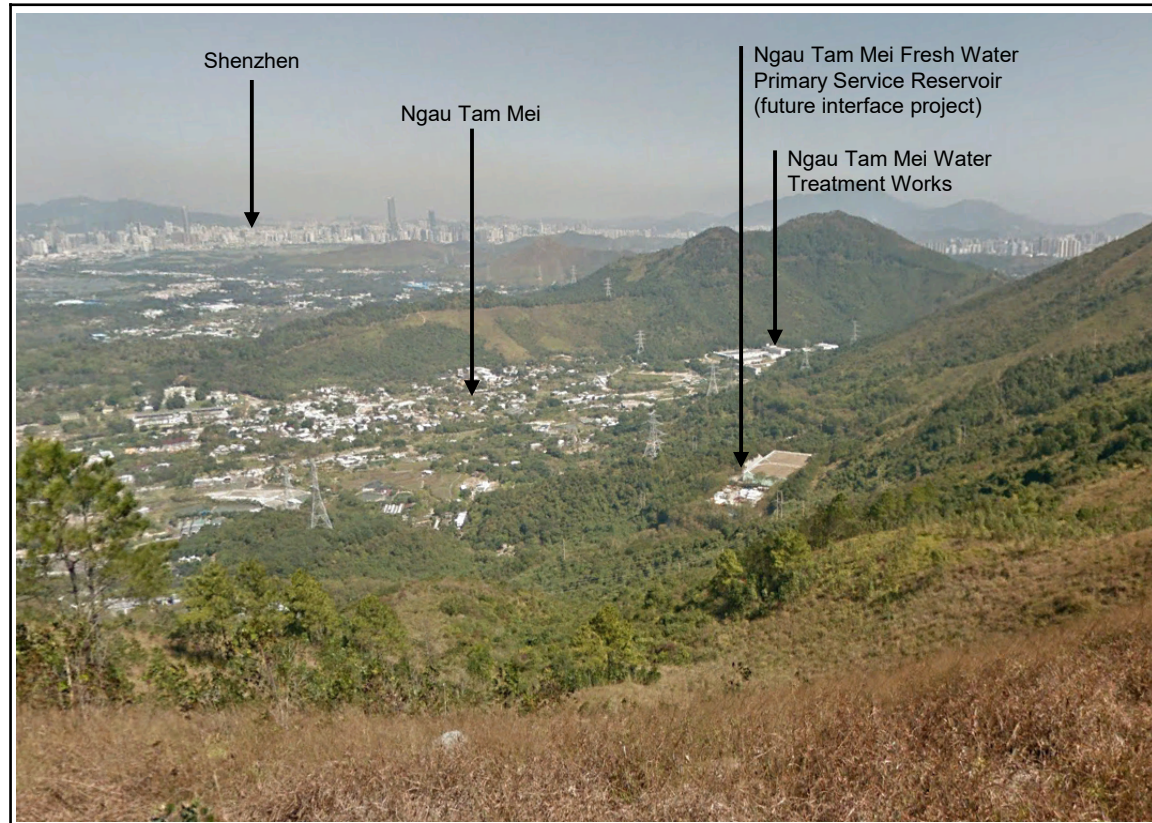
Existing Baseline Conditions

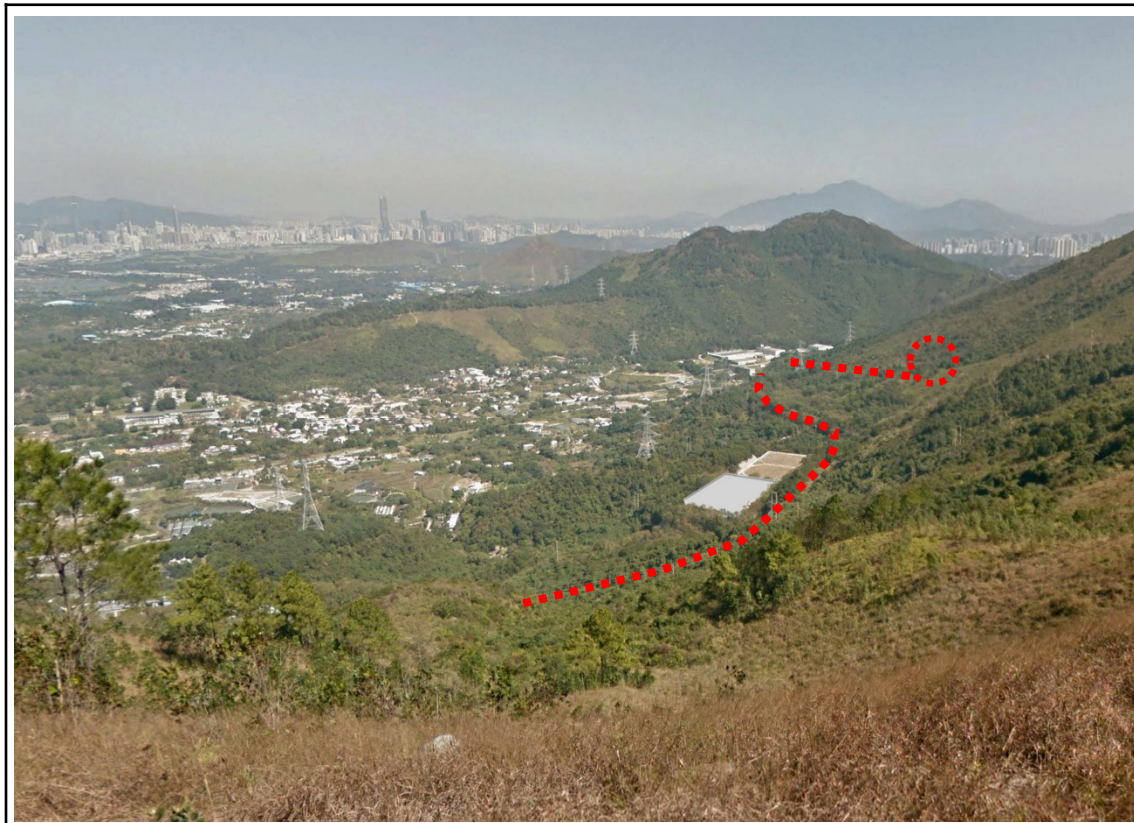
Day 1 in Operation Stage (without Mitigation)

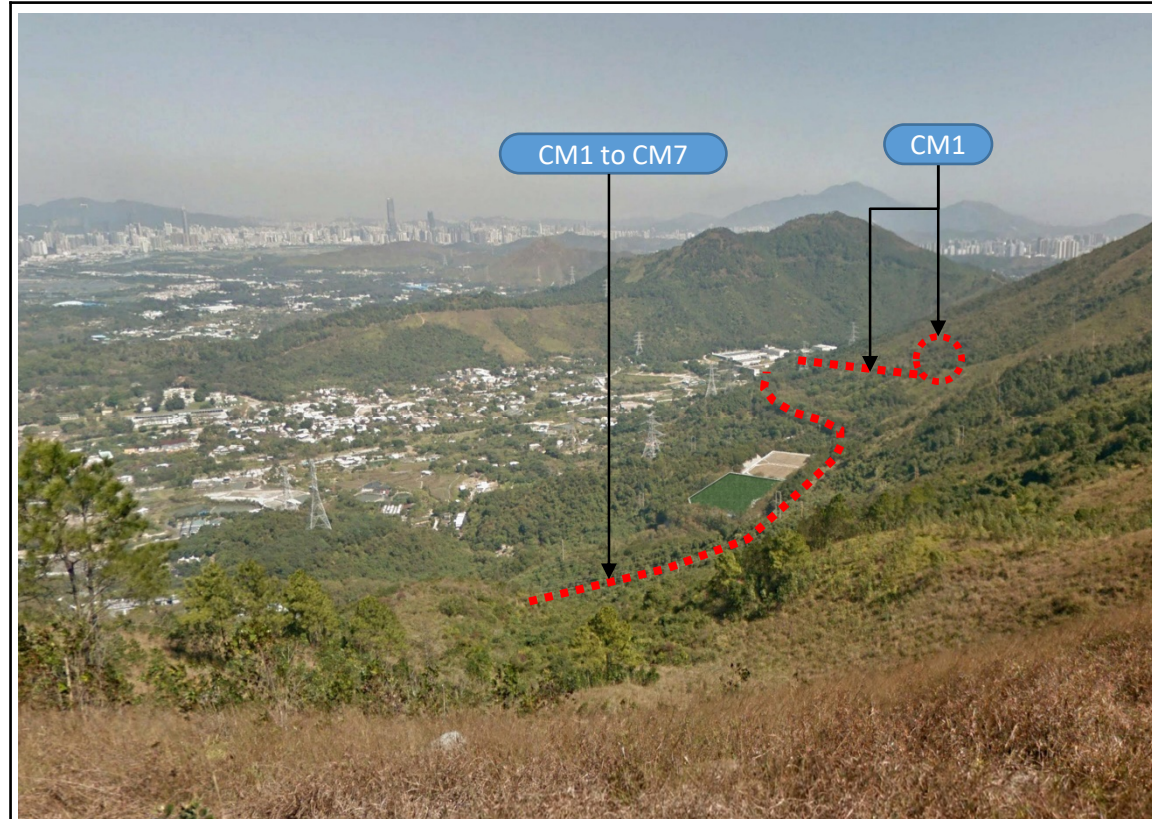
Day 1 in Operation Stage (with Mitigation)

- Construction Phase
- CM1 – Careful Site Planning and Management
  - CM2 – Careful Design of Slope Works
  - CM3 – Tree Preservation
  - CM4 – Tree Transplanting / Compensatory Tree Planting
  - CM5 – Regular Inspection of Retained Trees
  - CM6 – Minimisation of Light Impact
  - CM7 – Reinstatement of Temporarily Disturbed Areas

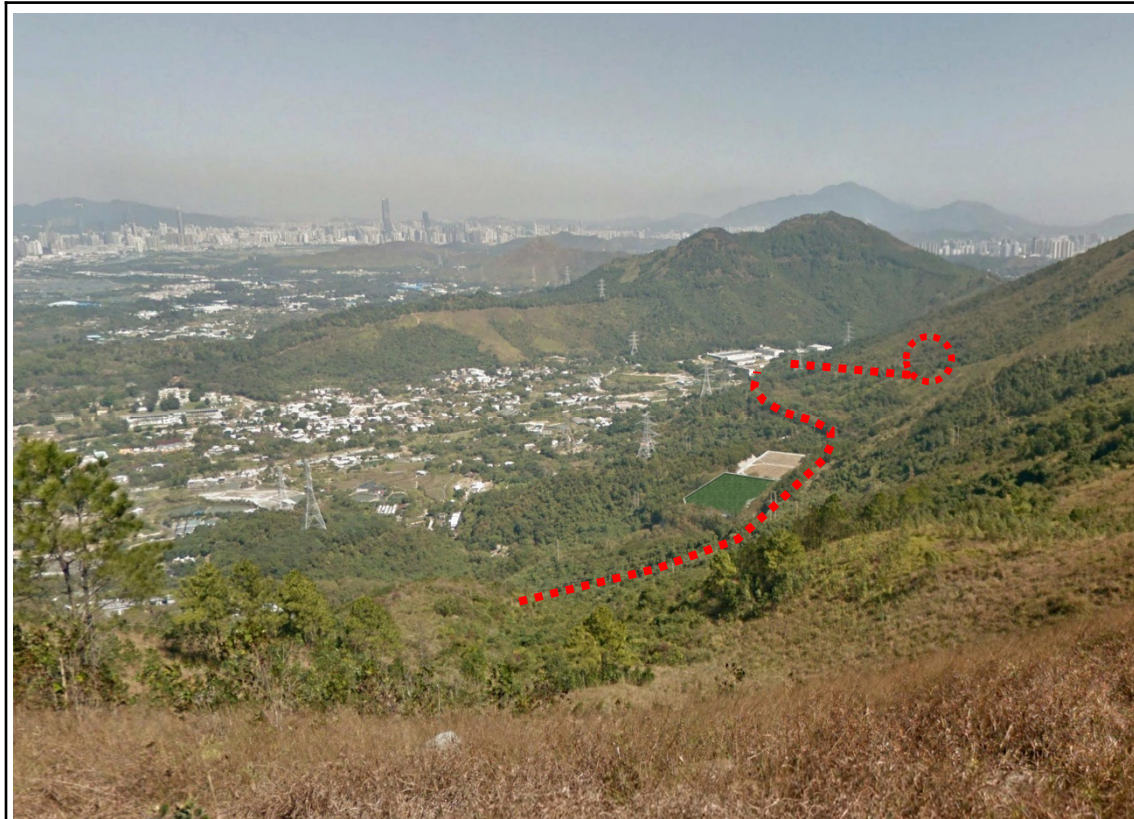
Year 10 in Operation Stage (with Mitigation)

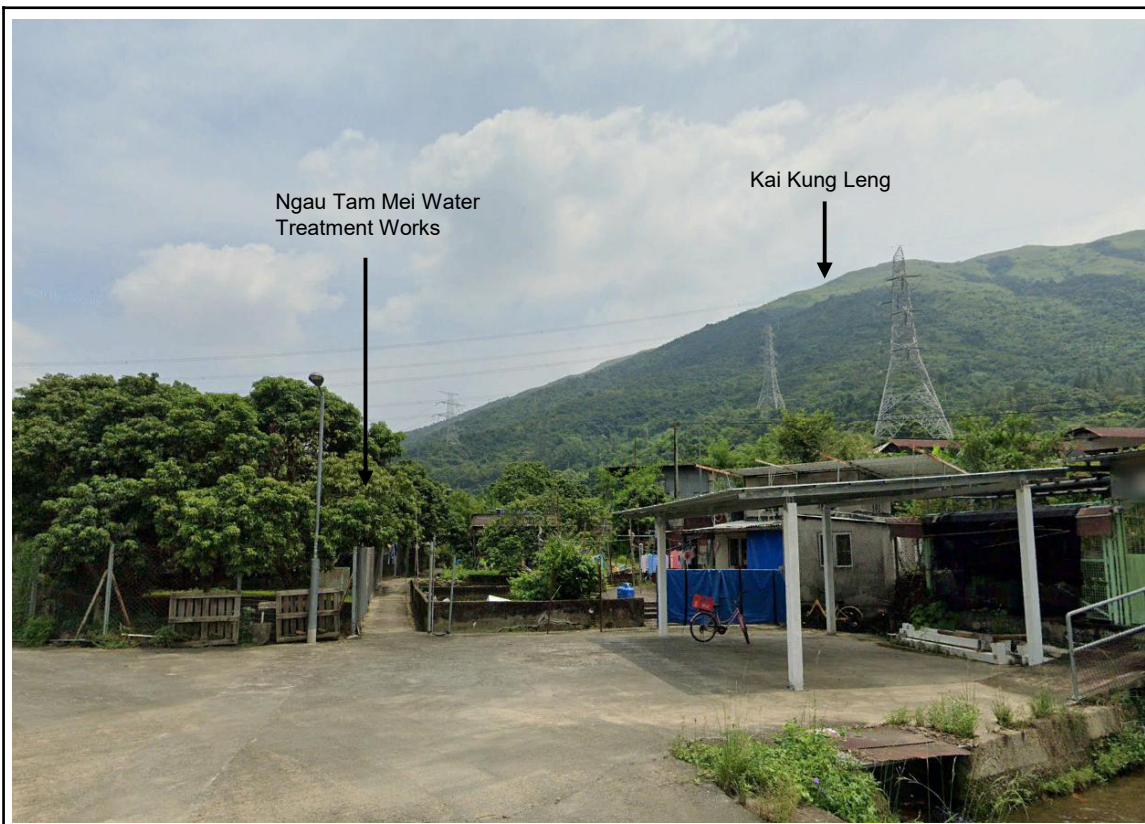
Existing Baseline Conditions

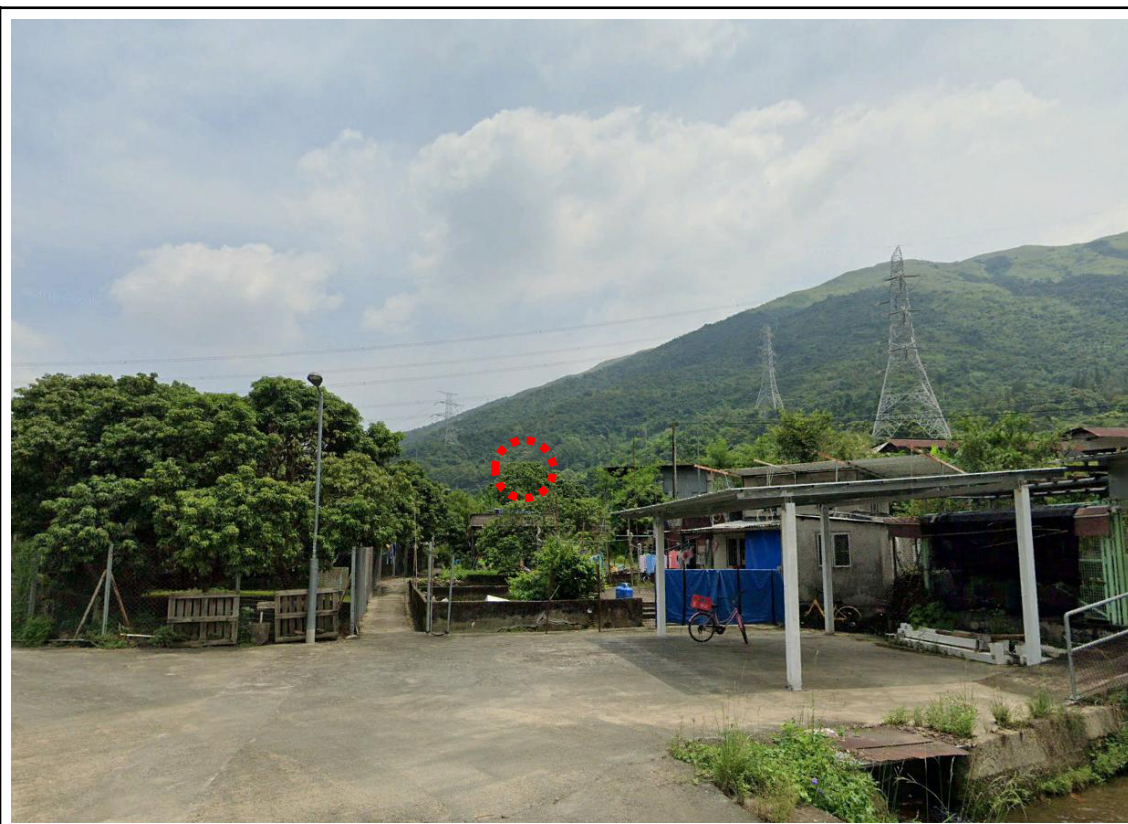
Day 1 in Operation Stage (without Mitigation)

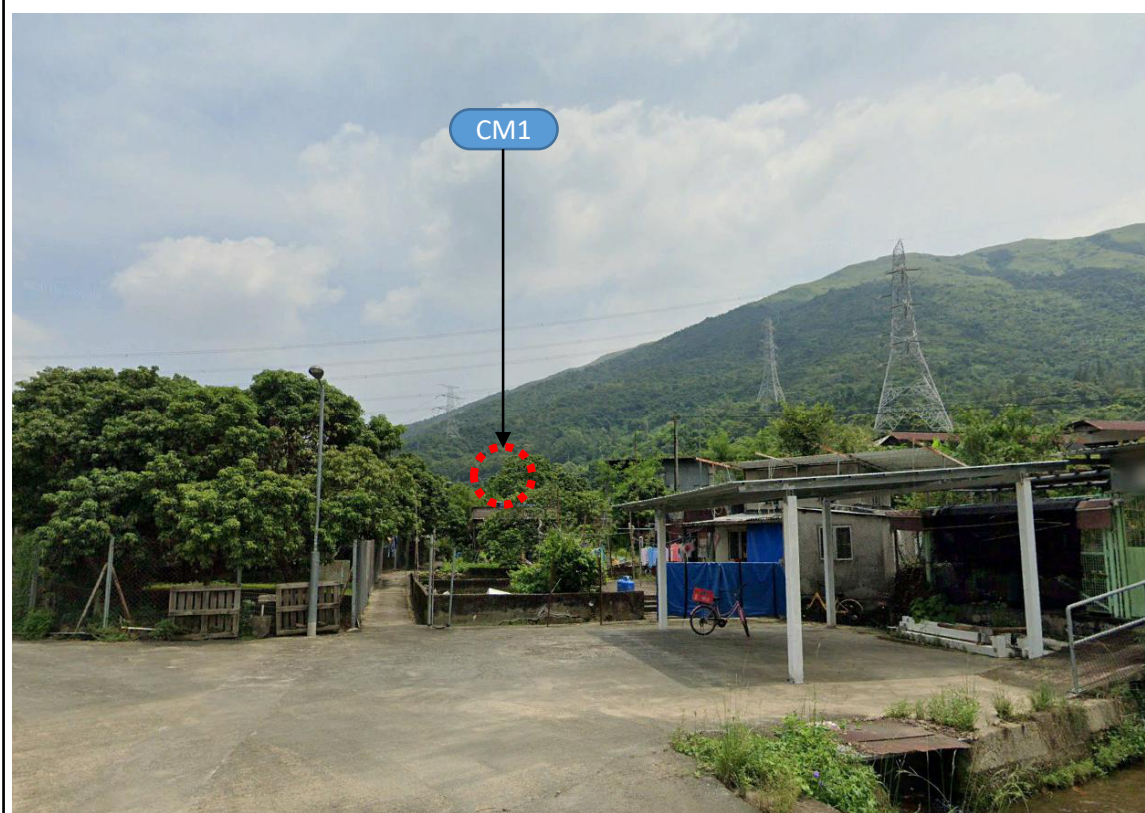
Day 1 in Operation Stage (with Mitigation)

- Construction Phase
- CM1 – Careful Site Planning and Management

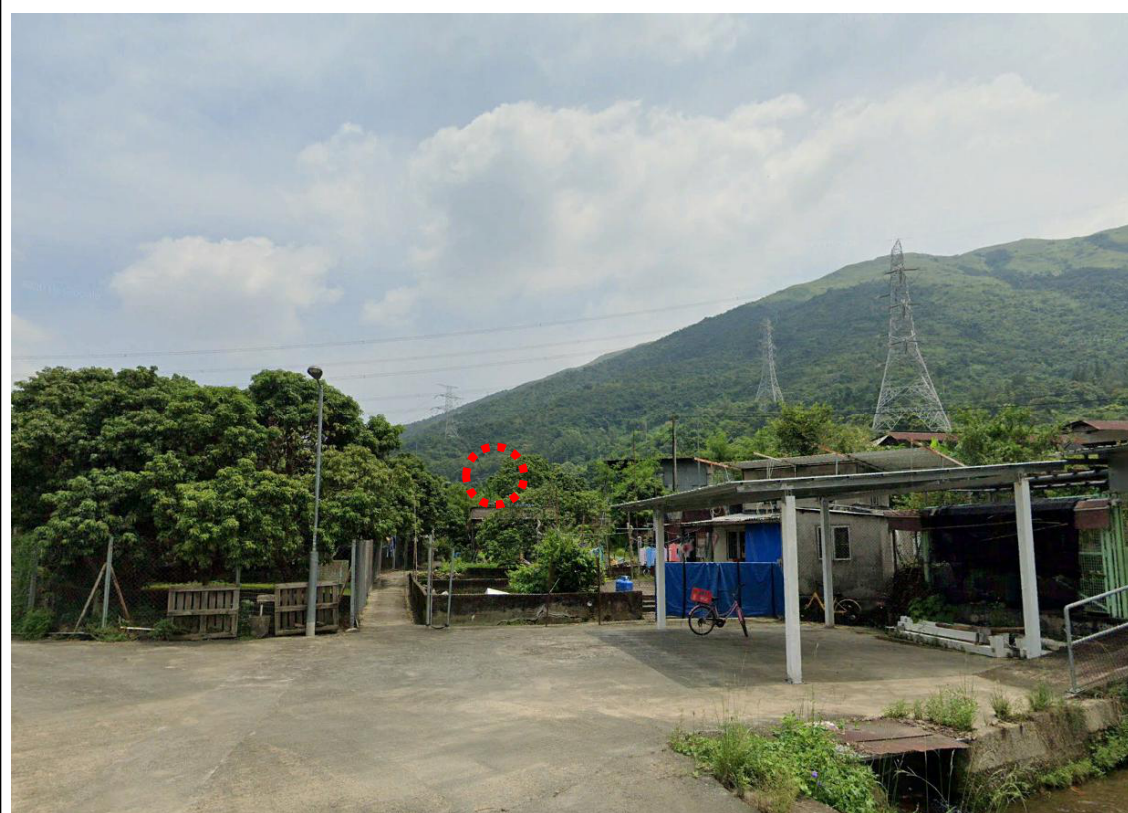
Year 10 in Operation Stage (with Mitigation)

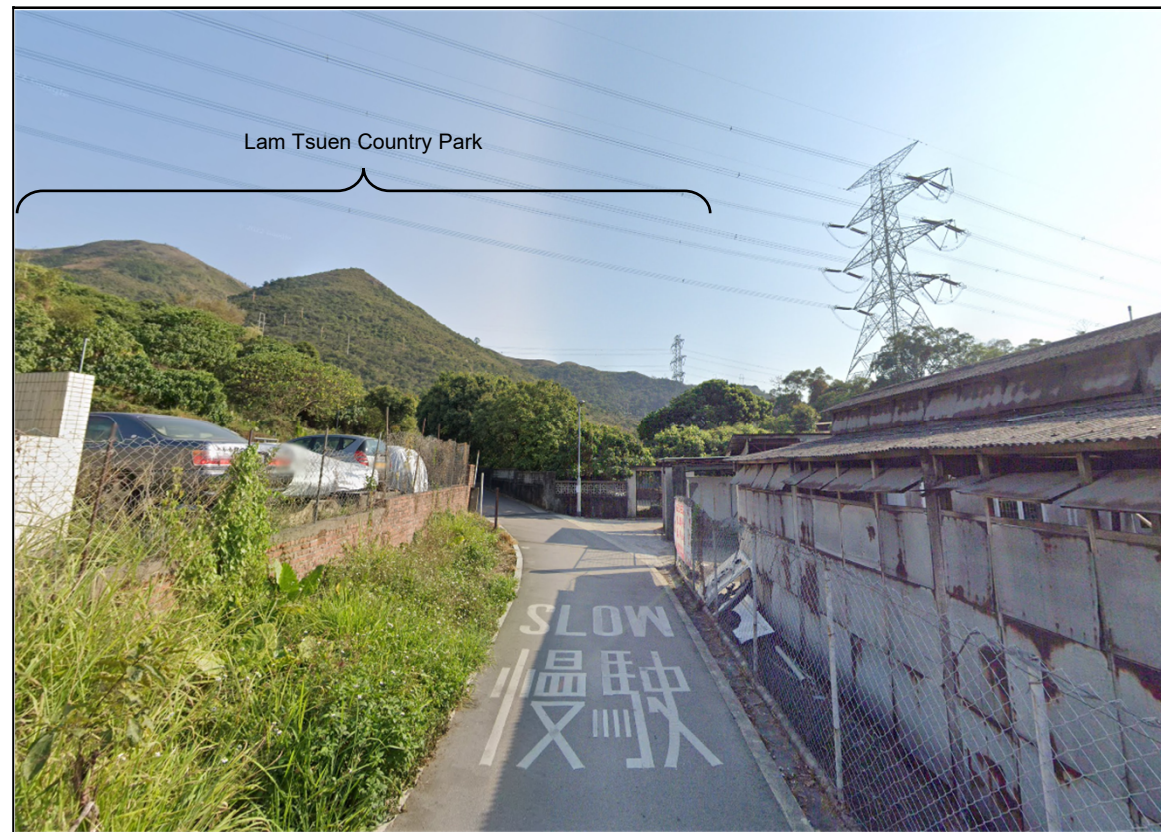
Existing Baseline Conditions

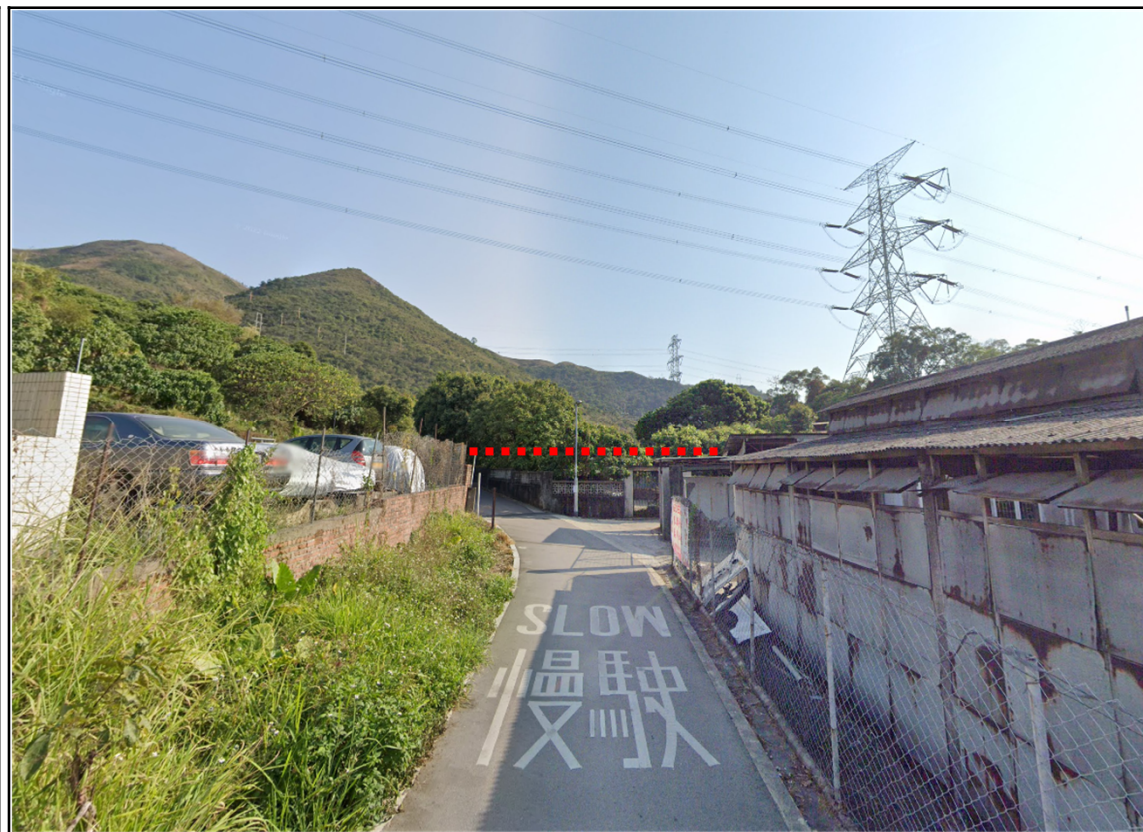
Day 1 in Operation Stage (without Mitigation)

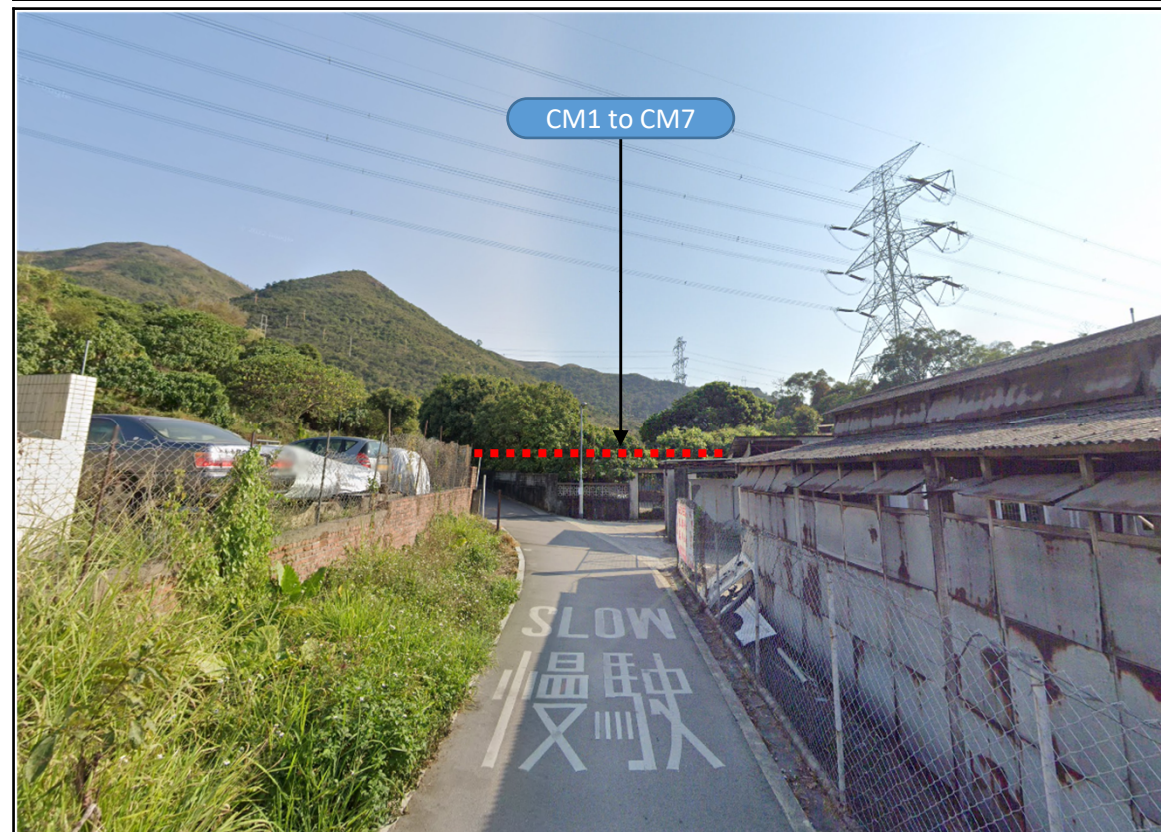
Day 1 in Operation Stage (with Mitigation)

- Construction Phase
- CM1 – Careful Site Planning and Management
  - CM2 – Careful Design of Slope Works
  - CM3 – Tree Preservation
  - CM4 – Tree Transplanting / Compensatory Tree Planting
  - CM5 – Regular Inspection of Retained Trees
  - CM6 – Minimisation of Light Impact
  - CM7 – Reinstatement of Temporarily Disturbed Areas

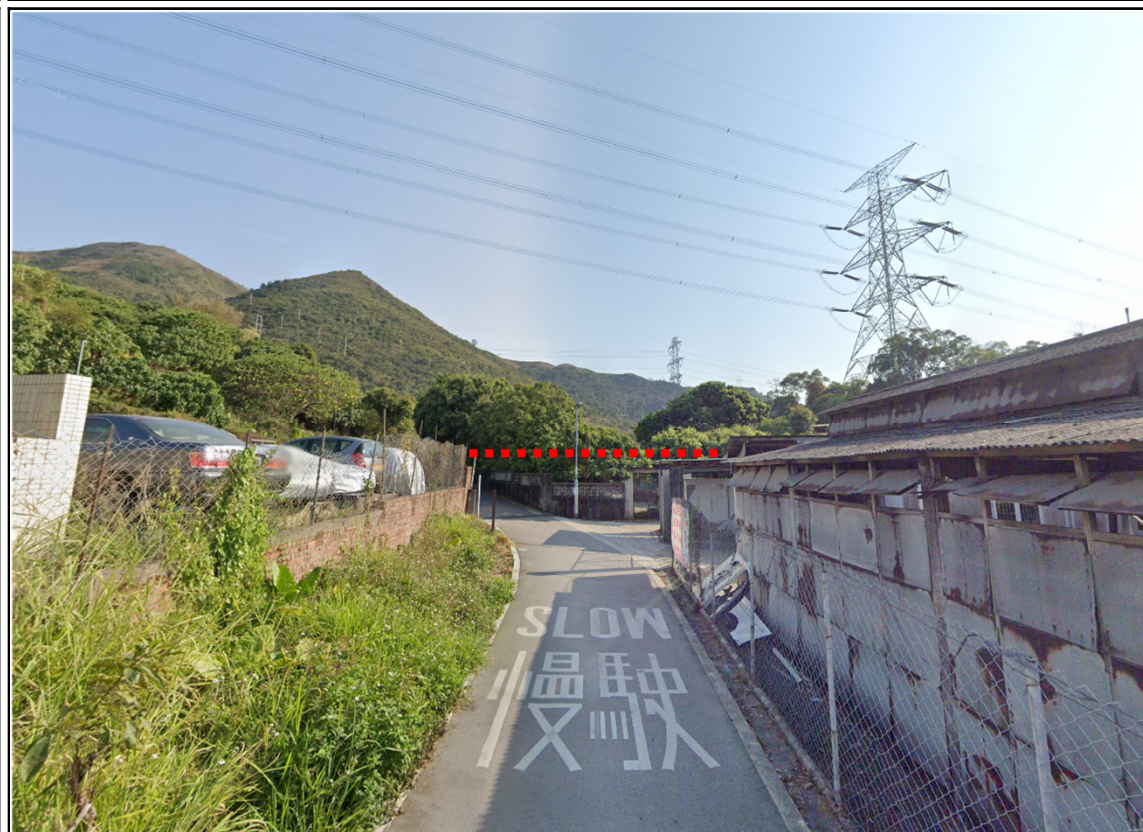
Year 10 in Operation Stage (with Mitigation)

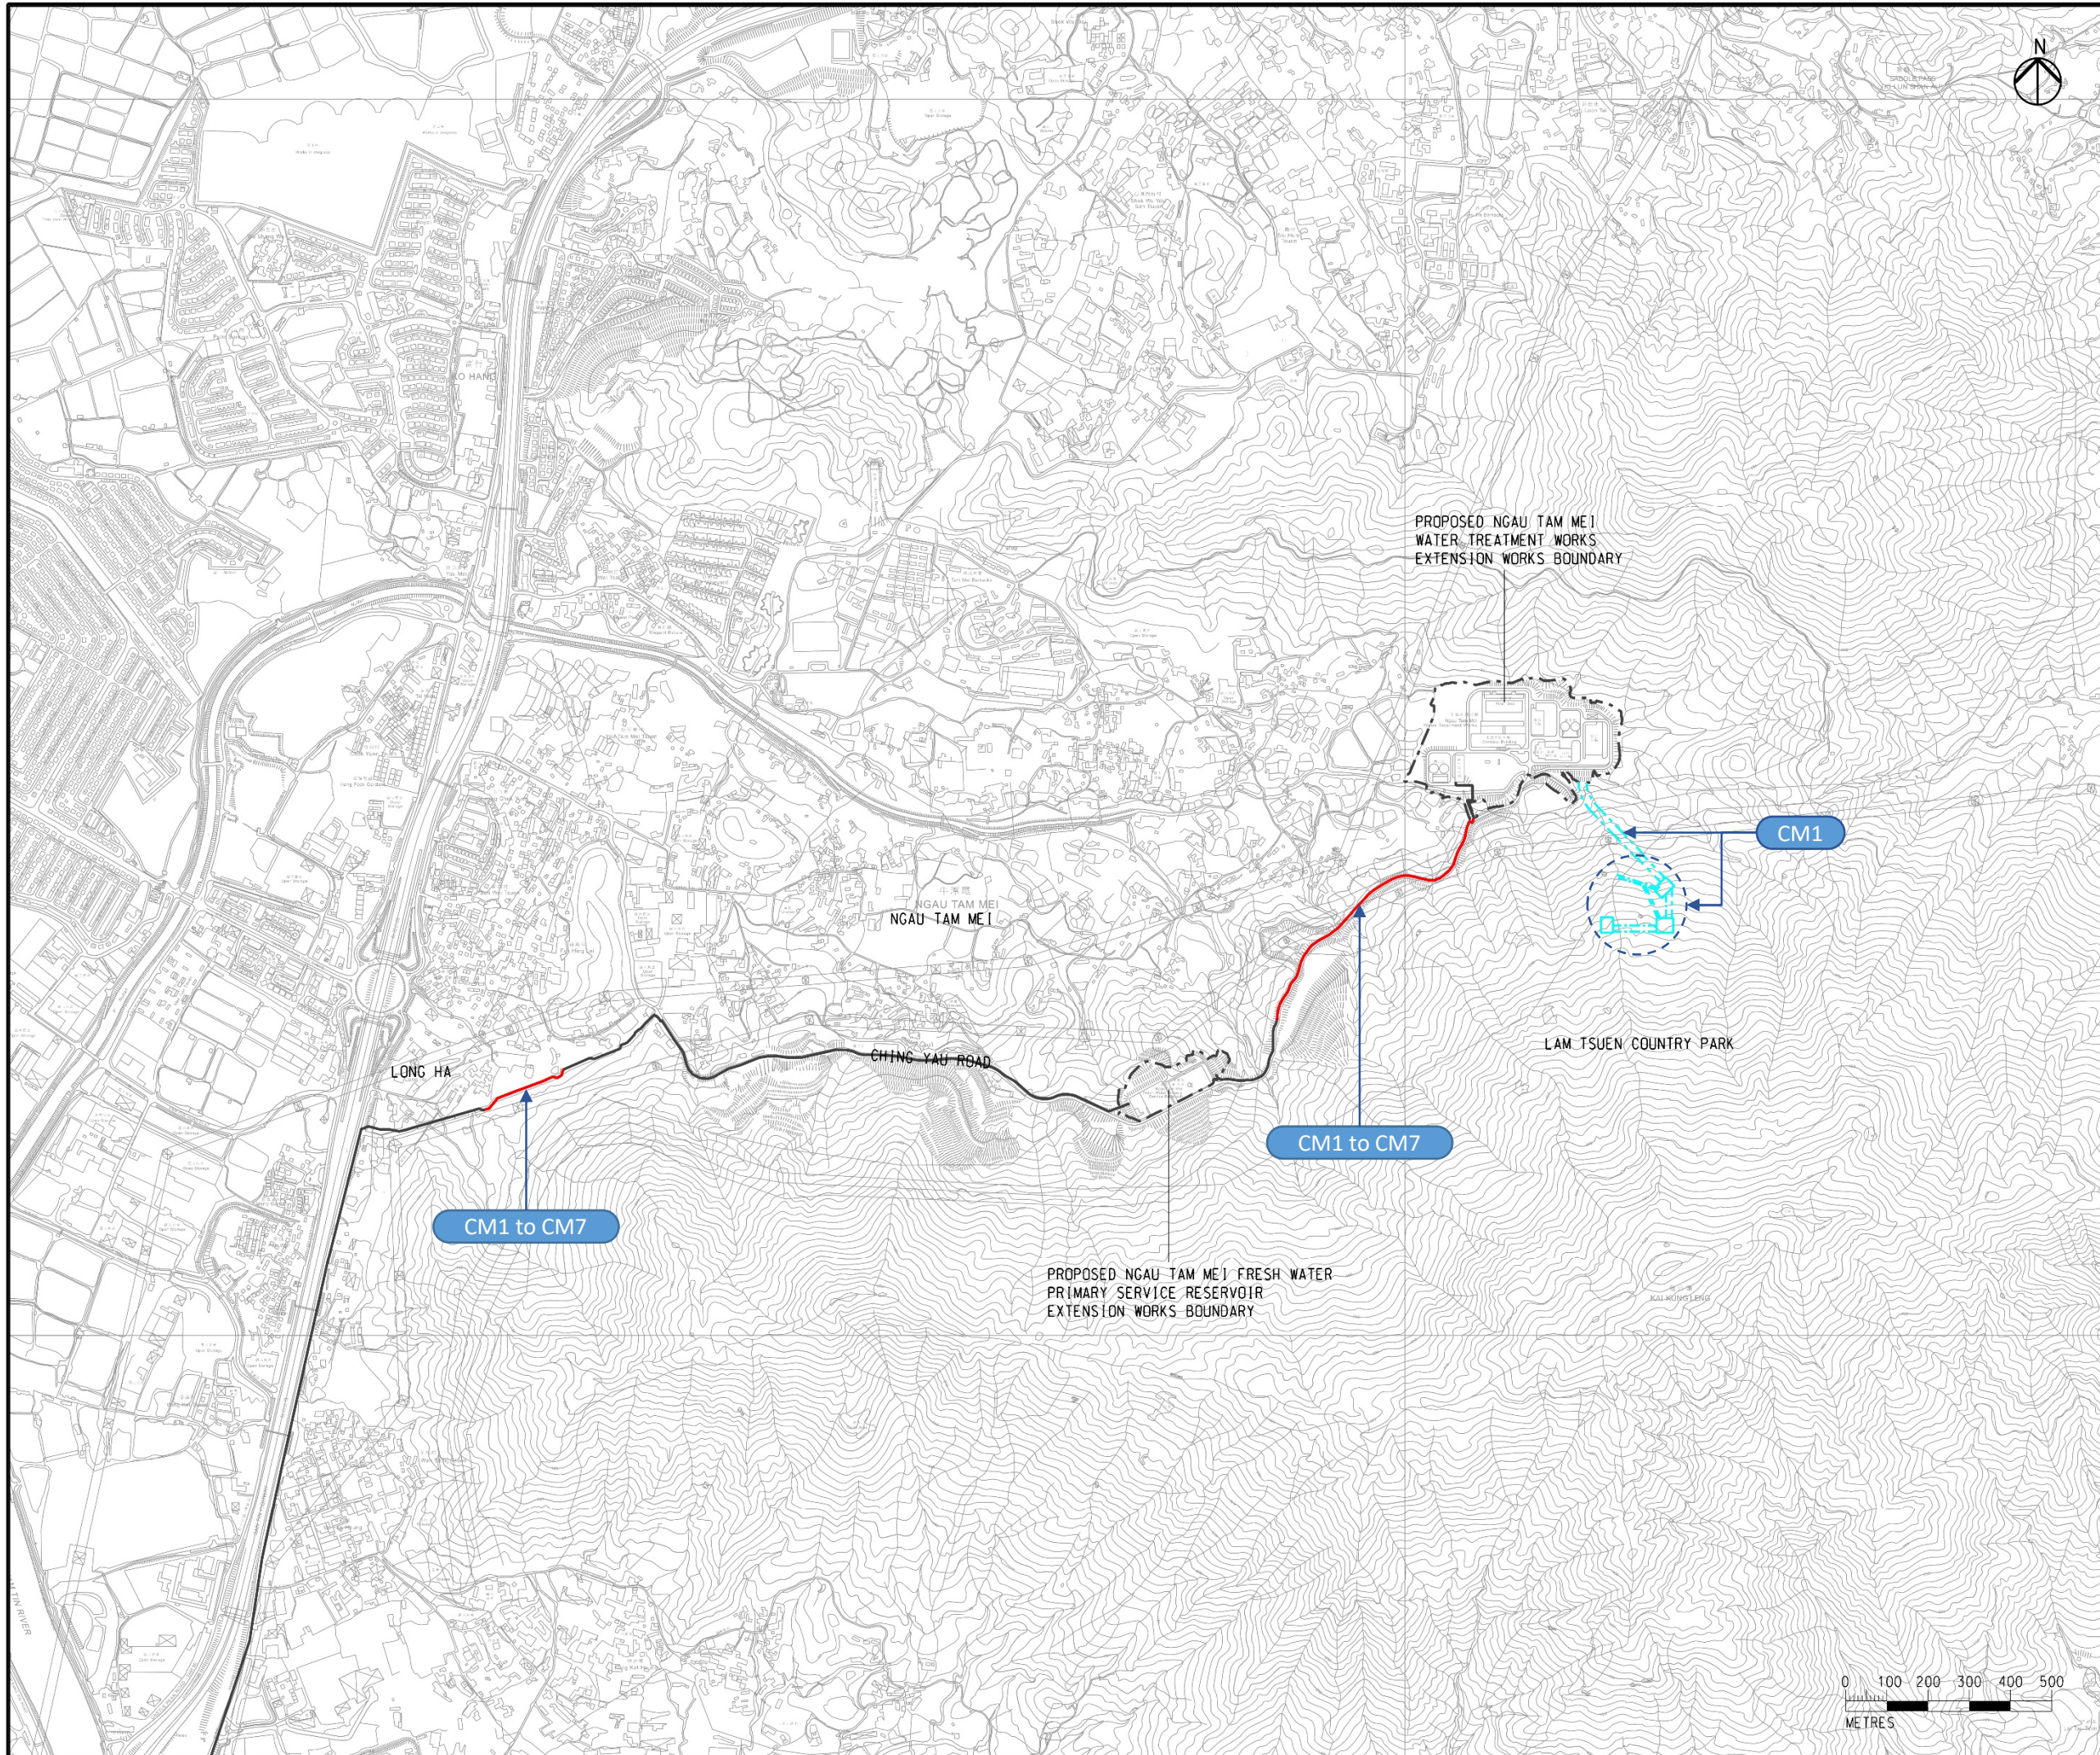
Drawing title  
**MITIGATION MEASURE PLAN**

- Construction Phase
- CM1 – Careful Site Planning and Management
  - CM2 – Careful Design of Slope Works
  - CM3 – Tree Preservation
  - CM4 – Tree Transplanting / Compensatory Tree Planting
  - CM5 – Regular Inspection of Retained Trees
  - CM6 – Minimisation of Light Impact
  - CM7 – Reinstatement of Temporarily Disturbed Areas
