**DRAINAGE IMPROVEMENT
WORKS AT YUEN LONG –
STAGE 2**

Contract No.: DC/2022/02

**Pre-Construction
Condition Survey
Report for Impacted
Graded Historic
Buildings**

**Wing Tat Civil Engineering
Company Limited**

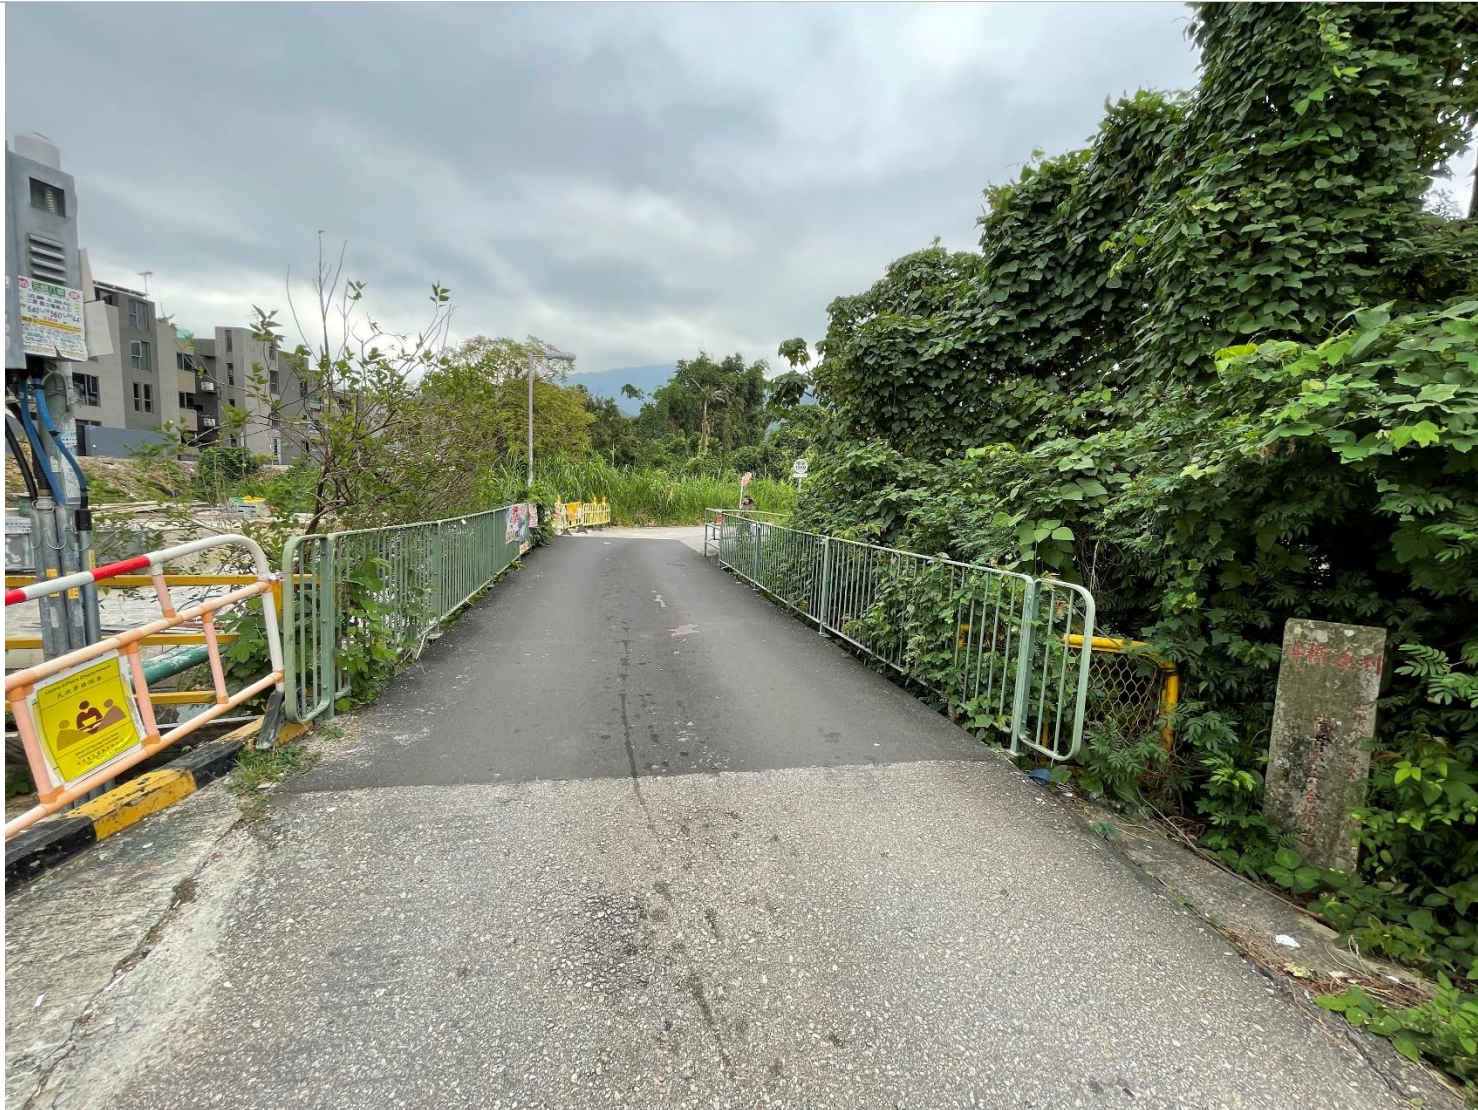
G1.1

Bridge Deck

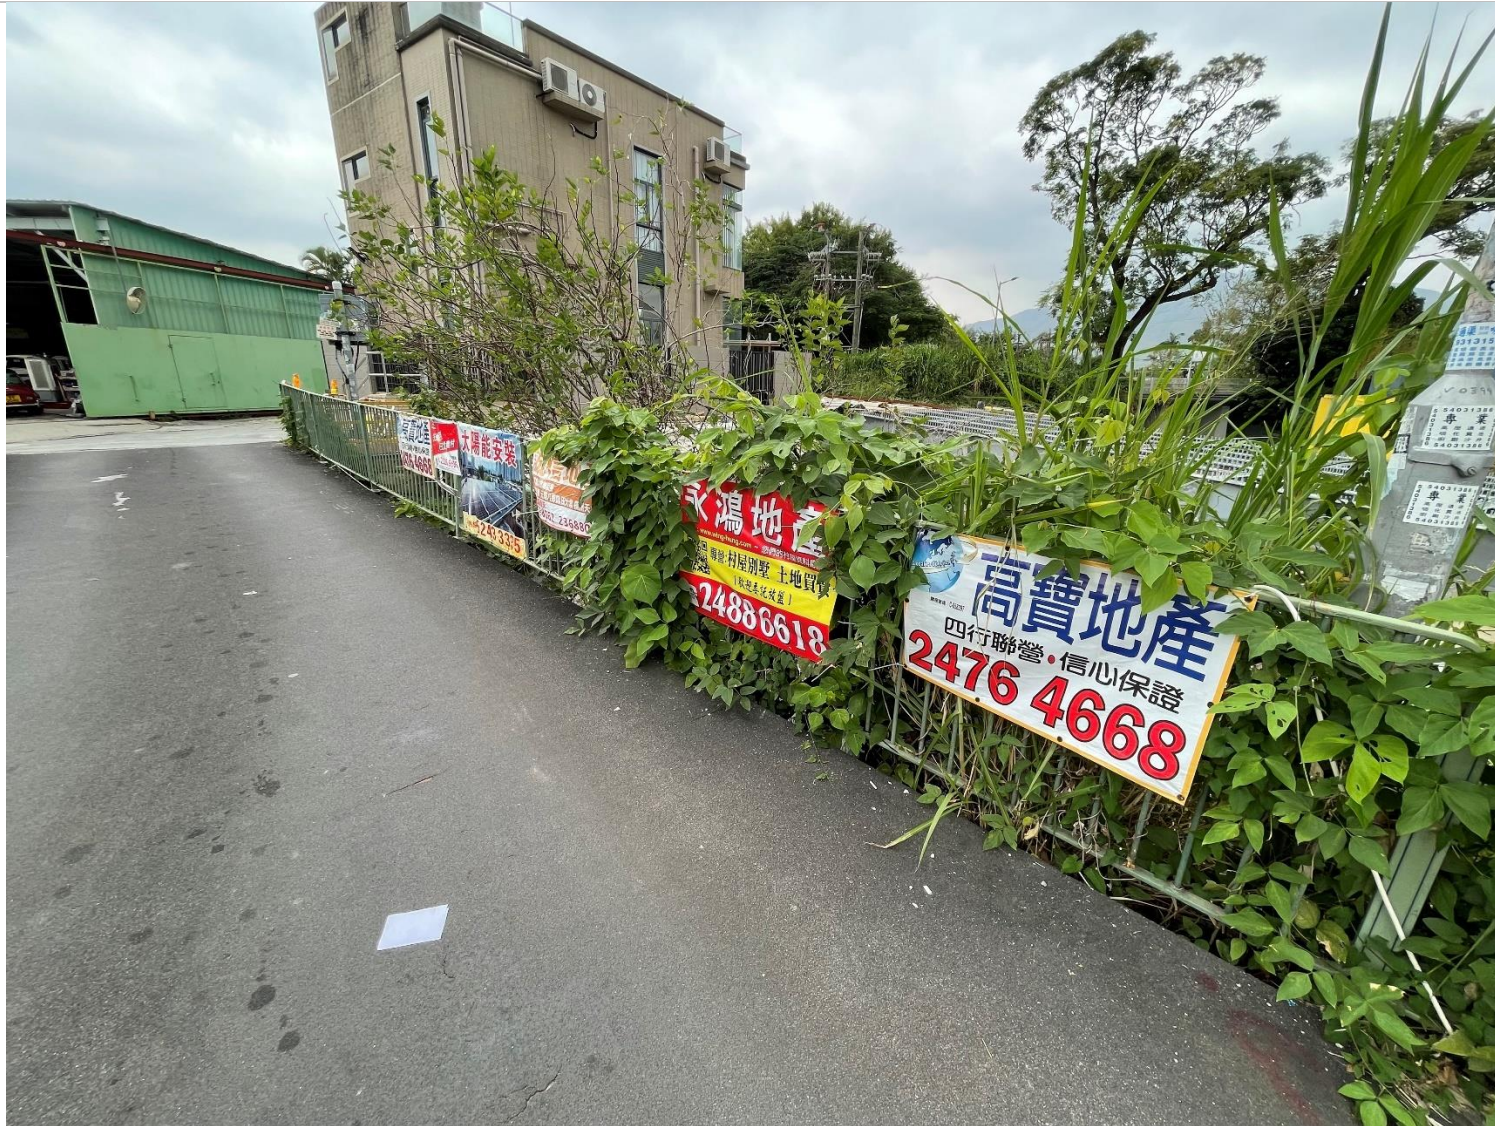
G1.2

N Parapet

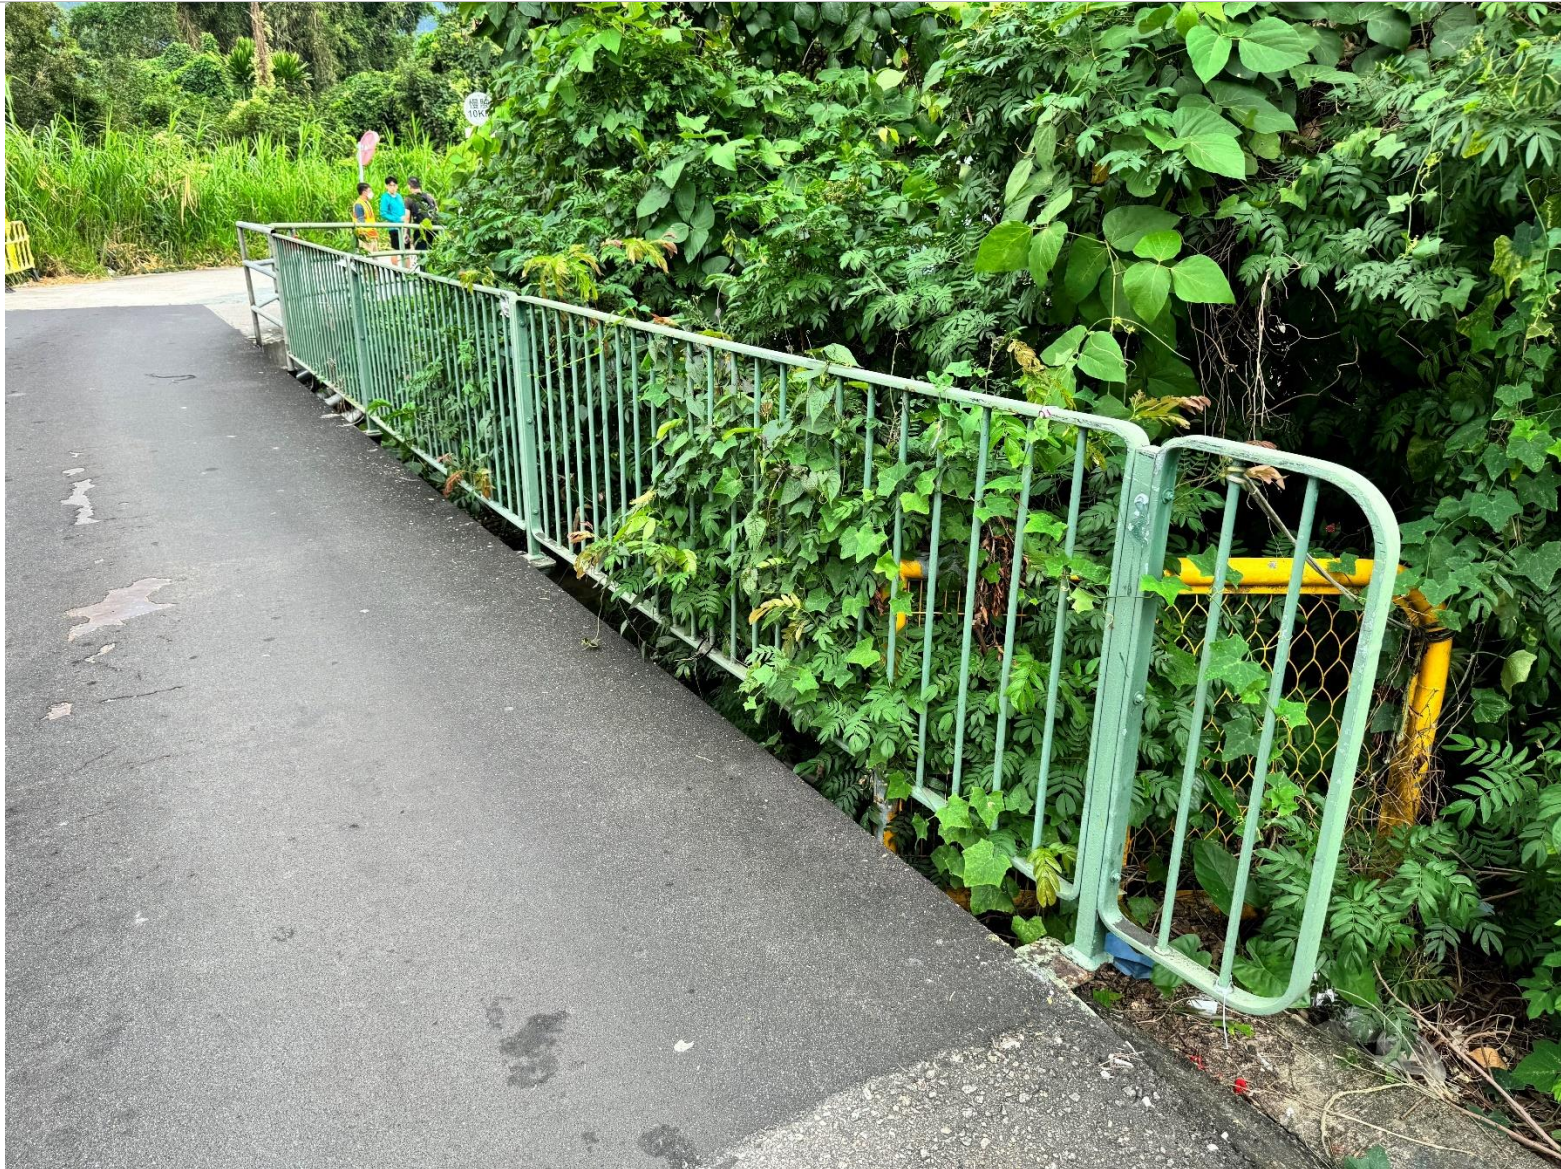
G1.3

S Parapet (1)

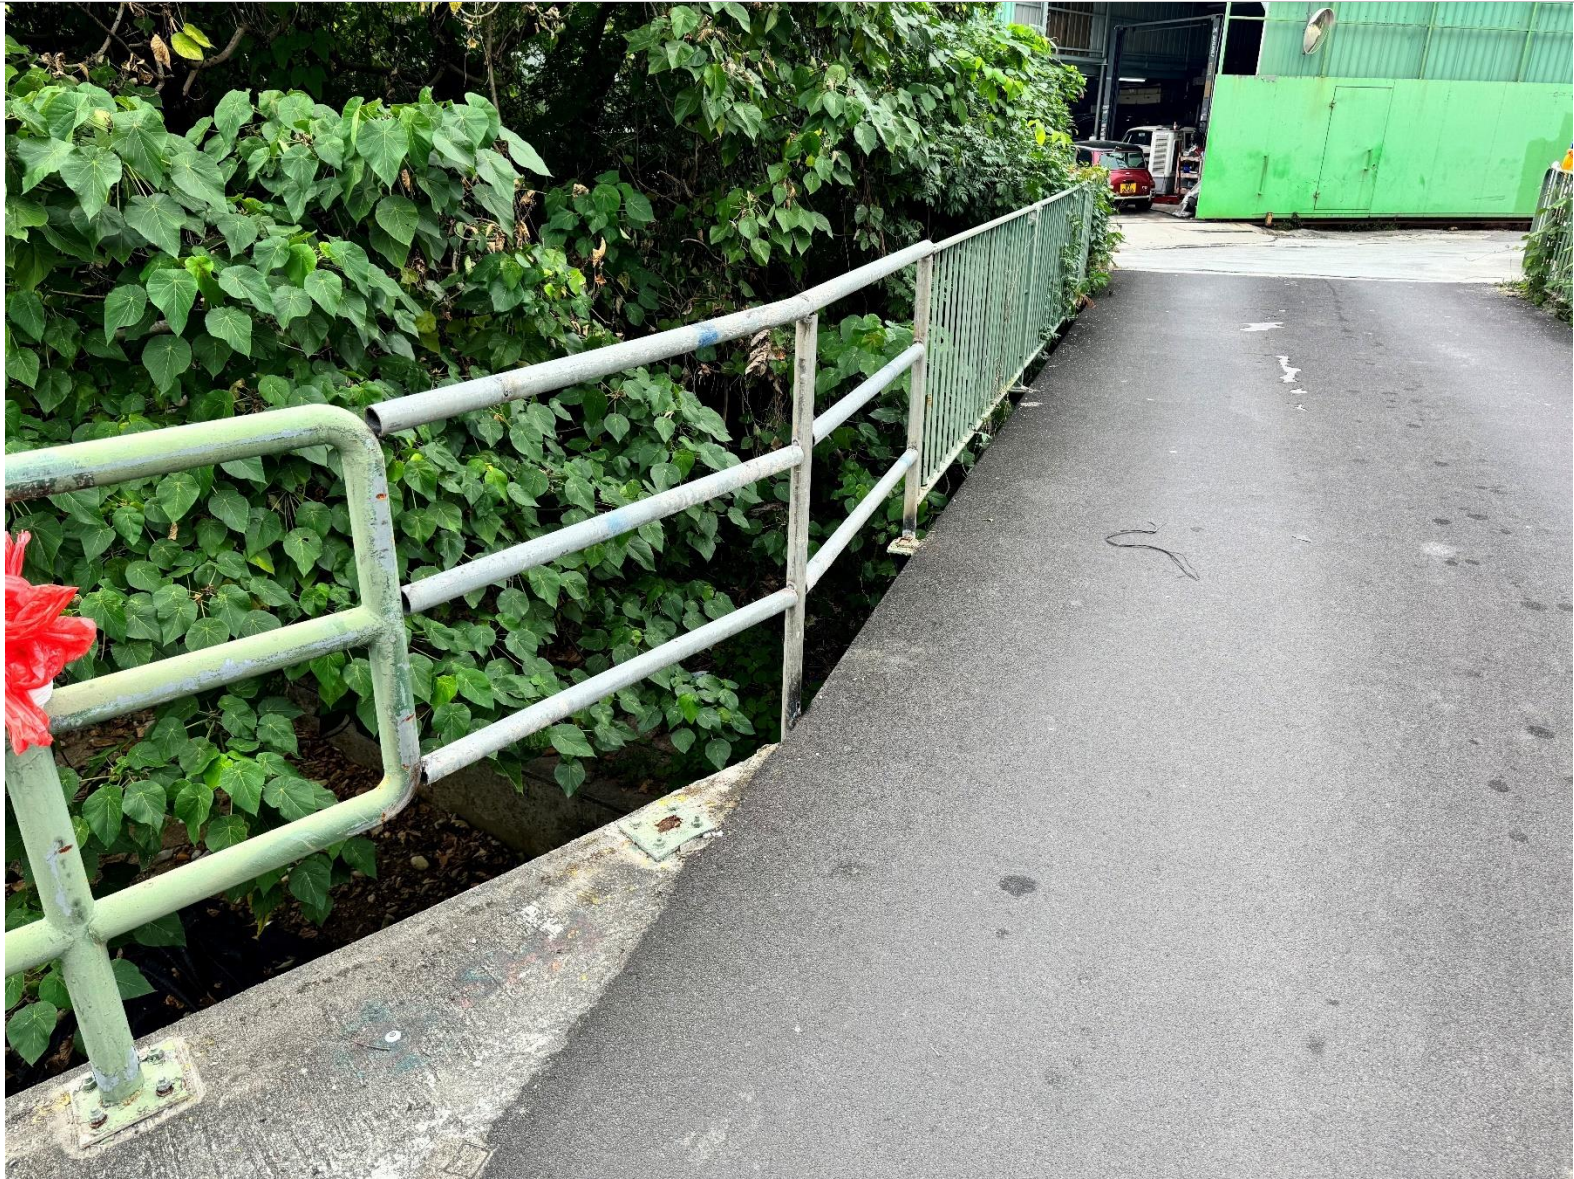
G1.4

S Parapet (2)

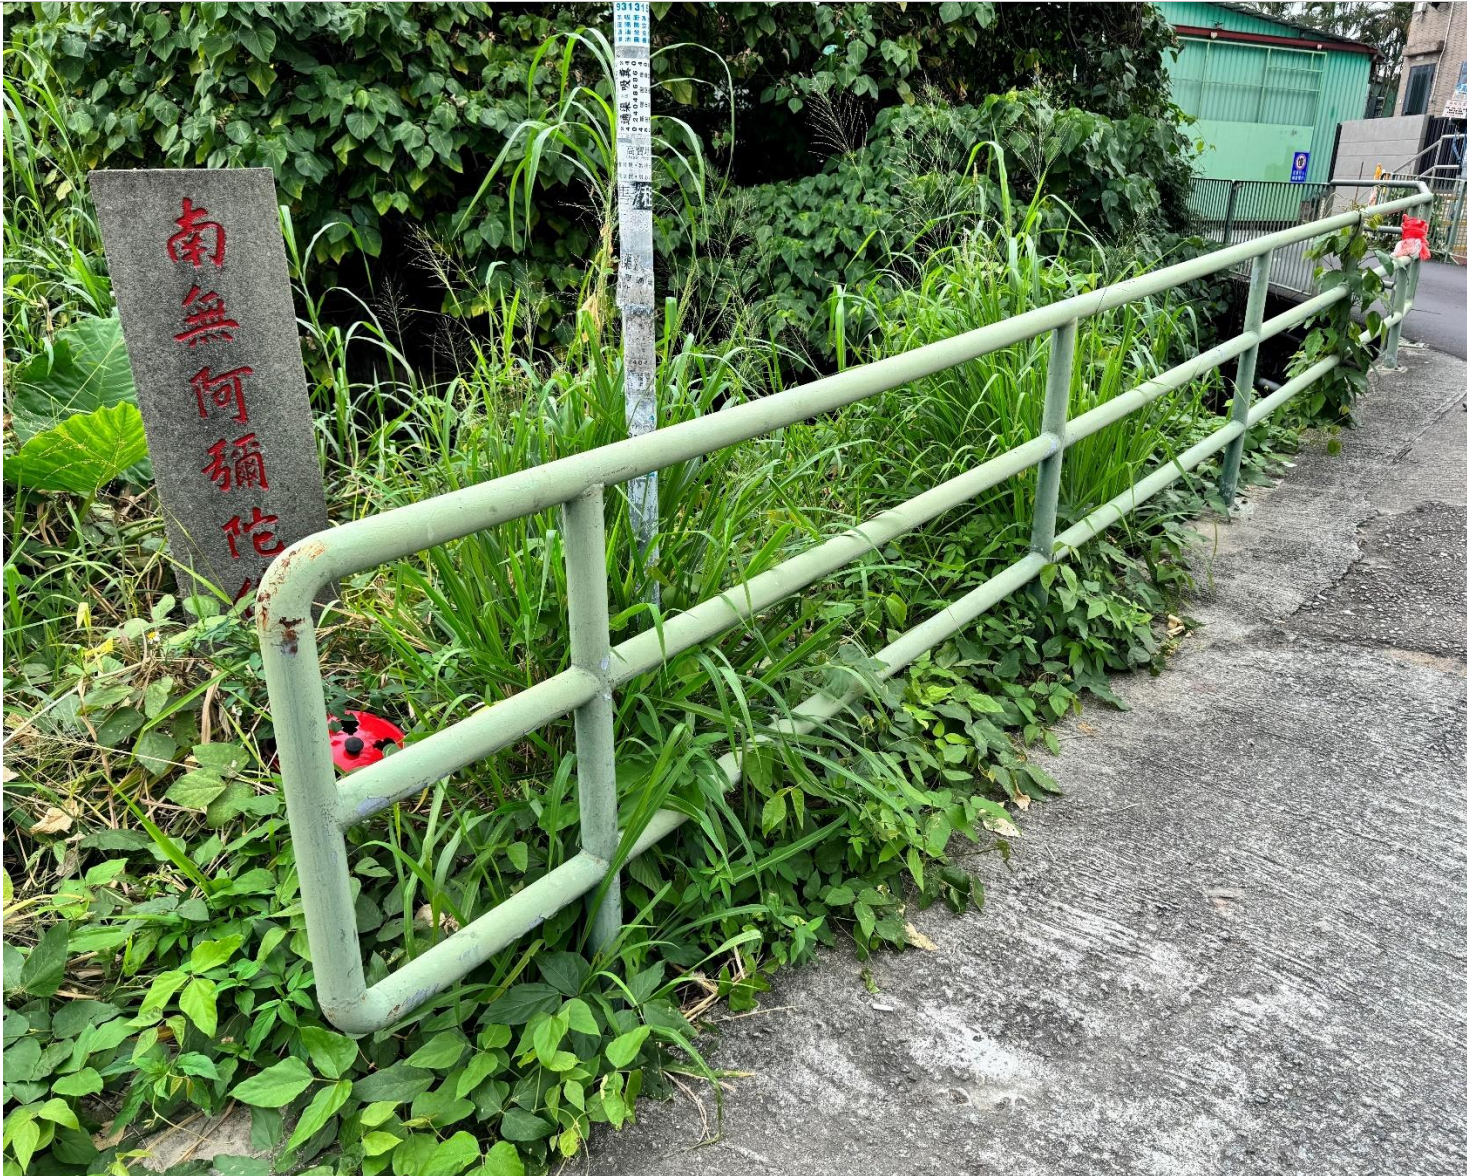
G1.5

S Parapet (3)

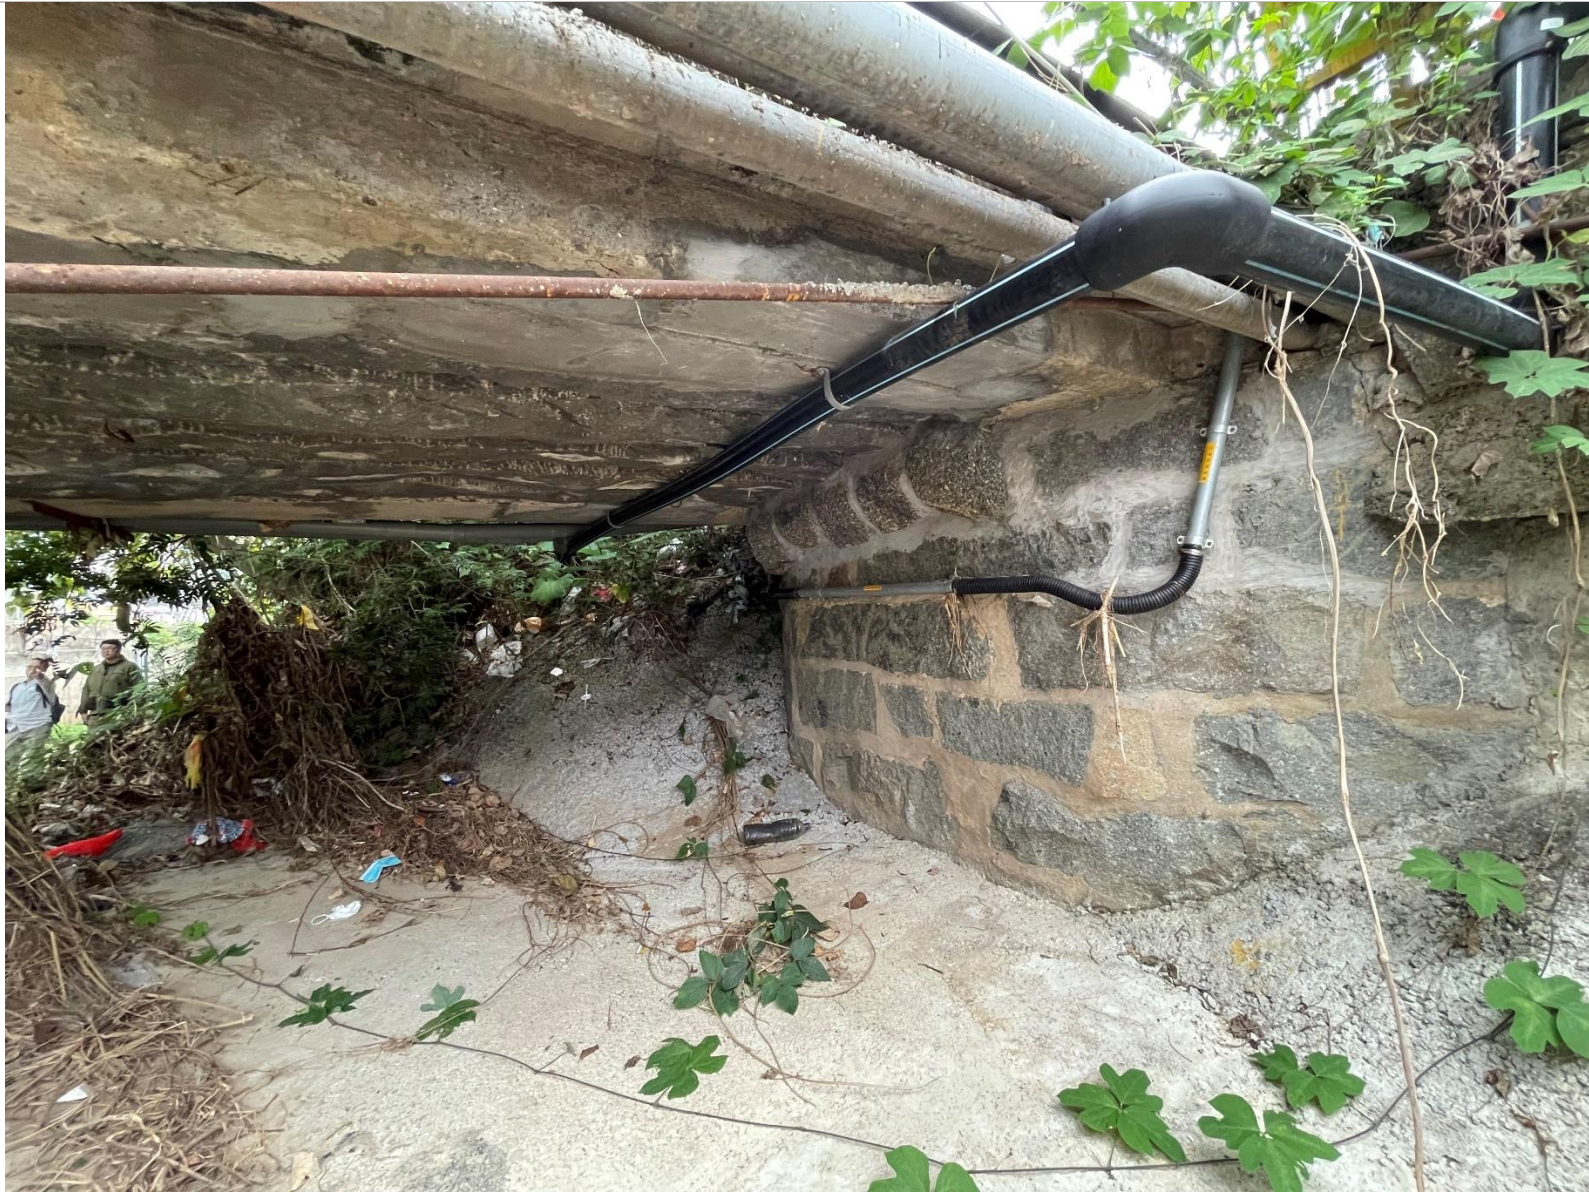
G1.6

W Abutment (1)

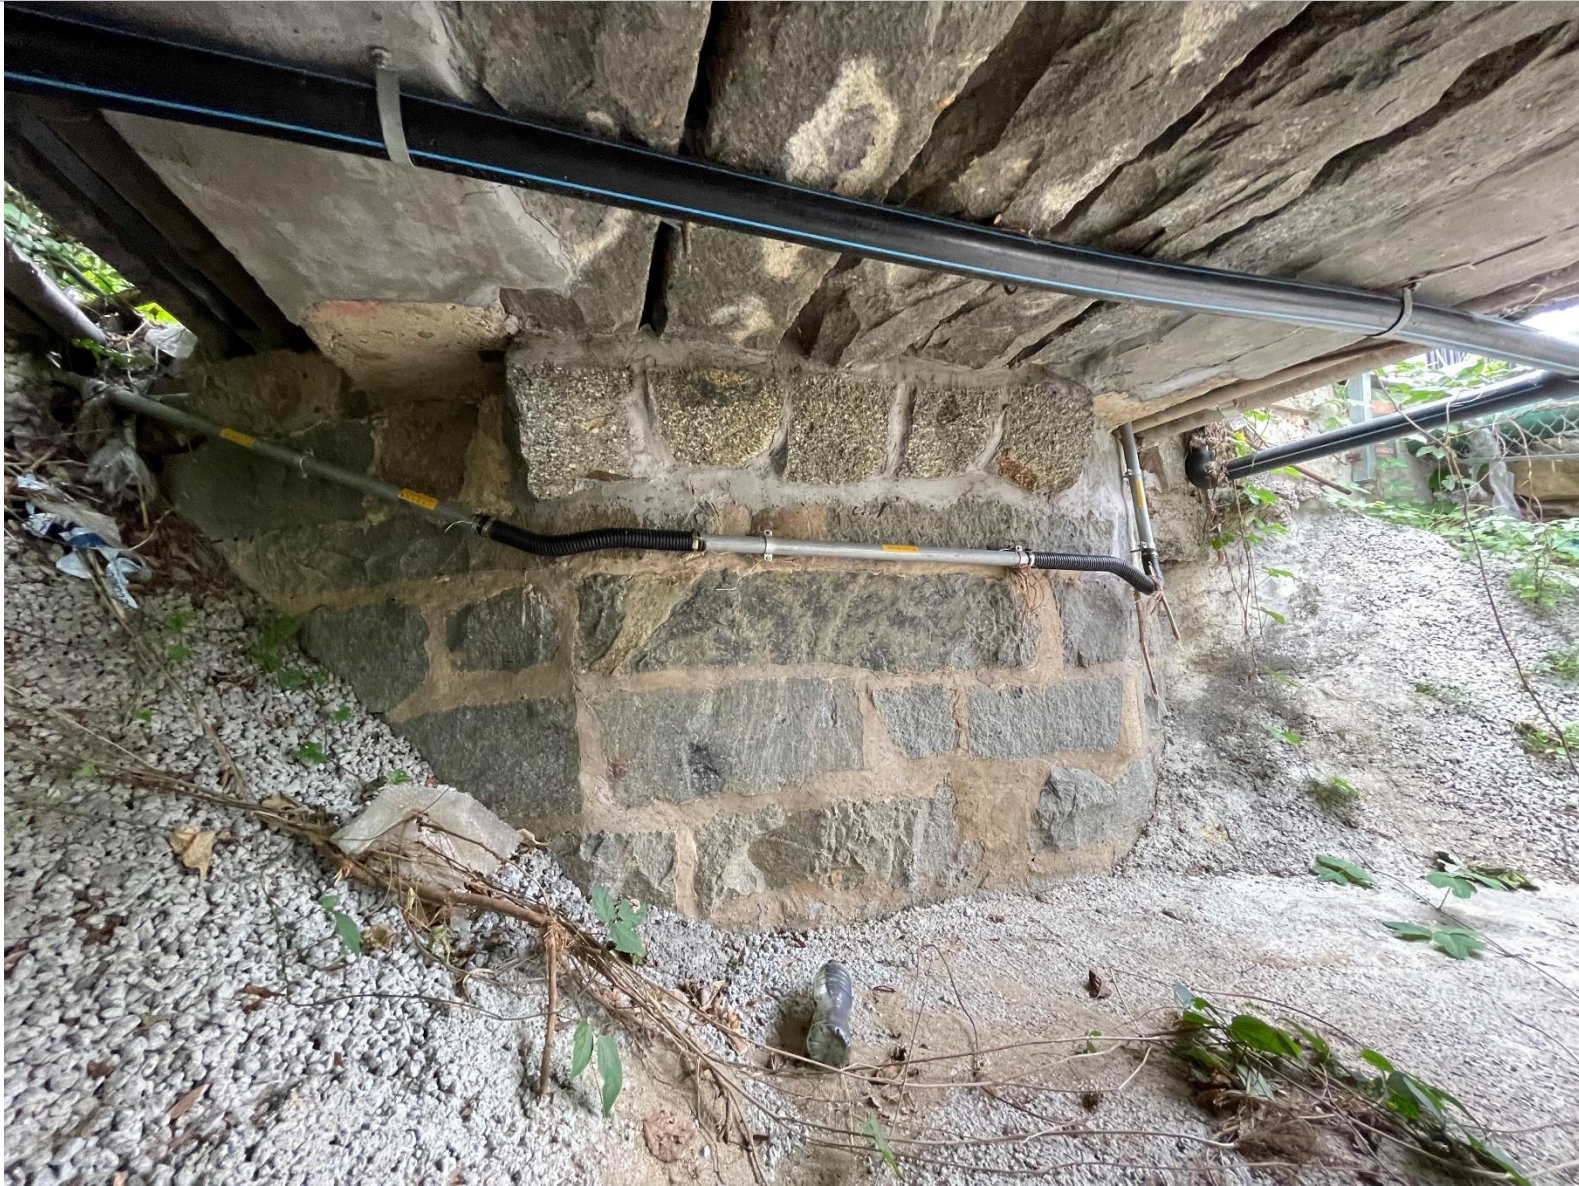
G1.7

W Abutment (2)

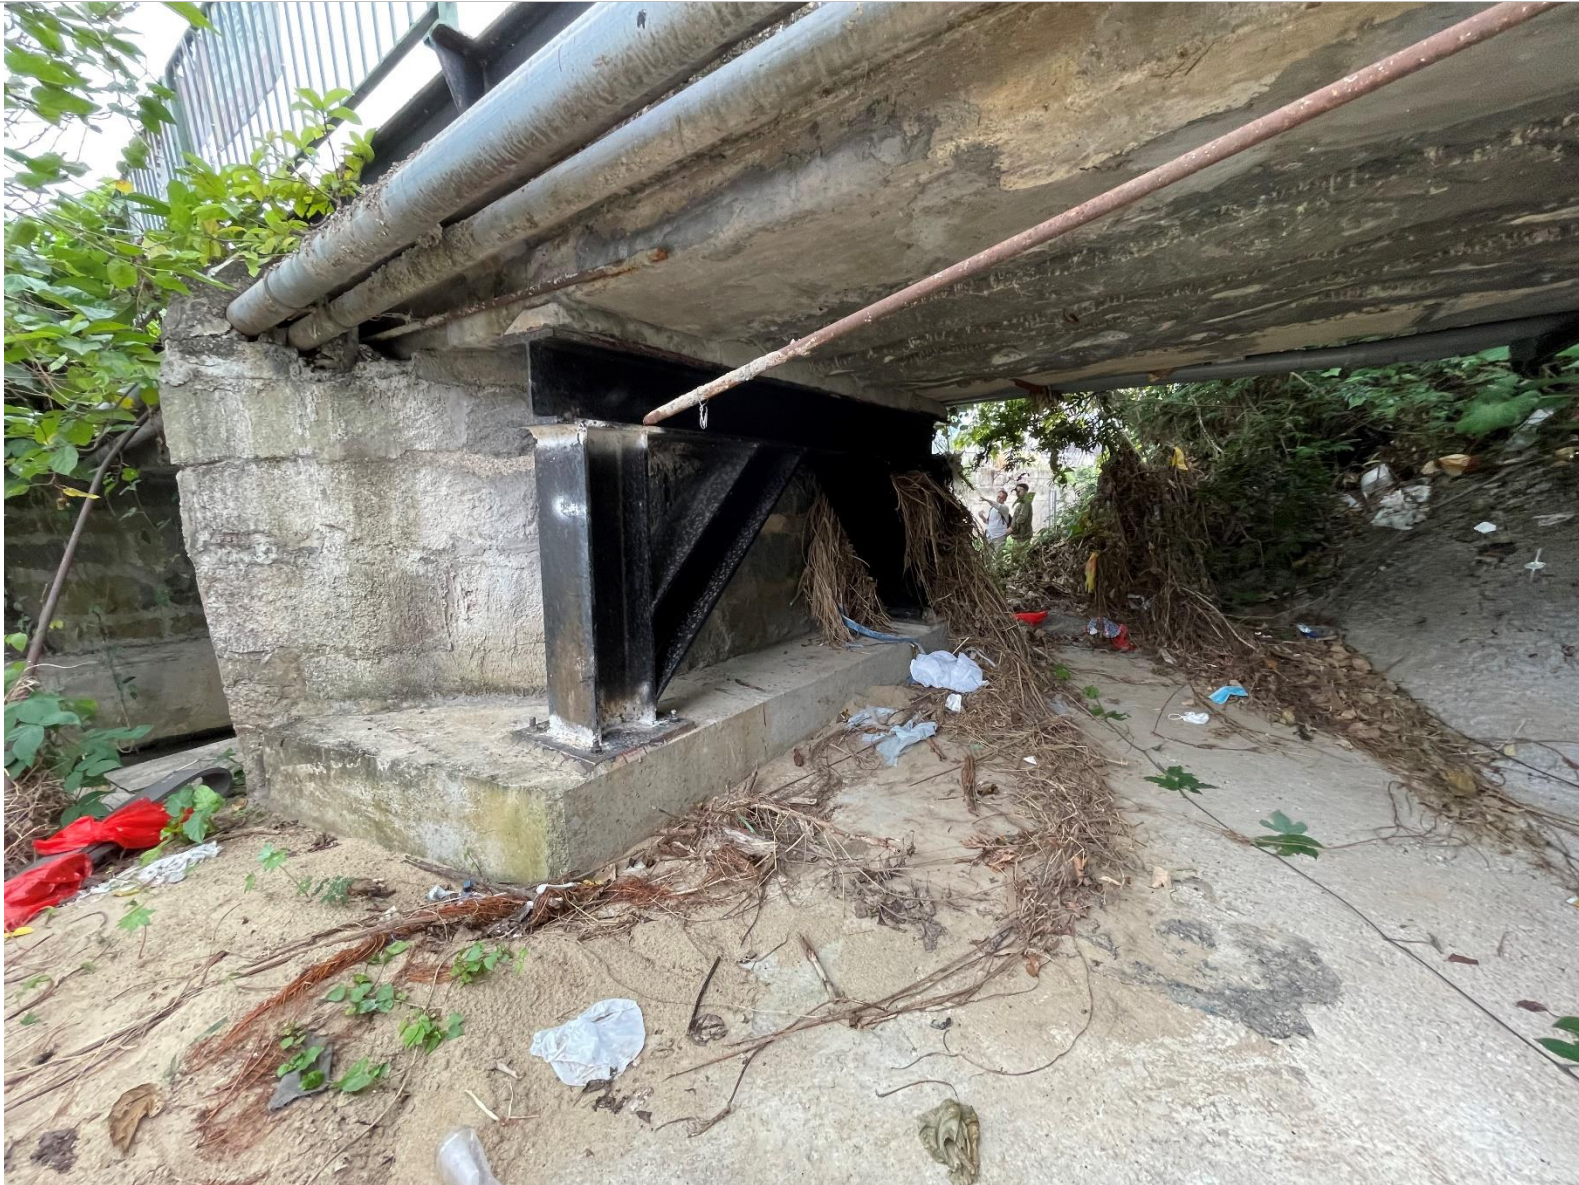
G1.8

Pier and Steel Support (1)

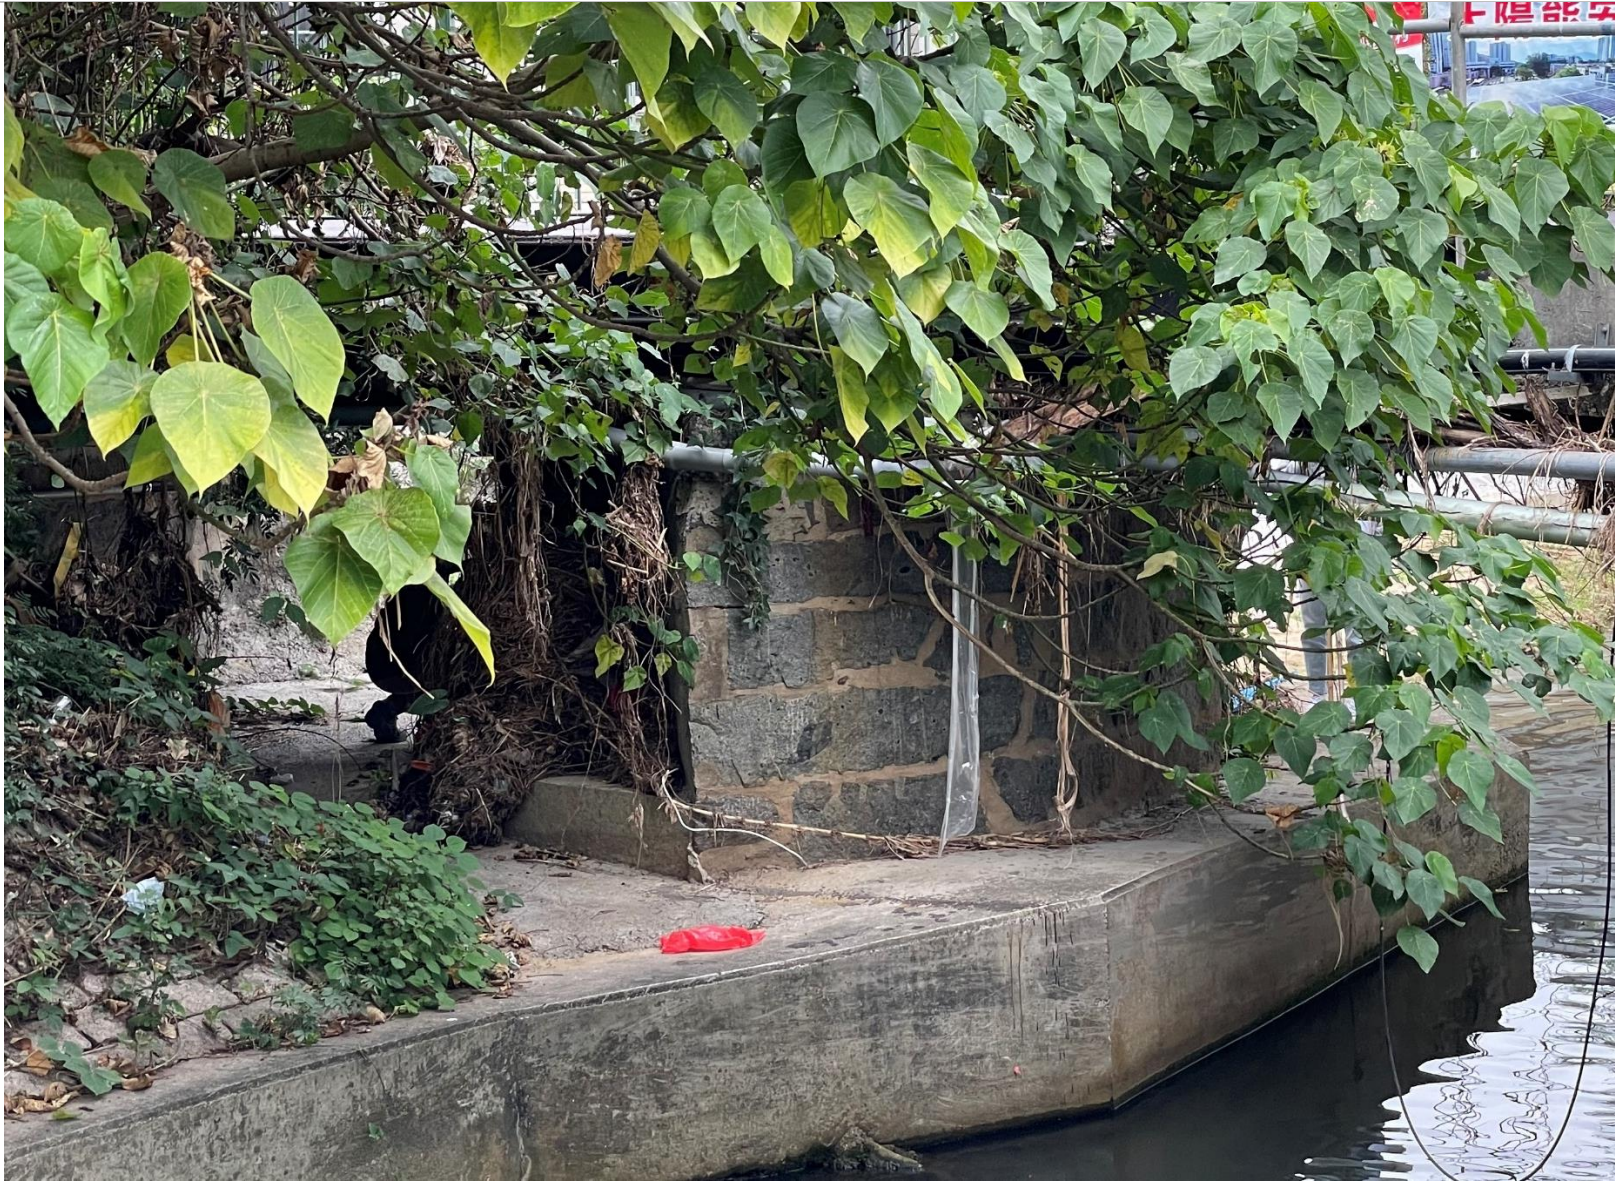
G1.9

Pier and Steel Support (2)

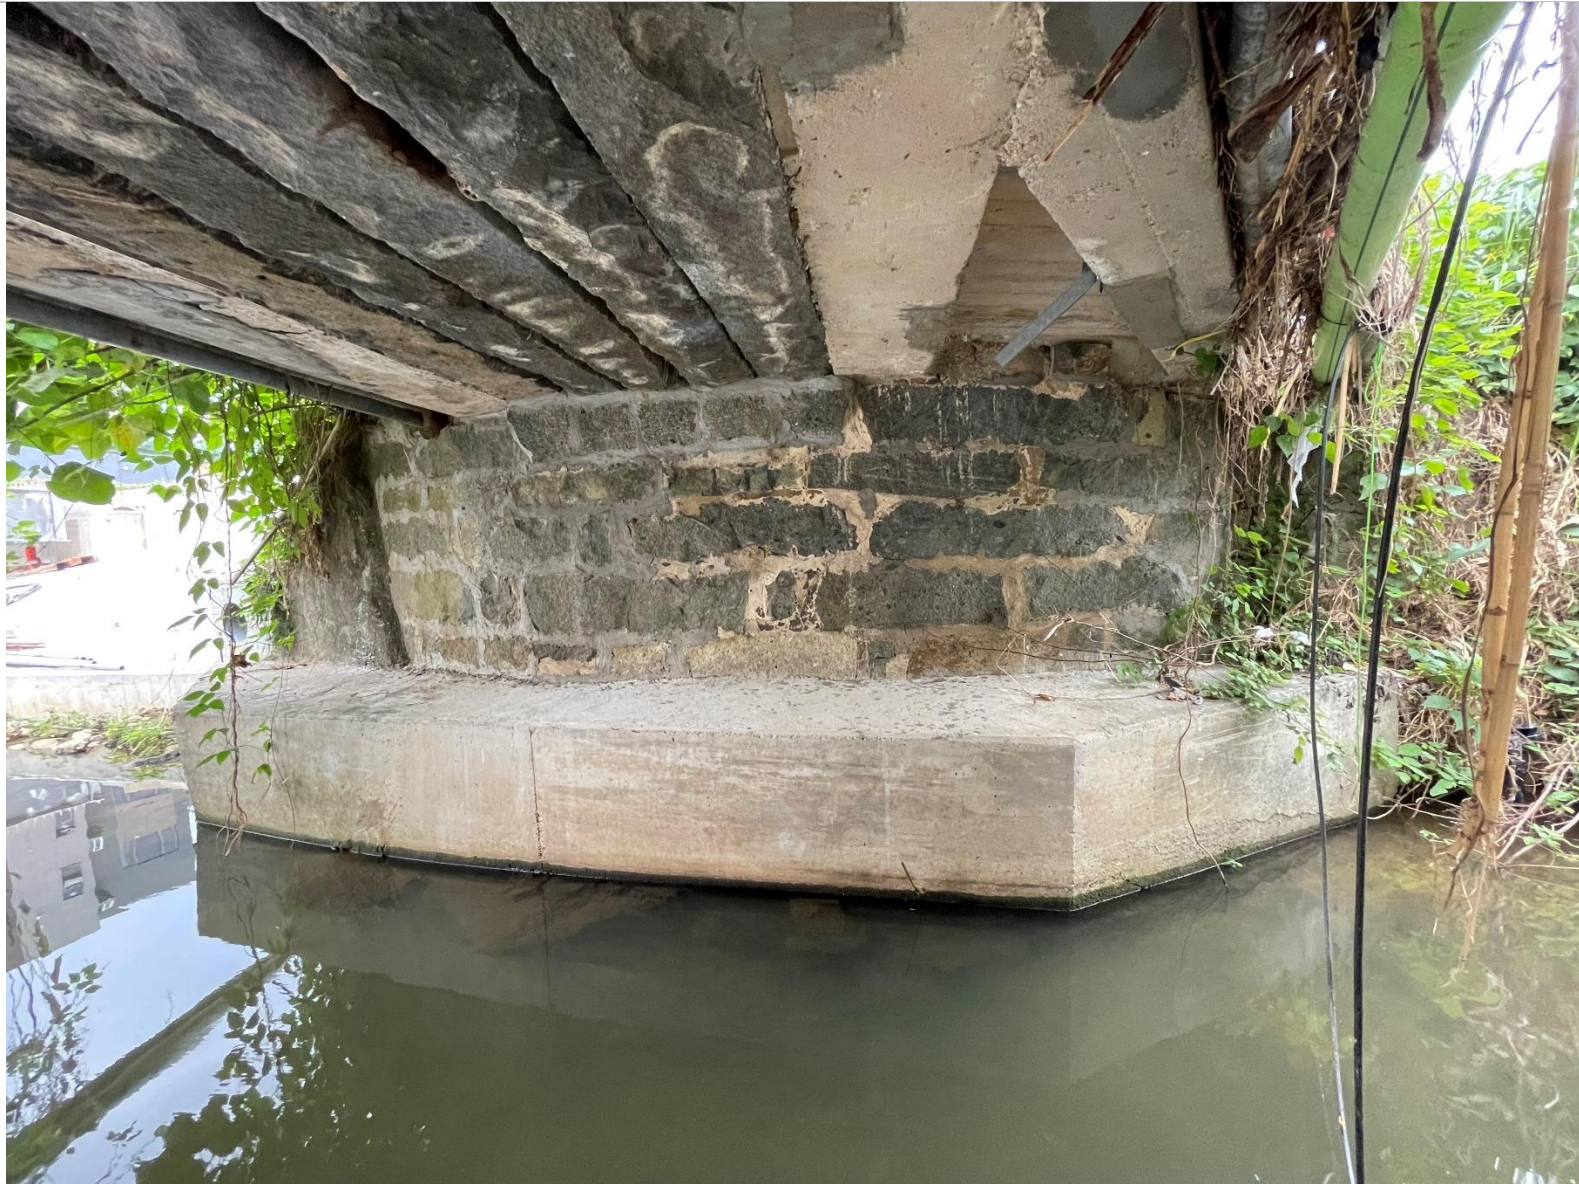
G1.10

E Abutment

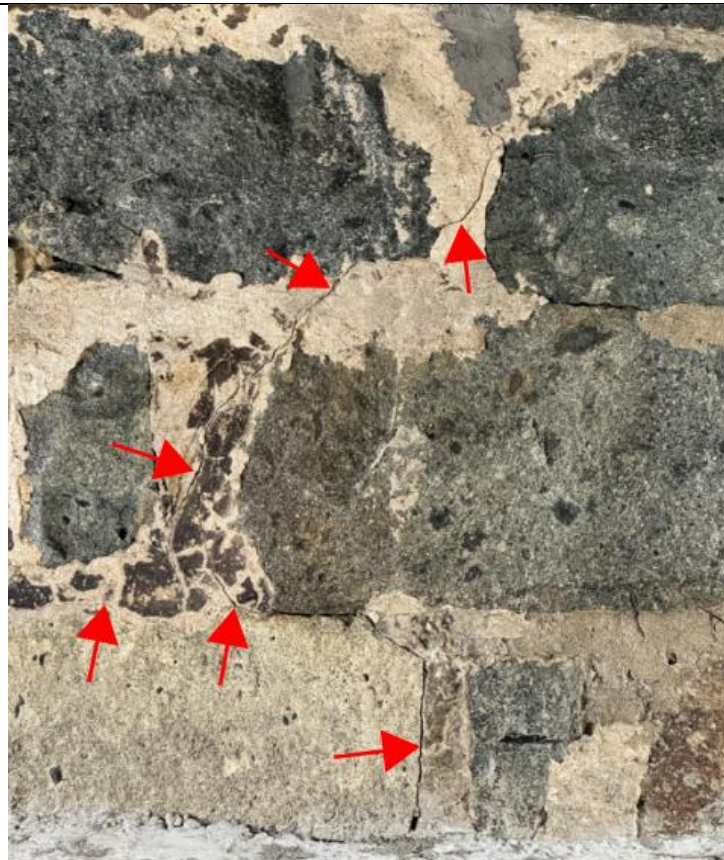
D1.26

Hairline Crack and Minor Crack were found on the E Abutment

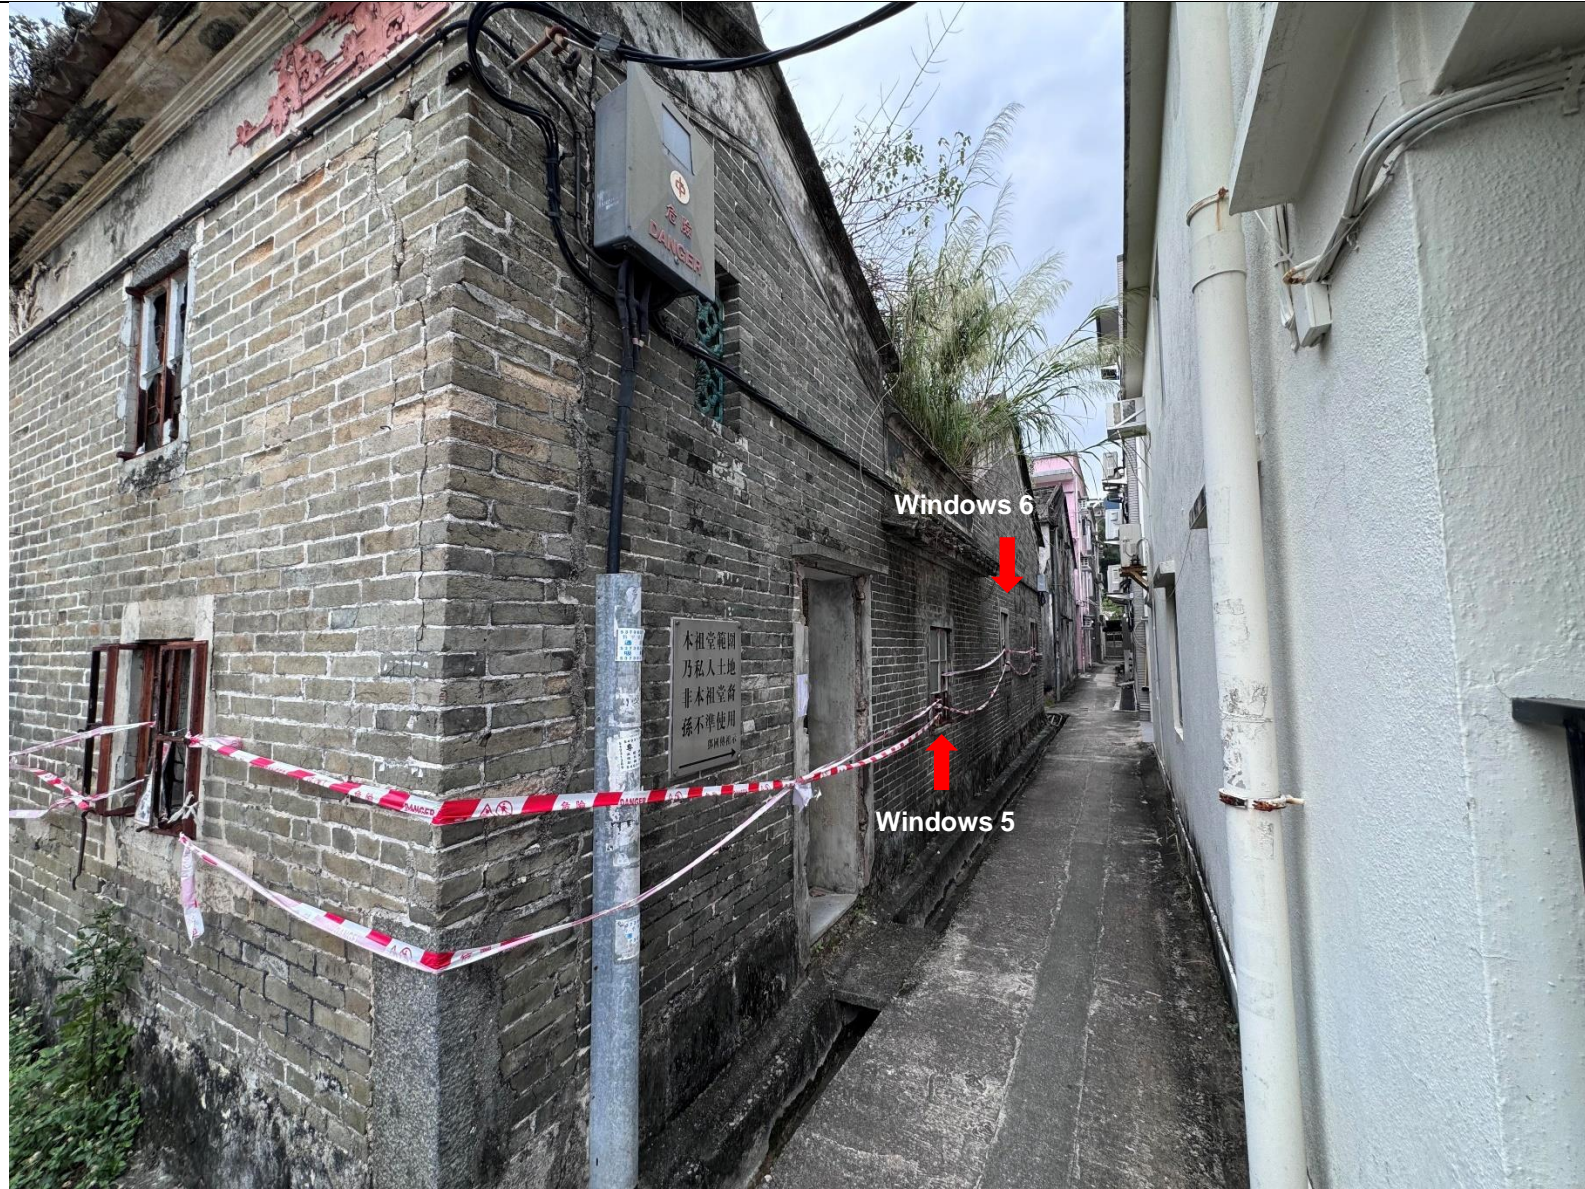
G2.2

W-S Elevation - General View of Study Hall (Side door, Windows 5 and Windows 6 on the south wall)

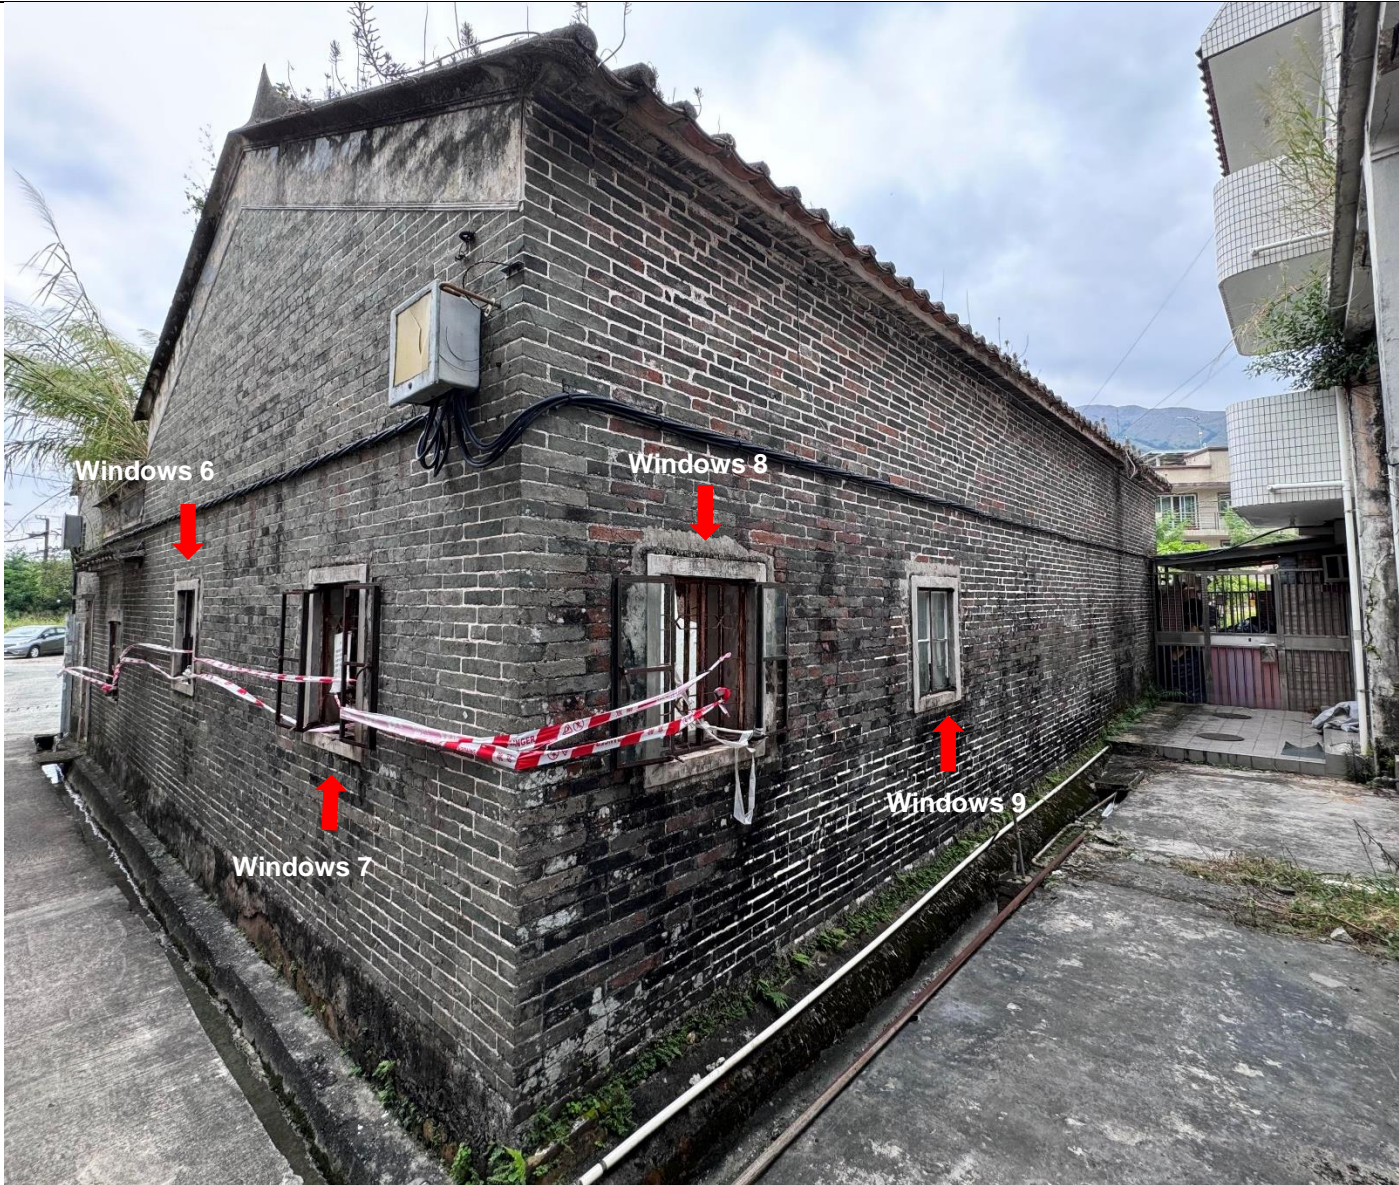
G2.3

S-E Elevation - General View of Study Hall (Windows 7 , Windows 8 and Windows 9 on the south and east wall)
