**DRAINAGE IMPROVEMENT
WORKS AT YUEN LONG –
STAGE 2**

Contract No.: DC/2022/02

**Pre-Construction
Condition Survey
Report for Impacted
Graded Historic
Buildings**

**Wing Tat Civil Engineering
Company Limited**

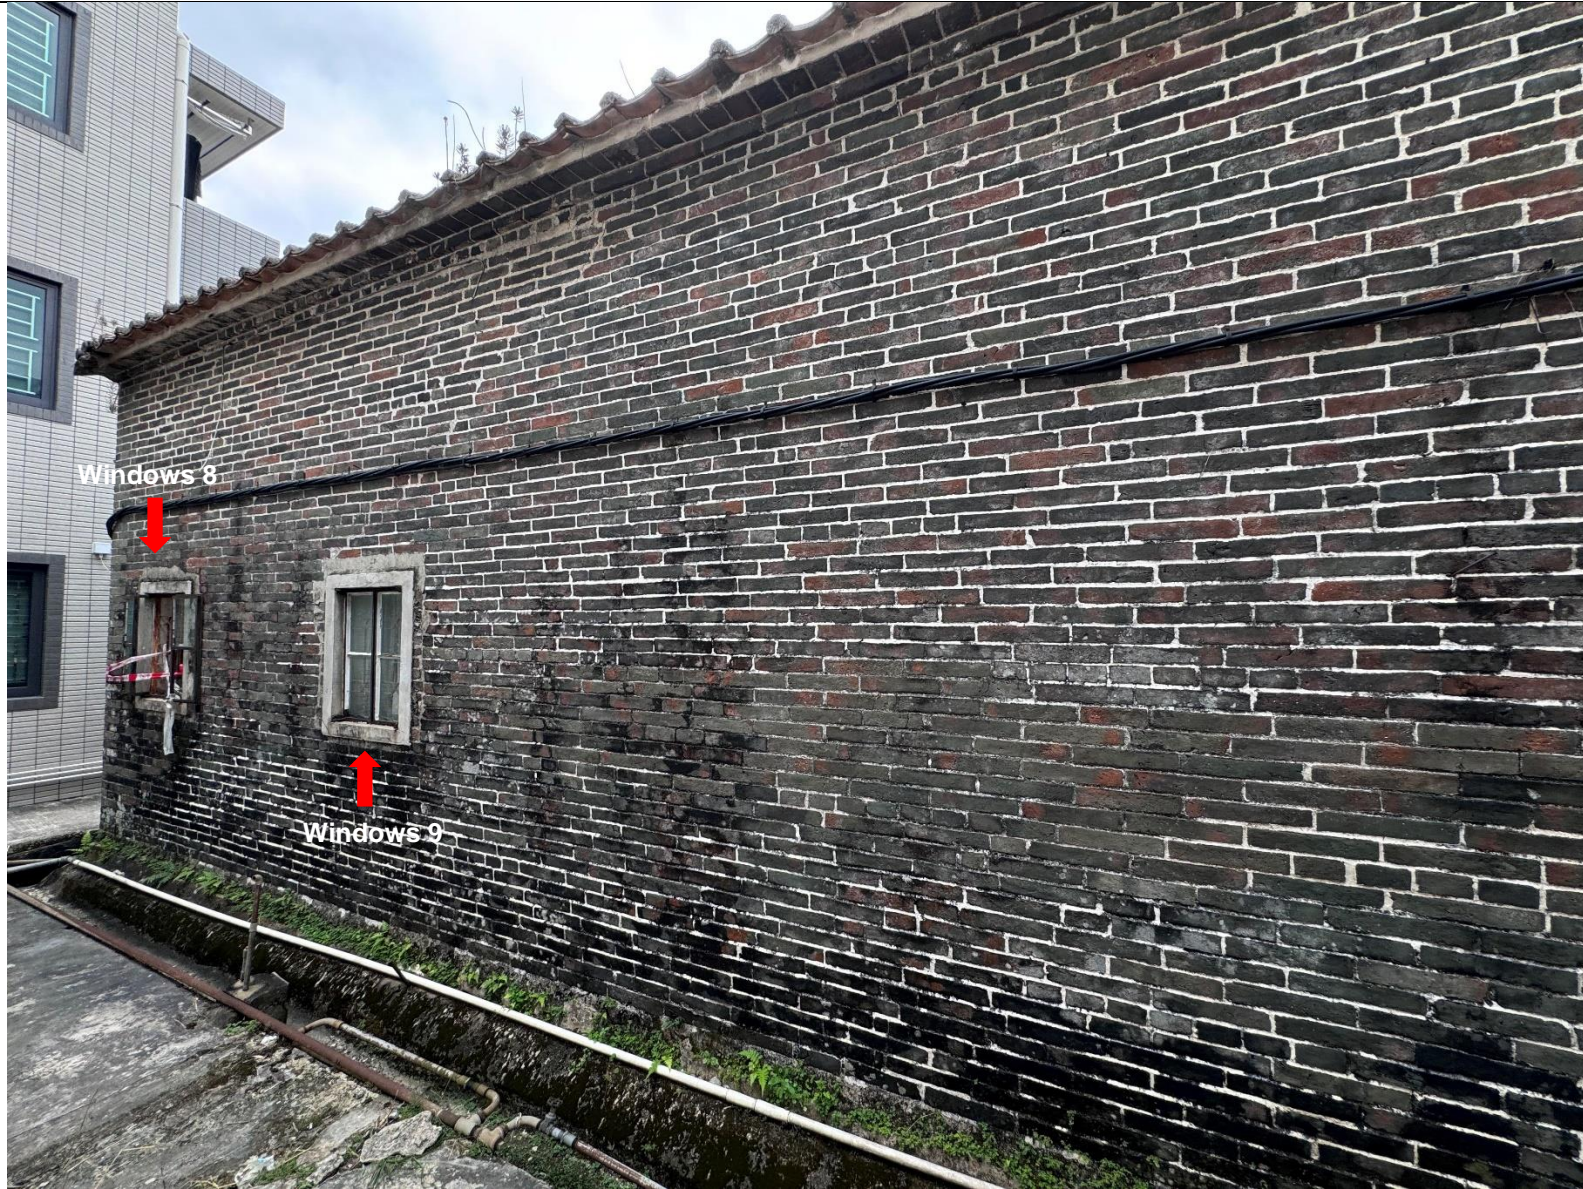
G2.4

E Elevation (1) - General View of Study Hall (Windows 8 and Windows 9 on the east wall)

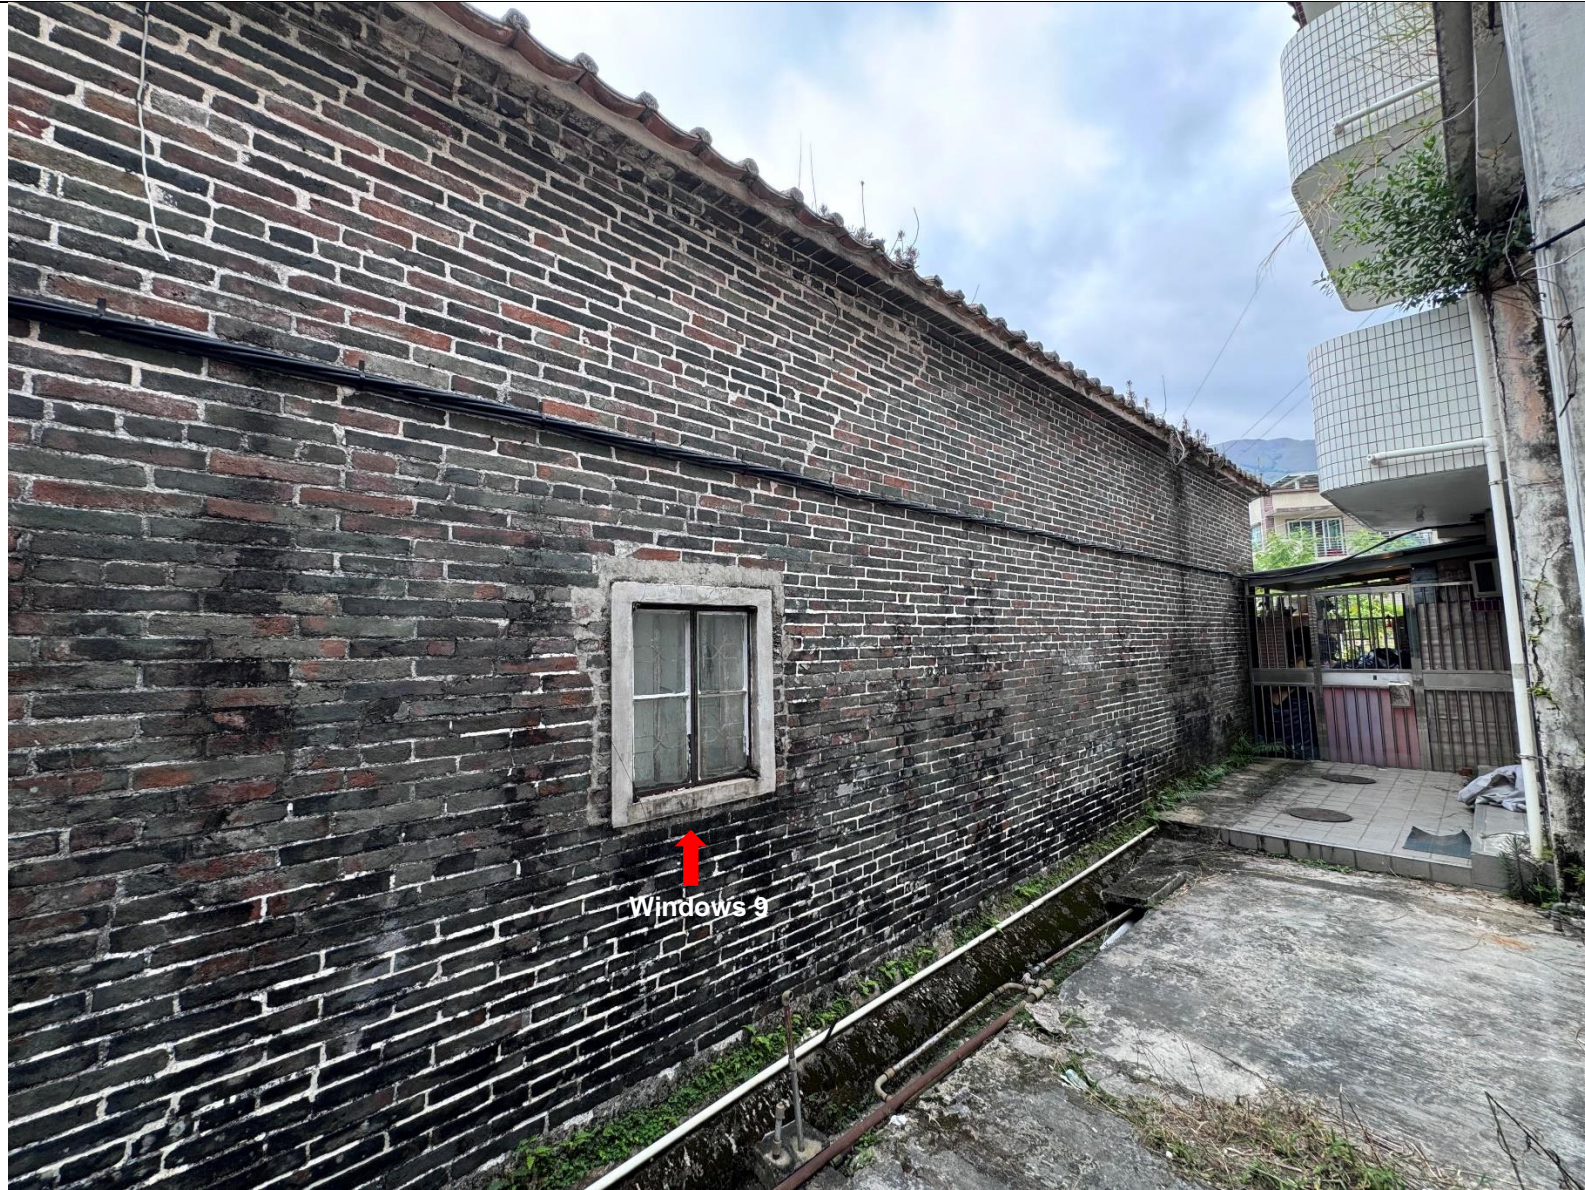
G2.5

E Elevation (2) - General View of Study Hall (Windows 8 and Windows 9 on the east wall)

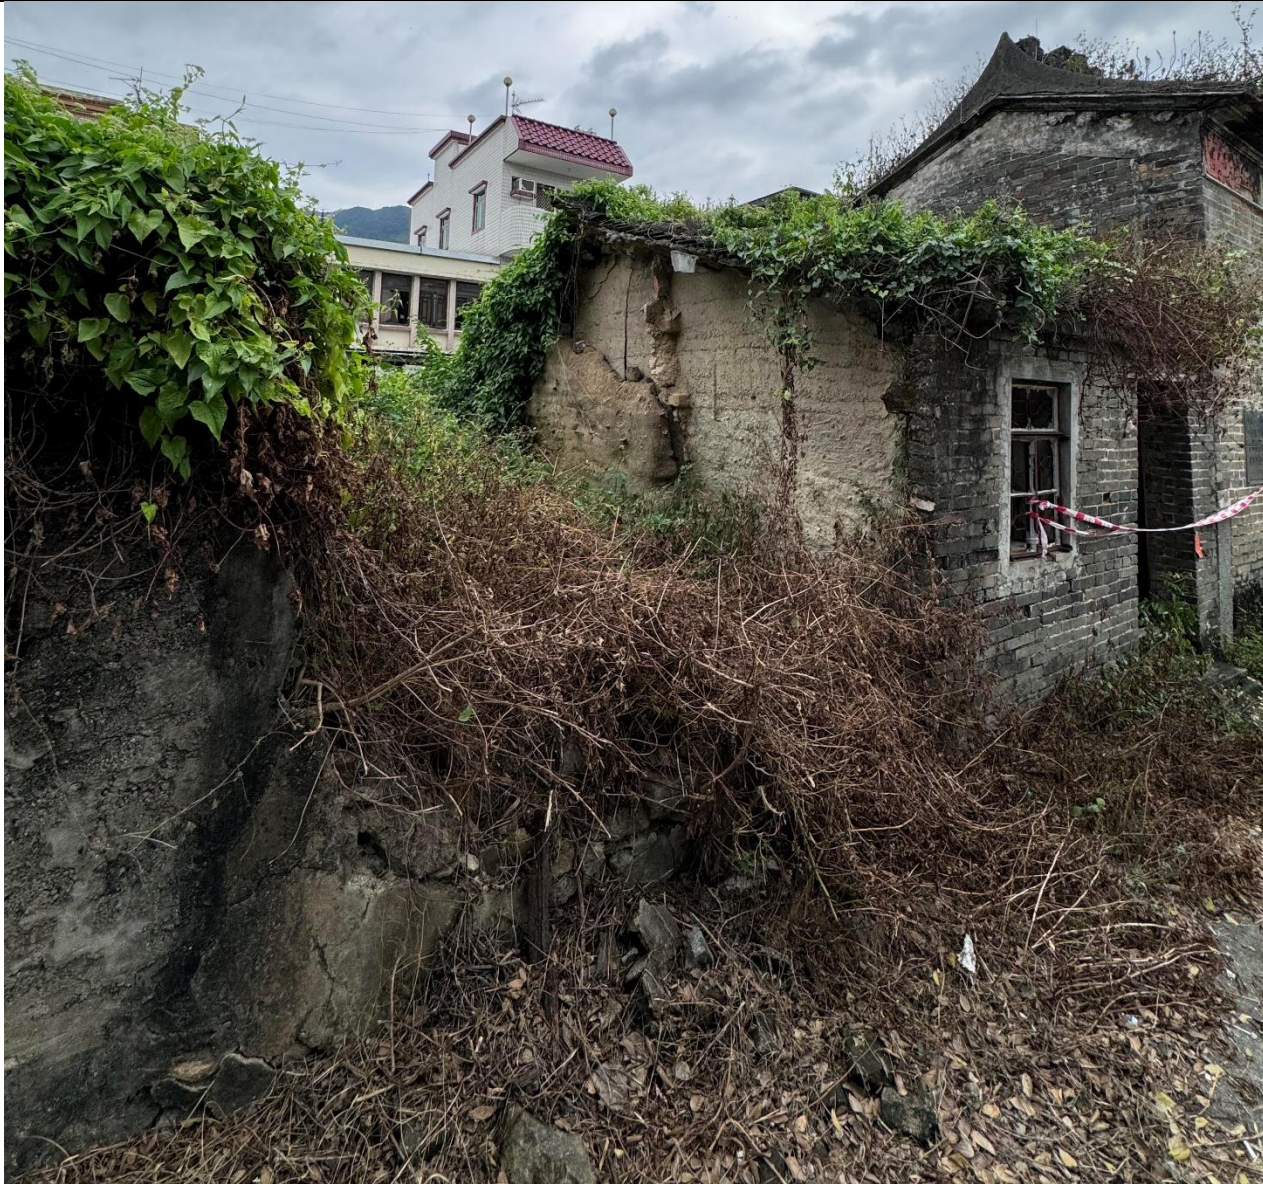
G2.6

N-W Elevation - General View of storeroom

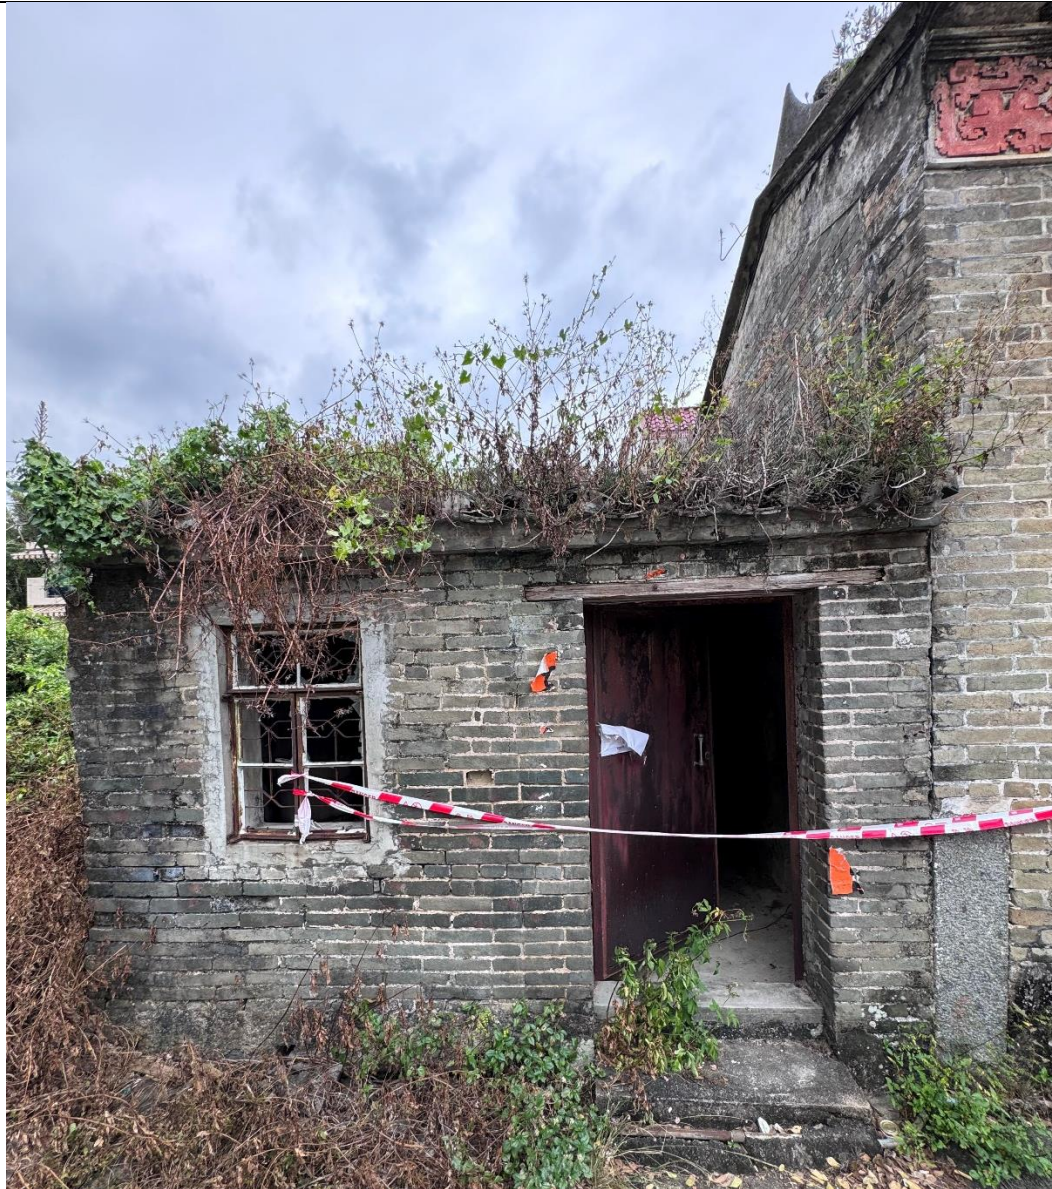
G2.7

W Elevation - General View of Storeroom

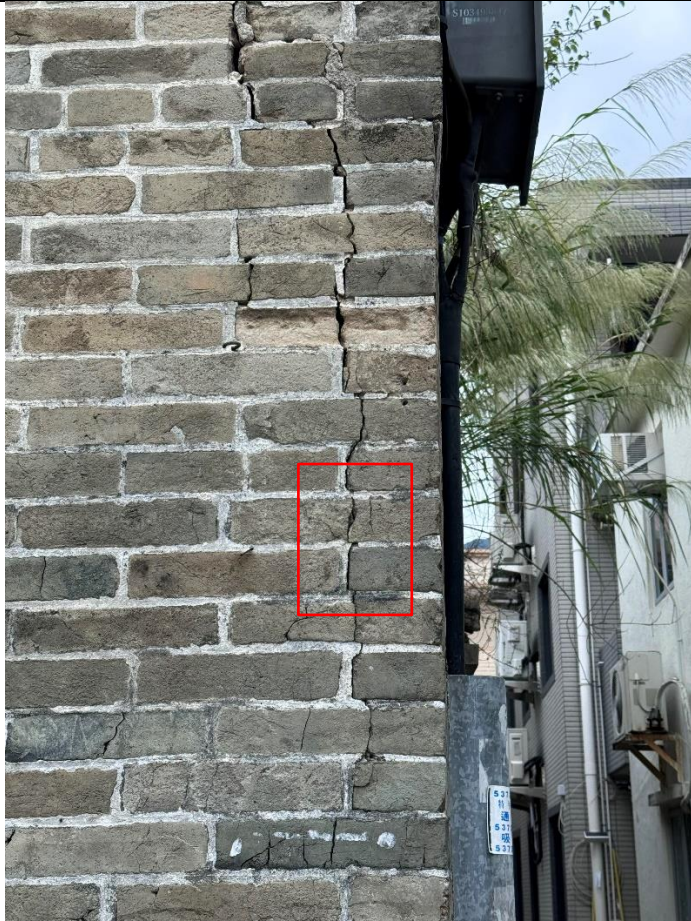
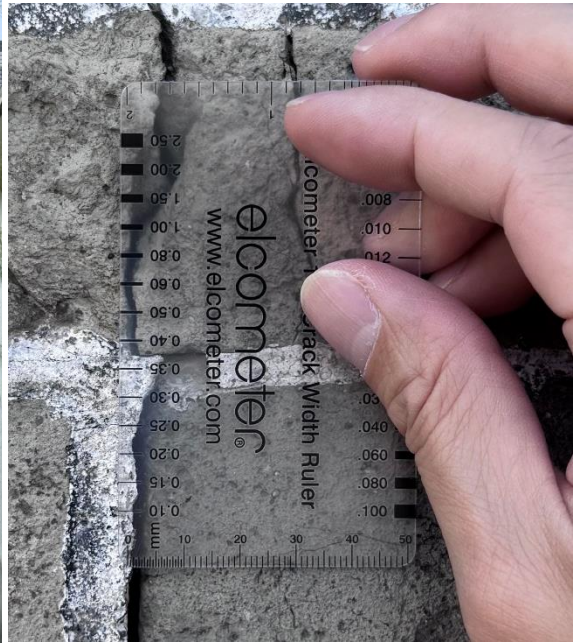
<p>D2.1</p>	  <p>D2.2</p>
D2.1, D2.2	Severe cracks were found on the west wall of the study hall.

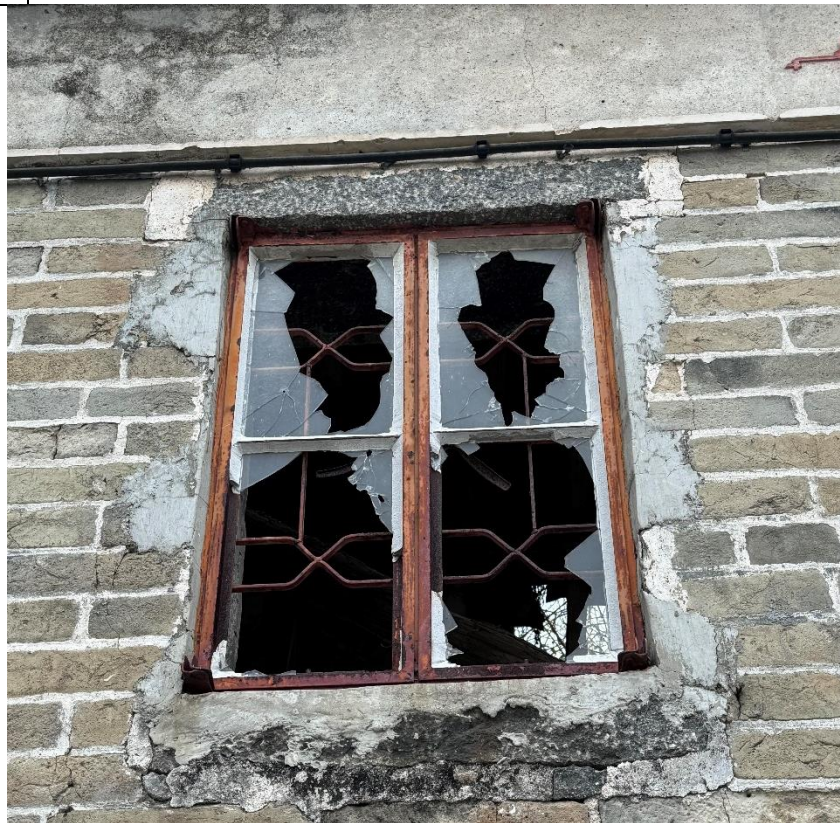
D2.3

Severe crack (wider than 2mm) was found on the west wall of the study hall.

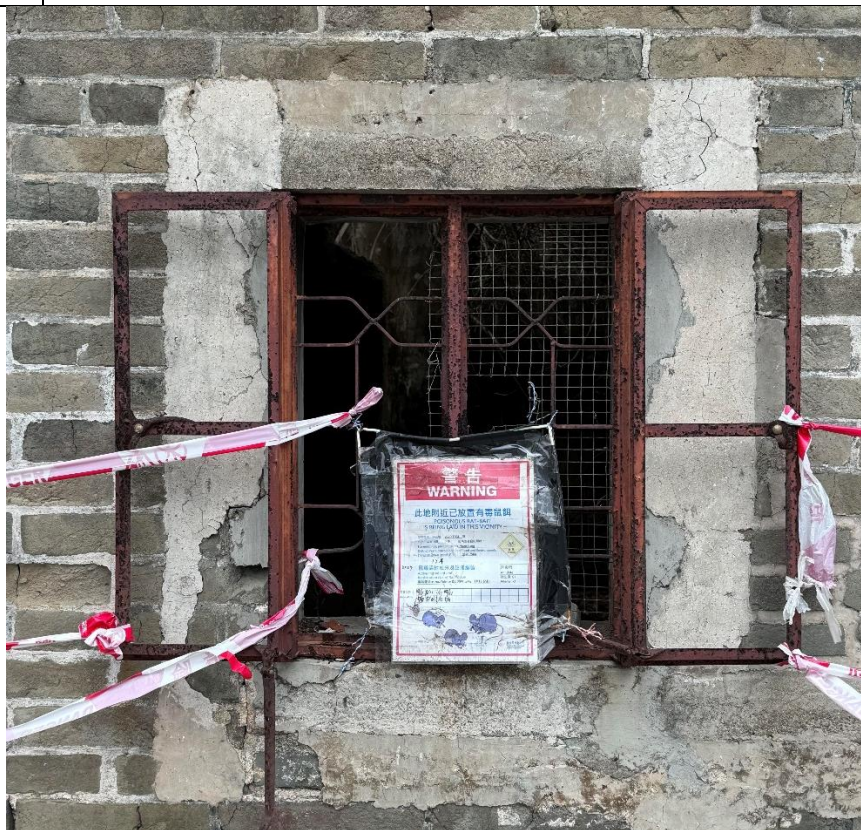
D2.9

The glass of windows 2 was missing on the west wall of the study hall.

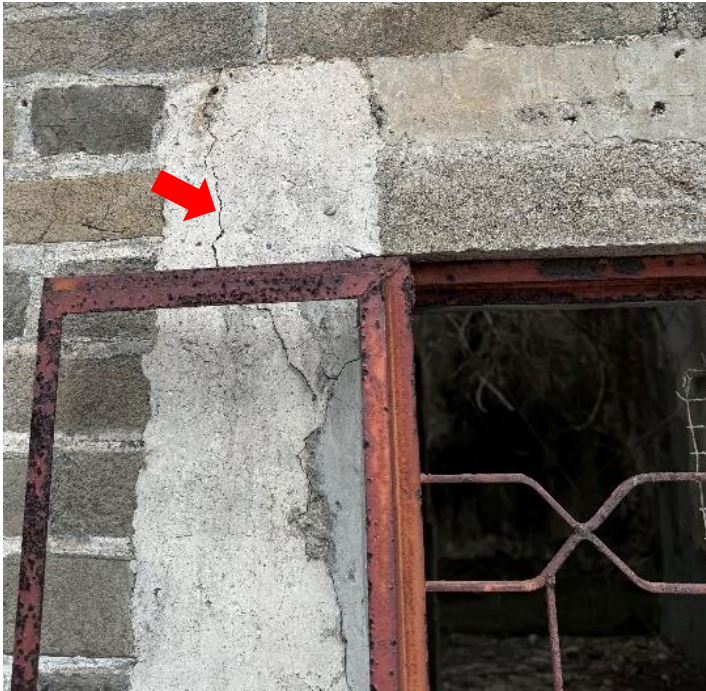
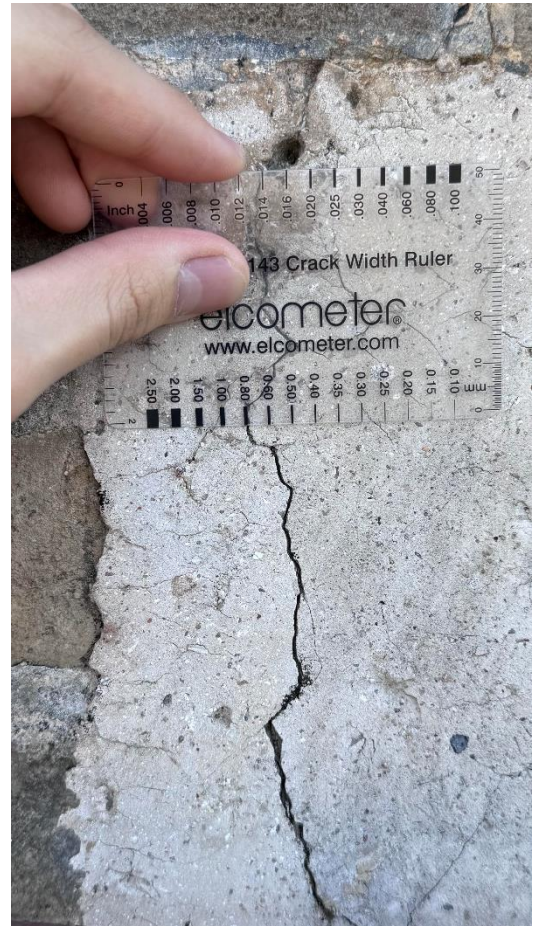
D2.10

Minor crack (below 1mm wide) was found on windows 2.

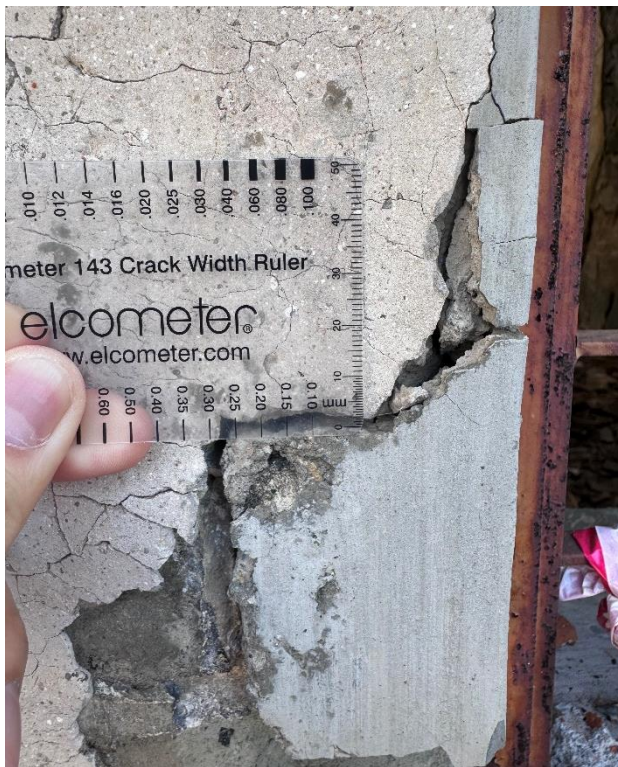
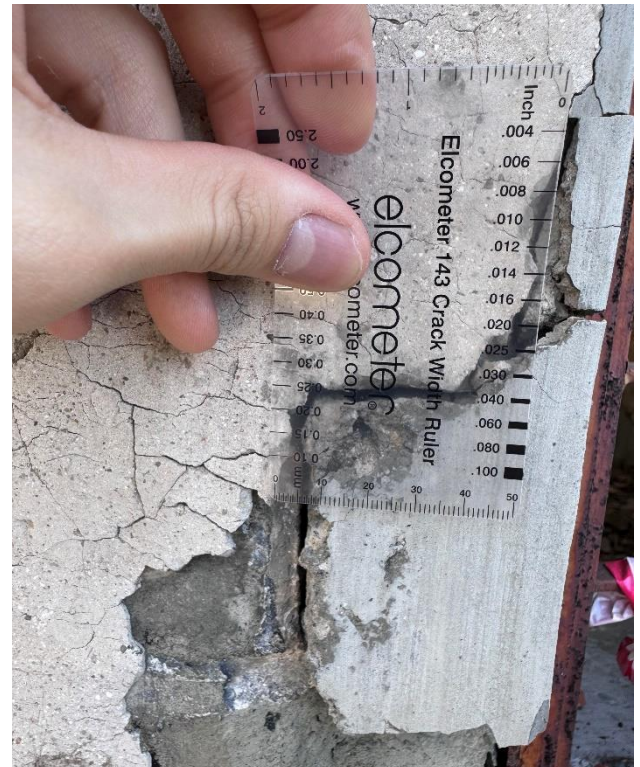
D2.11

Minor concrete spalling and severe crack (wider than 2mm) was found on windows 2.

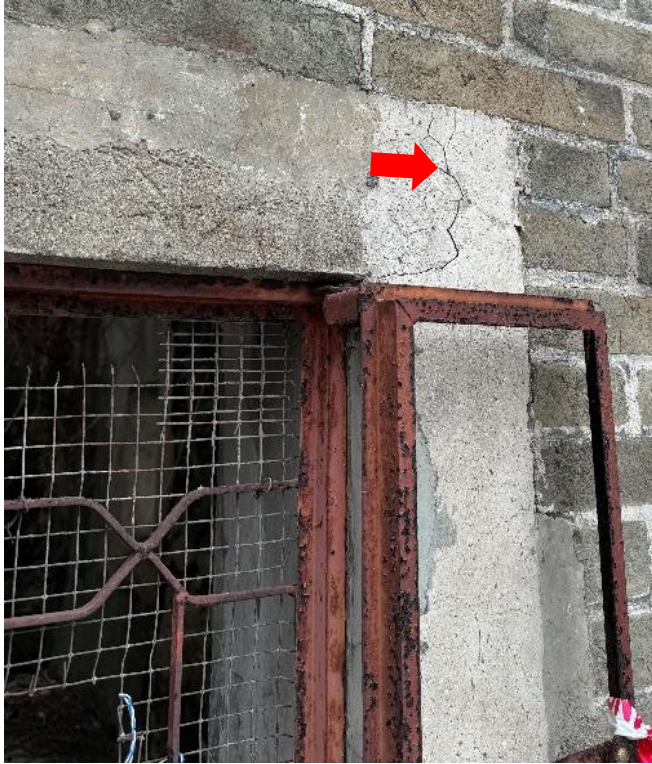
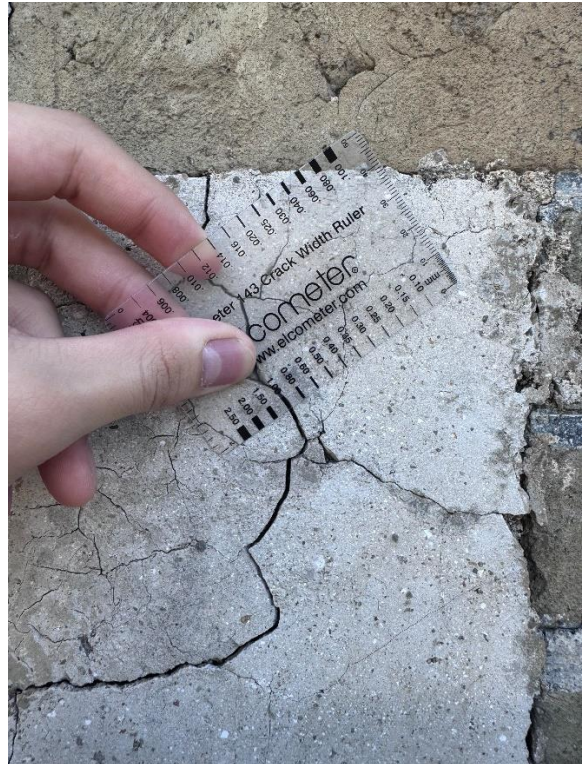
D2.12

Minor crack (equal to 1mm) was found on windows 2.

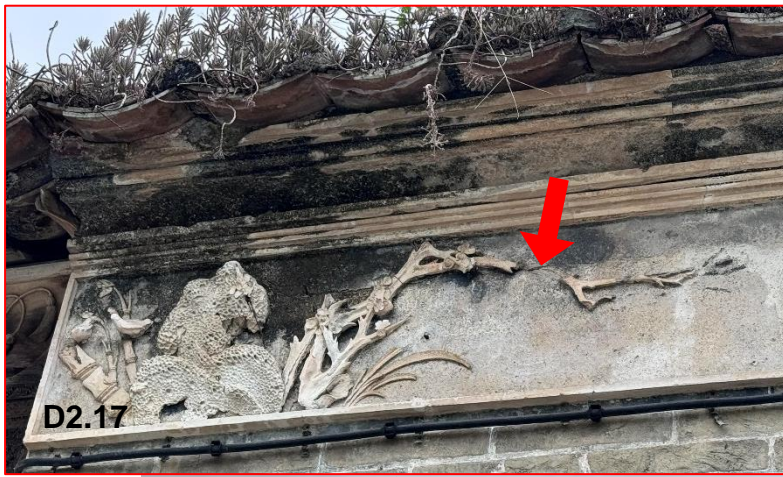
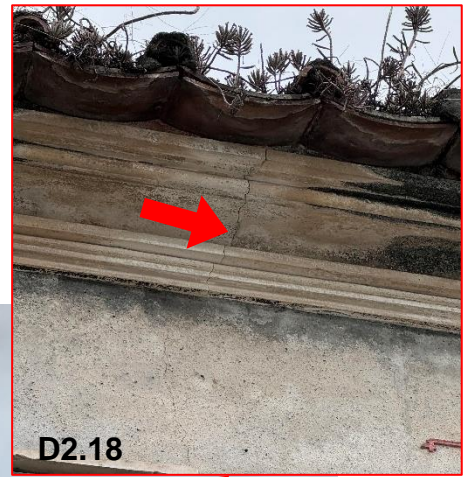
D2.16

Minor spalled concrete was found under the west wall.

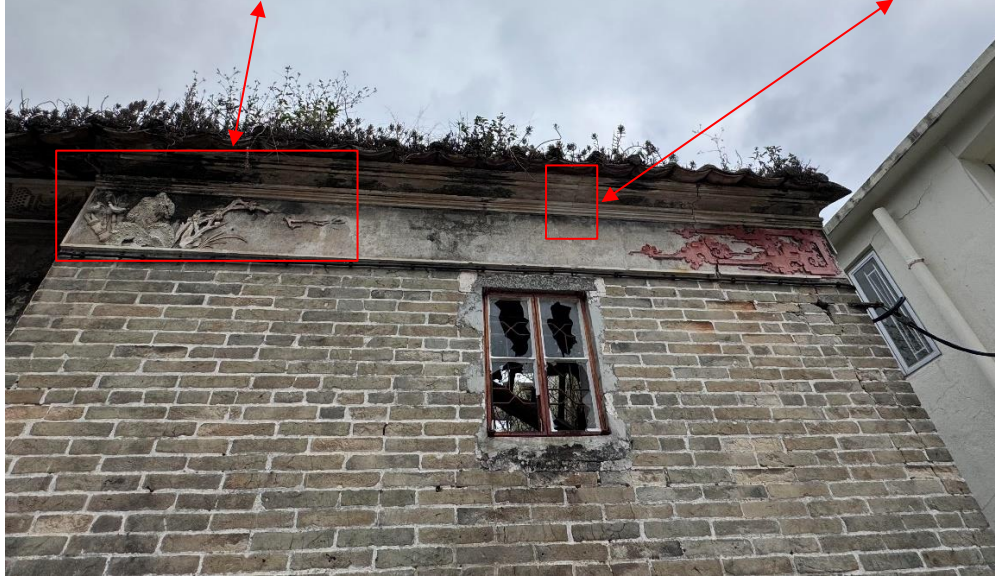
D2.17	The mural was damaged.
D2.18	Hairline crack was found on the eaves on west wall.

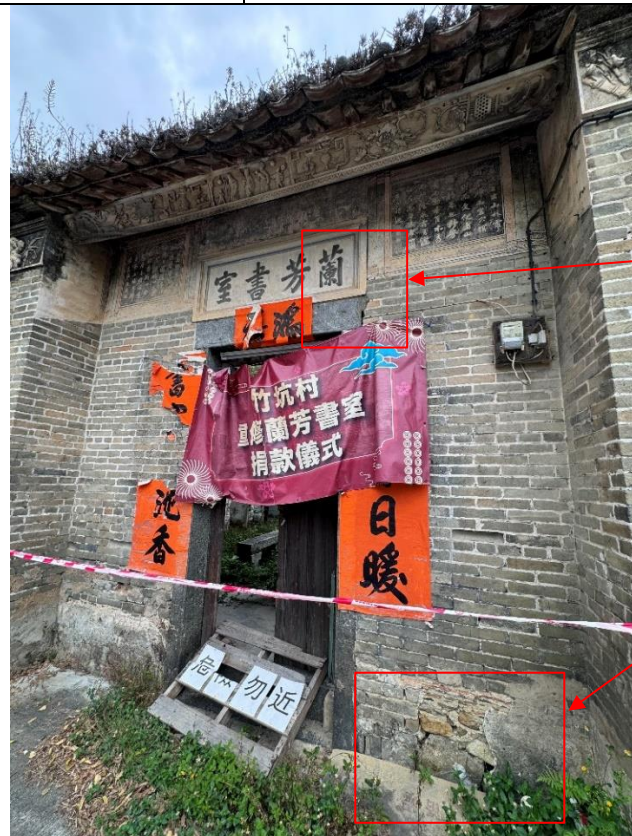
D2.19, D2.20

Some blocks were missing and weathered.

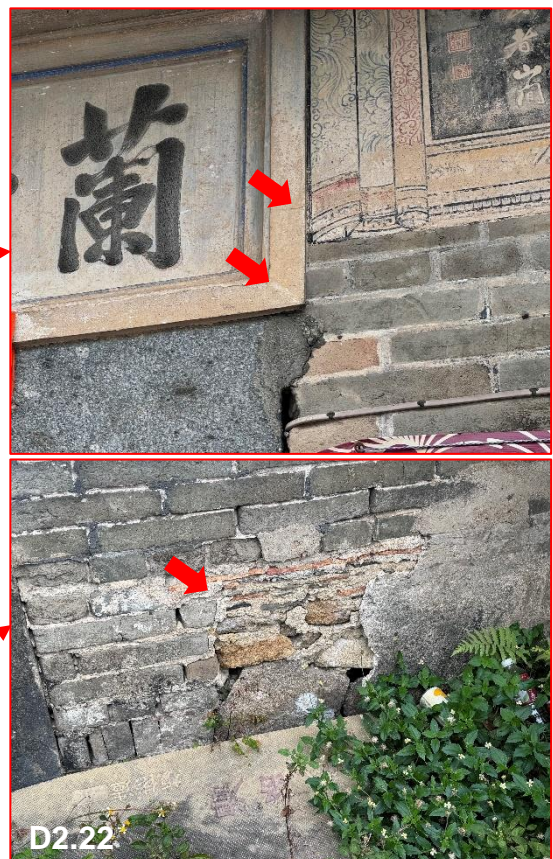
D2.21

Hairline crack was found on the board

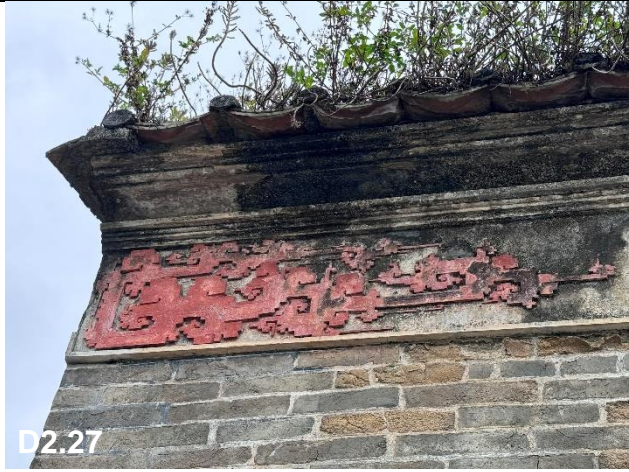
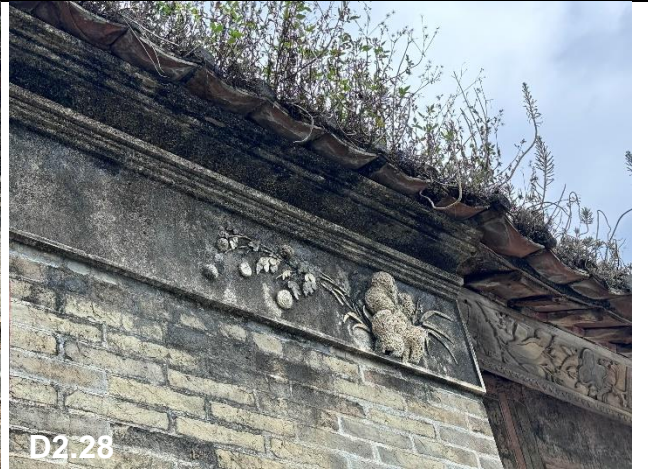
D2.26

Minor crack was found on the eaves.

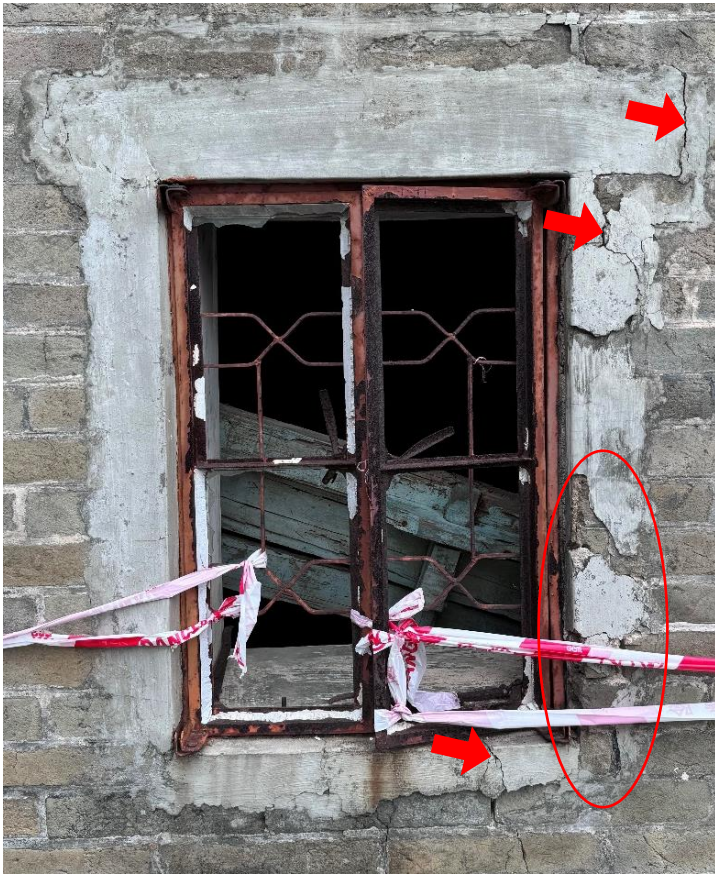
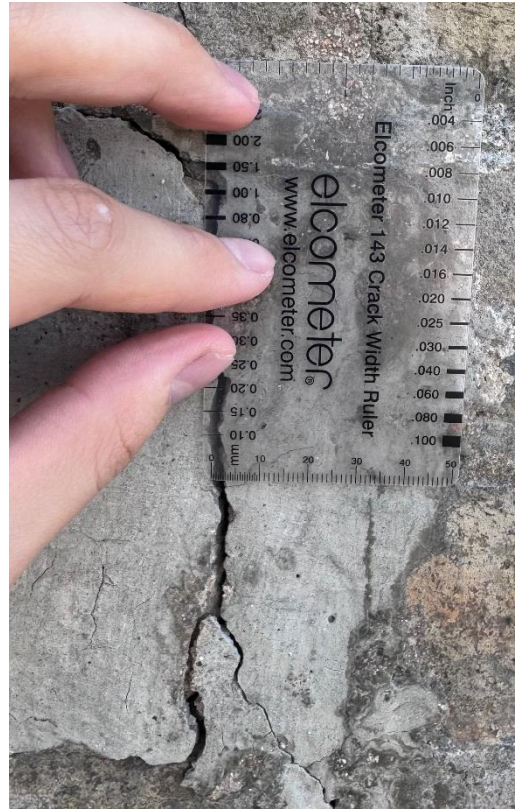
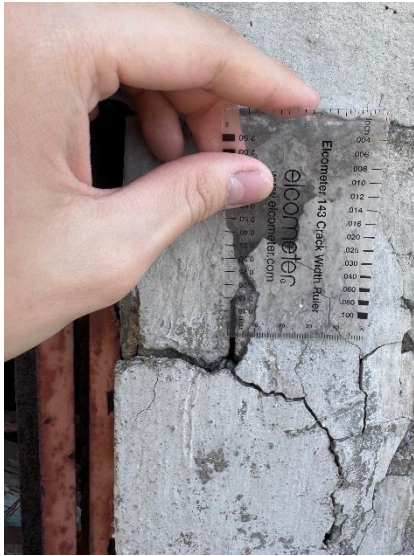
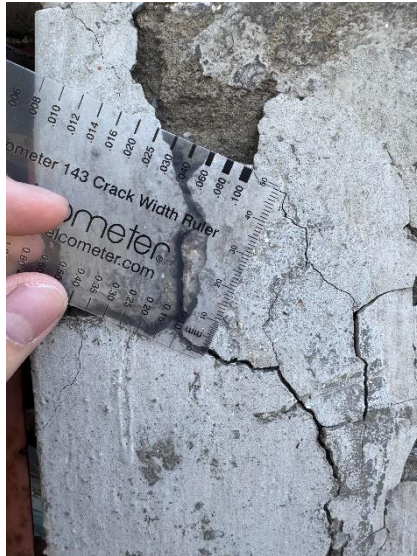
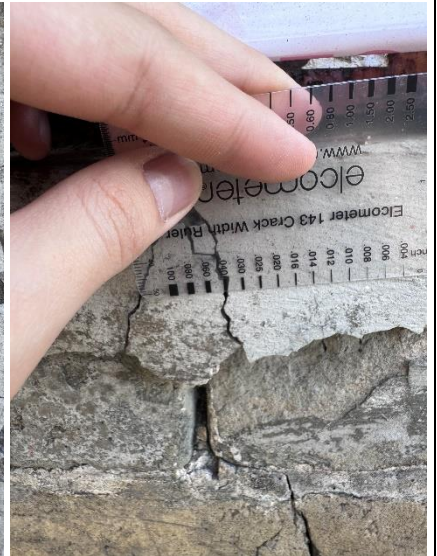
D2.30

Severe crack (equal to 2mm) was found between windows 3 and windows 4.

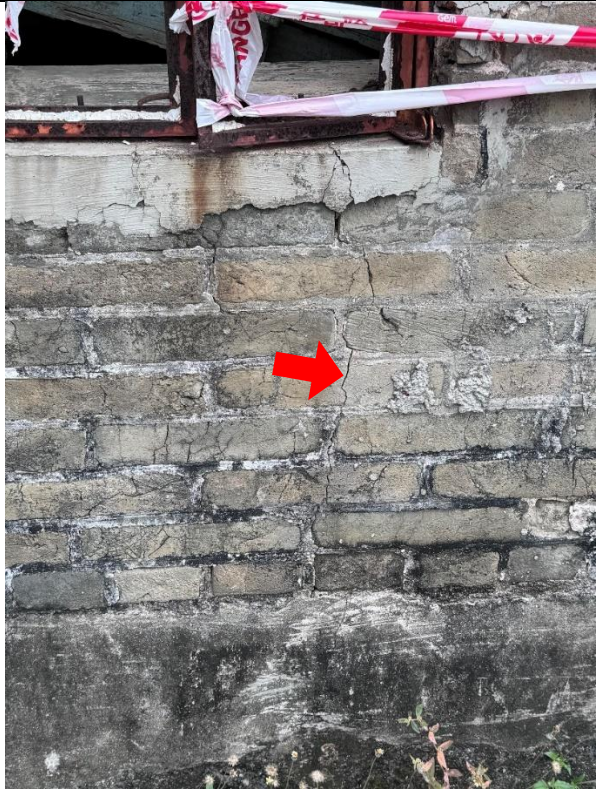
D2.31

Concrete spalling, minor crack and severe crack were appeared.

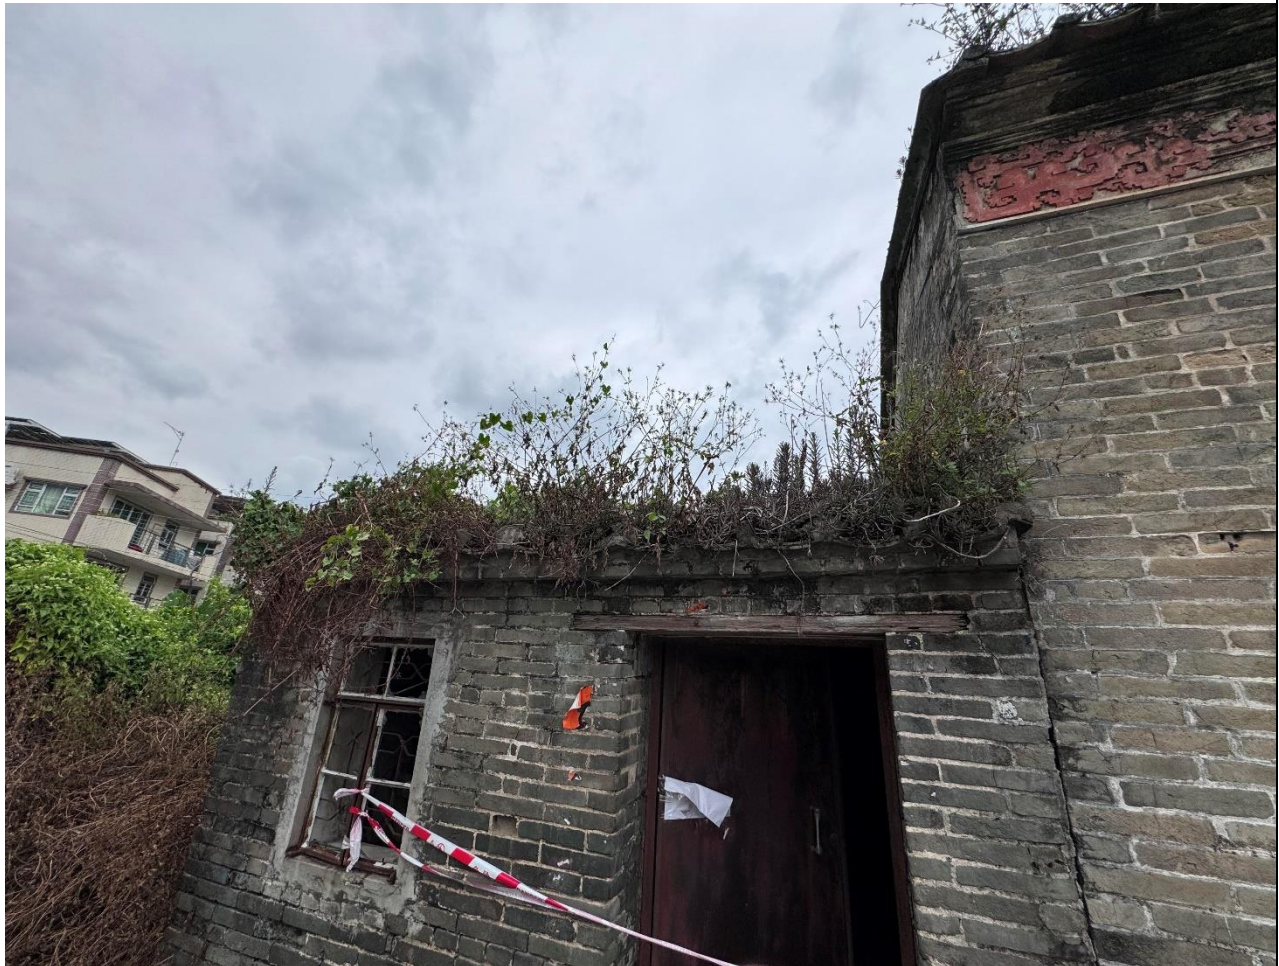
D2.34

Large of vegetation growing on the roof of the study hall.

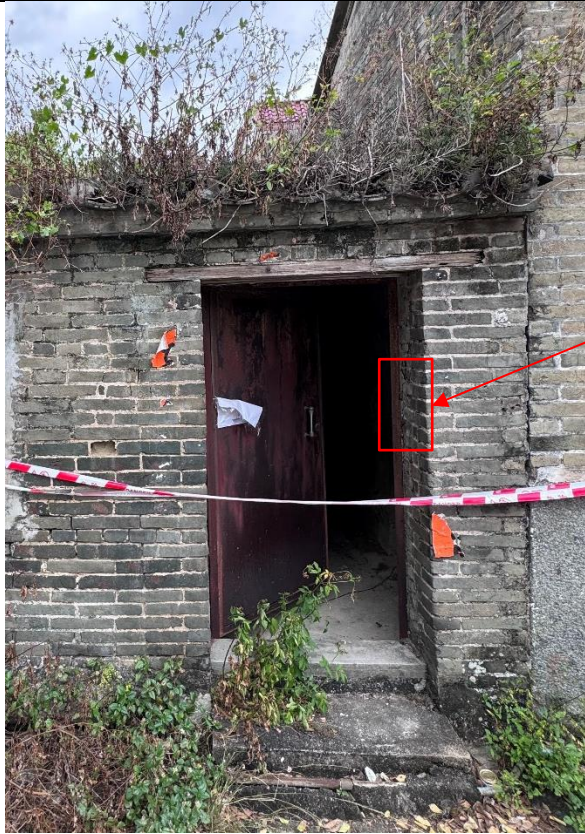
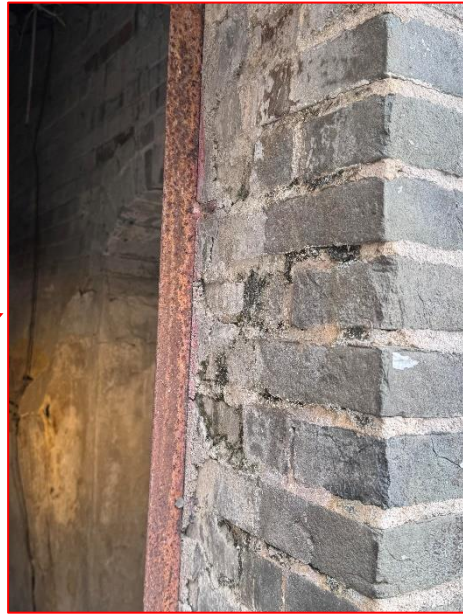
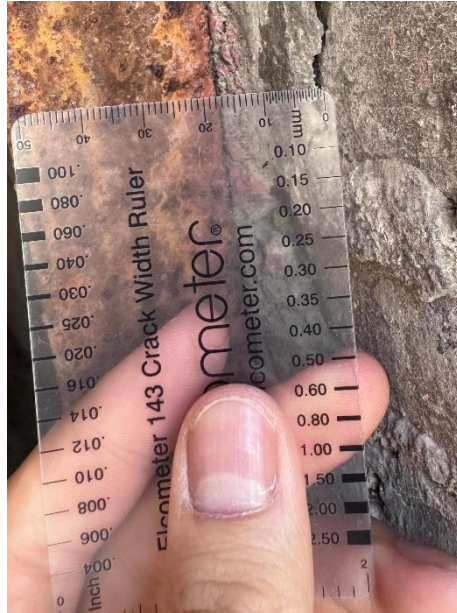
D2.36

Severe crack (equal to 2mm) was found on the front door of the storeroom.

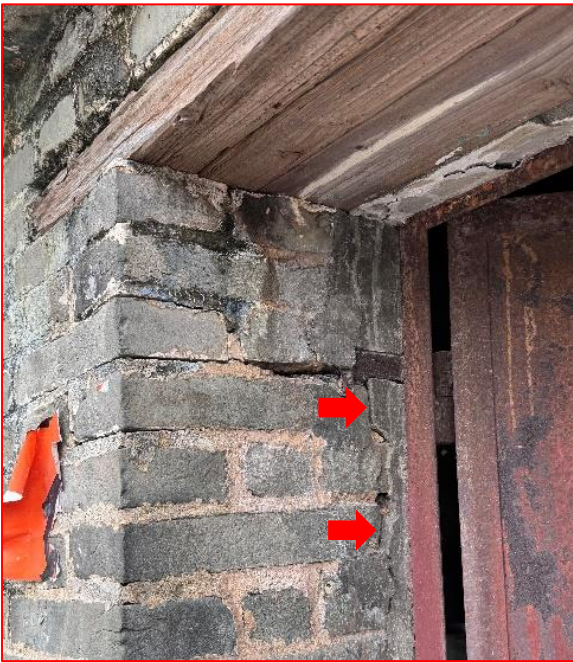
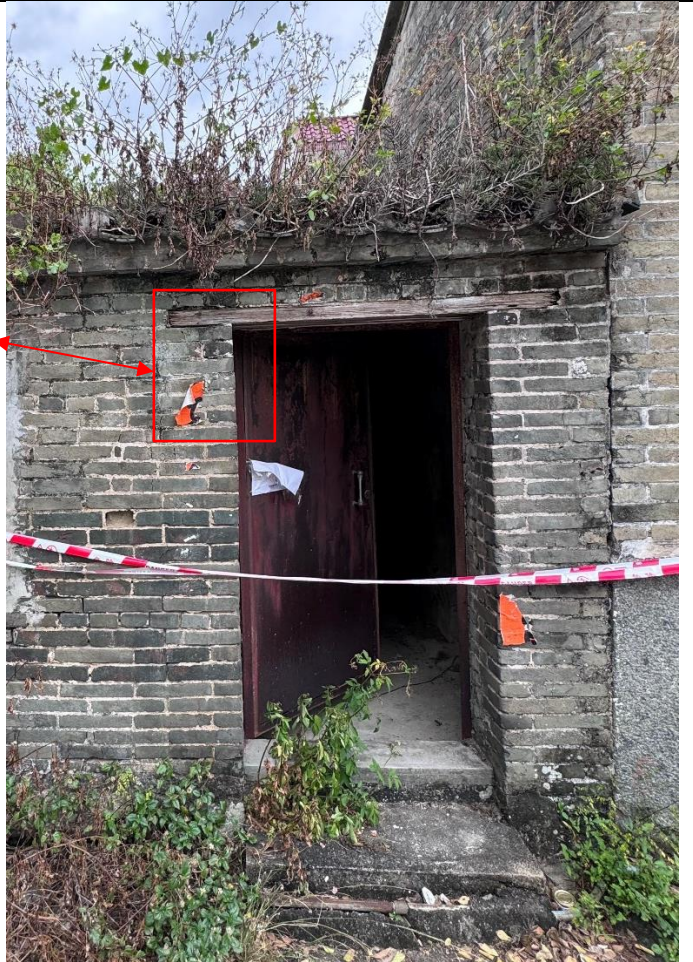
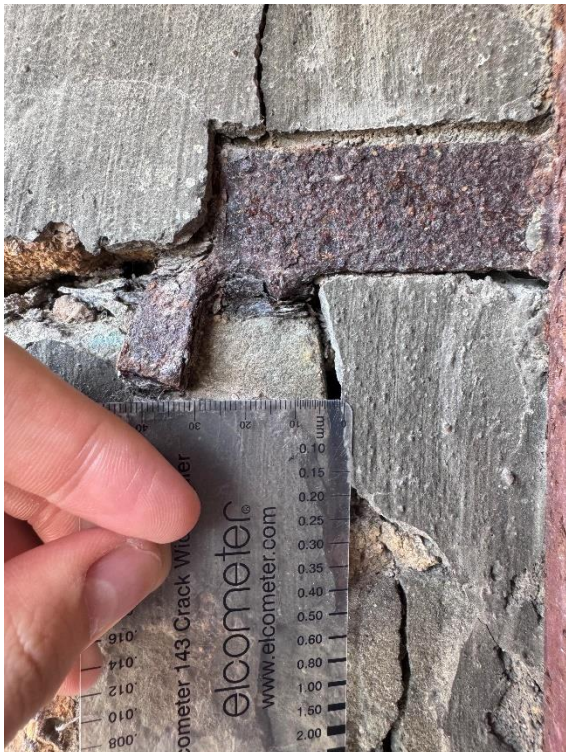
D2.37

Minor crack (wider than 2mm, but less than 1mm wide) was found on the front door of the storeroom.

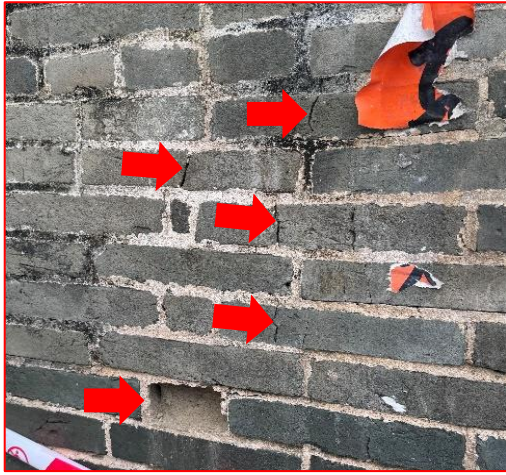
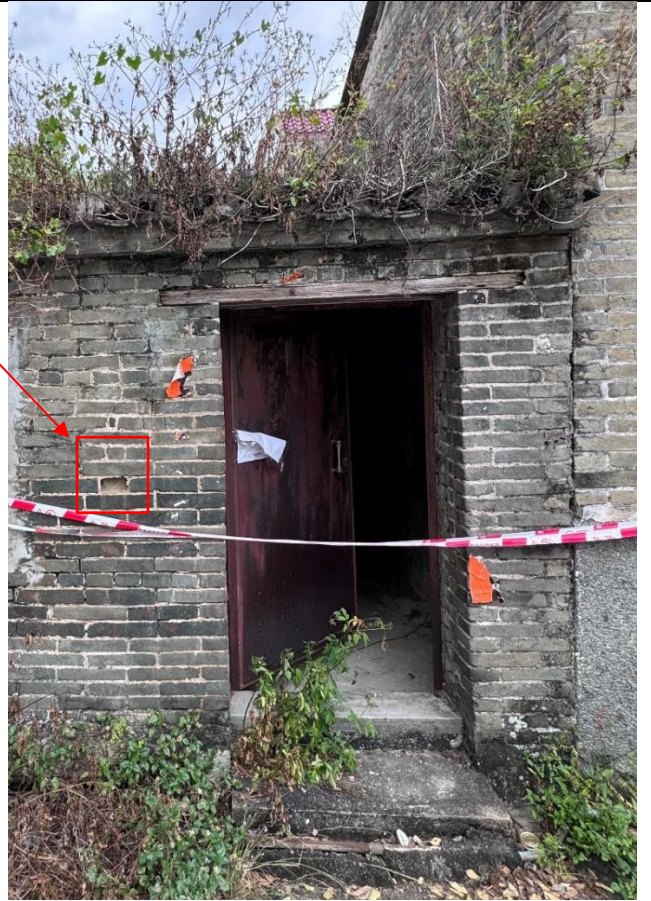
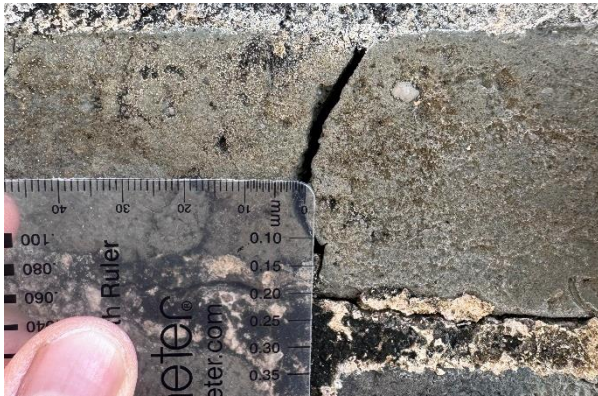
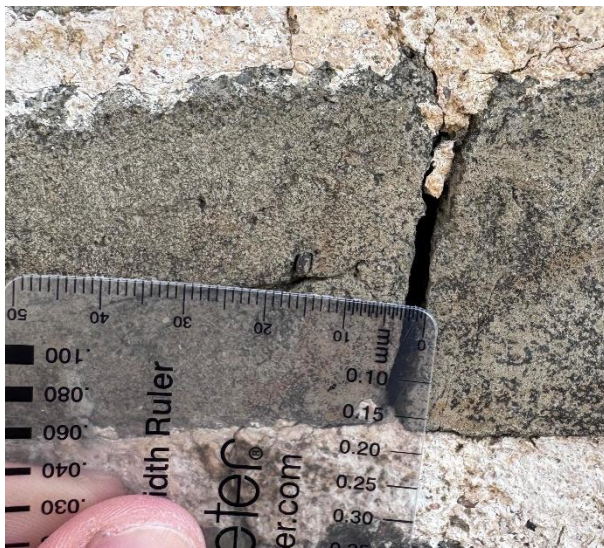
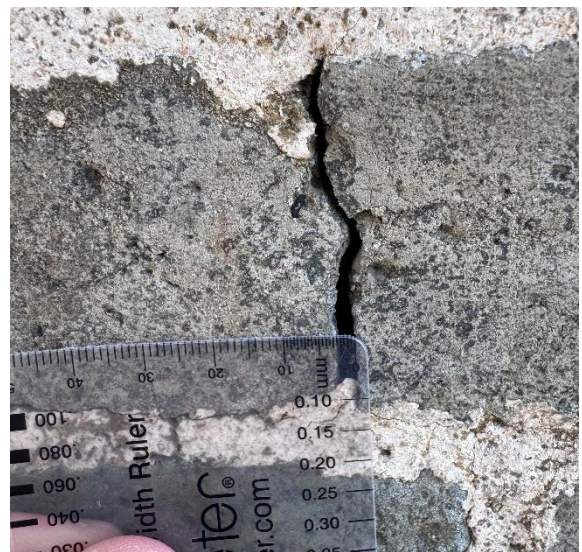
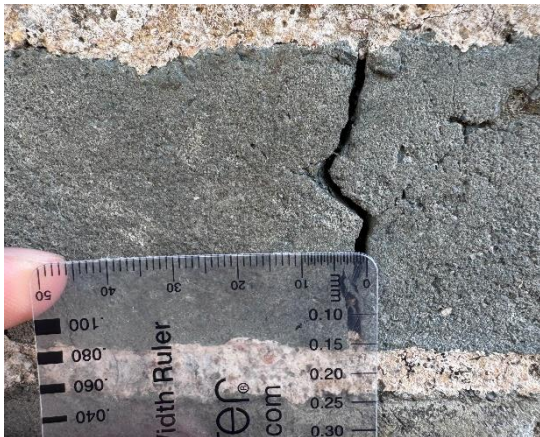
D2.38

Severe cracks (wider than 2mm) were found.
