**DRAINAGE IMPROVEMENT
WORKS AT YUEN LONG –
STAGE 2**

Contract No.: DC/2022/02

**Pre-Construction
Condition Survey
Report for Impacted
Graded Historic
Buildings**

**Wing Tat Civil Engineering
Company Limited**

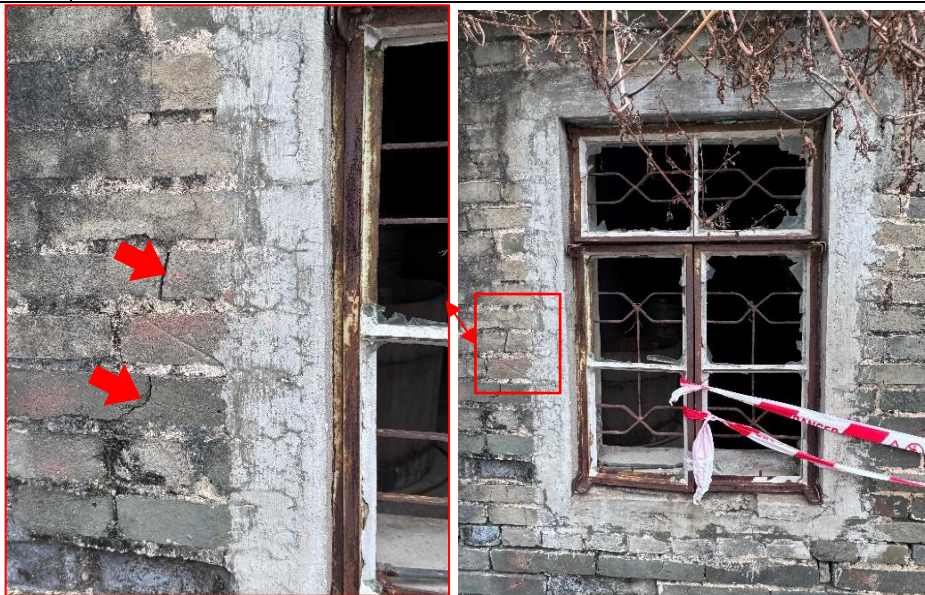
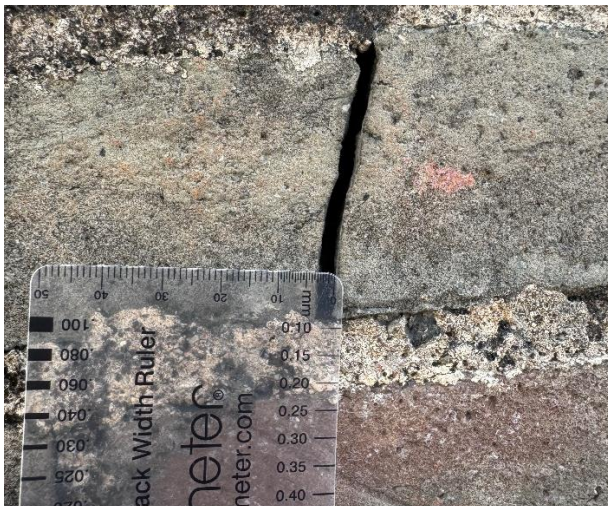
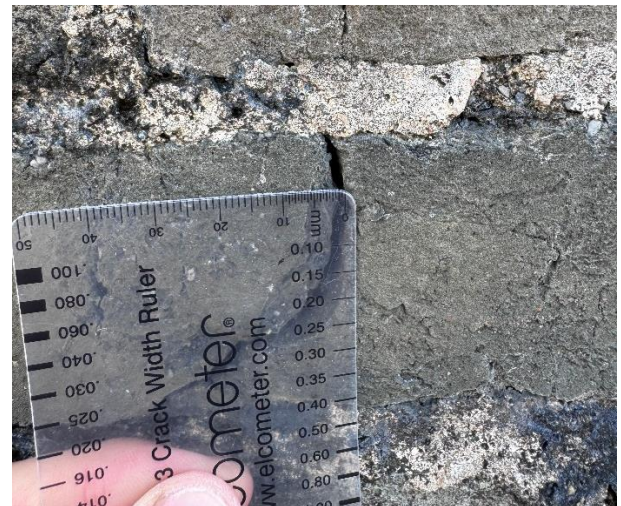
D2.40

The glass of window was broken at the storeroom.

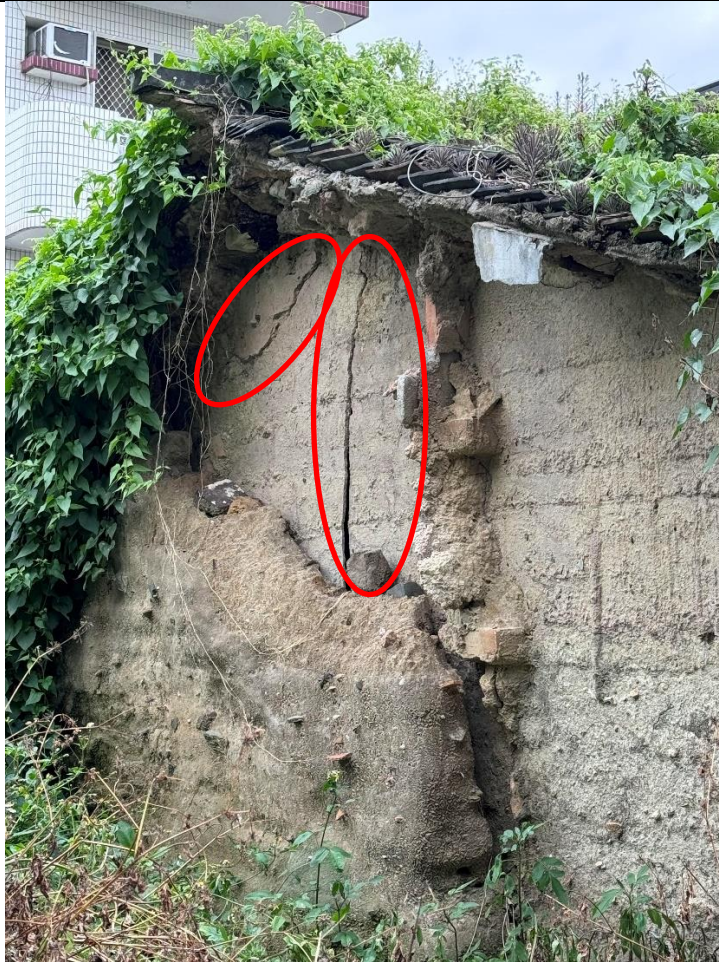
D2.43

Minor cracks (less than 2mm wide) were found, cement mortar was missing, and some blocks were broken.

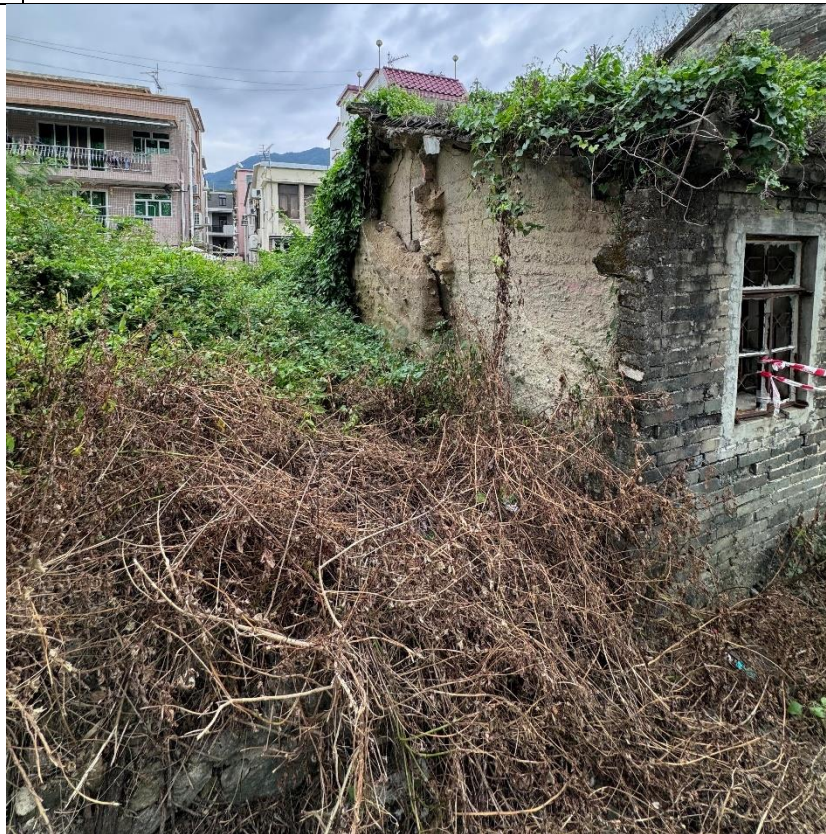
D2.44

Severe cracks were found on the north wall of storeroom.

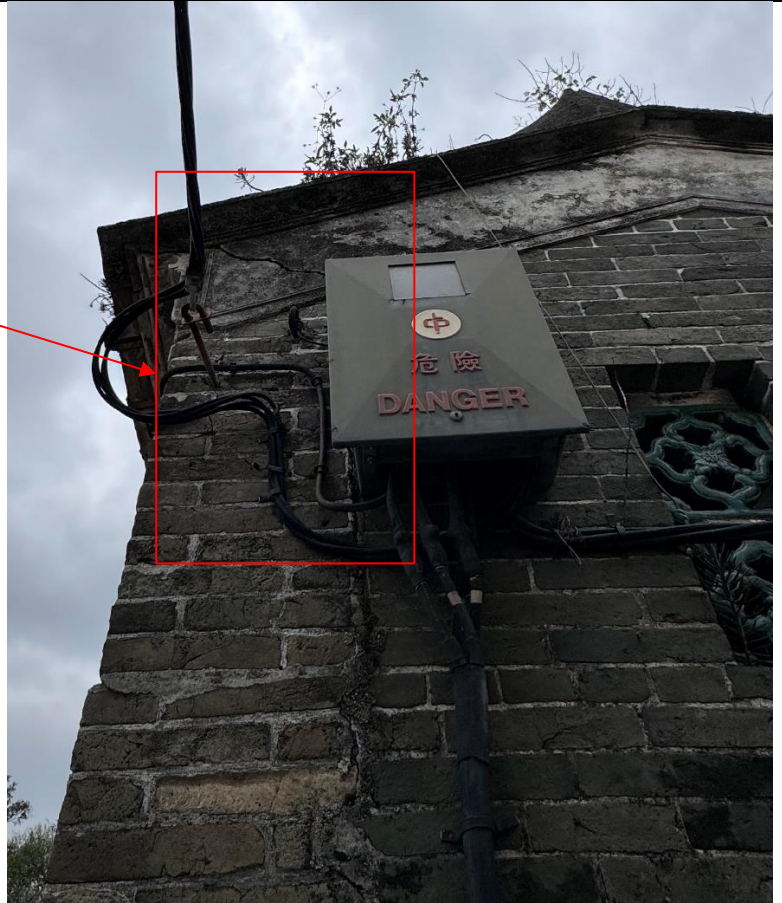
D2.45

Large of vegetation growing on the north wall of storeroom.

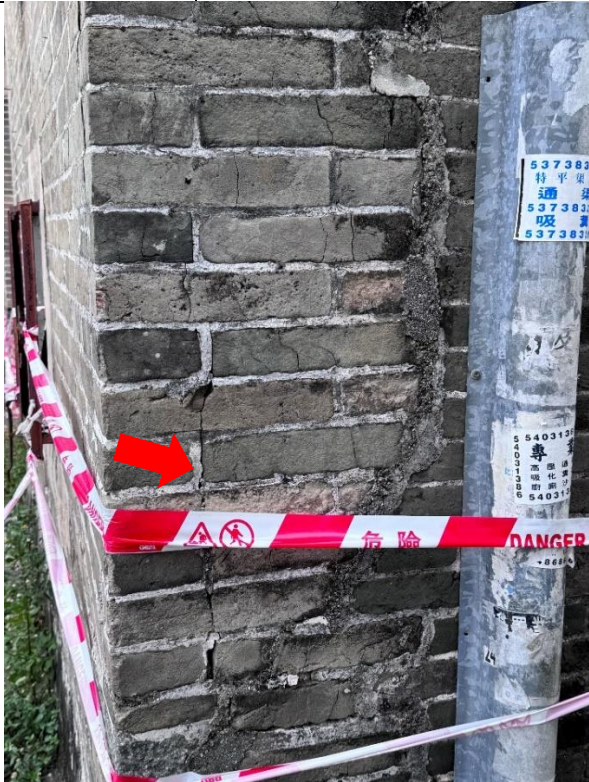
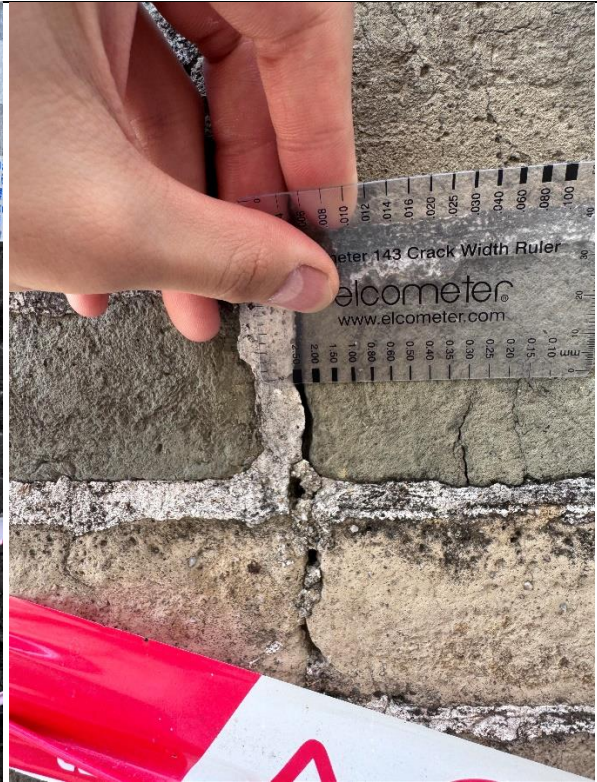
D2.46

Severe crack was found on the south wall of study hall.

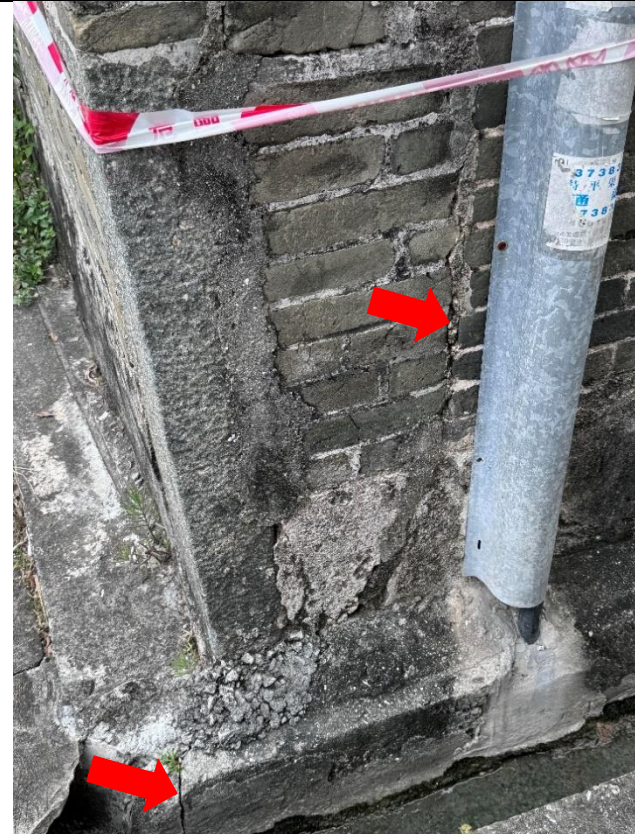
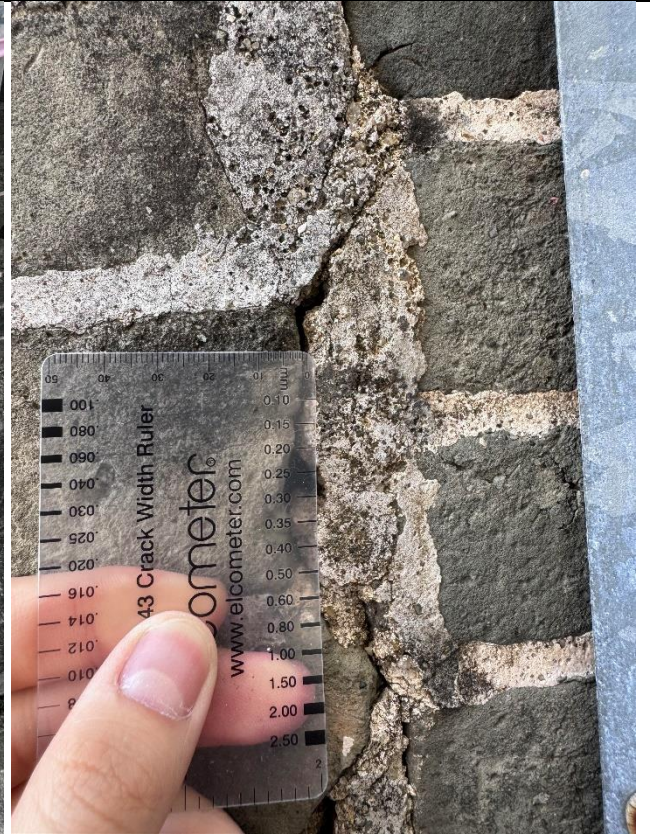
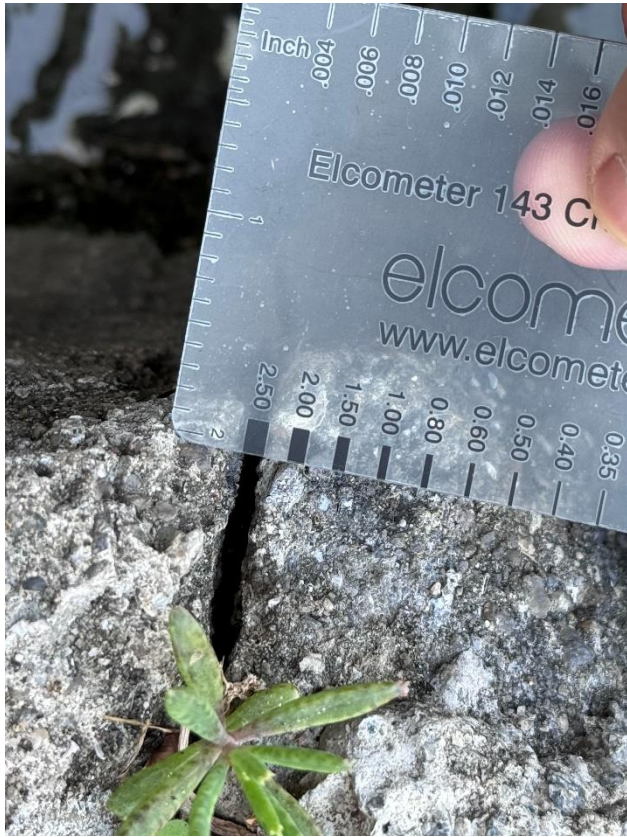
D2.47

Severe crack (wider than 2mm) was found on the south wall of study hall.

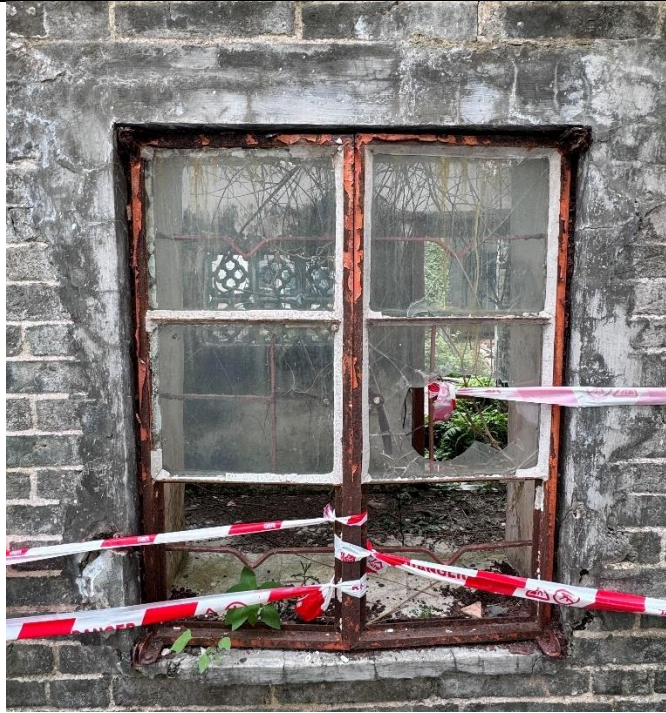
D2.58

Severe crack (wider than 2mm) and minor crack (equal to 1mm) was found on the blocks.

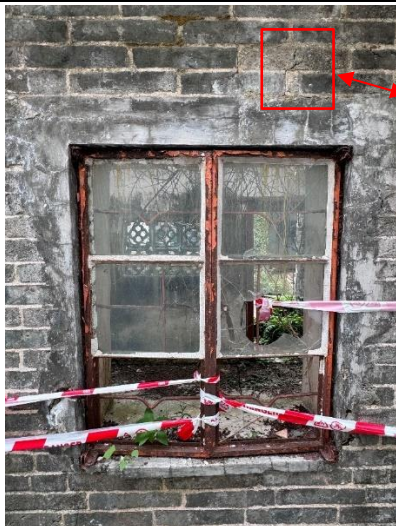
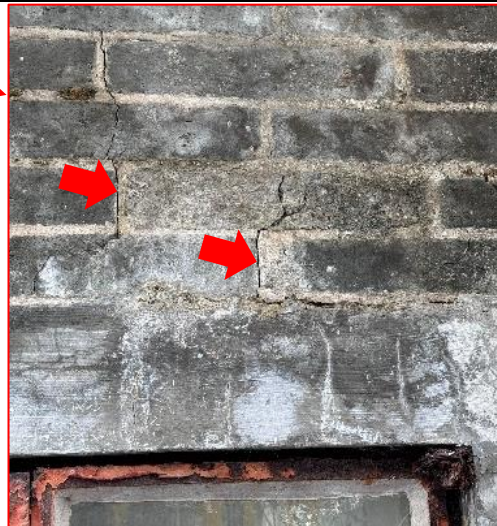
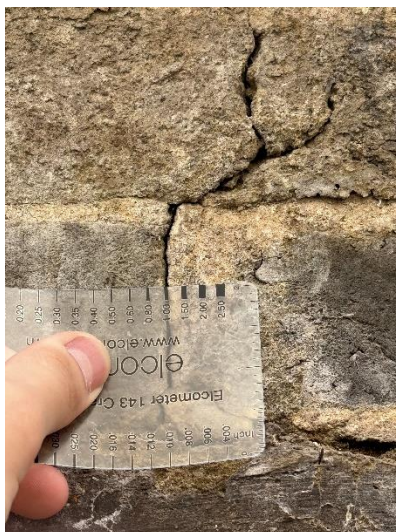
D2.59

The glass of window 5 was broken on the south wall of study hall.

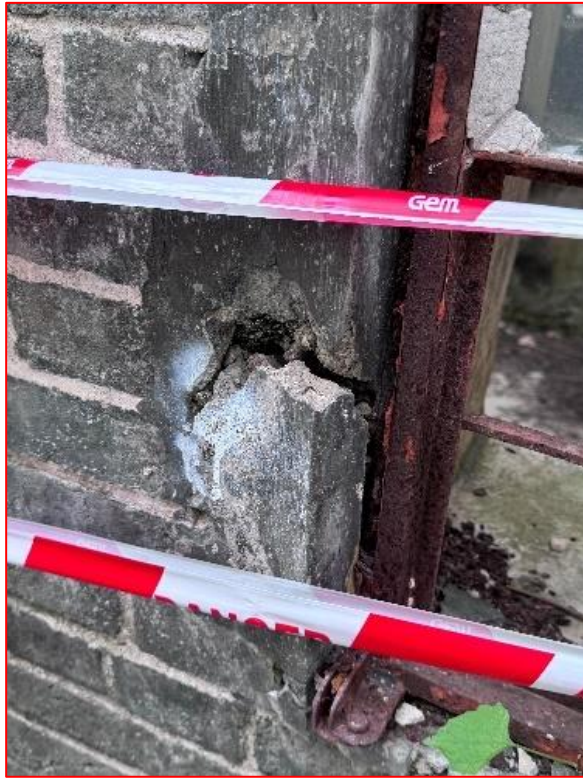
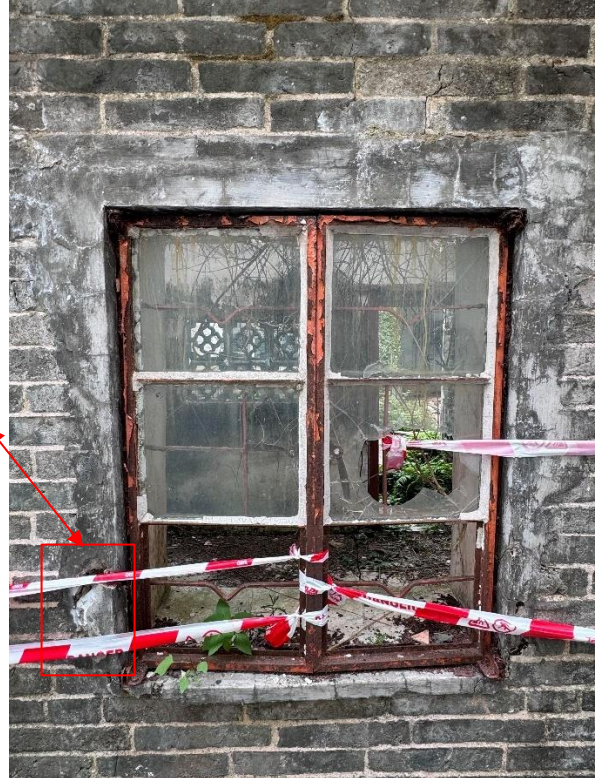
D2.60

Minor crack (equal to 1mm) was found.

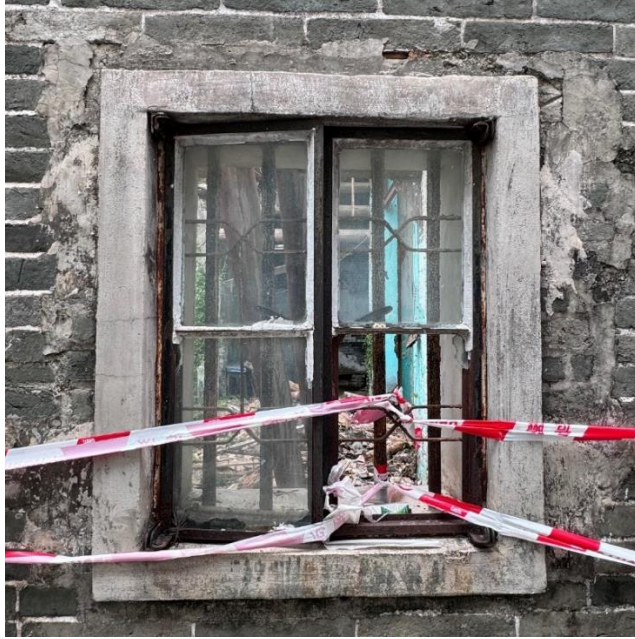
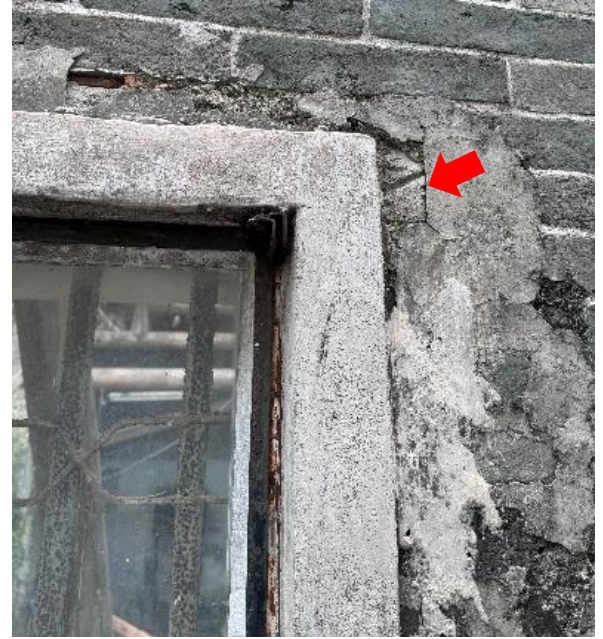
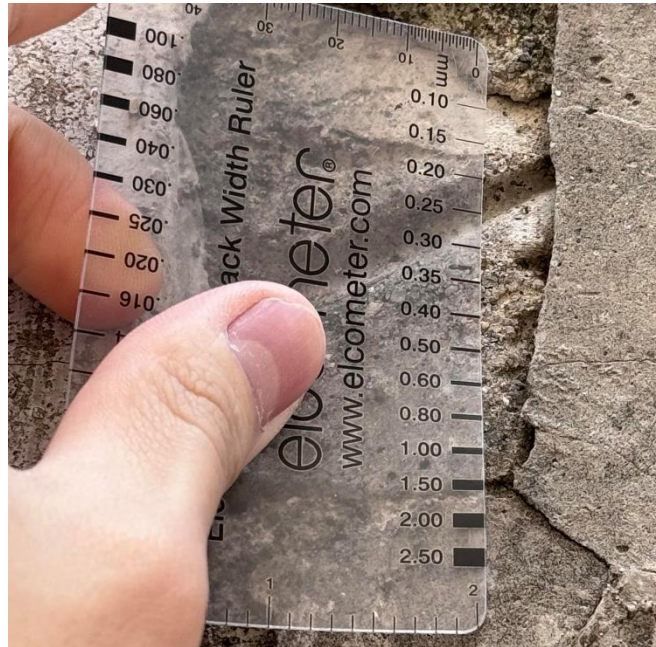
D2.63

Hairline cracks (less than 1mm) were found.

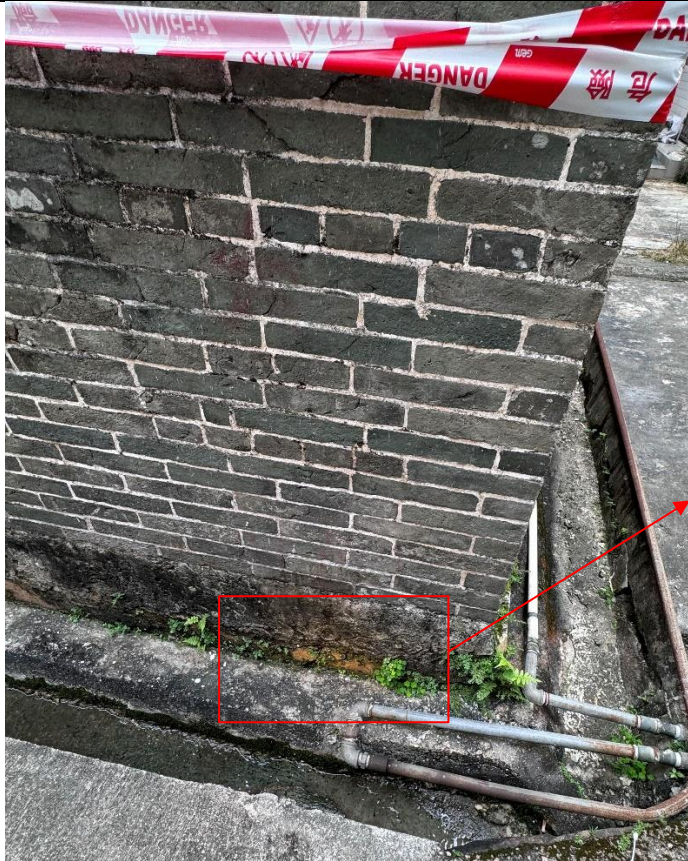
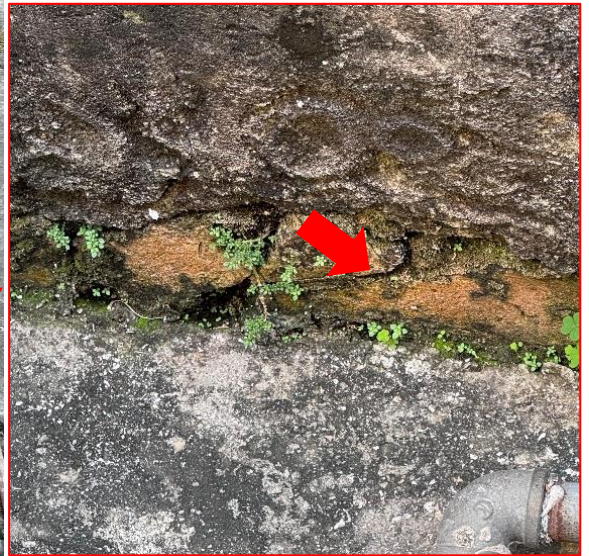
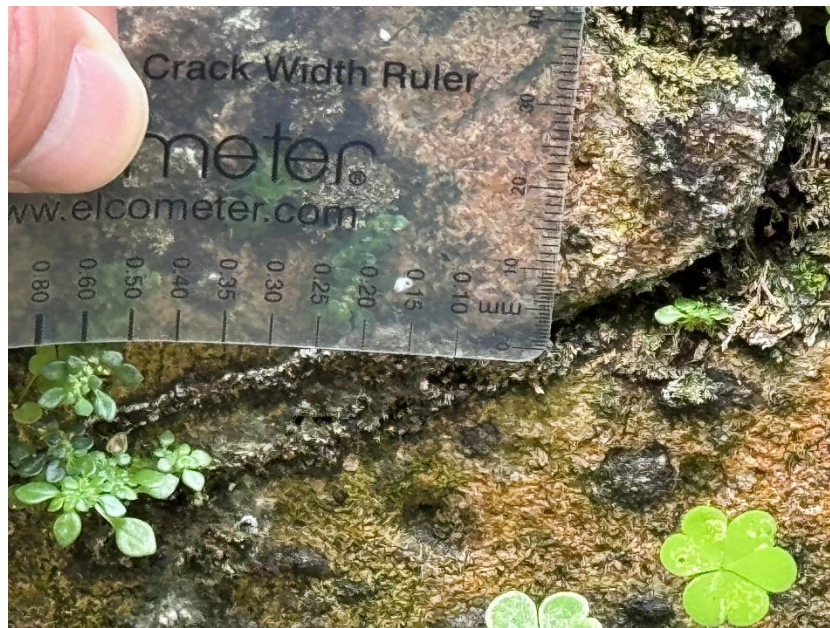
D2.65

The glass of window 7 was missing, and the steel frame was broken.

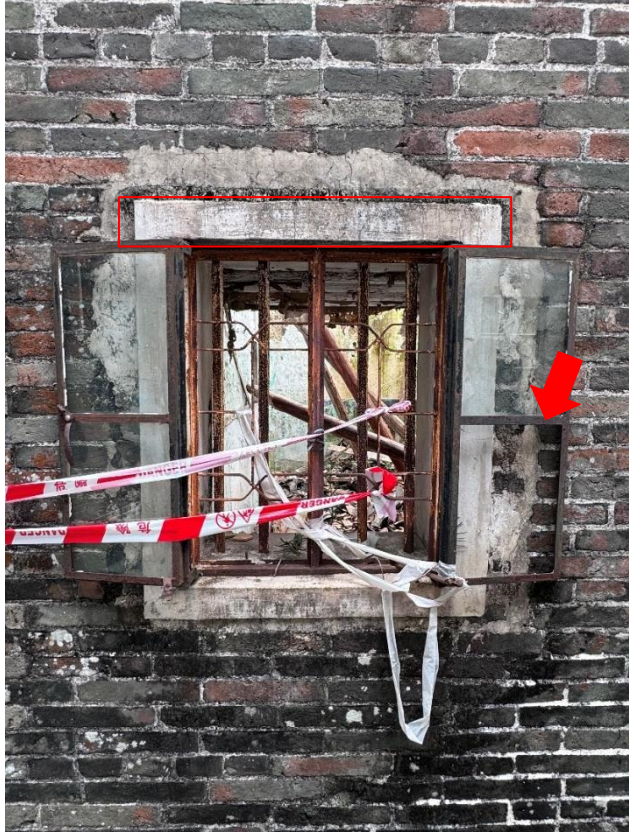
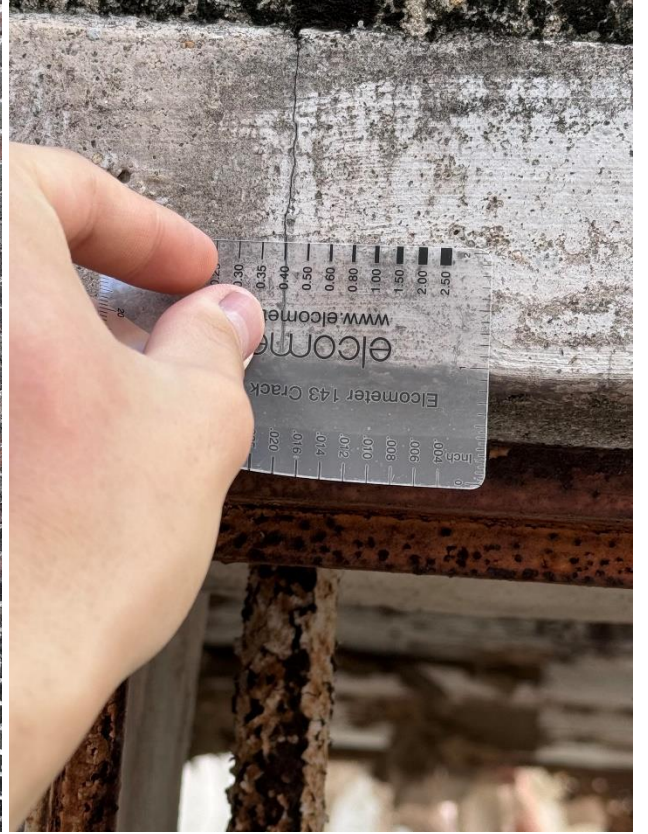
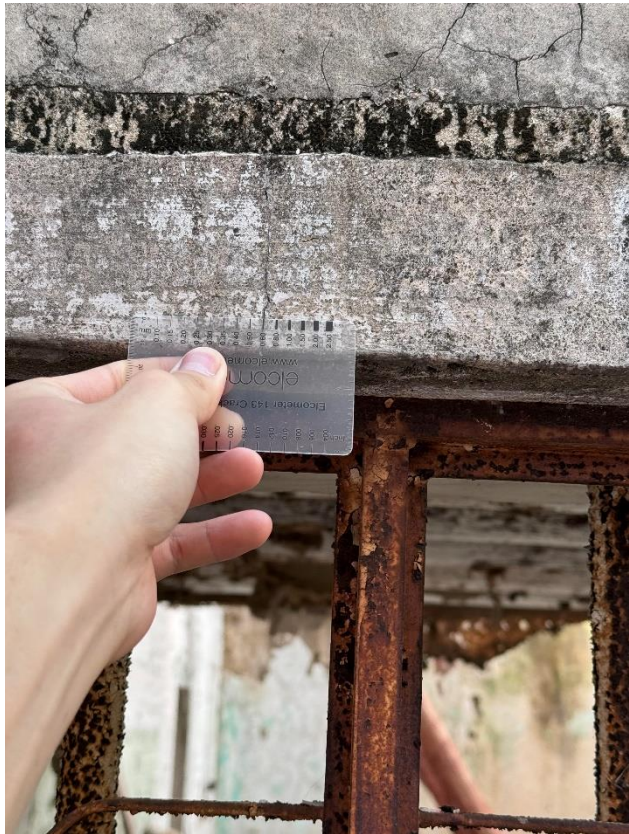
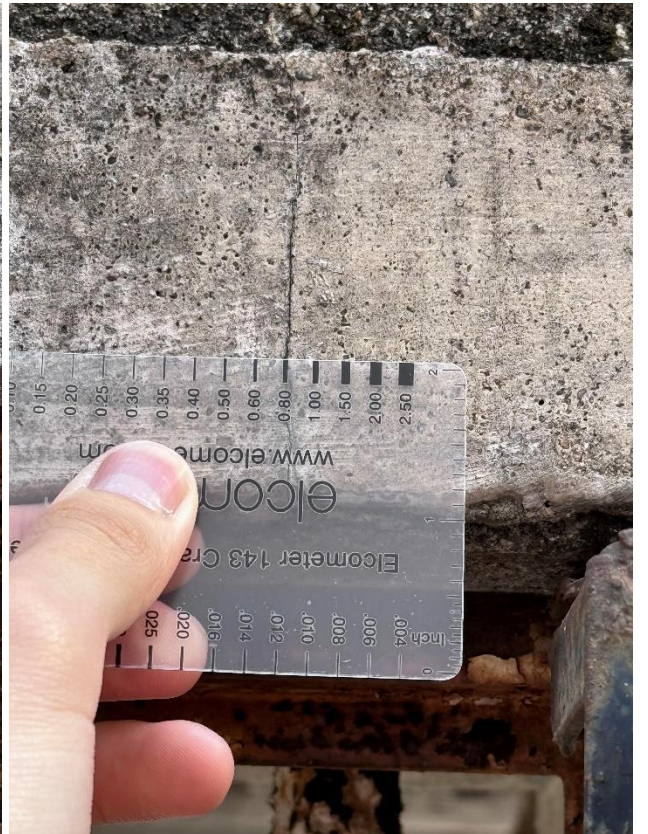
D2.67

A gap was found, and some concrete spalling were found under the south wall of study Hall.

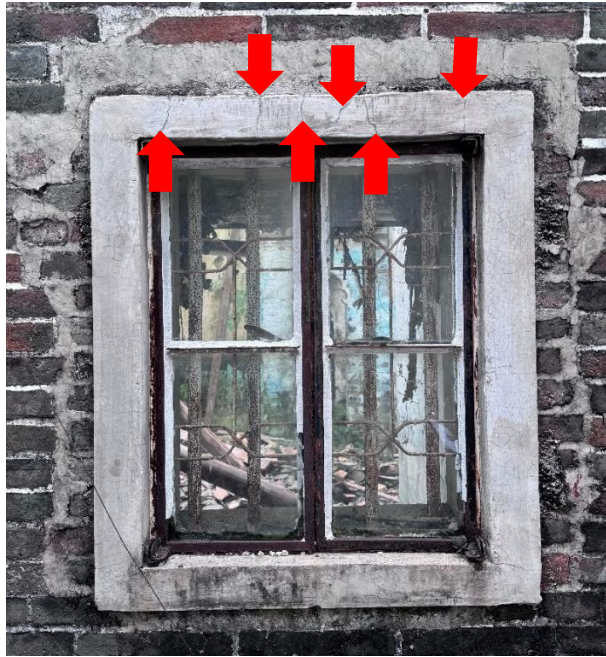
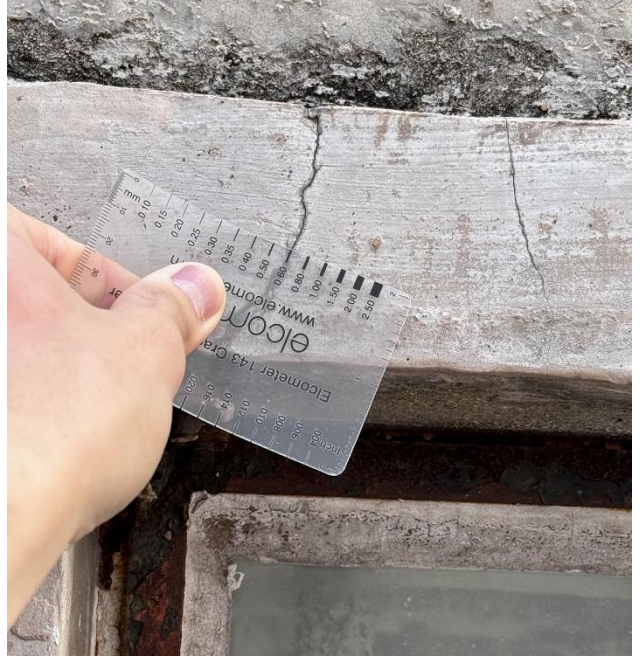
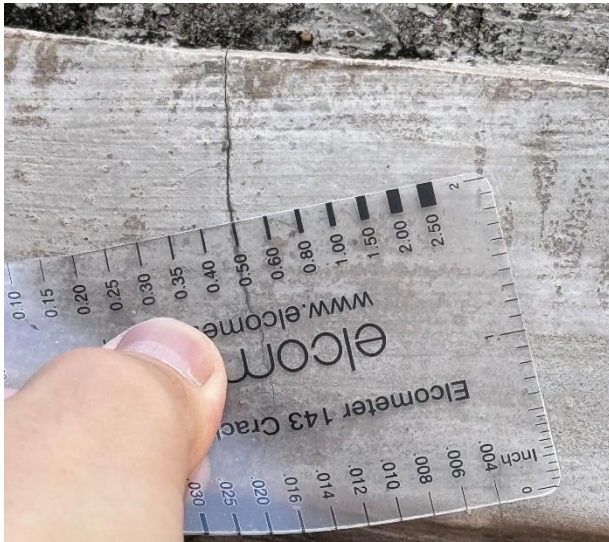
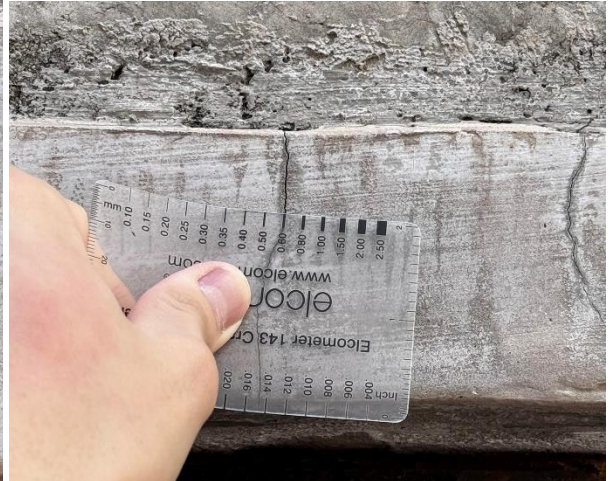
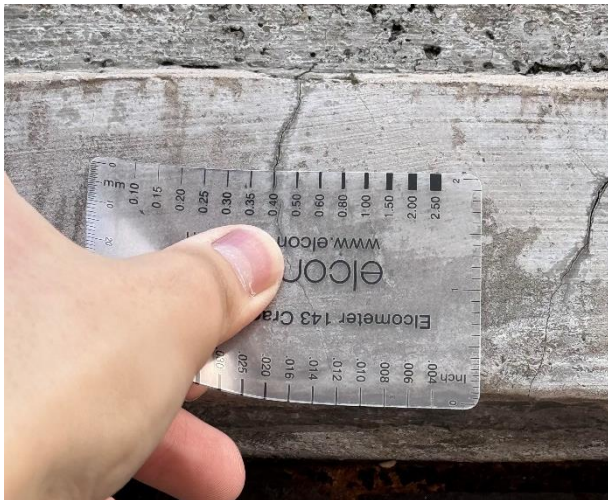
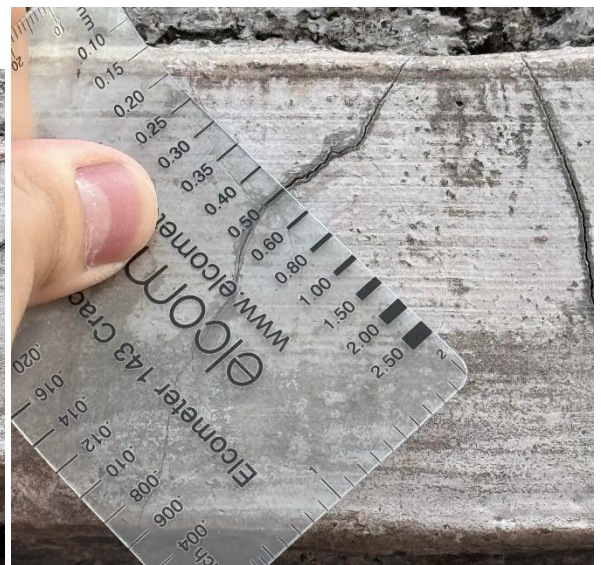
D2.68

The glass of window 8 was missing, and the hairline cracks (less than 1mm) were found on the frame of the window 8.

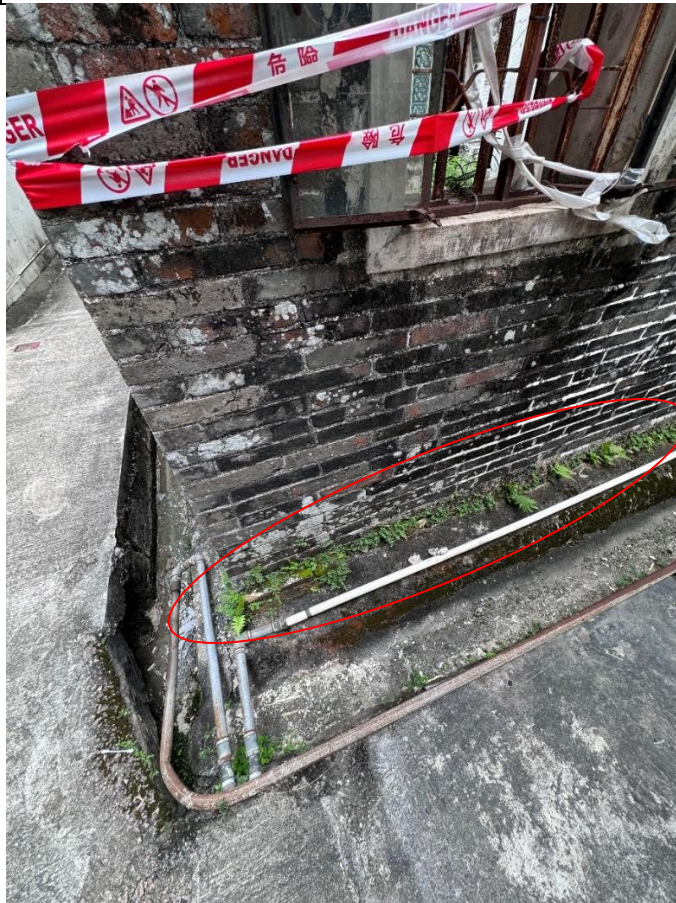
D2.70

Some vegetations were growing under the east wall.

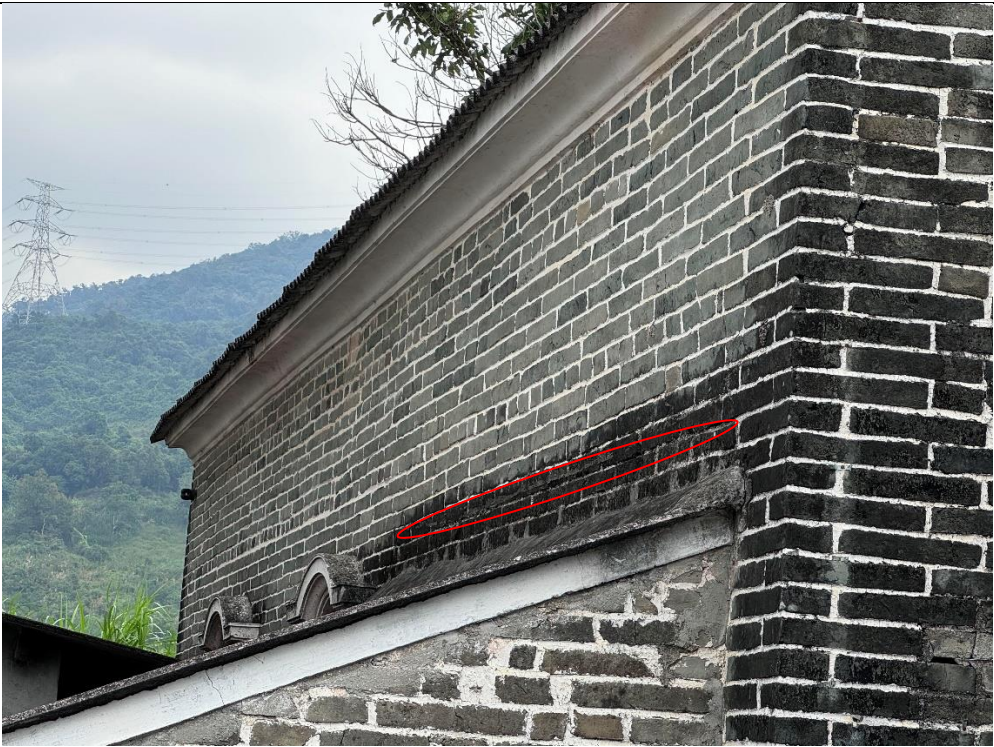
D3.1

Cement mortar is missing between the brickwork blocks on the north Wall of the Chapel.

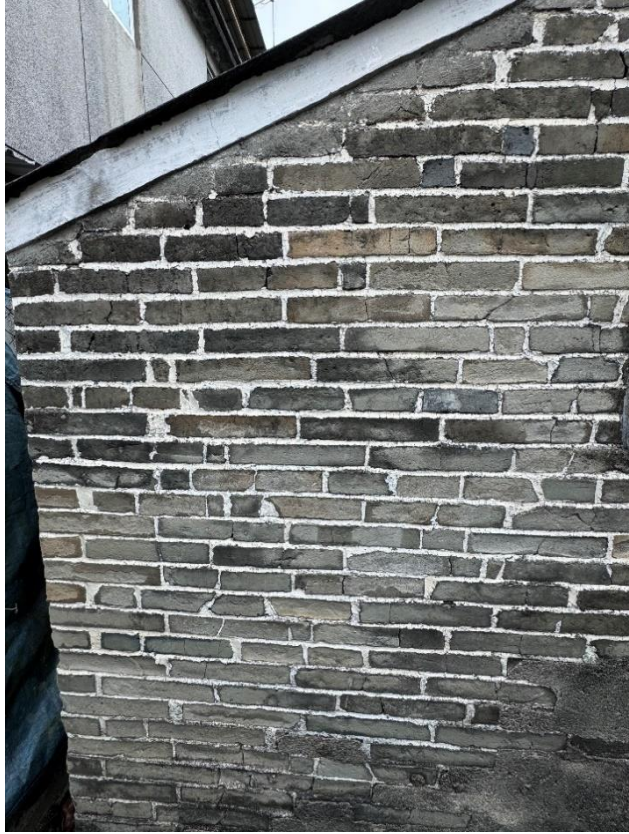
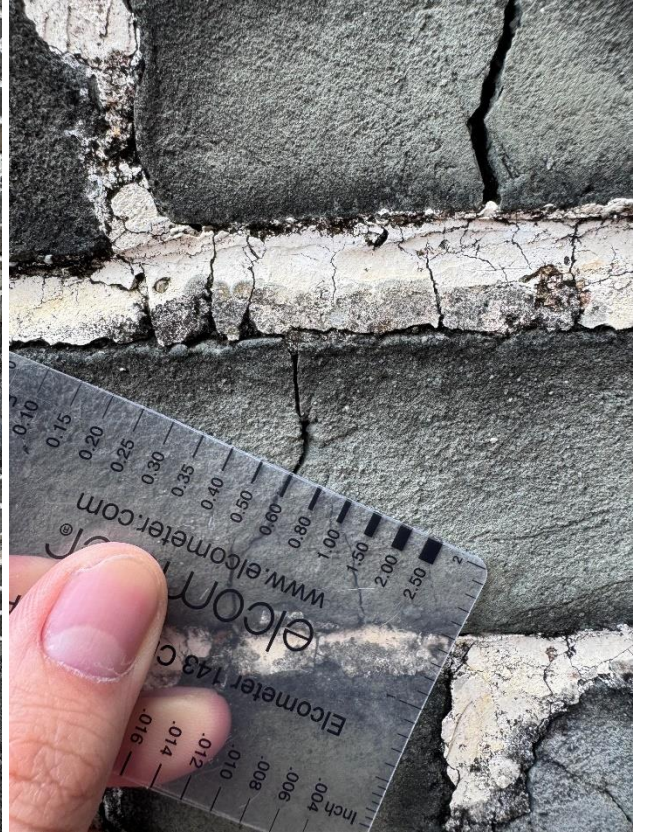
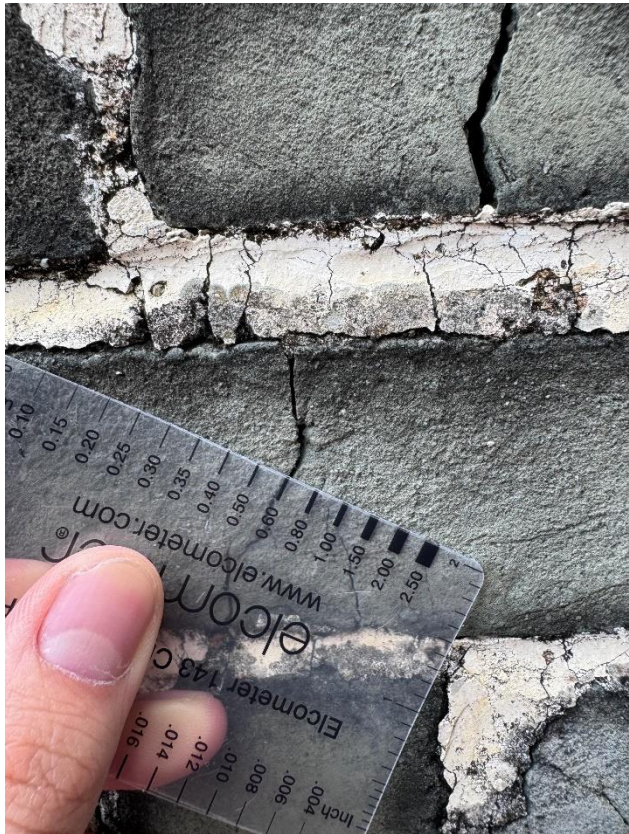
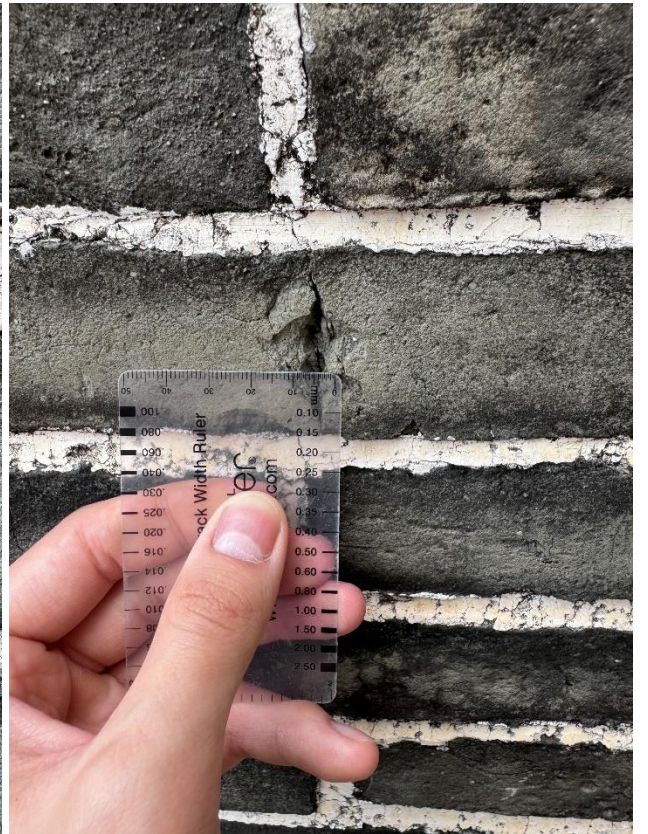
D3.2

Severe crack (wider than 2mm) and hairline cracks (less than 1mm) were appeared on the block.

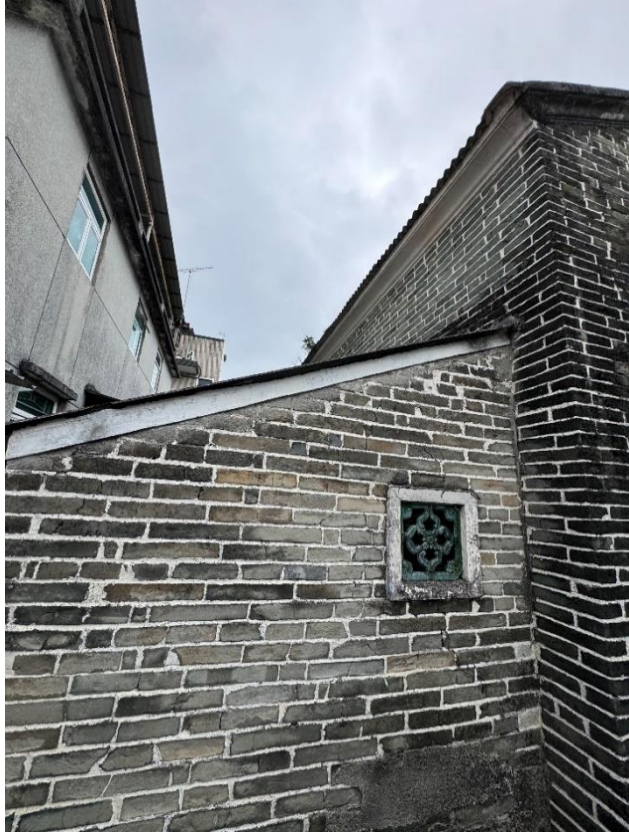
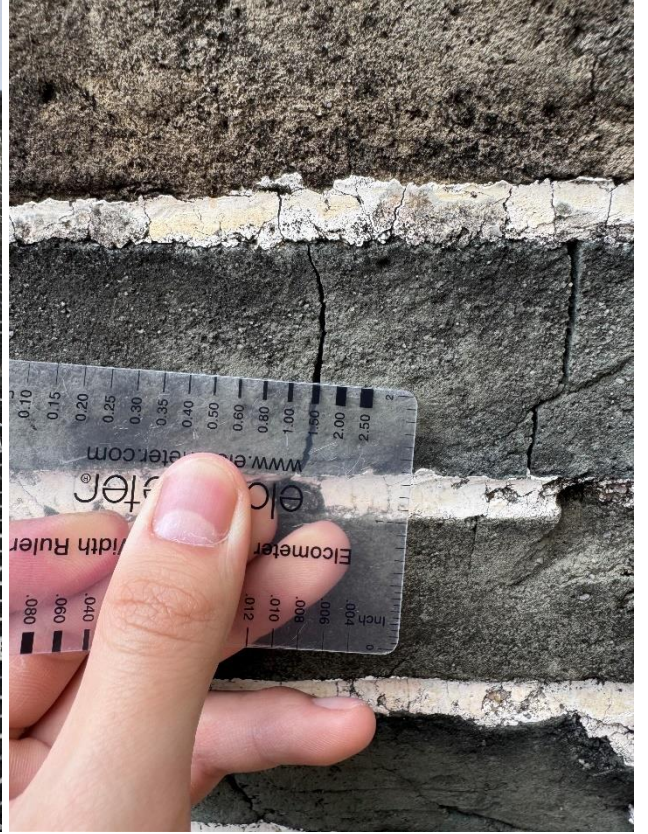
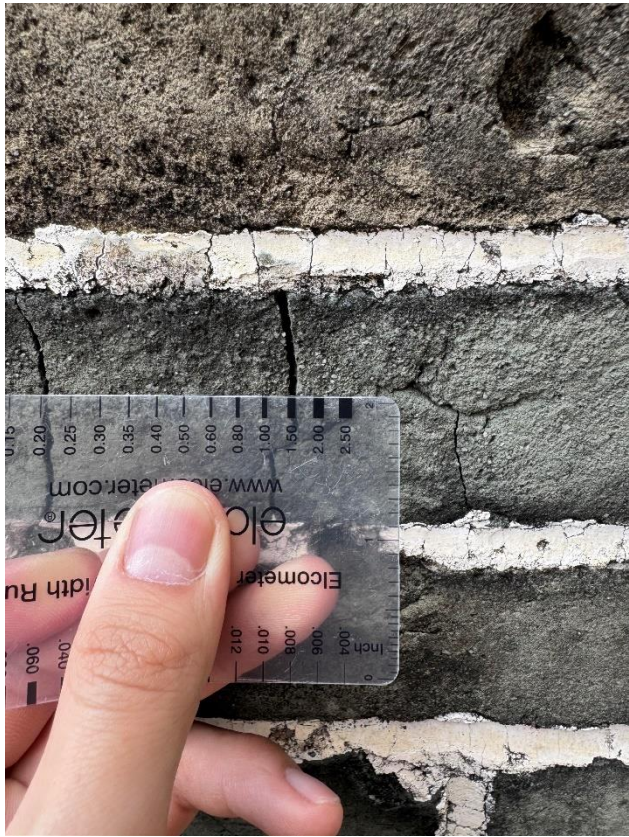
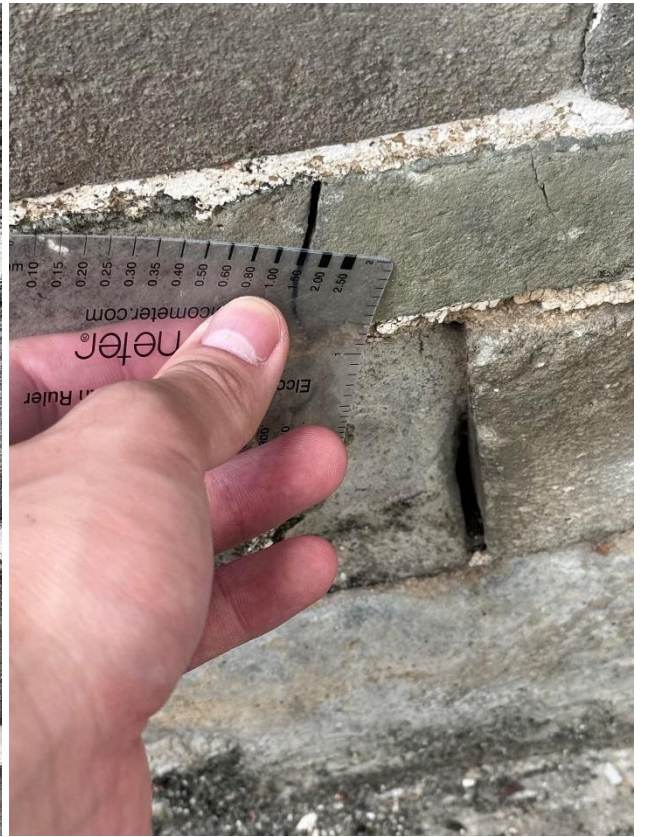
D3.3

Minor cracks (wider than 1mm but less than 2mm) were appeared on the block.

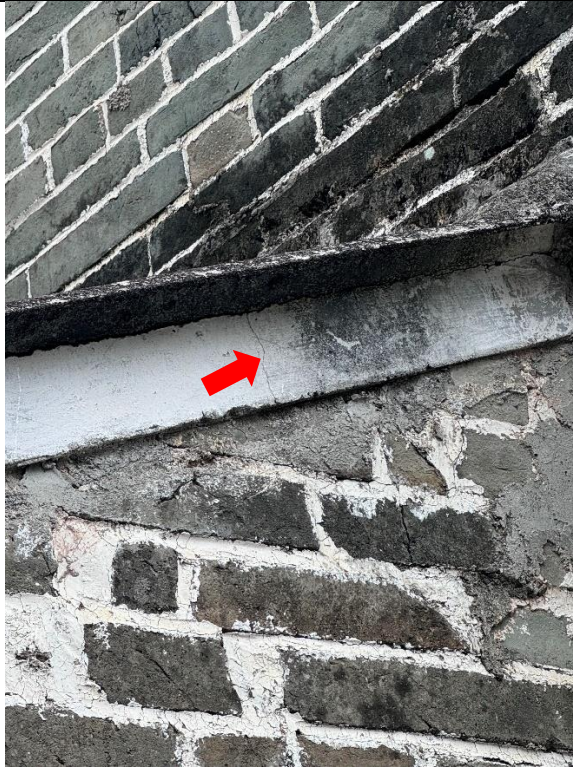
D3.4

Hairline crack was found on the west wall eaves of the storeroom1.

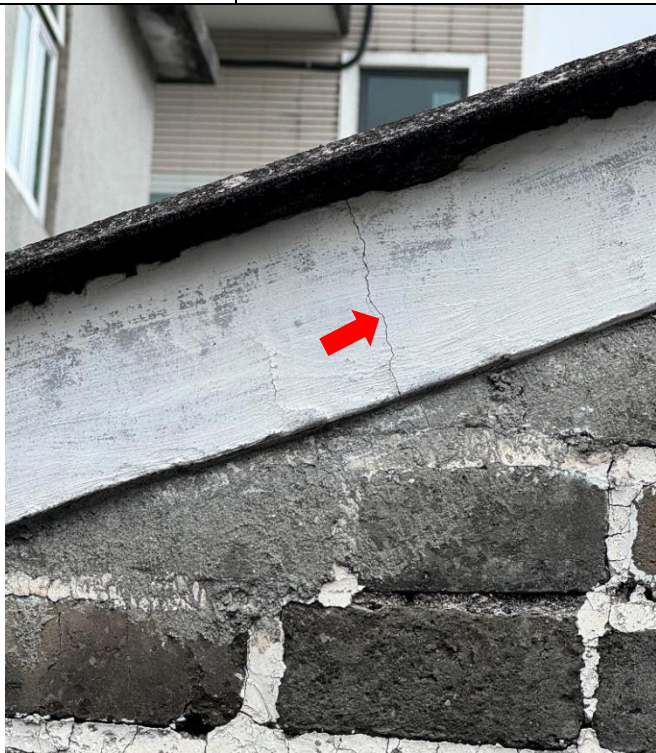
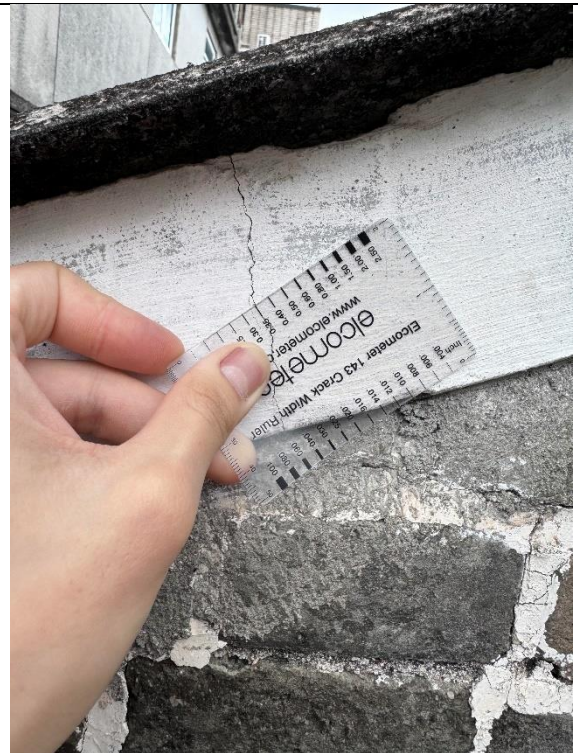
D3.5

Hairline crack (less than 1mm) was found on the west wall eaves of the storeroom1.
