**DRAINAGE IMPROVEMENT
WORKS AT YUEN LONG –
STAGE 2**

Contract No.: DC/2022/02

**Pre-Construction
Condition Survey
Report for Impacted
Graded Historic
Buildings**

**Wing Tat Civil Engineering
Company Limited**

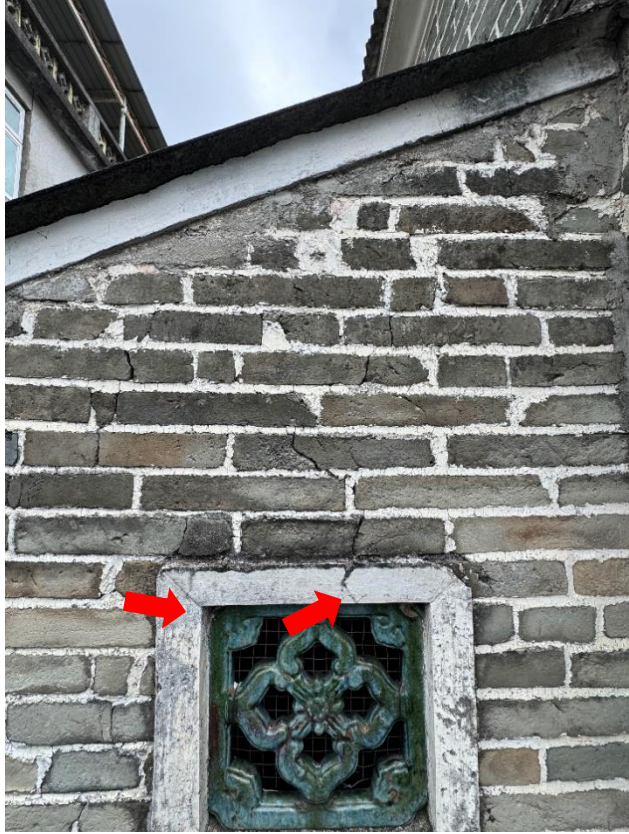
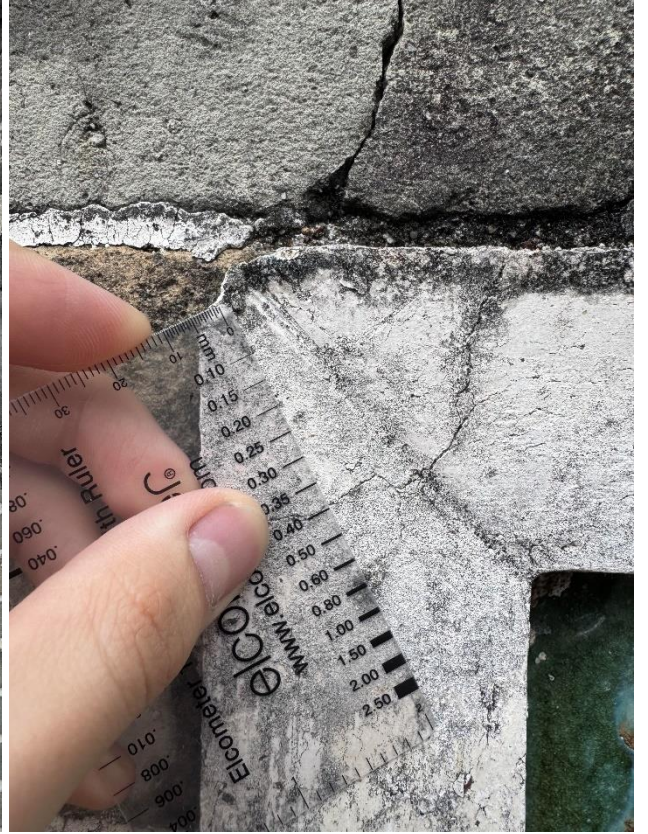
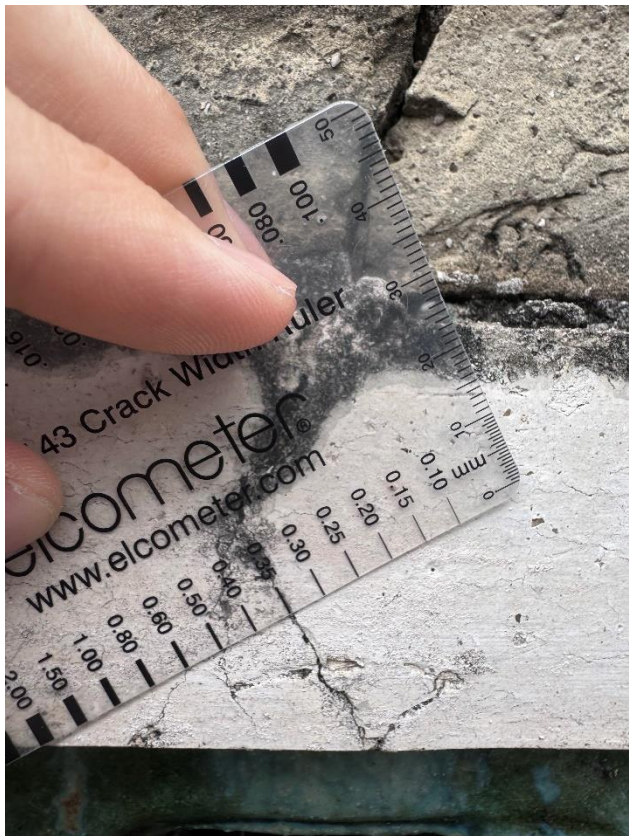
D3.6

Minor crack (equal to 1mm) was found on the west wall eaves of the streeroom2.

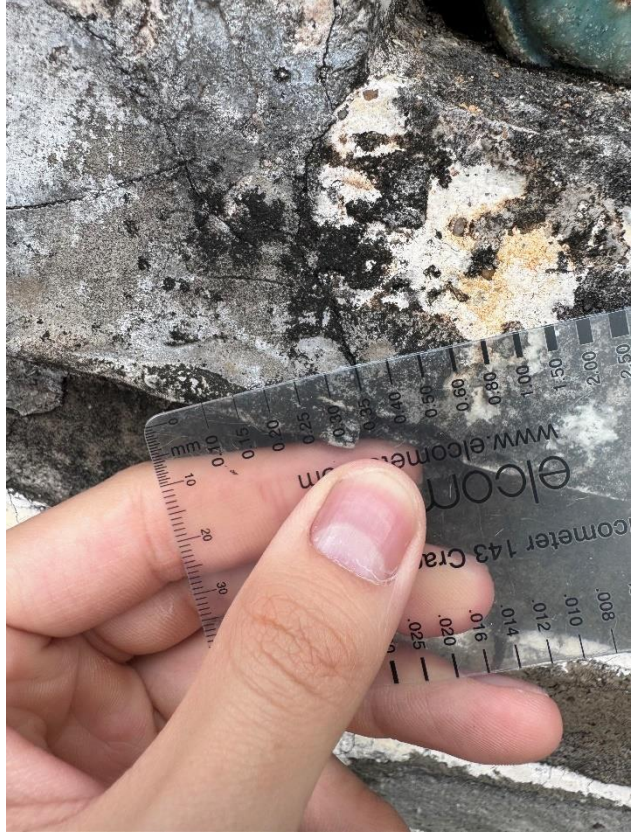
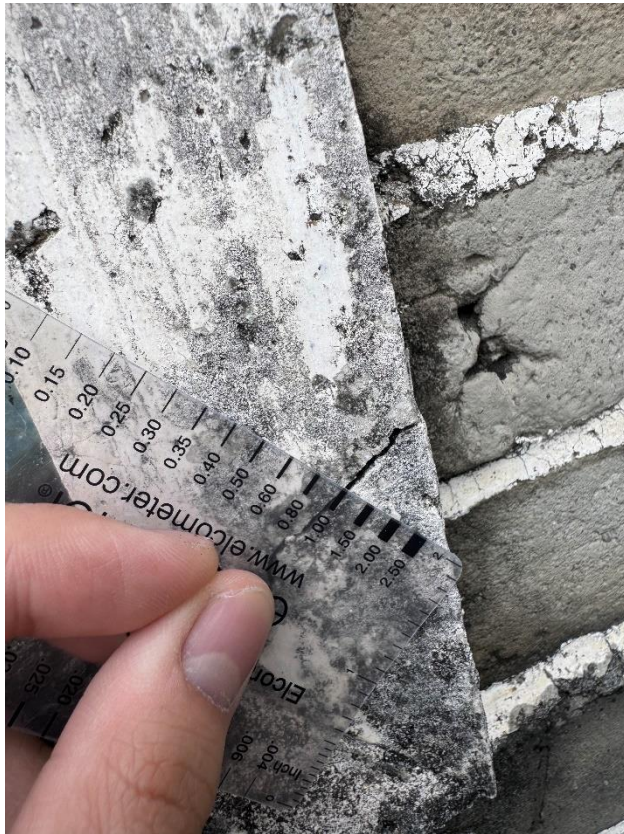
D3.7

Some hairline cracks (less than 1mm) were found on the window1.

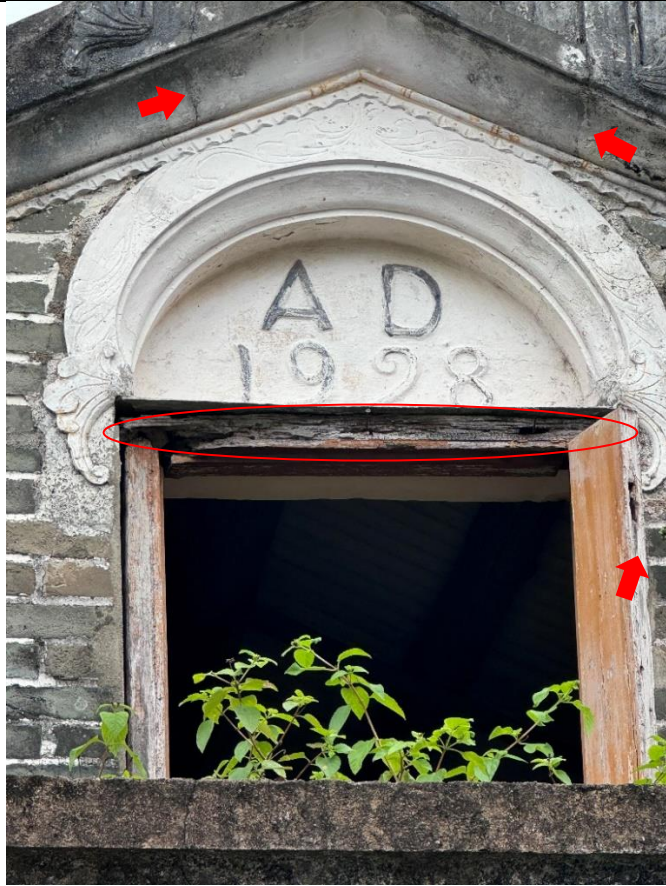
D3.8

Hairline crack (less than 1mm) and minor cracks (equal to 1mm) were found on the window1.

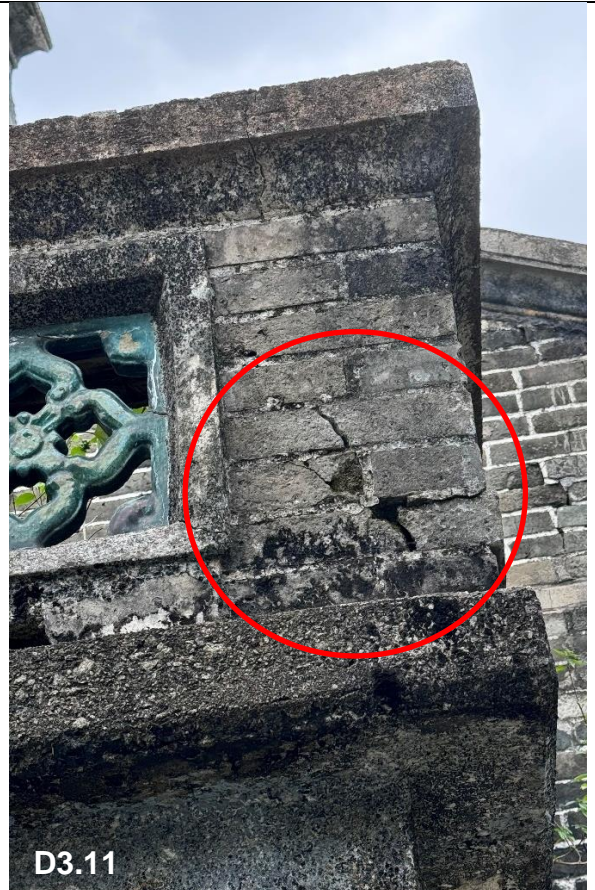
D3.10

Some blocks were broken and weathered.

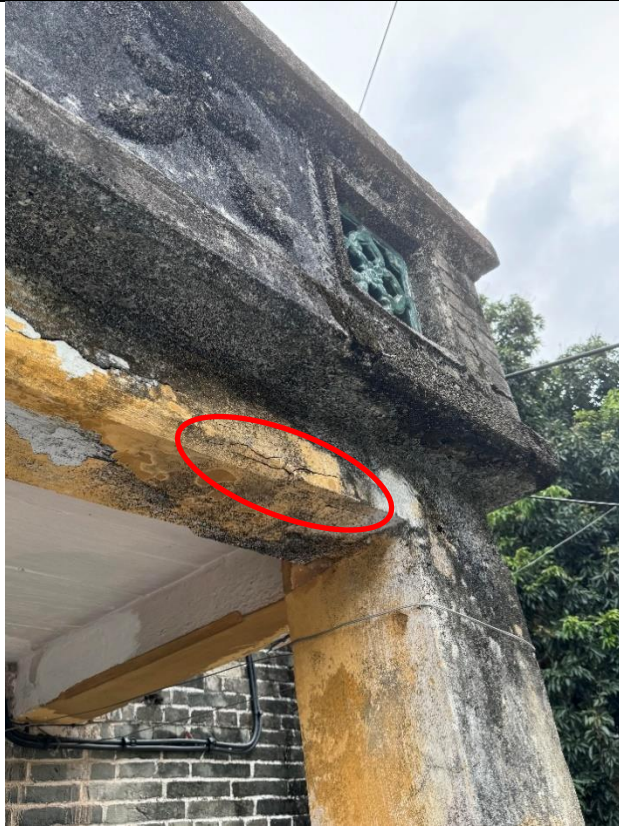
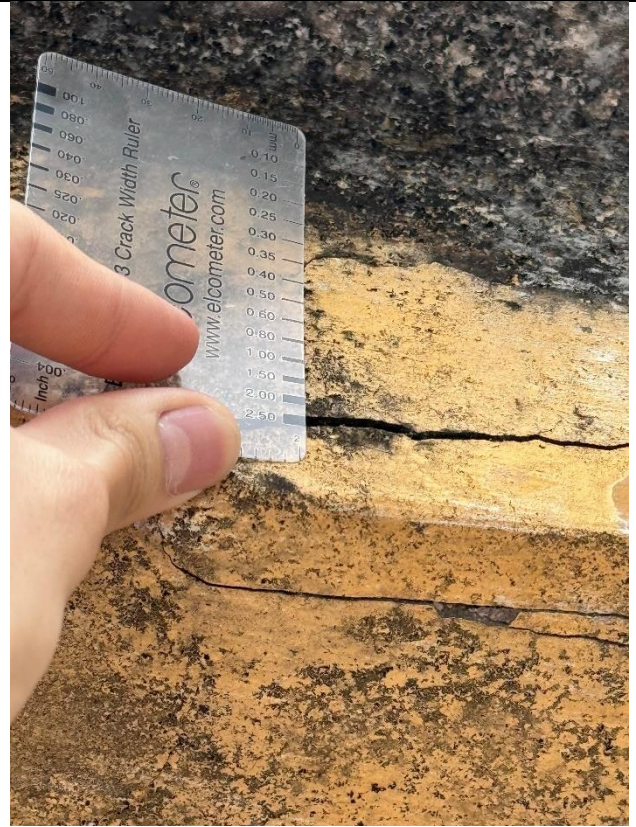
D3.17

Hairline cracks was found, and the roof tiles were missing on the north wall eaves of the Chapel.

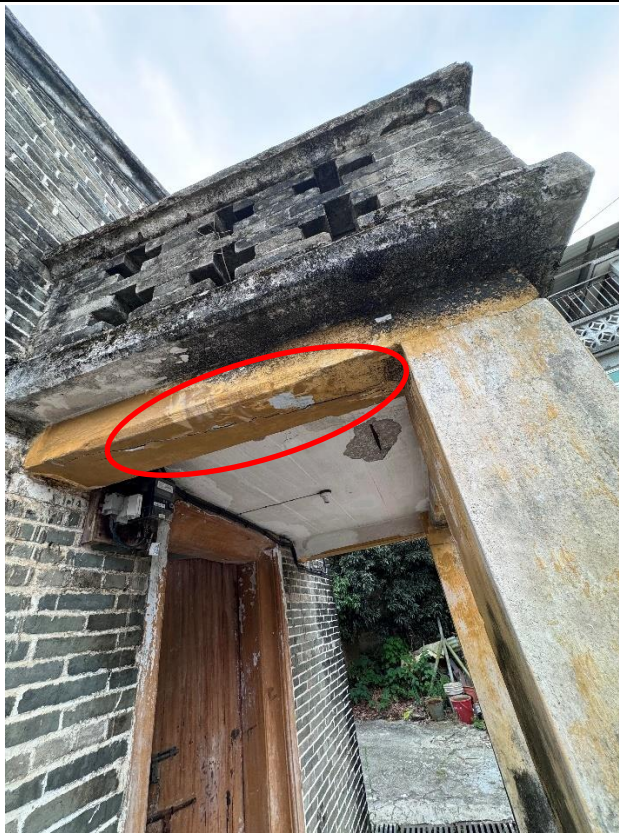
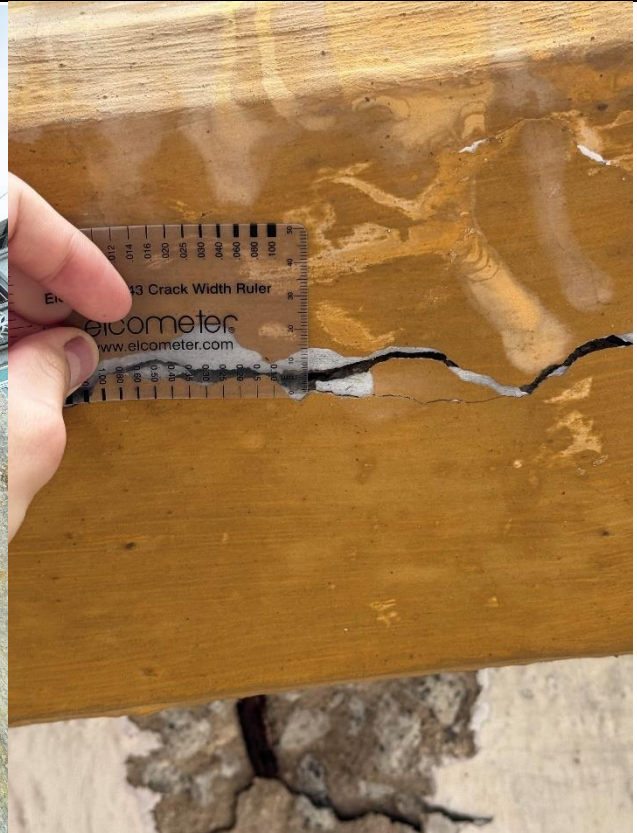
D3.18

Severe crack (wider than 2mm) was found on the beam.

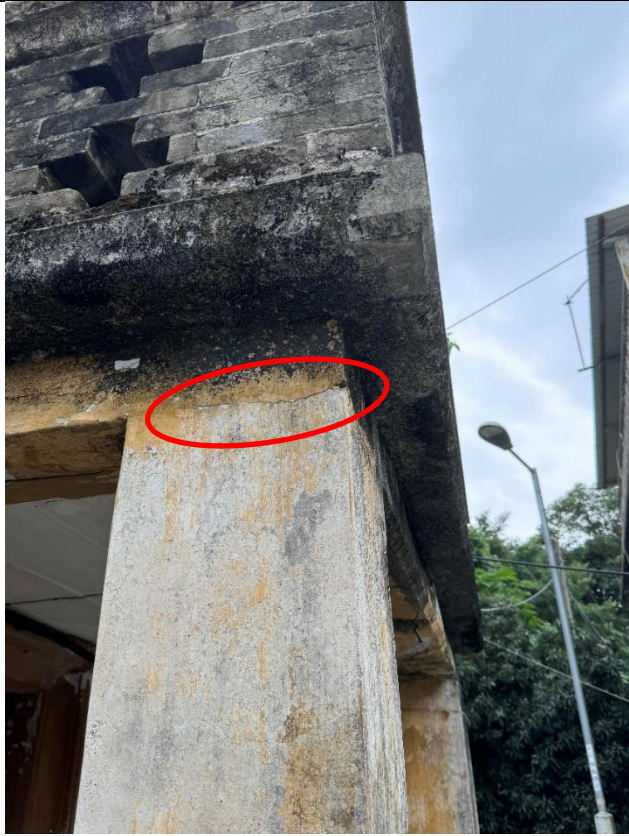
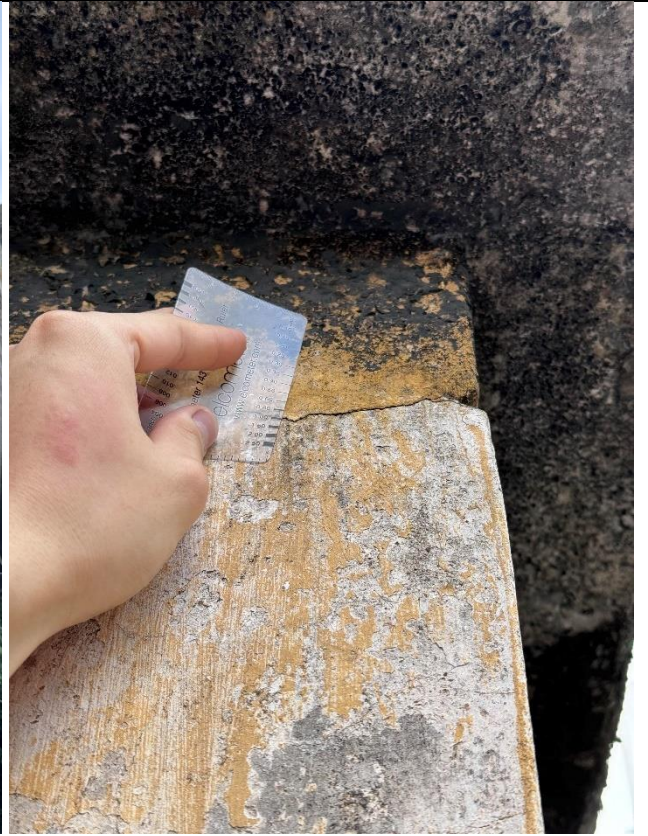
D3.19

Severe crack (wider than 2mm) was found on the beam.

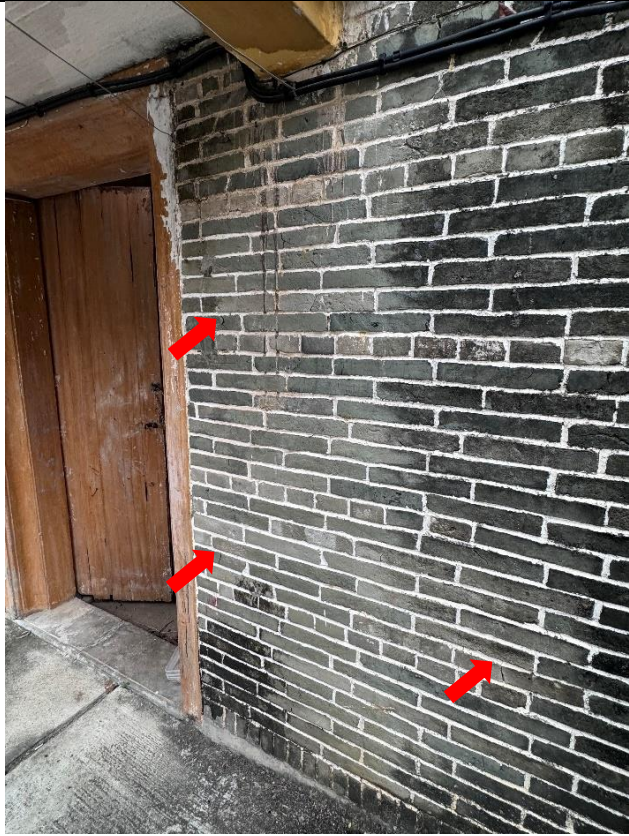
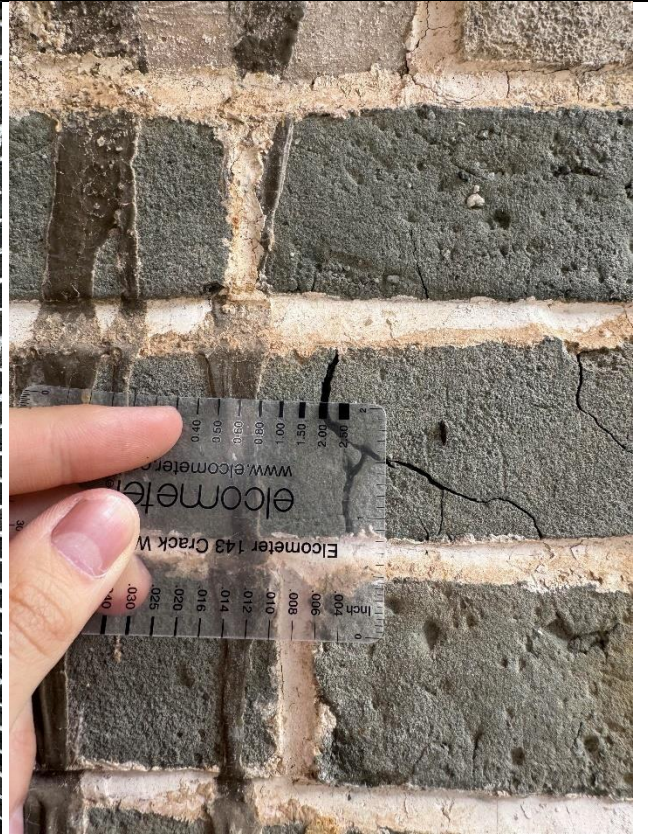
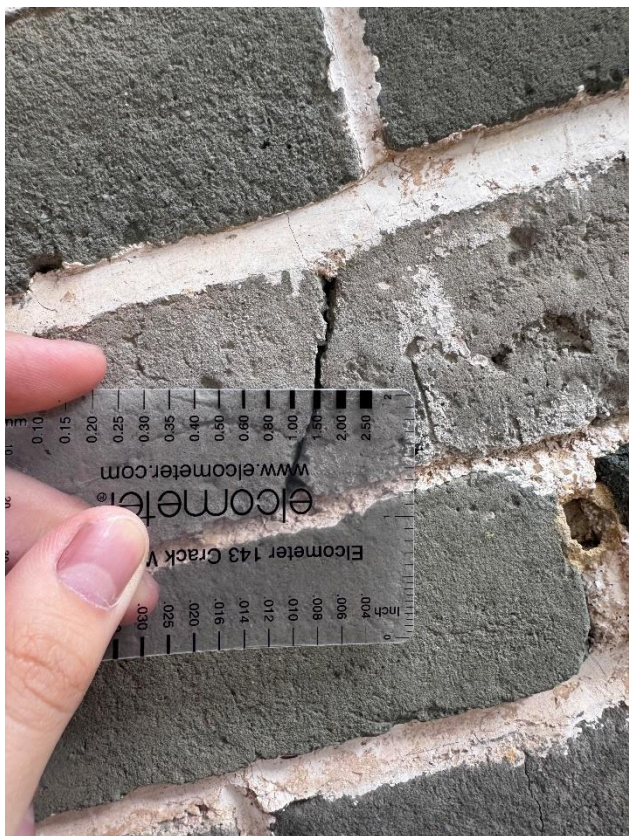
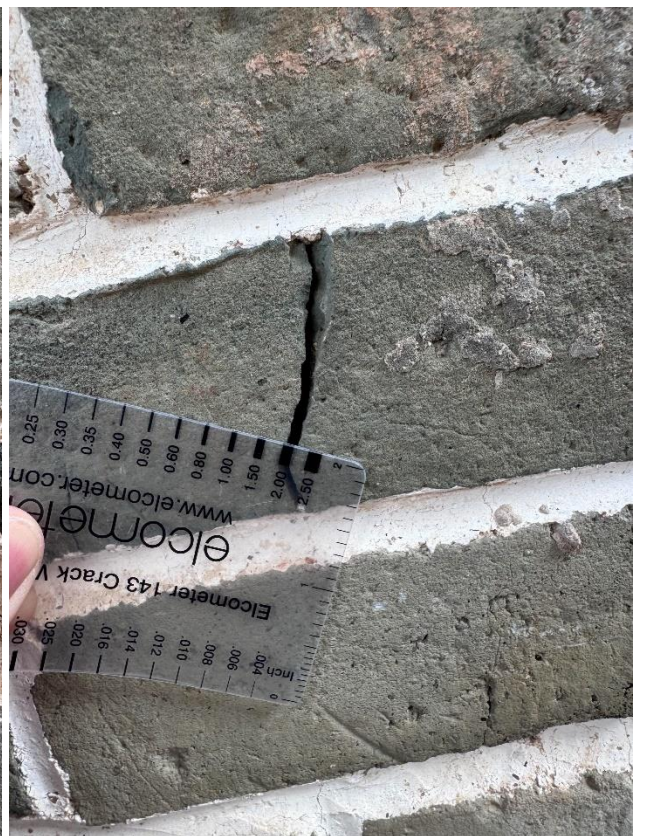
D3.23	Severe cracks (wider than 2mm) and hairline crack (less than 1mm) were found on the blocks.
-------	---

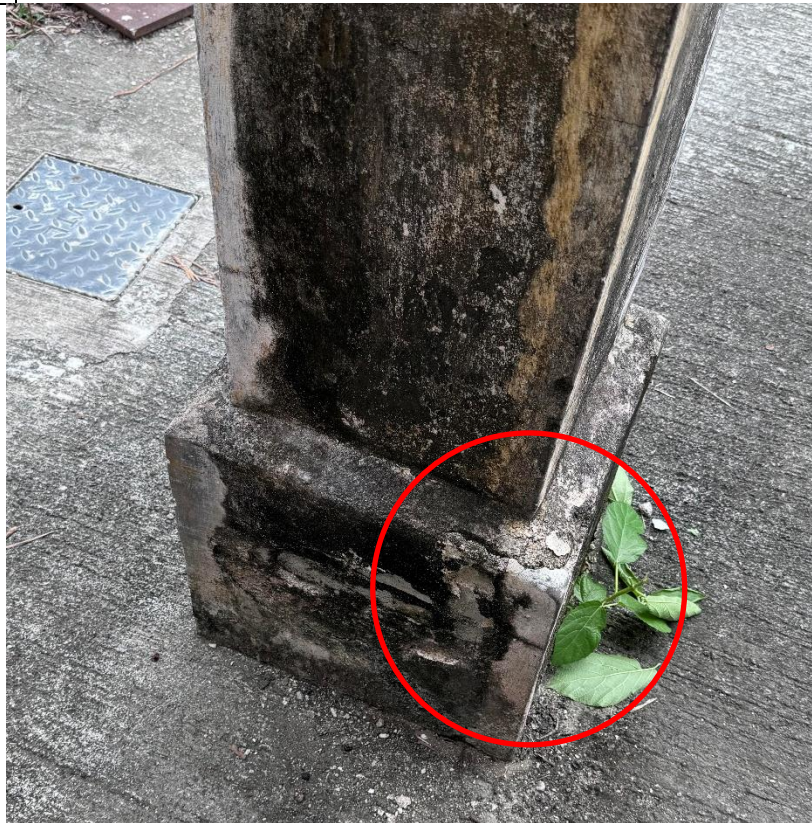
D3.25

Concrete spalling was found on the right-side column.

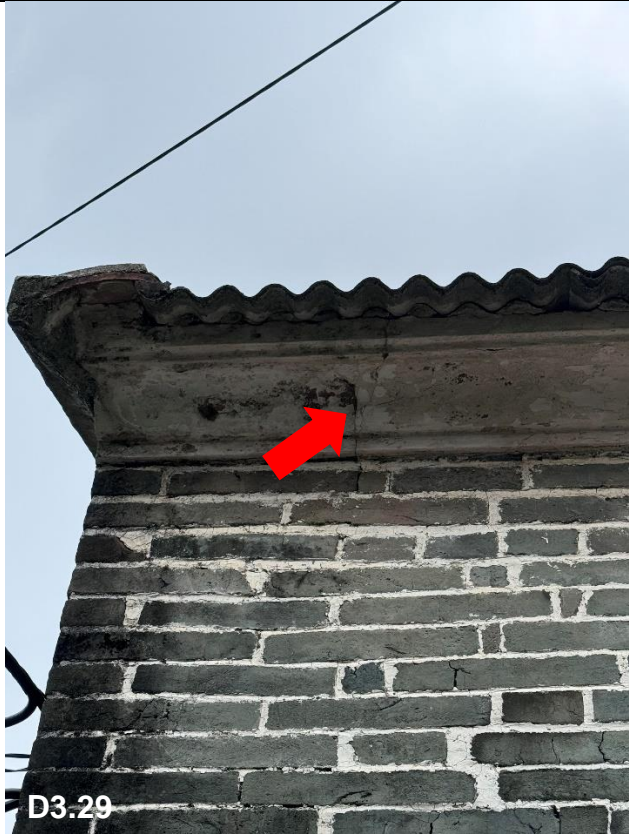
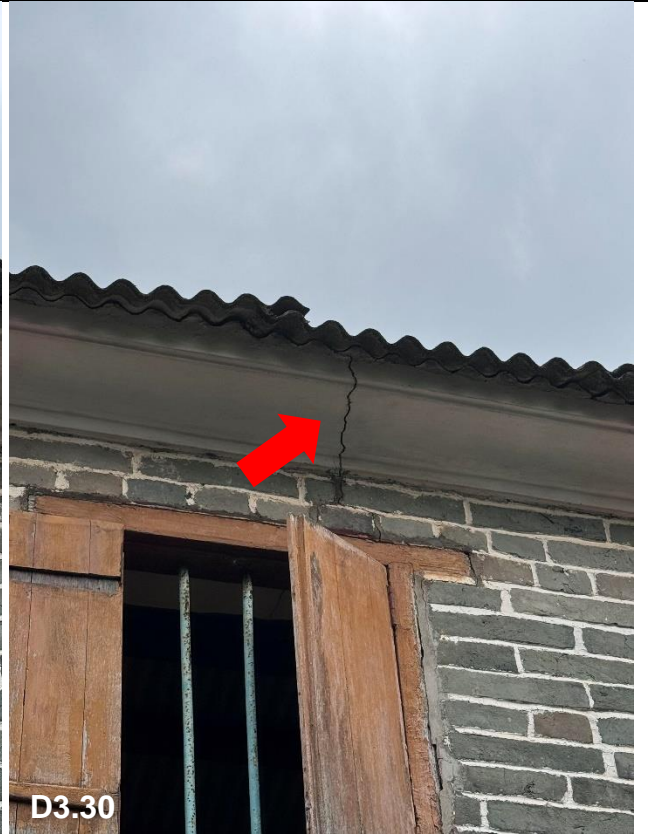
D3.28

Window3 was broken at the south wall of the Chapel.

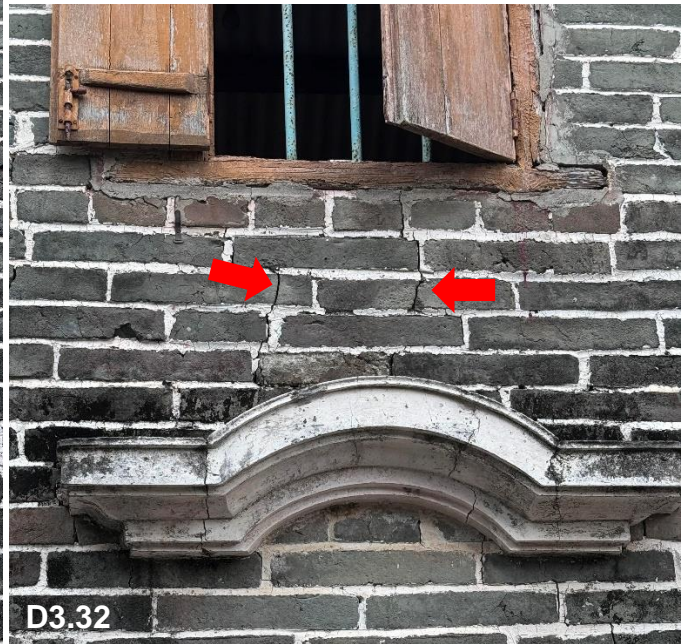
D3.29, D3.30

Severe cracks were found on the south wall eaves of the Chapel.

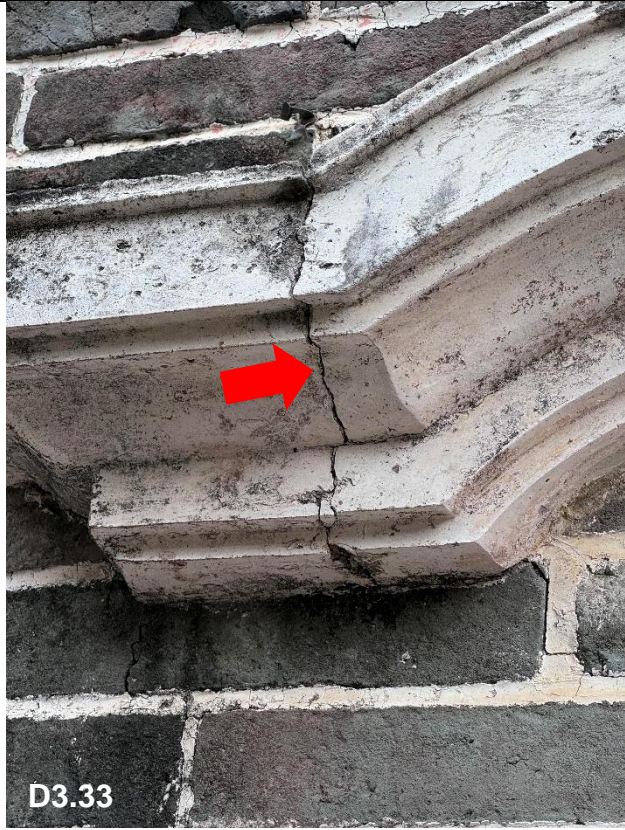
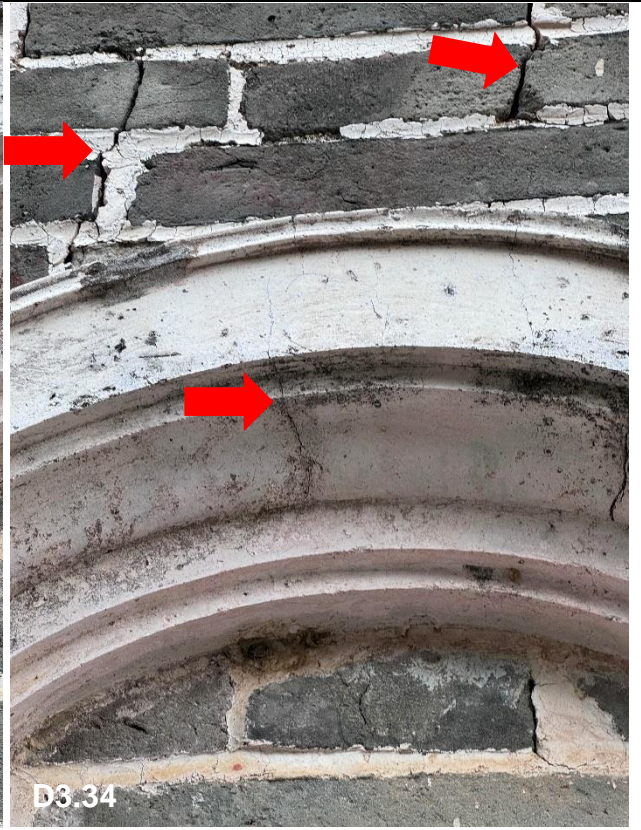
D3.31, D3.32

Severe cracks were found on the blocks.

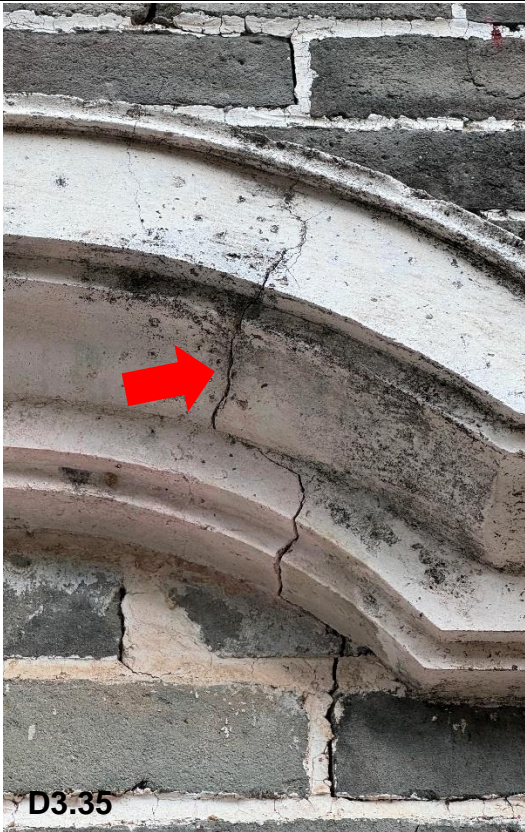
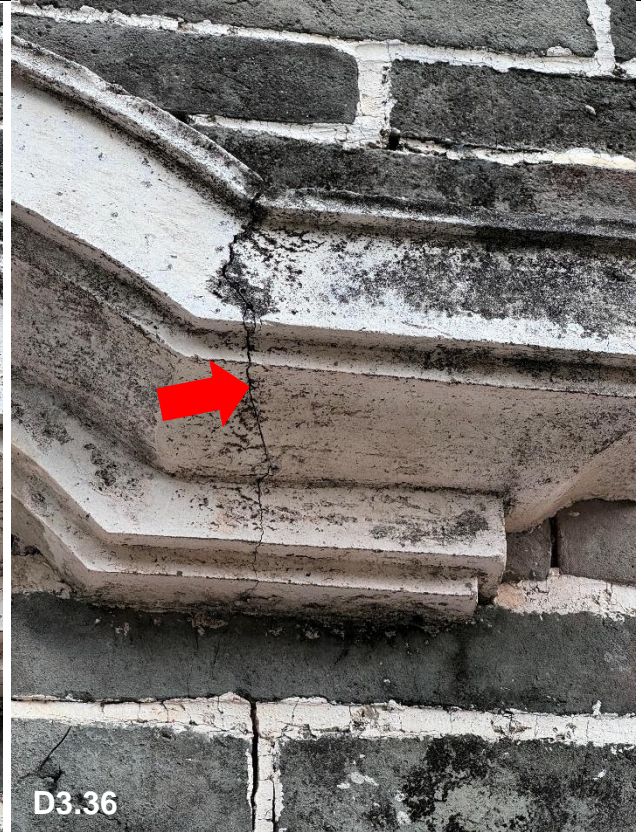
D3.33, D3.34

Severe cracks were found on the blocks and the windows eaves.

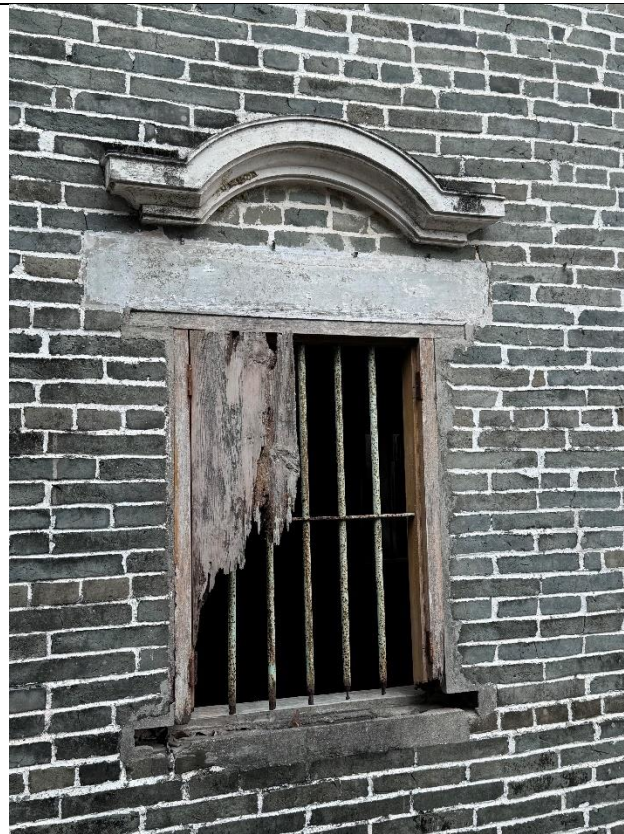
D3.38

Minor crack was found on the south wall eaves of Chapel.

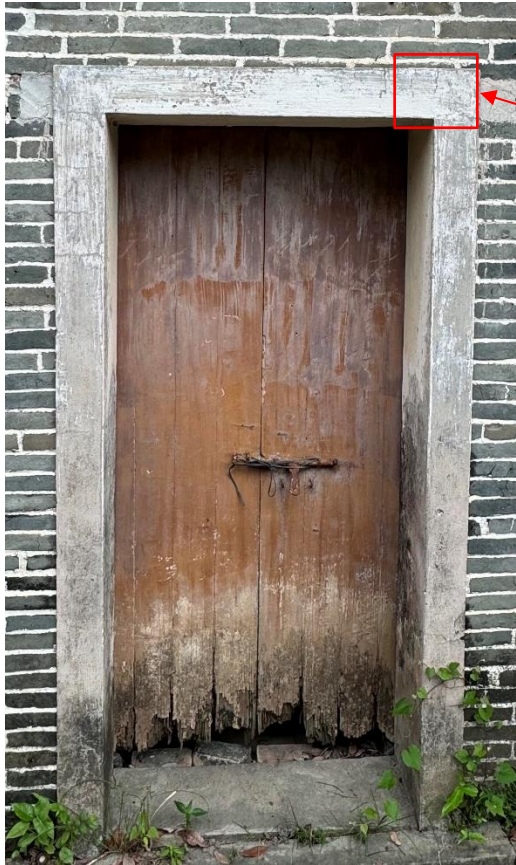
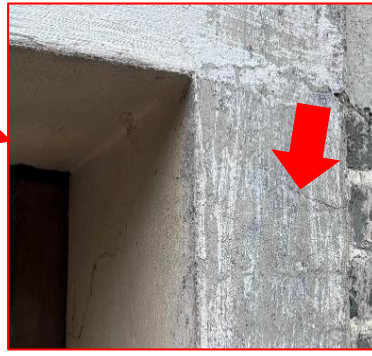
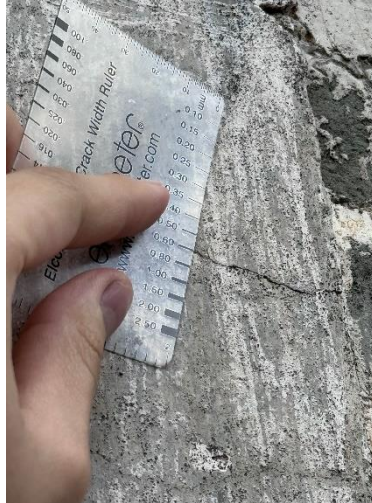
D3.46

Hairline crack (less than 1mm) and minor crack (wider the 1mm but less the 2mm) was found on the side door frame.

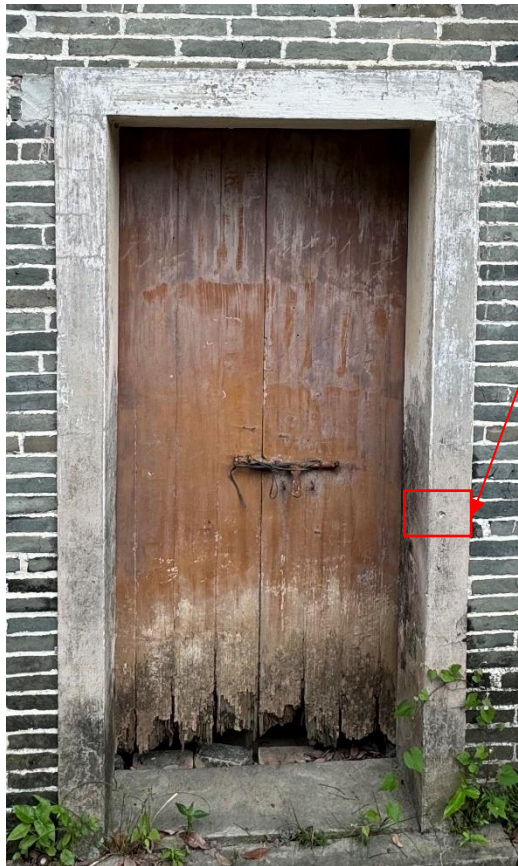
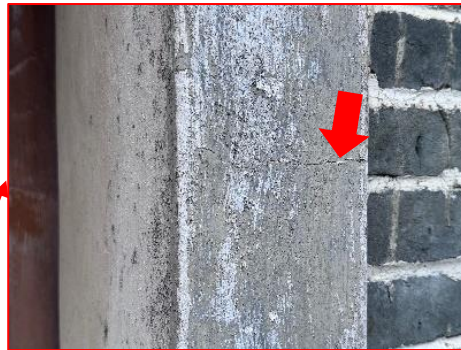
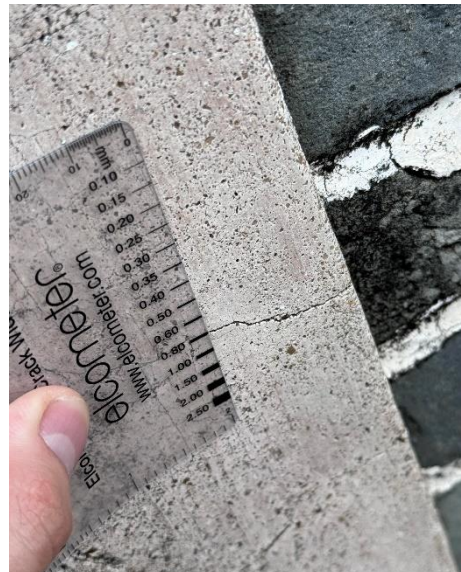
D3.47

Hairline crack (less than 1mm) was found on the side door frame.

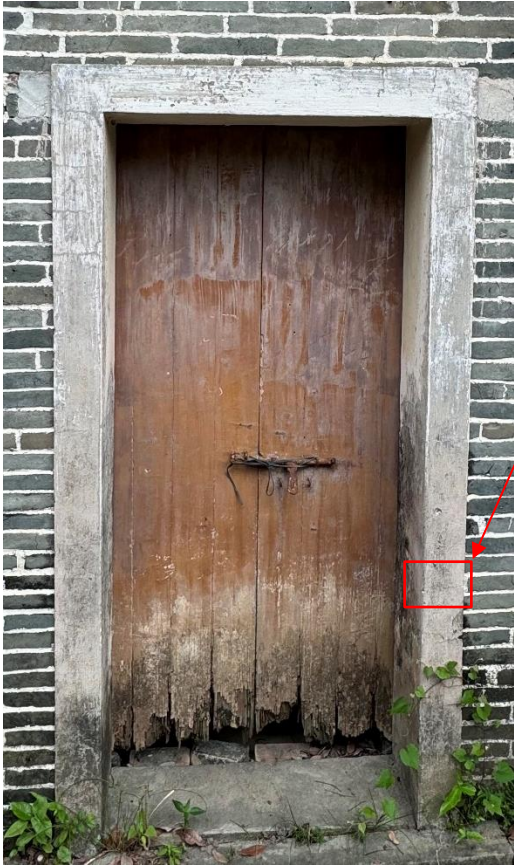
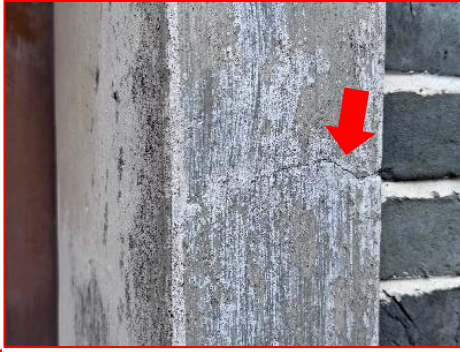
D3.48

Hairline crack (less than 1mm) was found on the side door frame.

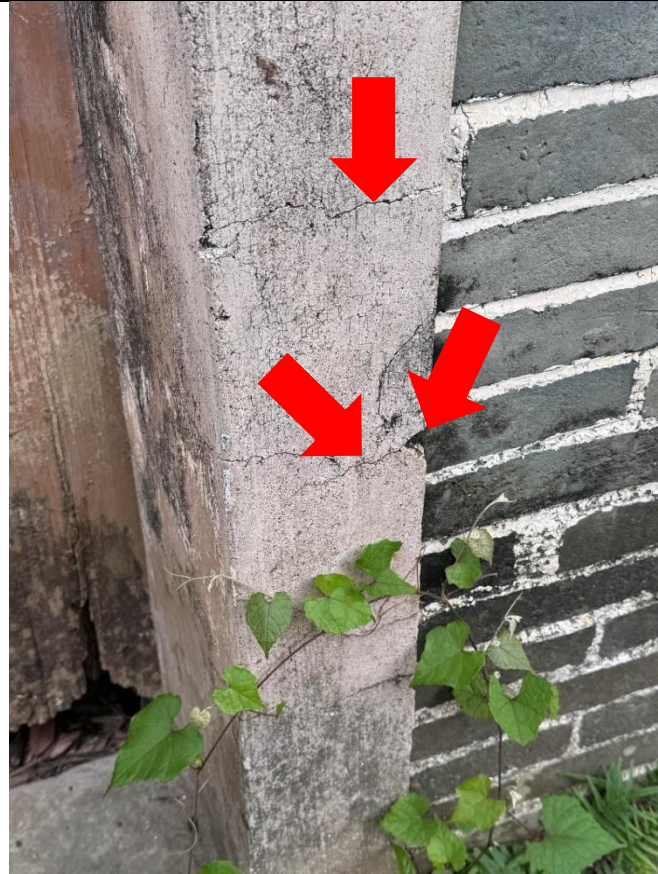
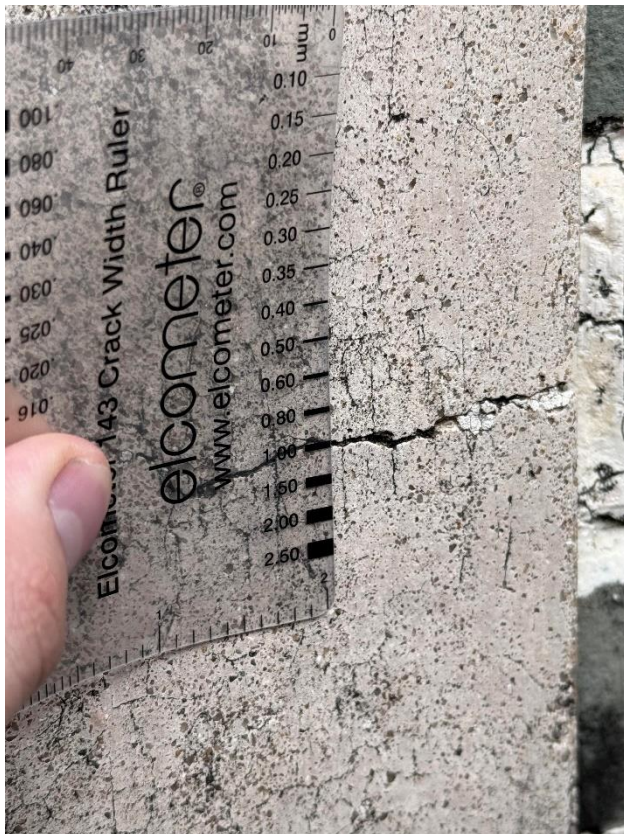
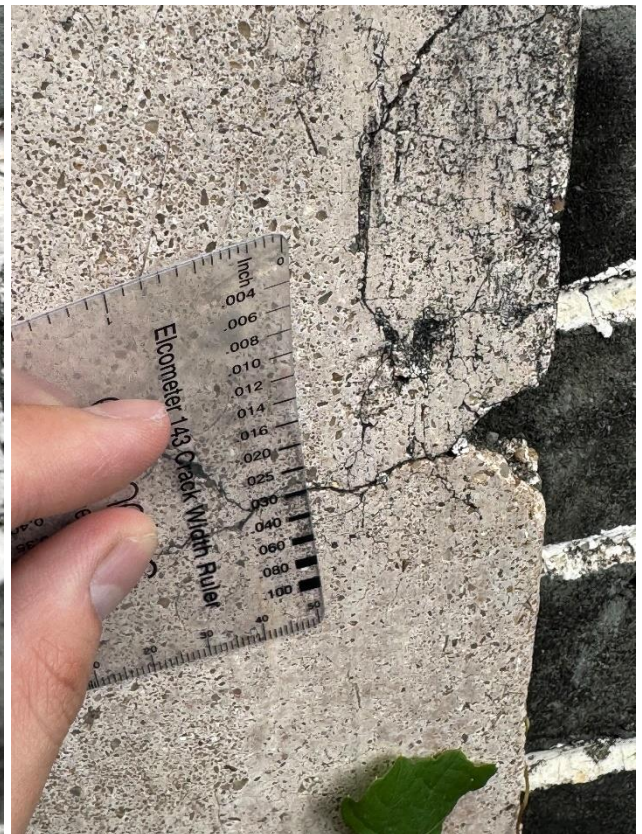
D3.49

Hairline crack (less than 1mm) was found on the side door frame.

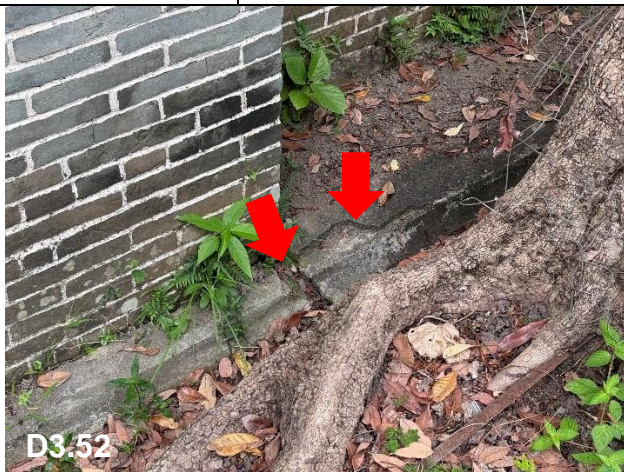
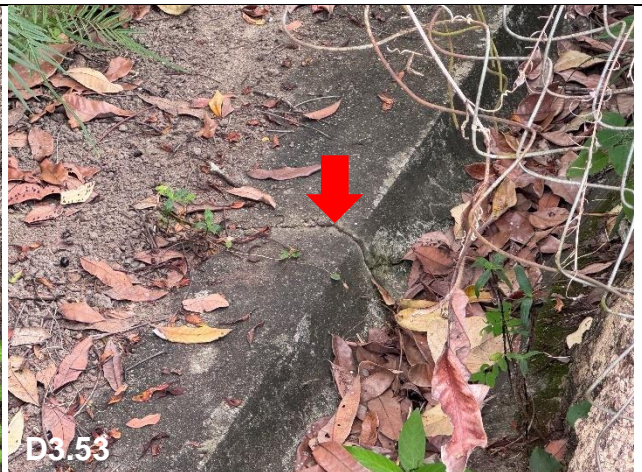
D3.51

Vegetation was found on the south wall of the storeroom2.

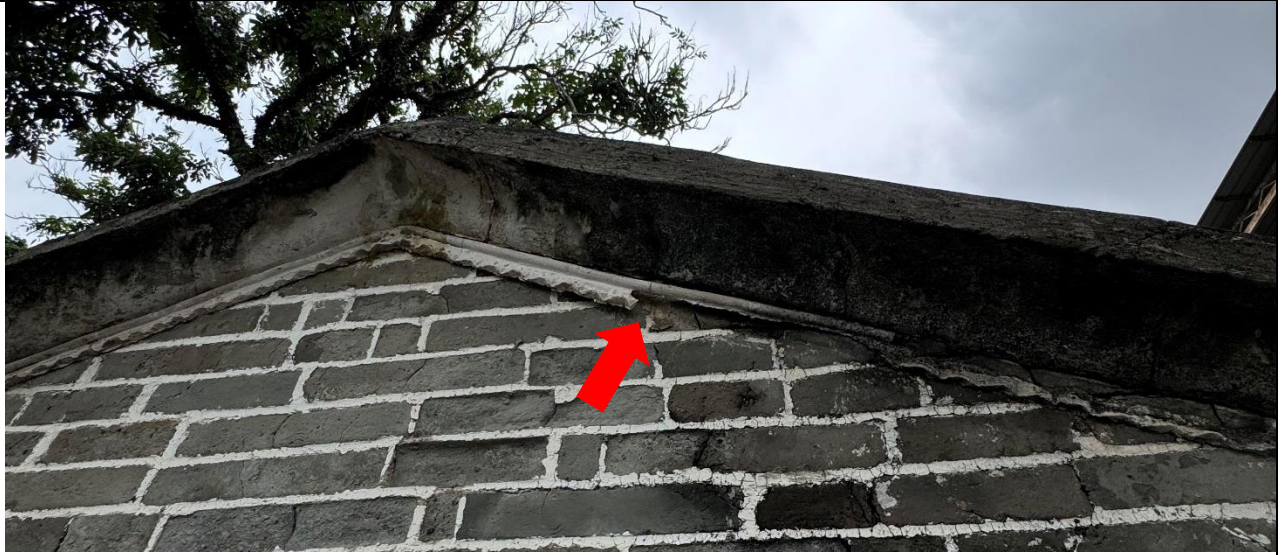
D3.54

Minor and severe cracks were found on the south wall of the Chapel.
