**Agreement no. CE 47/2014 (GE)
-Landslip Prevention and Mitigation
Programme near Bride's Pool Road,
Tai Po – 3SE-D/SA2**

**Monthly Environmental Monitoring and
Audit Report for
April 2024**

(Version 1.0)

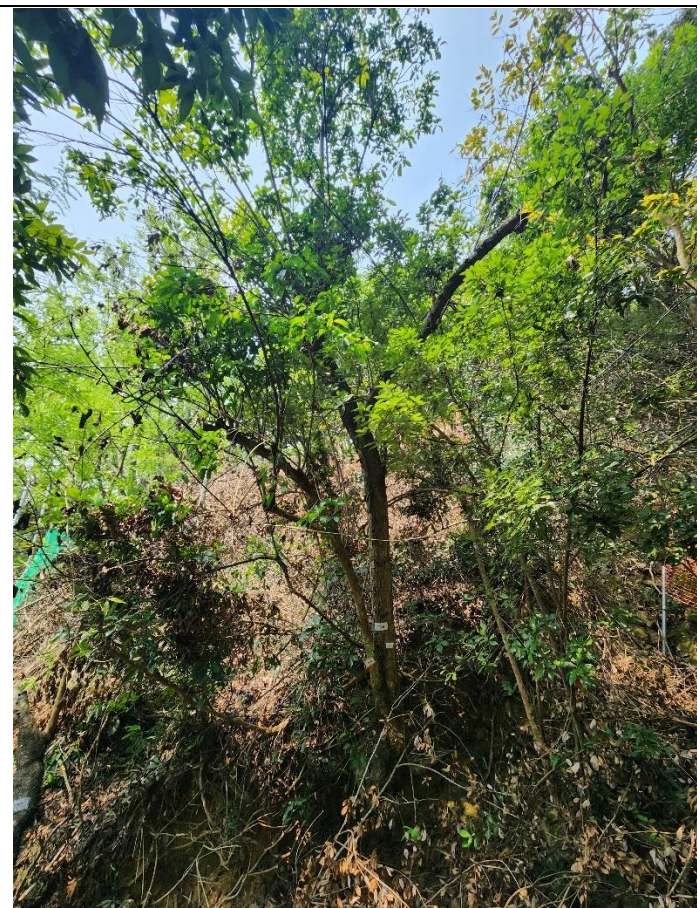
T86	樟	<i>Cinnamomum camphora</i>	Highways	M	P	P	P	/	many water sprouts	grow on slope, water sprouts, dieback
T87	陰香	<i>Cinnamomum burmannii</i>	Highways	M	A	G	P	/	/	grow on slope, incline, dieback, broken branches
T88	水團花	<i>Adina pilulifera</i>	Highways	M	G	G	G	/	/	grow on slope, next to concrete, broken branches, nearly dead
T89	陰香	<i>Cinnamomum burmannii</i>	Highways	M	A	A	A	/	many water sprouts	grow on slope, incline, water sprouts
T90	楓香	<i>Liquidambar formosana</i>	Highways	M	G	A	G	/	/	grow on slope, chopped trunk
T103	鴨腳木	<i>Schefflera heptaphylla</i>	AFCD	M	G	A	A	/	many water sprouts	incline, grow on slope, water sprout
T104	鴨腳木	<i>Schefflera heptaphylla</i>	AFCD	M	G	G	G	/	/	incline, grow on slope
T105	銀柴	<i>Aporosa dioica</i>	AFCD	M	P	G	P	/	many water sprouts	incline, grow on slope, water sprout, covered by climbers, broken branches

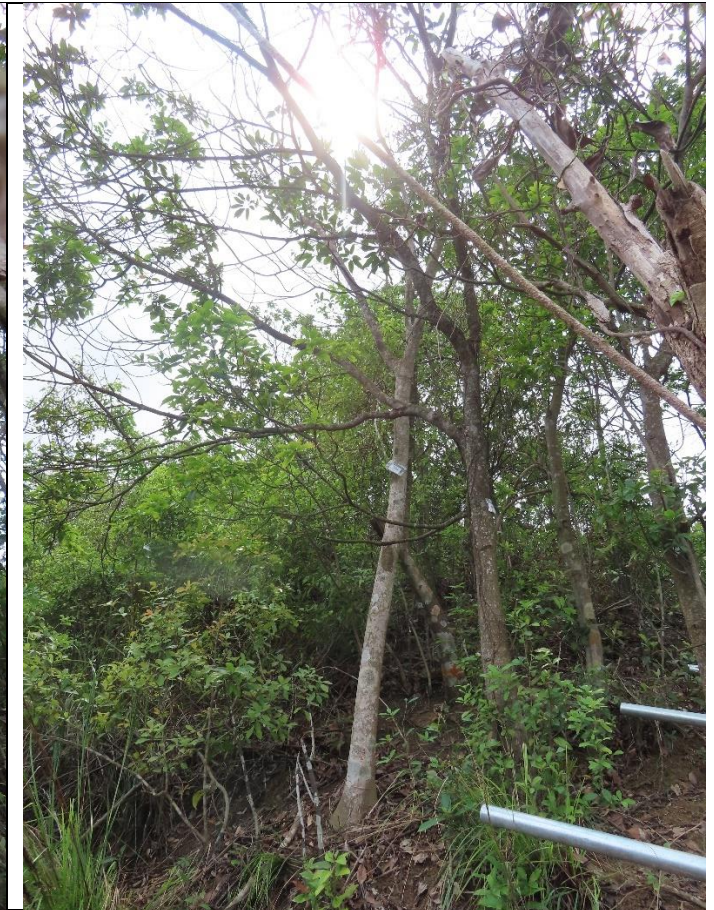
T349	鴨腳木	<i>Schefflera heptaphylla</i>	AFCD	M	G	A	G	/	/	grow on slope, broken branches, dieback
T350	木荷	<i>Schima superba</i>	AFCD	M	A	A	A	/	/	grow on slope, dieback, broken branches
T351	木荷	<i>Schima superba</i>	AFCD	M	A	A	A	/	/	grow on slope, broken branches, dieback
T352	黃瑞木	<i>Adinandra millettii</i>	AFCD	M	G	G	G	/	/	grow on slope, broken branches, dieback, water sprout
T353	鴨腳木	<i>Schefflera heptaphylla</i>	AFCD	M	G	G	G	/	/	grow on slope, broken branches, water sprout
T354	木荷	<i>Schima superba</i>	AFCD	M	G	G	G	/	/	grow on slope, water sprout, broken branches, dead branches
T355	竹節樹	<i>Carallia brachiata</i>	AFCD	M	G	G	G	/	/	grow on slope, water sprout
T356	木荷	<i>Schima superba</i>	AFCD	M	G	A	G	/	/	grow on slope, broken branches, water sprout, dieback
T357	木荷	<i>Schima superba</i>	AFCD	M	A	A	G	/	/	grow on slope, covered by climbers, dead branches

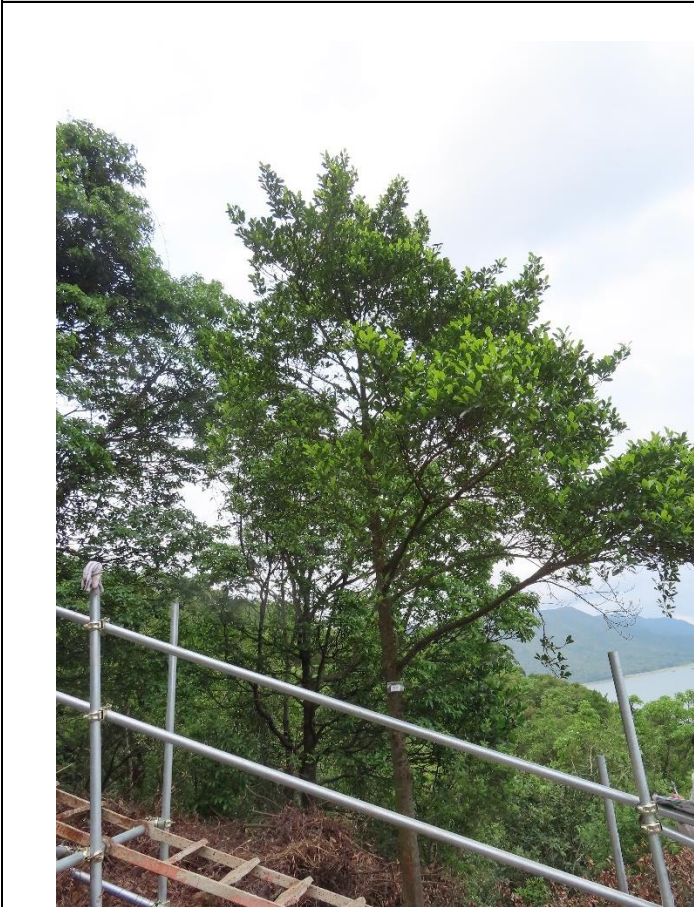
Tree No.	Chinese name	Scientific name	Jurisdiction (AFCD & Highways)	Amenity value	Form	Health	Structural condition	Conservation status	Remarks	Remarks (April)
				(High(H)/ Medium(M)/ Low(L))	(Good(G)/ Average(A)/ Poor(P))					
T360	竹節樹	<i>Carallia brachiata</i>	AFCD	M	G	G	G	/	/	grow on slope, water sprout, broken branches, dieback
T373	竹節樹	<i>Carallia brachiata</i>	AFCD	M	G	A	G	/	intertwined with T374	grow on slope, broken branches, dieback, covered by climbers
T374	竹節樹	<i>Carallia brachiata</i>	AFCD	M	G	G	G	/	intertwined with T373	grow on slope, stick to T373
T375	土沉香	<i>Aquilaria sinensis</i>	AFCD	L	A	P	A	Cap 586 Near Threatened (Rare and Precious Plants of Hong Kong (Status in China)) Vulnerable (China Plant Red Data Book) Vulnerable (IUCN Redlist)	Die back	Dead
T394	樟	<i>Cinnamomum camphora</i>	AFCD	M	P	A	P	/	codominant, covered by climbers	grow on slope, covered by climbers, broken branches, dead branches, co-dominant

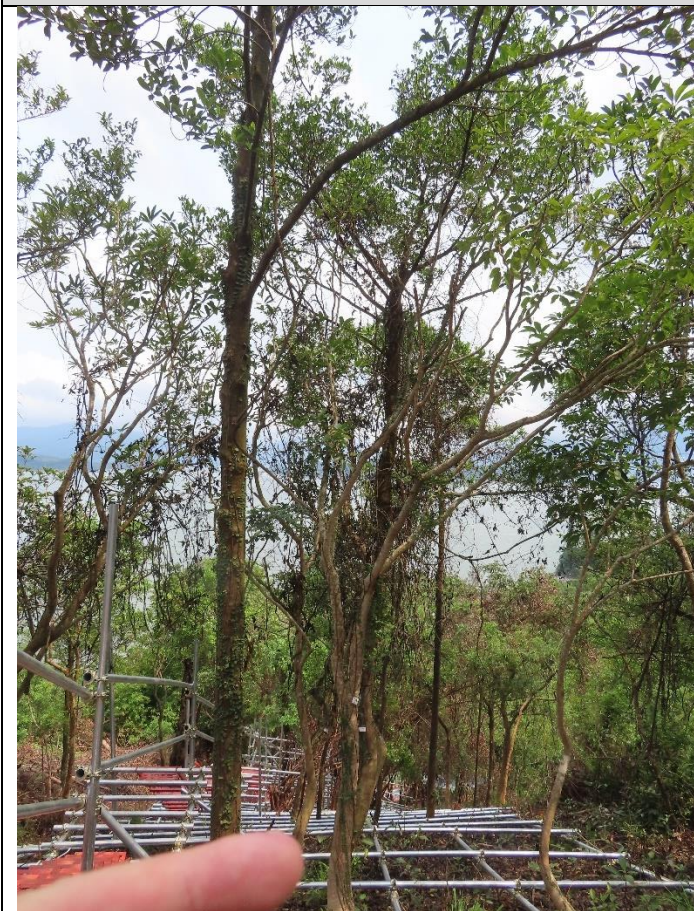
T396	鴨腳木	<i>Schefflera heptaphylla</i>	AFCD	M	A	A	A	/	covered by climbers	grow on slope, broken branches, covered by climbers, dead branches
T397	竹節樹	<i>Carallia brachiata</i>	AFCD	M	G	A	G	/	/	grow on slope, covered by climbers
T398	竹節樹	<i>Carallia brachiata</i>	AFCD	M	G	A	A	/	covered by climbers	grow on slope, covered by climbers
T399	鴨腳木	<i>Schefflera heptaphylla</i>	AFCD	M	A	P	A	/	covered by climbers	grow on slope, broken branches, covered by climbers, low foliage
T400	鴨腳木	<i>Schefflera heptaphylla</i>	AFCD	M	A	A	A	/	have wound, covered by climbers	grow on slope, covered by climbers, water sprout, low foliage

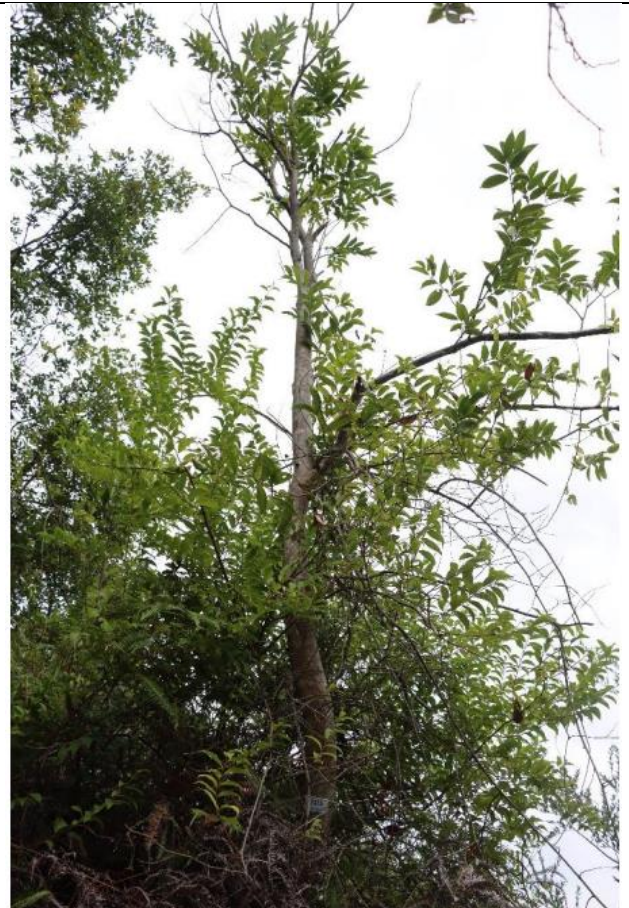
A004(T375): Dead

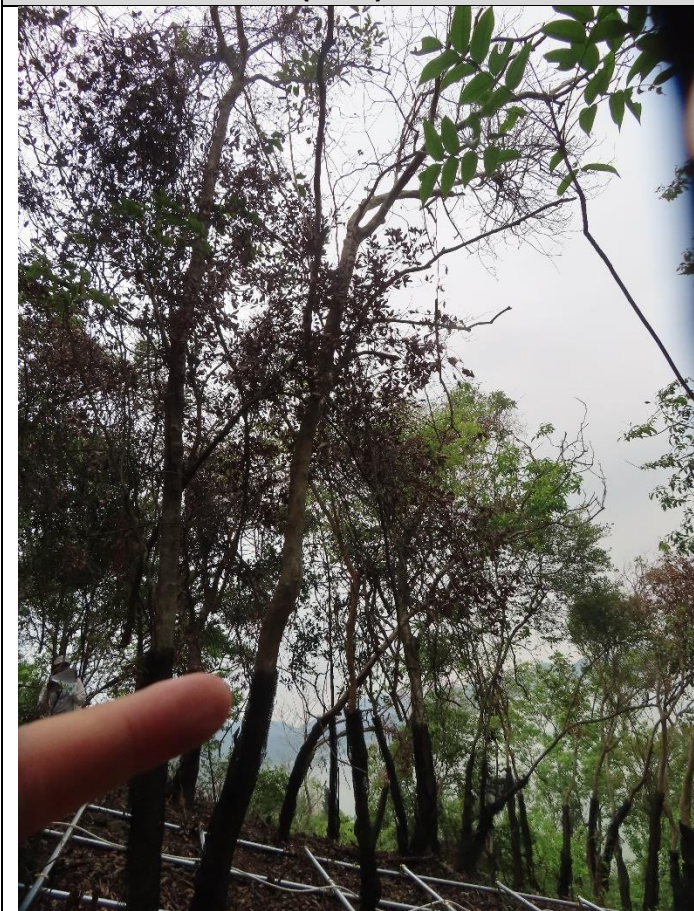
A004(T375): Baseline stage

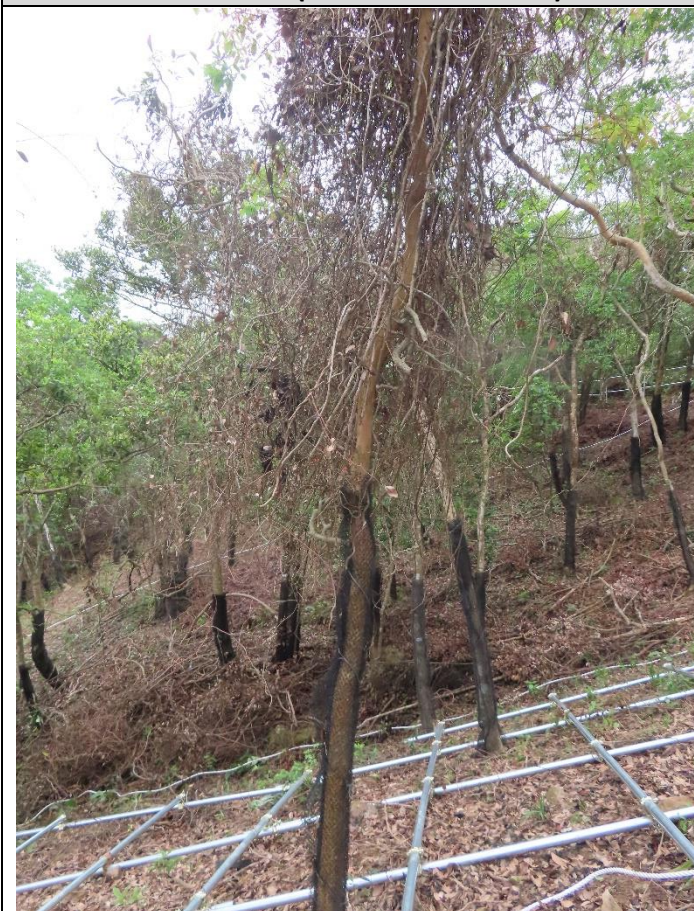
T694: Baseline stage

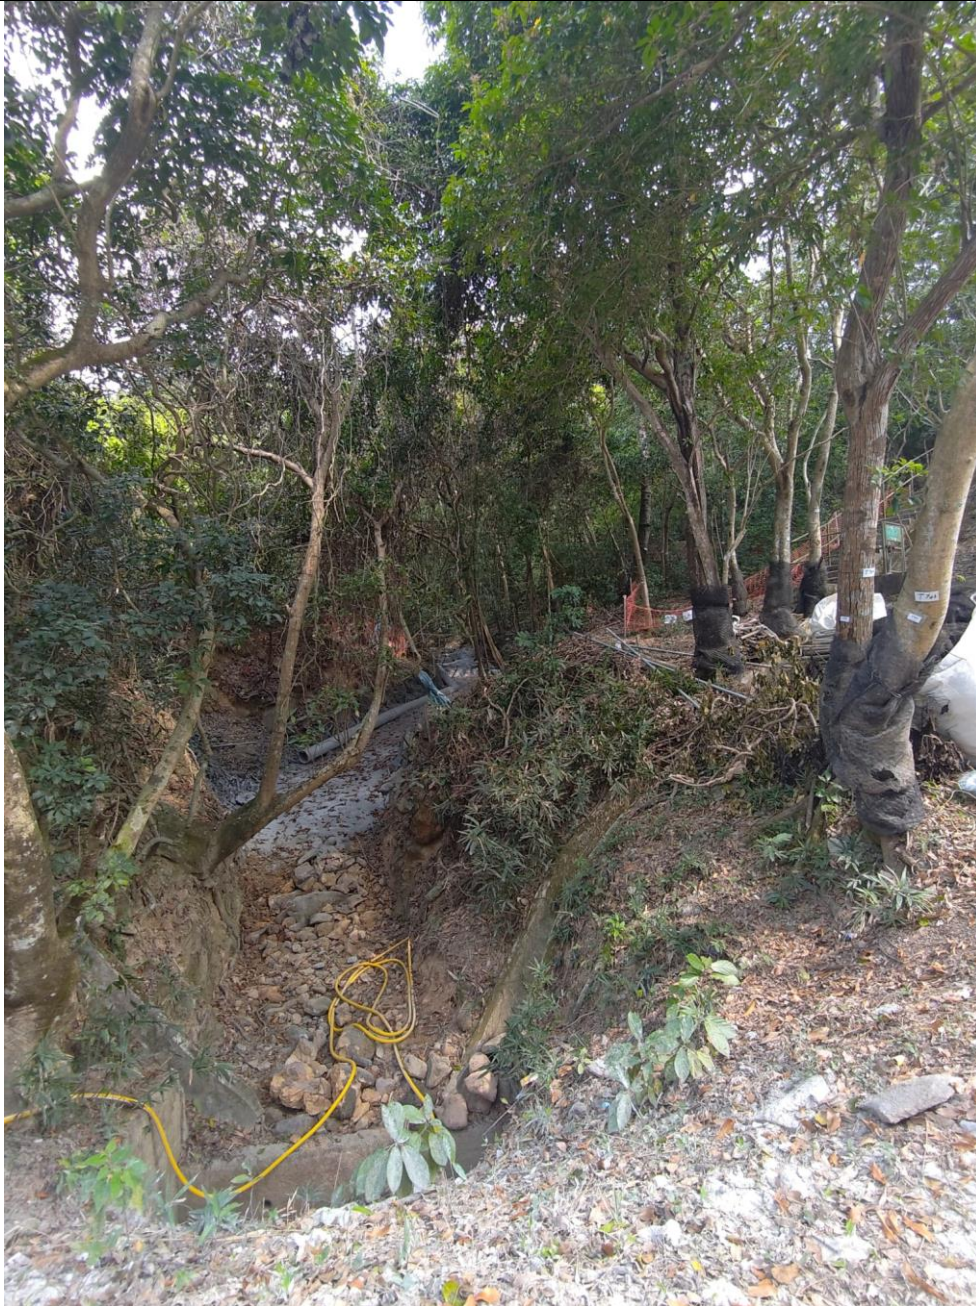
Photo 1: Site photo of Catchment A

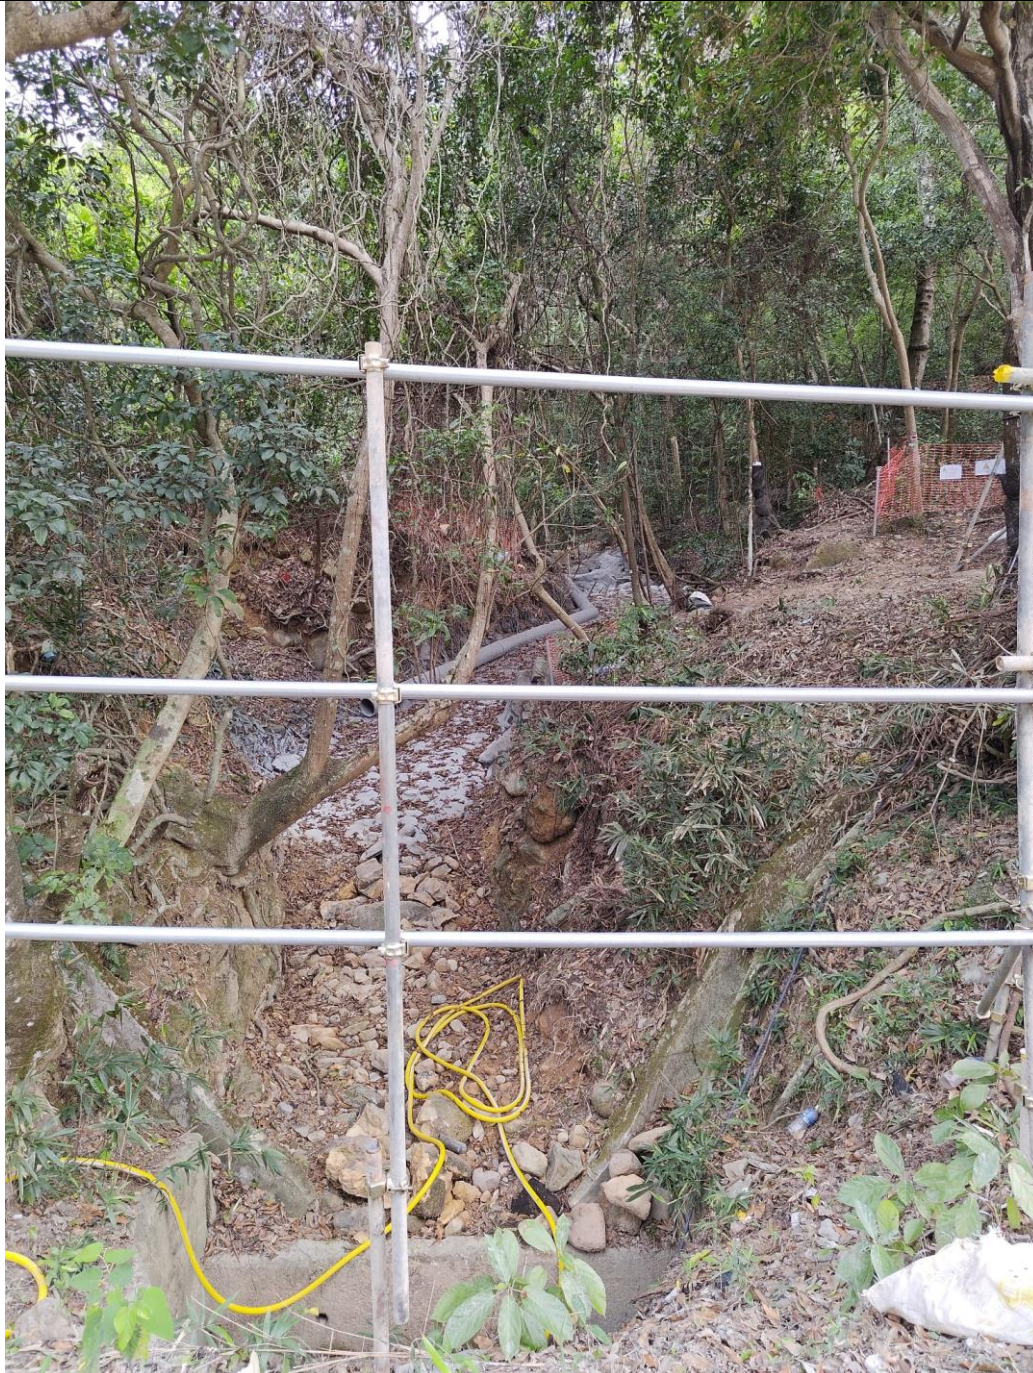
Photo 1: Site photo of Catchment A

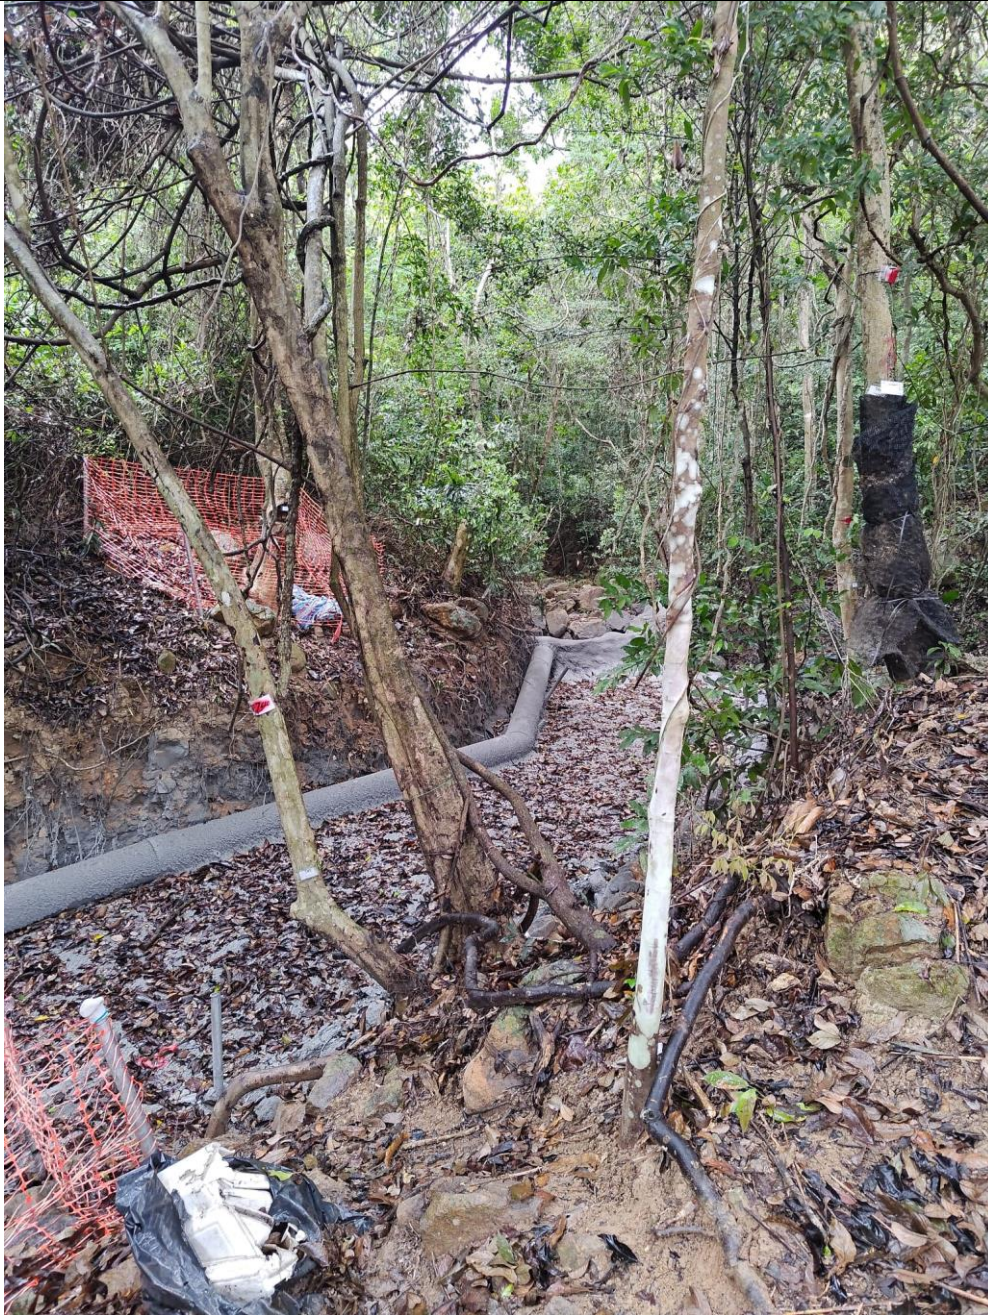
Photo 1: Site photo of Catchment A

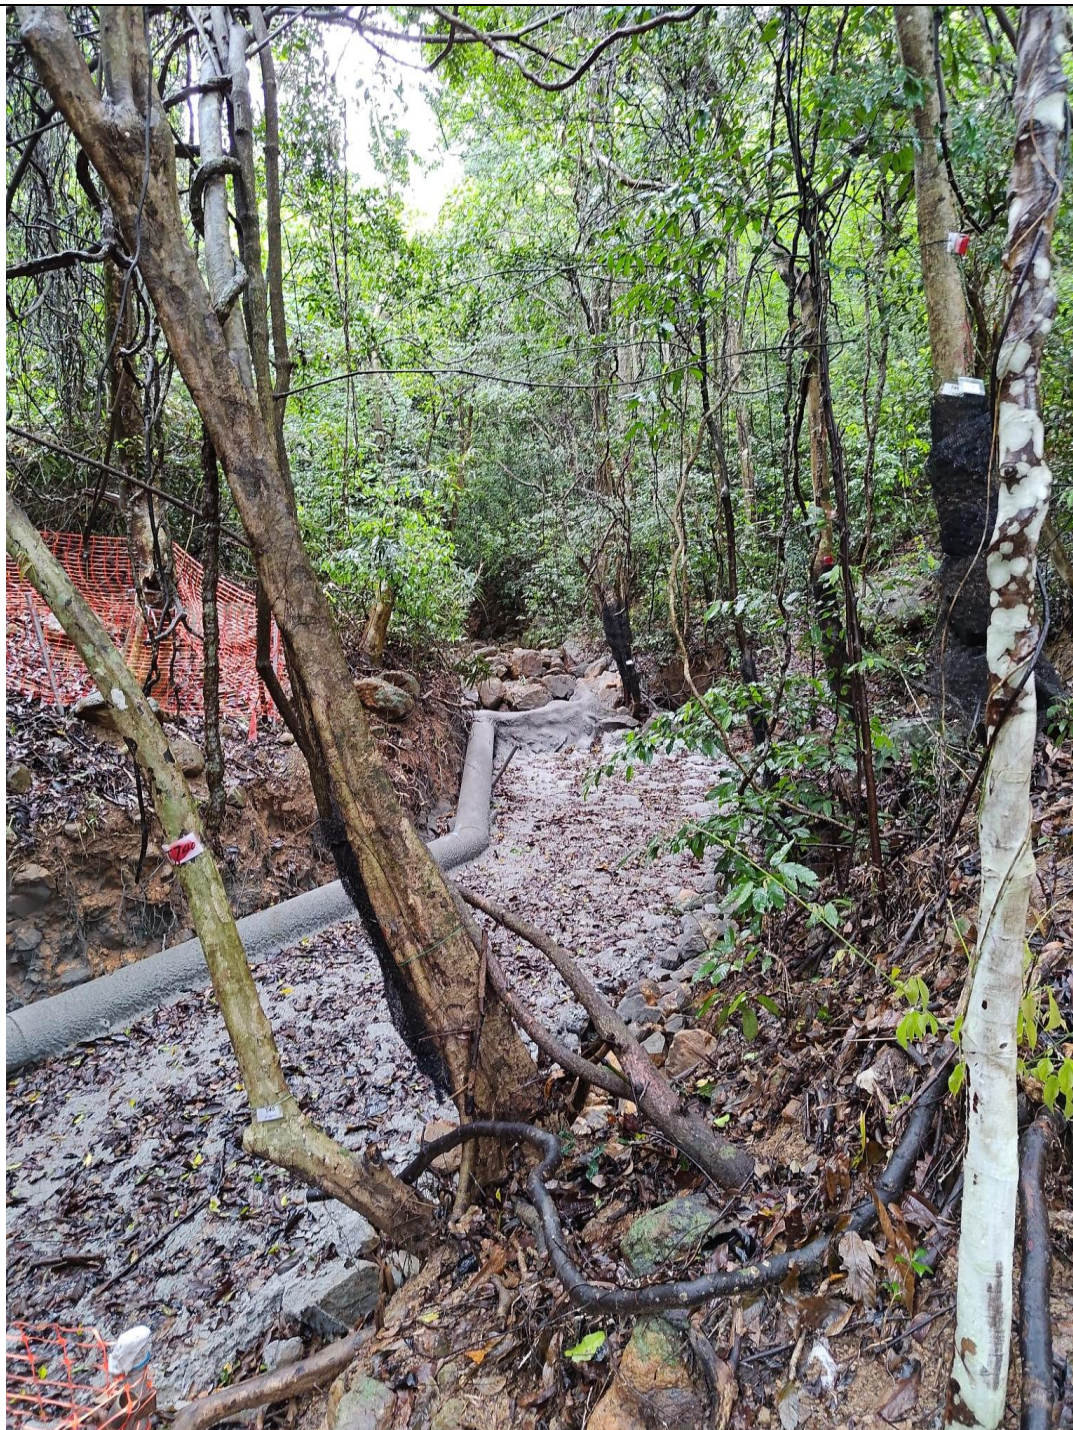
Photo 1: Site photo of Catchment A
