Civil Engineering and Development Department

**Agreement no. CE 47/2014 (GE)
-Landslip Prevention and Mitigation
Programme near Bride's Pool Road,
Tai Po – 3SE-D/SA2**

**Monthly Environmental Monitoring and
Audit Report for
July 2024**

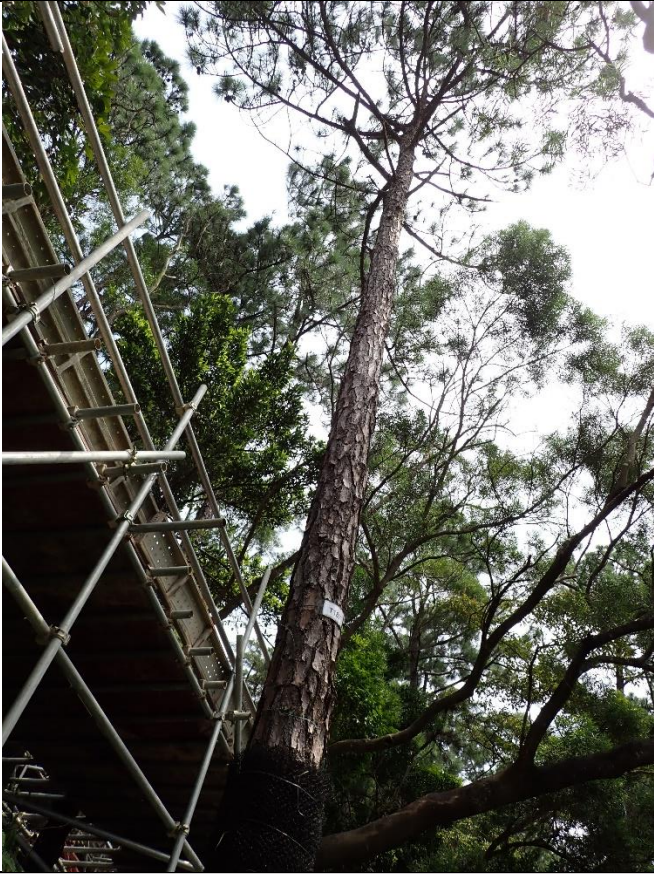
Tree No.	Chinese name	Scientific name	Jurisdiction (AFCD & Highways)	Amenity value	Form	Health	Structural condition	Conservation status	Remarks	Remarks (July)
				(High(H)/ Medium(M)/ Low(L))	(Good(G)/ Average(A)/ Poor(P))					
T187	濕地松	<i>Pinus elliottii</i>	AFCD	M	G	A	A	/	/	Grow on slope, broken branches
T188	台灣相思	<i>Acacia confusa</i>	AFCD	L	A	A	P	/	/	Grow on slope, exposed root, incline, broken branches, dead branch
T189	黃牙果	<i>Garcinia oblongifolia</i>	AFCD	M	G	G	G	/	/	Grow on slope, dieback, broken branches
T190	台灣相思	<i>Acacia confusa</i>	AFCD	L	P	P	P	/	/	Grow on slope, incline, broken trunk, water sprouts, covered by climbers
T191	濕地松	<i>Pinus elliottii</i>	AFCD	M	G	G	A	/	/	Grow on slope, covered by climbers, broken branches
T192	濕地松	<i>Pinus elliottii</i>	AFCD	H	G	G	A	/	/	Grow on slope, broken branches
T193	濕地松	<i>Pinus elliottii</i>	AFCD	M	G	A	A	/	/	Grow on slope, covered by climbers, broken branches

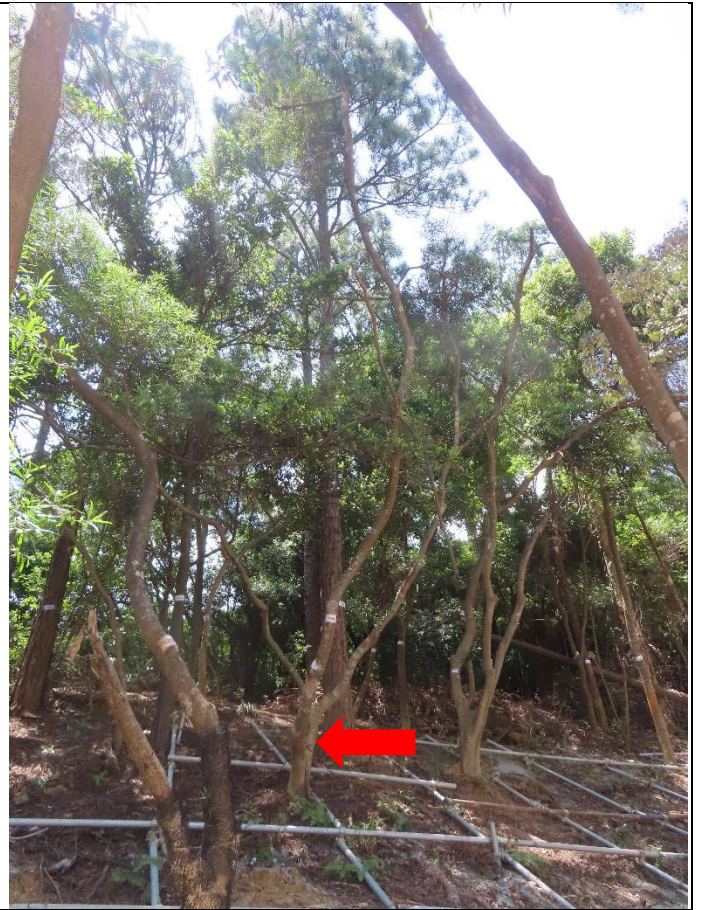
T205	台灣相思	<i>Acacia confusa</i>	AFCD	L	A	A	P	/	many climbers	Grow on slope, water sprouts, broken trunk, broken branches, co-dominant
T206	濕地松	<i>Pinus elliottii</i>	AFCD	H	G	G	A	/	/	Grow on slope, broken branches
T207	黃牙果	<i>Garcinia oblongifolia</i>	AFCD	M	A	G	A	/	many climbers	Grow on slope, covered by climbers, dieback

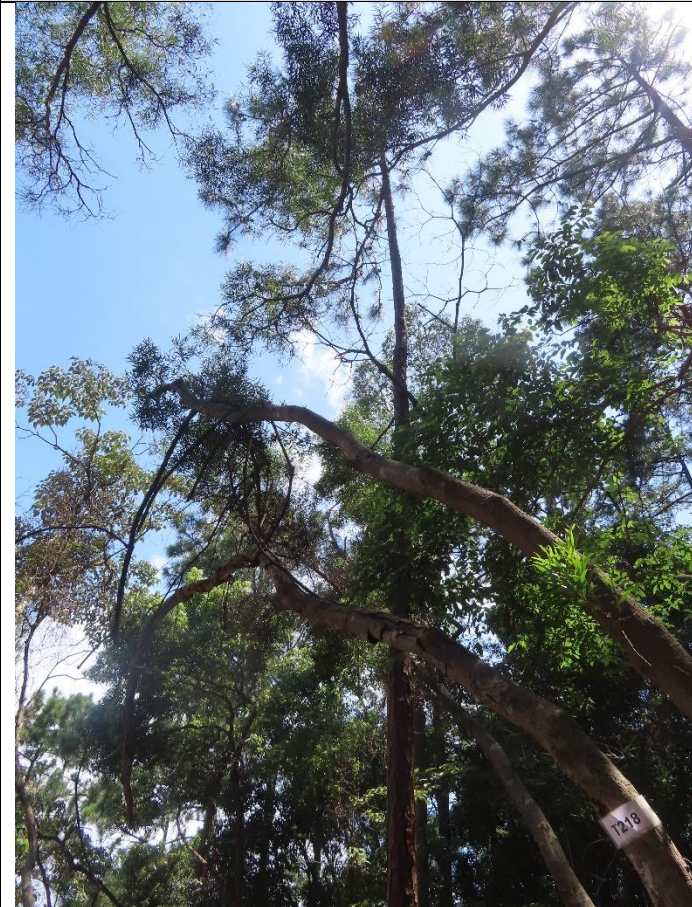
Tree No.	Chinese name	Scientific name	Jurisdiction (AFCD & Highways)	Amenity value	Form	Health	Structural condition	Conservation status	Remarks	Remarks (July)
				(High(H)/ Medium(M)/ Low(L))	(Good(G)/ Average(A)/ Poor(P))					
T208	台灣相思	<i>Acacia confusa</i>	AFCD	L	A	P	A	/	/	Grow on slope, broken trunk, low foliage, water sprouts
T209	台灣相思	<i>Acacia confusa</i>	AFCD	M	A	A	A	/	/	Grow on slope, exposed root, broken trunk, dead branch, covered by climbers
T210	白楸	<i>Mallotus paniculatus</i>	AFCD	/	/	/	/	/	/	Dead Tree
T211	白楸	<i>Mallotus paniculatus</i>	AFCD	L	P	P	P	/	/	Grow on slope, broken trunk, water sprouts, covered by climbers
T212	大頭茶	<i>Polyspora axillaris</i>	AFCD	M	A	A	A	/	/	Grow on slope, incline, water sprouts, covered by climbers, broken branches
T213	白楸	<i>Mallotus paniculatus</i>	AFCD	/	/	/	/	/	/	Dead Tree
T214	濕地松	<i>Pinus elliottii</i>	AFCD	M	G	G	A	/	/	Grow on slope, broken branches

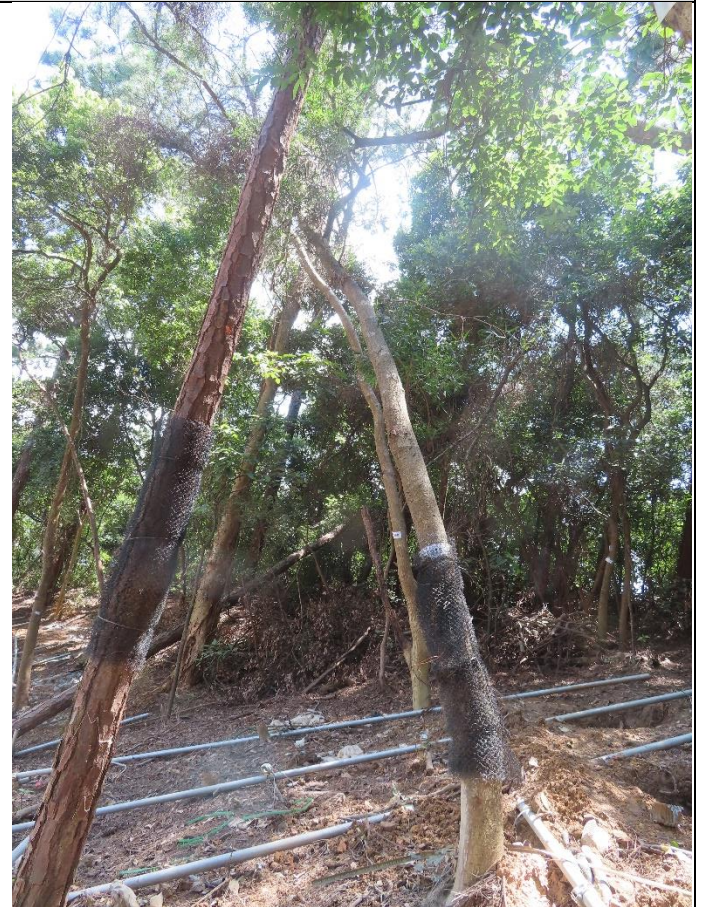
T215	台灣相思	<i>Acacia confusa</i>	AFCD	L	P	P	P	/	/	Grow on slope, incline, water sprouts, covered by climbers
T216	白楸	<i>Mallotus paniculatus</i>	AFCD	M	A	A	A	/	leaves bitten by insects, many climbers & water sprouts, various fractures	Grow on slope, water sprouts, incline
T217	台灣相思	<i>Acacia confusa</i>	AFCD	/	/	/	/	/	/	Dead Tree
T218	台灣相思	<i>Acacia confusa</i>	AFCD	M	A	A	P	/	codominant trunk	Grow on slope, co-dominant, incline, water sprouts, covered by climbers, dead trunk, broken branches

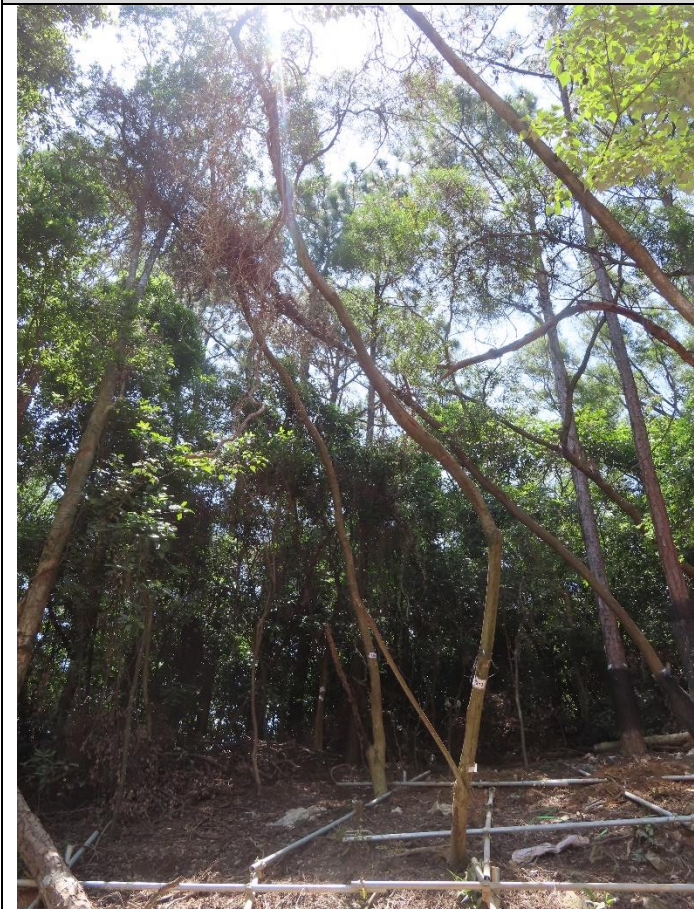
T213 (dead)

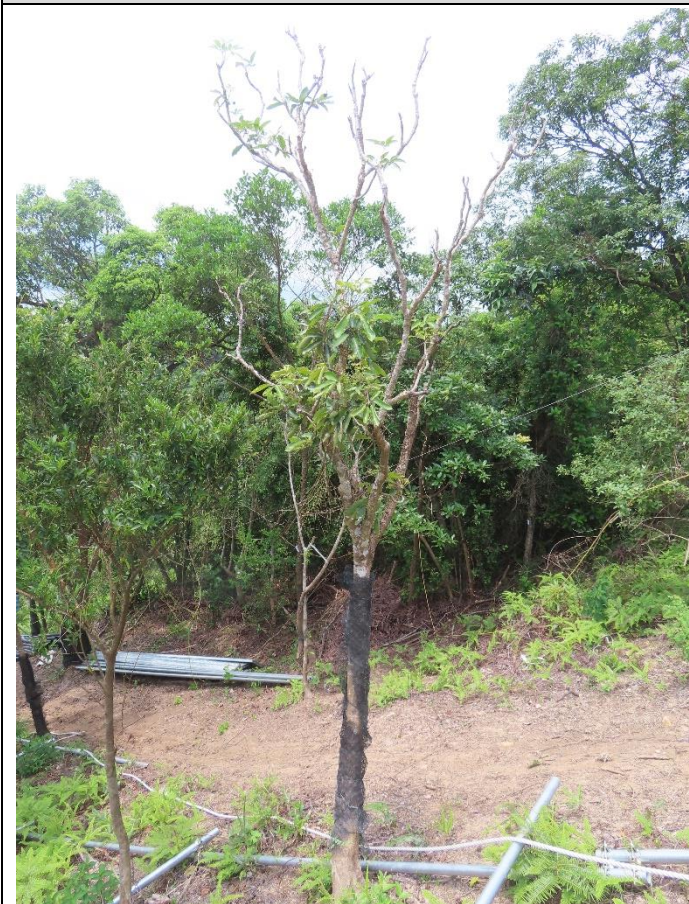
T376 (low foliage)

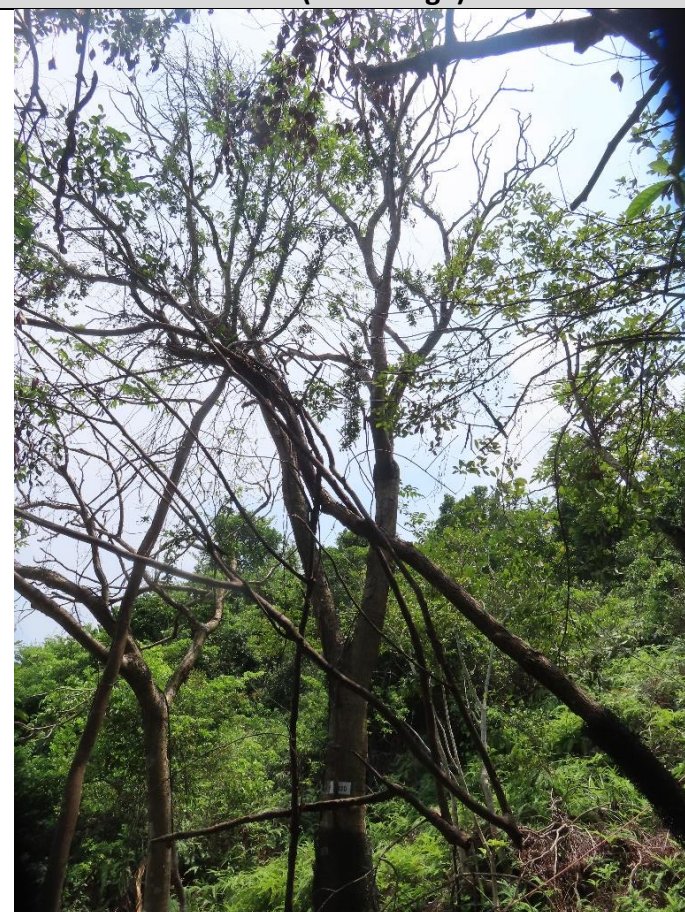
T420 (low foliage)

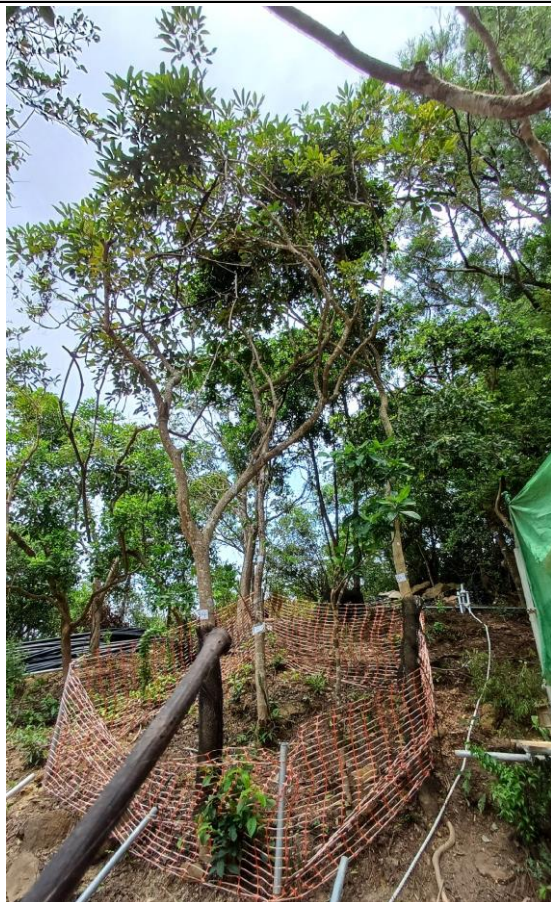
A023 (low foliage)
